**IMERYS REFRACTORY MINERALS SOUTH AFRICA (PTY) LTD –
BLESBOKFONTEIN CLAY QUARRY**

**Annual Rehabilitation Plan and Annual Financial Provision
Based on Appendix 3 (Minimum Content of An Annual Rehabilitation Plan) of
the Regulations Pertaining to the Financial Provision for Prospecting,
Exploration, Mining or Production Operations, 2015 9(GN 1147) (as amended)
i.t.o. the National Environmental Management Act No 107 of 1998 (as
amended).**

DMR ref: MP30/5/1/1/2/450MR

**Location: Portion 4 of the Farm Blesbokfontein 459 JR, Thembisile Hani Local
Municipality, Mpumalanga**

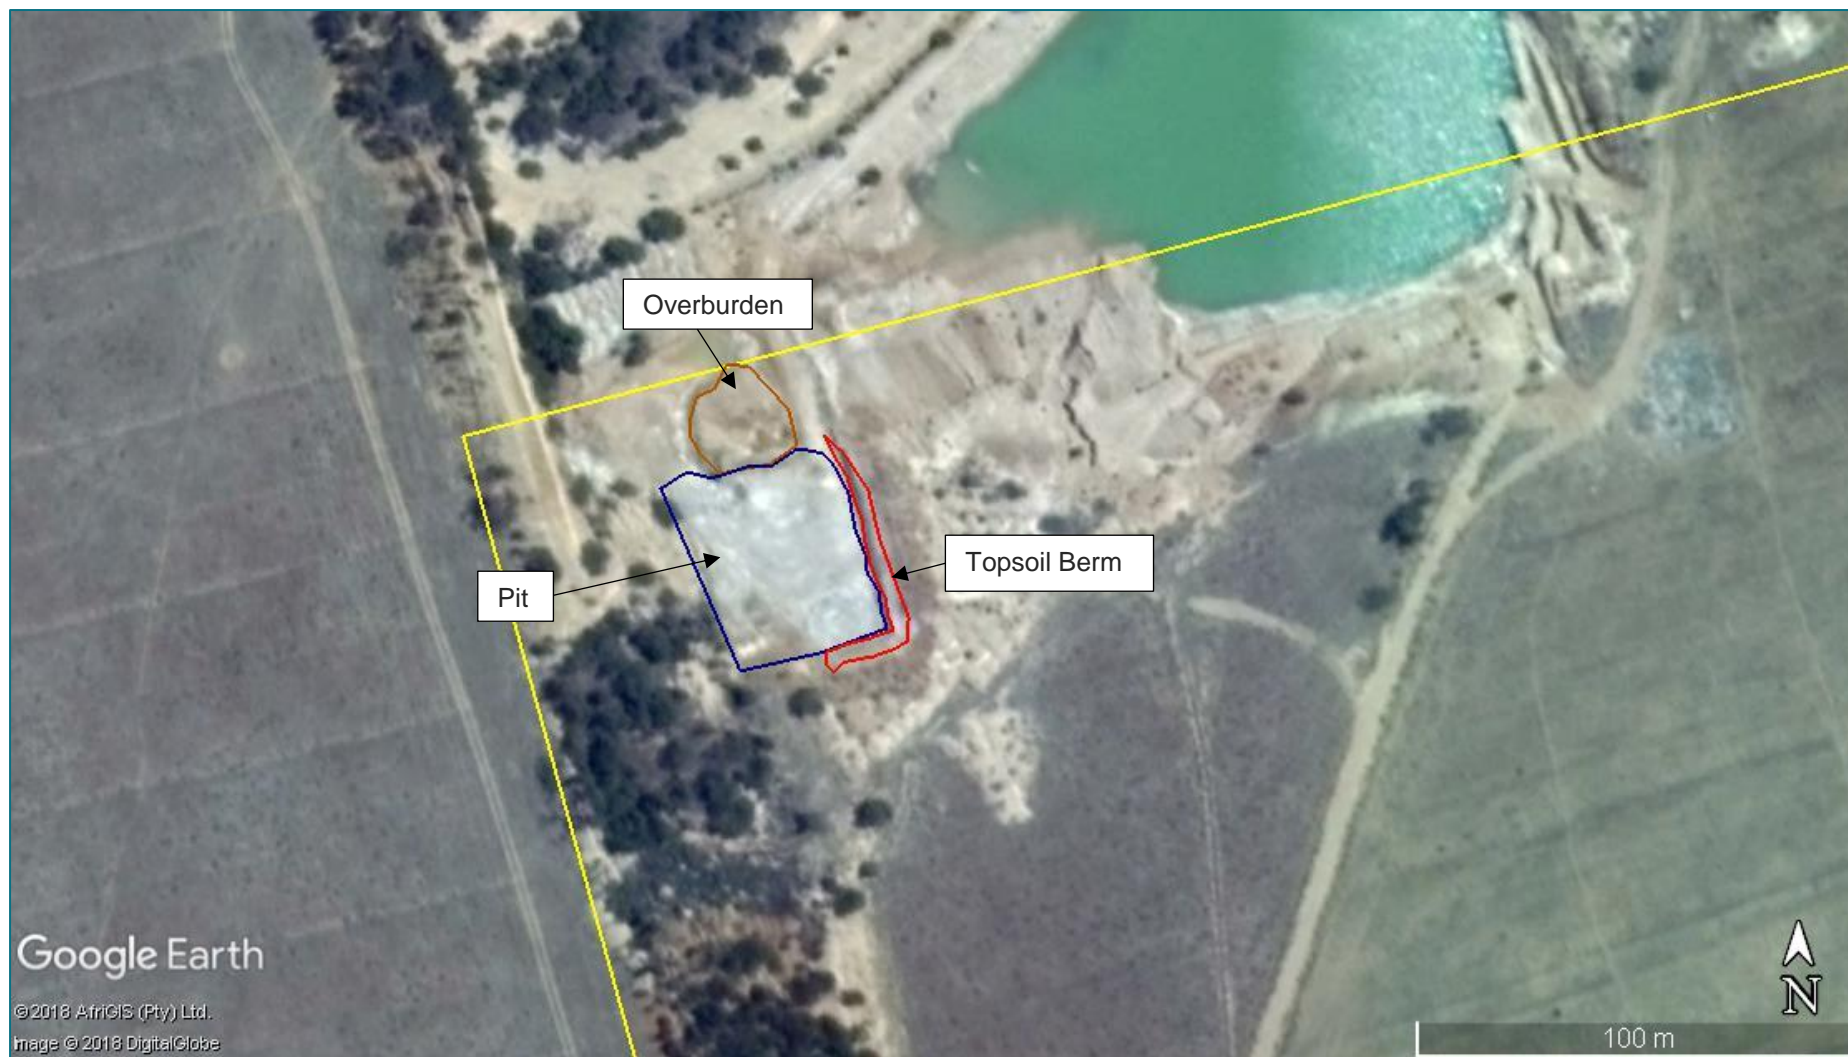
Figure 3: GoogleEarth image indicating area of disturbance

Table 6: Pit development with berm, placement of overburden and topsoil stockpile

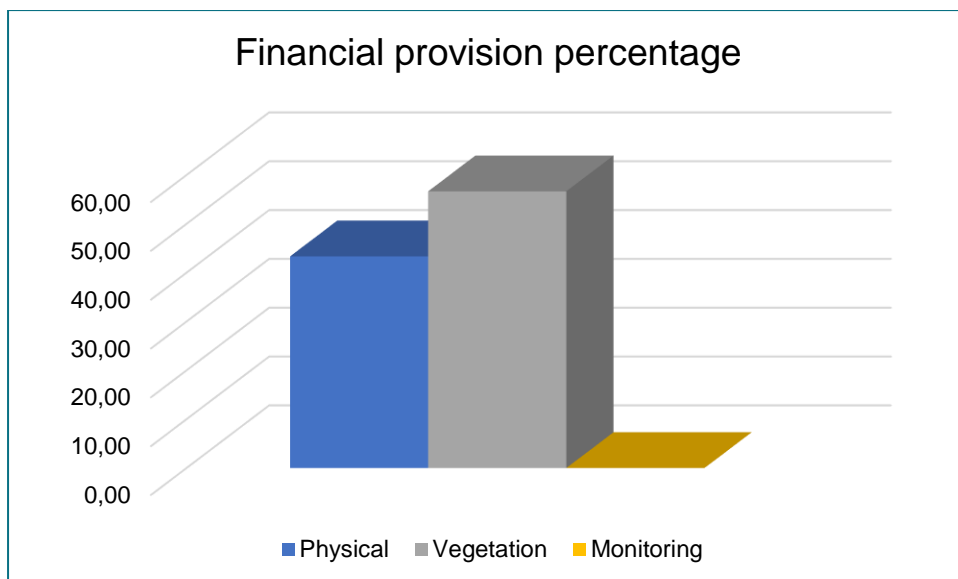
Figure 5: Percentage of financial provision
