### Locality map for the proposed solar development (extent of 134 hectares) for the Wonderpan solar facility located near Prieska, Northern Cape Province.

**Surface water delineation for the proposed solar development (extent of 134 hectares) for the Wonderpan solar facility located near Prieska, Northern Cape Province.**

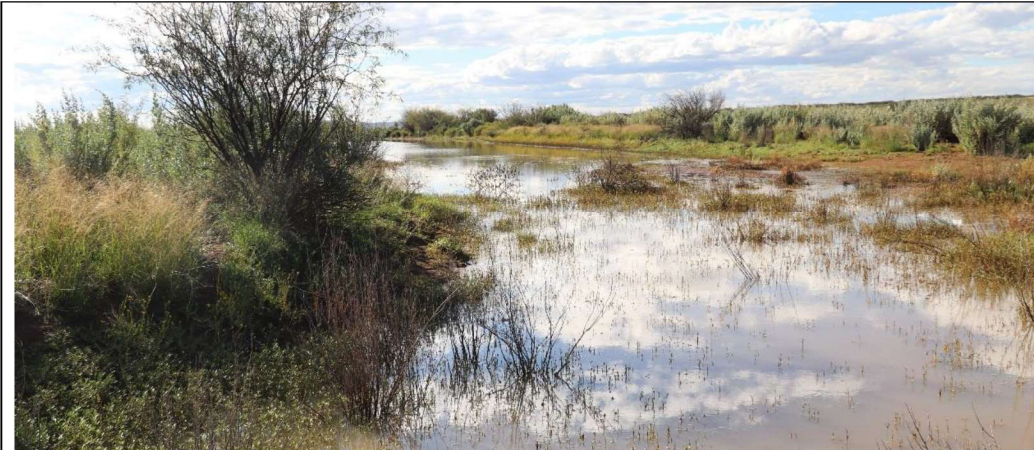
Large pools and extensive wetland conditions are also present within the system.

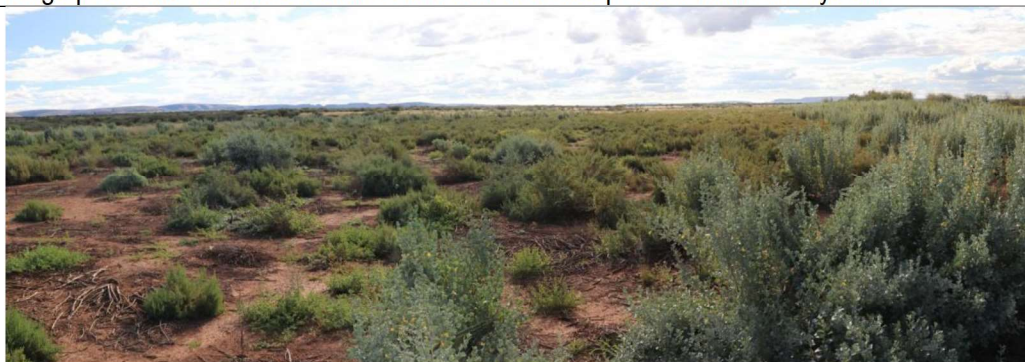
The Karabeelooop has a very wide floodplain dominated by riparian shrubs adapted to high salt concentrations.

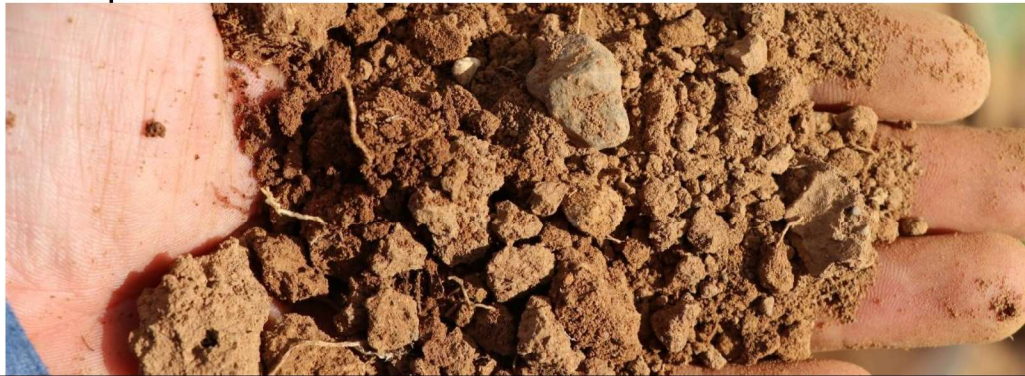
The affected drainage lines are quite small. This specific drainage line does not contain a defined channel (blue) while terrestrial species also dominate.

Because these drainage lines are so small, they are also fairly indistinct and do not contain clearly defined channels. They do however form depressions in the landscape, contain riparian vegetation and clearly function in the transport of surface runoff.

Soils within these drainage lines consist of reddish sandy soils and are devoid of any wetland characteristics. Likewise, vegetation along these drainage lines contain a high degree of riparian grasses and dwarf shrubs while terrestrial species may also be abundant. No exotic weeds were noted which confirms the relatively natural condition of these watercourses. Despite being small, these drainage lines contain distinct riparian conditions and must therefore be regarded as watercourses.

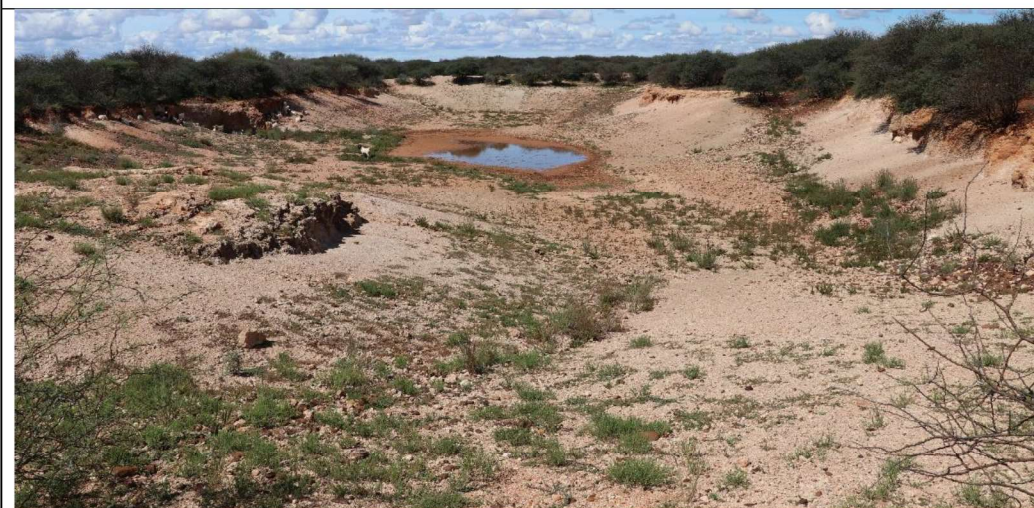
View of the historical borrow pit which is clearly manmade.

**Description of watercourse:**  
A historical borrow pit along the north eastern border of the solar development is clearly a manmade excavation which now accumulates surface water during the rainy season. The borrow pit is however completely artificial, does not form part of any surrounding surface water features and is therefore not regarded as forming either a natural watercourse or wetland. Due to the modification of the topography it does contain surface water for some periods which may form artificial wetland conditions though it is not considered to play any role in the surface drainage pattern of the site and is therefore not considered to be of consequence to the development. The borrow pit is simply listed here to confirm that it had been surveyed and confirmed to be of low sensitivity in terms of the development.

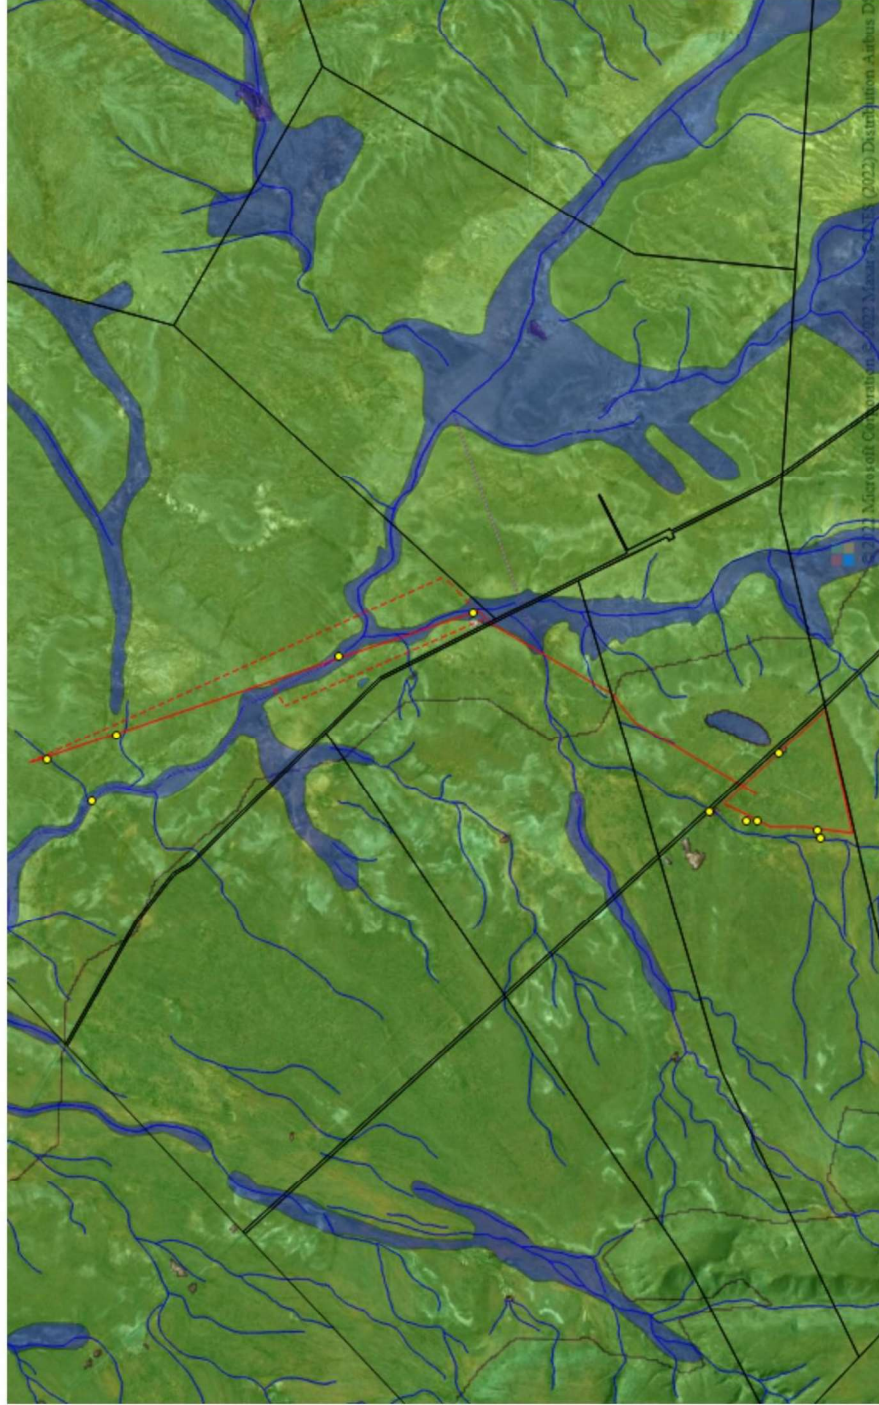
Map 1: Locality map of the proposed Wonderpan solar development near Prieska. Areas identified as being wetland areas according to the National Wetland Map 5 are indicated as well as smaller watercourses and drainage lines. Sampling points along affected watercourses are also indicated. A small stream system to the west of the solar development is clearly visible as well as the Karabeeloo and smaller drainage lines which will be affected by the grid connection powerline. It is notable that a large portion of the powerline will be situated within the Karabeeloo and will cause significant disturbance, alternative powerline alignment is also indicated which should considerably decrease the impact on this stream system. The remaining natural vegetation in the area is also indicated and confirms that the area remains largely natural.

The proposed grid connection powerline will also cross over several small drainage lines and construction is likely to have some impact on these systems (Appendix A: Map 1). The powerline will cross these watercourses perpendicularly which will minimise the disturbance footprint. The powerline alignment should also endeavour to place pylons on either side of the drainage lines and not within the channel as this will increase erosion. Given the small size of these drainage lines and the low anticipated impact of the powerline, the risk is anticipated to remain low.

According to the current powerline alignment a large portion of it (Approximately 3 km section) will be situated within the main channel of the Karabeeloo and as can be expected this will result in significant disturbance of the stream (Appendix A: Map 1). Construction and pylons in the main channel is also likely to cause significant scouring and erosion of the stream. As a result, this will be regarded as a moderate risk and will consequently require significant mitigation. Re-alignment of the powerline should also be considered which should aim to perpendicularly cross the Karabeeloo only once and should not be located parallel within the main channel (Appendix A: Map 1). This will minimise the anticipated impacts of the powerline and should such an alignment be taken the risk is anticipated to be considerably lower. This is also subject to the powerline avoiding the placement of pylons directly within the main channel of this watercourse.

- The re-alignment of the grid connection powerline should be considered which should aim to perpendicularly cross the Karabeeloo only once and should not be located parallel within the main channel (Appendix A: Map 1).
