BASIC ASSESSMENT FOR THE PROPOSED TEN NEW PV DEVELOPMENTS AT THE BOKPOORT FARM NEAR GROBLERSHOOP NORTHERN CAPE PROVINCE

**BASIC ASSESSMENT**

# Hydrogeological Baseline Assessment for Photovoltaic Solar Development

*Our Reference* 19-0993-Review of Surface Water Investigation- Bokpoort II

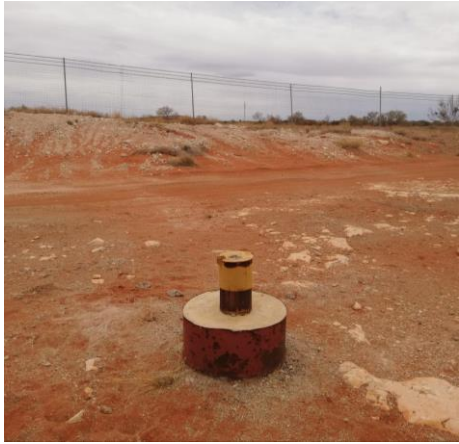
- Other
		Equipment:	Not Applicable
		Equipment Status:	Not Applicable
		Abstraction Rate:	[L/s] Not Applicable
		Pump Inlet:	[m] Not Applicable
Hydrogeological Information:		Field Physio-Chemical Information:	
Static Water Level:	[m brl]	27.25	pH: [pH Unit] 7.85
Aquifer Type:	Not Applicable		Electrical Conductivity: [µS/cm] 1180
			Temperature: [°C] 26.7
Water Strike Depth:	[m bgl]	Not Applicable	Sample Information:
		(Strike 1)	Sample Date: [dd-mmm-yy] Wednesday, 20 November 2019
		(Strike 2)	Sample Time: [ hh:mm] 12:40
Accumulative Yield:	[L/s]	Not Applicable	Sample Method: Grab sample
		(Strike 2)	Sample Depth: [m brl] Not Applicable
Comments			
<p><b>Note/s:</b></p> <ol style="list-style-type: none"> <li>Not measured / recorded</li> <li>Geological Map Series (1:250,000)</li> <li>Closed / damaged system</li> <li>No information available / made available to GCS</li> <li>Calculation (GCS)</li> <li>Borehole not sampled</li> <li>Dynamic Water Level</li> </ol> <p><b>Additional Note/s:</b></p> <p>Boreholes Bok BH1 and Bok BH2 are used for monitoring purposes around the evaporation ponds of the operational CSP.</p> <p><b>Acronyms:</b></p> <ul style="list-style-type: none"> <li>- m - metres</li> <li>- m bgl - metres below ground level</li> <li>- m amsl - metres above mean sea level</li> <li>- m brl - metres below reference level</li> <li>- L/s - Litres per second</li> <li>- µS/m - micro Sileens per metre</li> </ul>		<p><b>Photo/s:</b></p>

<p style="text-align: right;">Source: GCS, 2019</p>

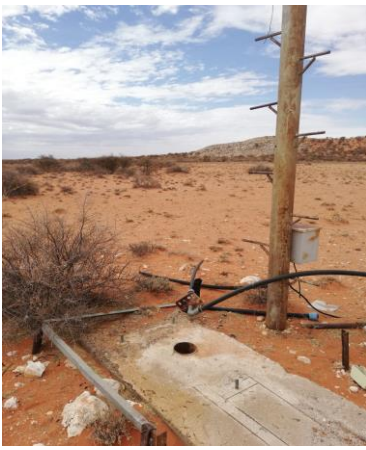
Hydrogeological Information:				Field Physio-Chemical Information:		
Static Water Level:	[m brl]	DRY		pH:	[pH Unit]	Not Applicable
Aquifer Type:		Not Applicable		Electrical Conductivity:	[µS/cm]	Not Applicable
				Temperature:	[ °C]	Not Applicable
Water Strike Depth:	[m bgl]	Not Applicable	(Strike 1)	Sample Information:		
			(Strike 2)	Sample Date:	[dd-mmm-yy]	Not Applicable
Accumulative Yield:	[L/s]	Not Applicable	(Strike 1)	Sample Time:	[ hh:mm]	Not Applicable
			(Strike 2)	Sample Method:		Not Applicable
				Sample Depth:	[m brl]	Not Applicable

Comments	
<p><b>Note/s:</b></p> <ol style="list-style-type: none"> <li>Not measured / recorded</li> <li>Geological Map Series (1:250,000)</li> <li>Closed / damaged system</li> <li>No information available / made available to GCS</li> <li>Calculation (GCS)</li> <li>Borehole not sampled</li> <li>Dynamic Water Level</li> </ol> <p><b>Additional Note/s:</b></p> <p>Borehole Bok BH3 previously had a submersible pump installed and was utilized for domestic water supply for farm owner's house and farm village workers but this borehole is now dry.</p> <p><b>Acronyms:</b></p> <ul style="list-style-type: none"> <li>- m - metres</li> <li>- m bgl - metres below ground level</li> <li>- m amsl - metres above mean sea level</li> <li>- m brl - metres below reference level</li> <li>- L/s - Litres per second</li> <li>- µS/m - micro Sieens per metre</li> </ul>	<p><b>Photo/s:</b></p>

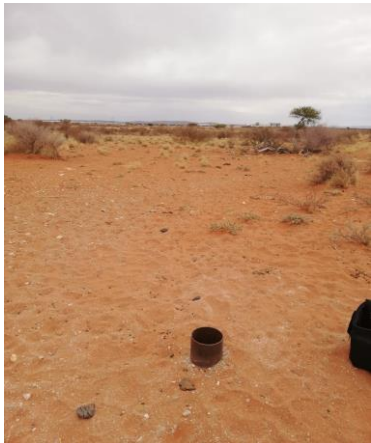
- Northing/Longitude:	[m]/[DD] 22.001860		
- Elevation:	[m amsl] 953		
Survey Method:	GPS-Handheld		
Bore/Spring Construction Information:		Bore/Spring Status & Equipment:	
Bore Installation Date	[mmmm-yyyy] Unknown (1)	Status:	Not Equipped
Bore Depth:	[m] Not Applicable	Water Application:	
Collar Height:	[m] 0.15	- Primary	None
Reference Level Height:	[m] Not Applicable	- Other	
Casing Diameter (ID)	[m] Not Applicable	- Domestic	
Screen/Perforated Casinig Length:	[m] Not Applicable	- Stock Watering	
Casing Type:	Not Applicable	- Irrigation

- Other	
		Equipment:	Not Applicable
		Equipment Status:	Not Applicable
		Abstraction Rate:	[L/s] Not Applicable
		Pump Inlet:	[m] Not Applicable
Hydrogeological Information:		Field Physio-Chemical Information:	
Static Water Level:	[m brl] 38.4	pH:	[pH Unit] Not Applicable
Aquifer Type:	Not Applicable	Electrical Conductivity:	[µS/cm] Not Applicable
		Temperature:	[ °C] Not Applicable
Water Strike Depth:	[m bgl] Not Applicable (Strike 1)	Sample Information:	
	(Strike 2)	Sample Date:	[dd-mmm-yy] Not Applicable
Accumulative Yield:	[L/s] Not Applicable (Strike 1)	Sample Time:	[ hh:mm] Not Applicable
	(Strike 2)	Sample Method:	Not Applicable
		Sample Depth:	[m brl] Not Applicable
Comments			
<p><b>Note/s:</b></p> <ol style="list-style-type: none"> <li>Not measured / recorded</li> <li>Geological Map Series (1:250,000)</li> <li>Closed / damaged system</li> <li>No information available / made available to GCS</li> <li>Calculation (GCS)</li> <li>Borehole not sampled</li> <li>Dynamic Water Level</li> </ol> <p><b>Additional Note/s:</b></p>		<p><b>Photo/s:</b></p>

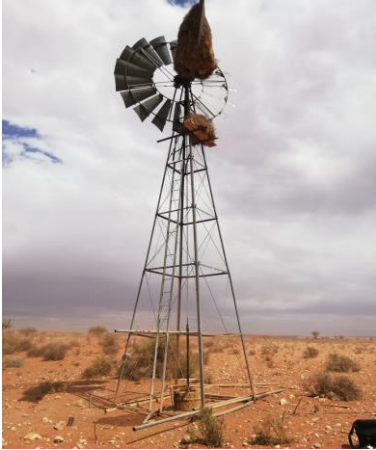
- Northing/Longitude:	[m]/[DD]	21.999890		
- Elevation:	[m amsl]	958		
Survey Method:	GPS-Handheld			
Bore/Spring Construction Information:		Bore/Spring Status & Equipment:		
Bore Installation Date	[m d m m - y y y y]	Unknown (1)	Status:	Operational
Bore Depth:	[m]	Not Applicable	Water Application:	
Collar Height:	[m]	Not Applicable	- Primary	Stock Watering (Small Scale)
Reference Level Height:	[m]	Not Applicable	- Other	
Casing Diameter (ID)	[m]	Not Applicable	- Domestic	
Screen/Perforated Casinig Length:	[m]	Not Applicable	- Stock Watering	Yes (Small Scale)
Casing Type:	Not Applicable		- Irrigation

- Other	
			Equipment:	Yes
			Equipment Status:	Windmill
			Abstraction Rate:	[L/s] Unknown (1)
			Pump Inlet:	[m] Unknown (1)
Hydrogeological Information:		Field Physio-Chemical Information:		
Static Water Level:	[m brl]	Unknown (1)	pH:	[pH Unit] 7.06
Aquifer Type:	Not Applicable		Electrical Conductivity:	[µS/cm] 2080
			Temperature:	[ °C] 23.02
Water Strike Depth:	[m bgl]	Not Applicable	Sample Information:	
		(Strike 1)	Sample Date:	[dd-mmm-yy] Wednesday, 20 November 2019
		(Strike 2)	Sample Time:	[ hh:mm] 14:29
Accumulative Yield:	[L/s]	Not Applicable	Sample Method:	Grab sample
		(Strike 2)	Sample Depth:	[m brl] Not Applicable
Comments				
<b>Note/s:</b> <sup>1</sup> Not measured / recorded <sup>2</sup> Geological Map Series (1:250,000) <sup>3</sup> Closed / damaged system <sup>4</sup> No information available / made available to GCS <sup>5</sup> Calculation (GCS) <sup>6</sup> Borehole not sampled <sup>7</sup> Dynamic Water Level  <b>Additional Note/s:</b>     <b>Acronyms:</b> - m - metres - m bgl - metres below ground level - m amsl - metres above mean sea level - m brl - metres below reference level - L/s - Litres per second - µS/m - micro Siemens per metre		<b>Photo/s:</b>

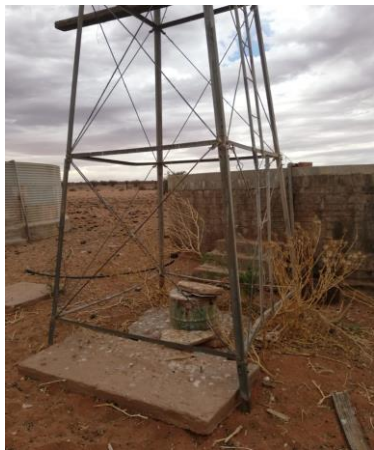
Hydrogeological Information:			Field Physio-Chemical Information:		
Static Water Level:	[m brl]	DRY	pH:	[pH Unit]	Not Applicable
Aquifer Type:		Not Applicable	Electrical Conductivity:	[µS/cm]	Not Applicable
			Temperature:	[ °C]	Not Applicable
Water Strike Depth:	[m bgl]	Not Applicable (Strike 1)	Sample Information:		
		(Strike 2)	Sample Date:	[dd-mmm-yy]	Not Applicable
Accumulative Yield:	[L/s]	Not Applicable (Strike 1)	Sample Time:	[ hh:mm]	Not Applicable
		(Strike 2)	Sample Method:		Not Applicable
			Sample Depth:	[m brl]	Not Applicable

Comments	
<p><b>Note/s:</b></p> <ol style="list-style-type: none"> <li>Not measured / recorded</li> <li>Geological Map Series (1:250,000)</li> <li>Closed / damaged system</li> <li>No information available / made available to GCS</li> <li>Calculation (GCS)</li> <li>Borehole not sampled</li> <li>Dynamic Water Level</li> </ol> <p><b>Additional Note/s:</b></p> <p>Bok BH6 previously had a windmill installed and was utilized for livestock watering but this borehole is now dry.</p> <p><b>Acronyms:</b></p> <ul style="list-style-type: none"> <li>- m - metres</li> <li>- m bgl - metres below ground level</li> <li>- m amsl - metres above mean sea level</li> <li>- m brl - metres below reference level</li> <li>- L/s - Litres per second</li> <li>- µS/m - micro Sieens per metre</li> </ul>	<p><b>Photo/s:</b></p>

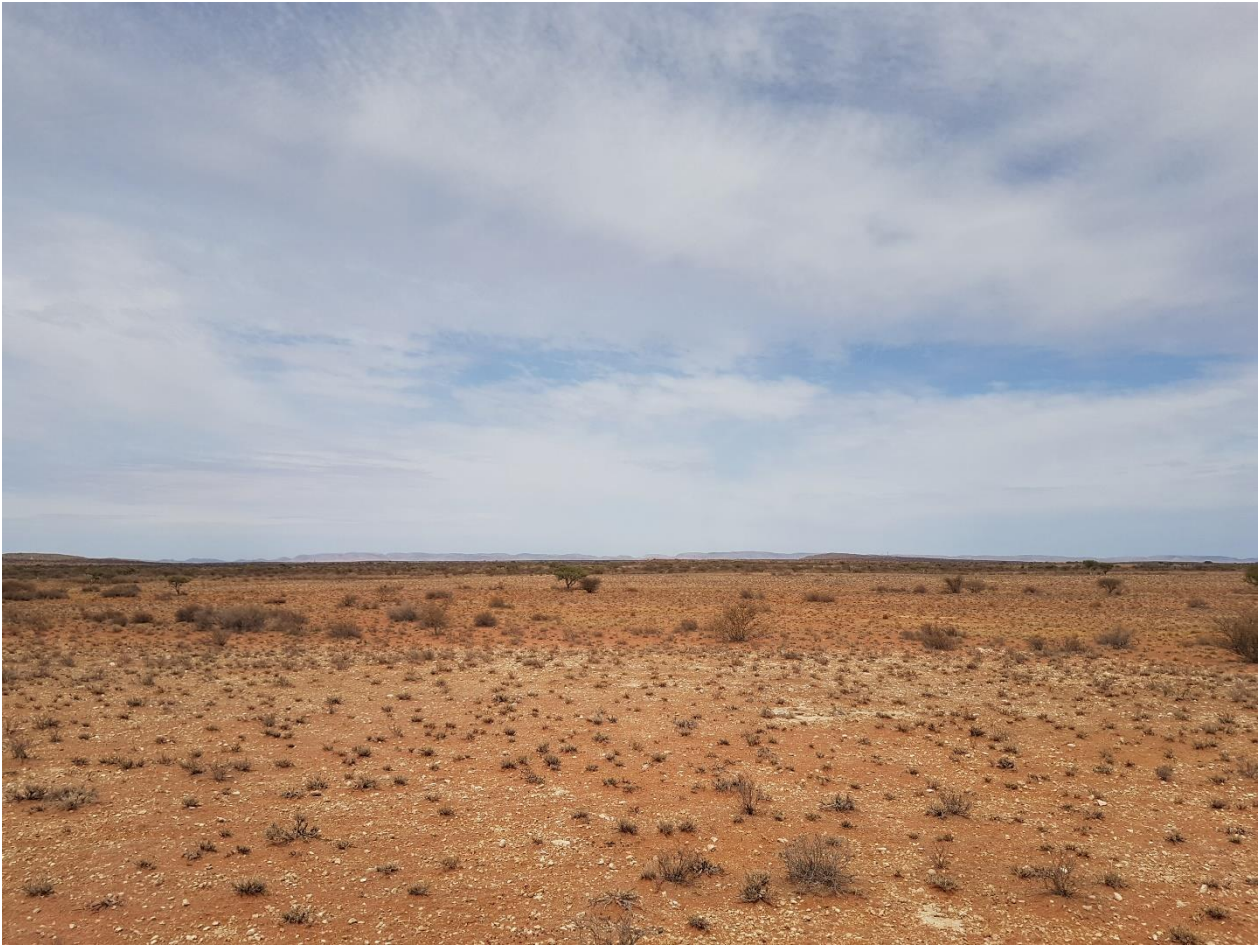
The topography of most remainder of the site, in particular the central parts of the site is similarly very flat, but with a different substrate in the form of red aeolian sands. There is similarly no linear drainage in this part of the site and no pan (a type of wetland that can occur in flat terrain in arid settings) occurrence.

*Figure 4 – An example of flat calcrete plains on the development site*

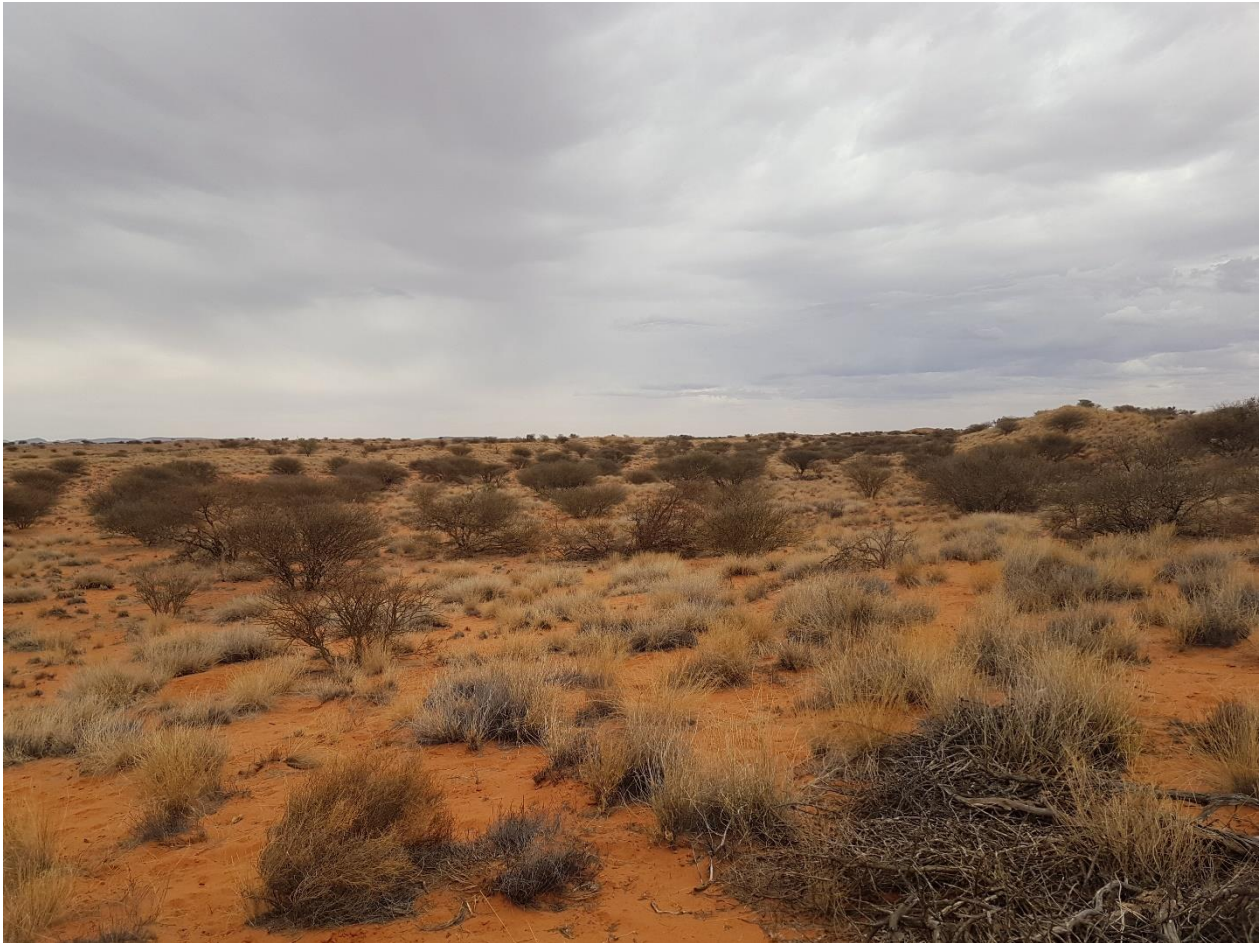
The Duneveld that occurs in the far north-eastern quarter of the site is comprised of low, parallel-aligned dunes, with intervening flat areas of sandy substrate covered in a grassy vegetation cover. No surface water drainage was observed in this Duneveld, in spite of the site becoming more sloping, with an increase in altitude to the north-east. The combination of a highly permeable substrate (sandy material) and the presence of parallel-aligned dunes that run roughly perpendicular to the direction of the slope prevents the development of surface drainage features that would under other circumstances be aligned south-westwards.

*Figure 5 – Duneveld terrain in the far north-eastern part of the site*
