**Development of Lodges, Roads and other Tourist Infrastructure in
Kapama Private Game Reserve, Limpopo Province
Section 24G**

VISUAL IMPACT ASSESSMENT

May 2019

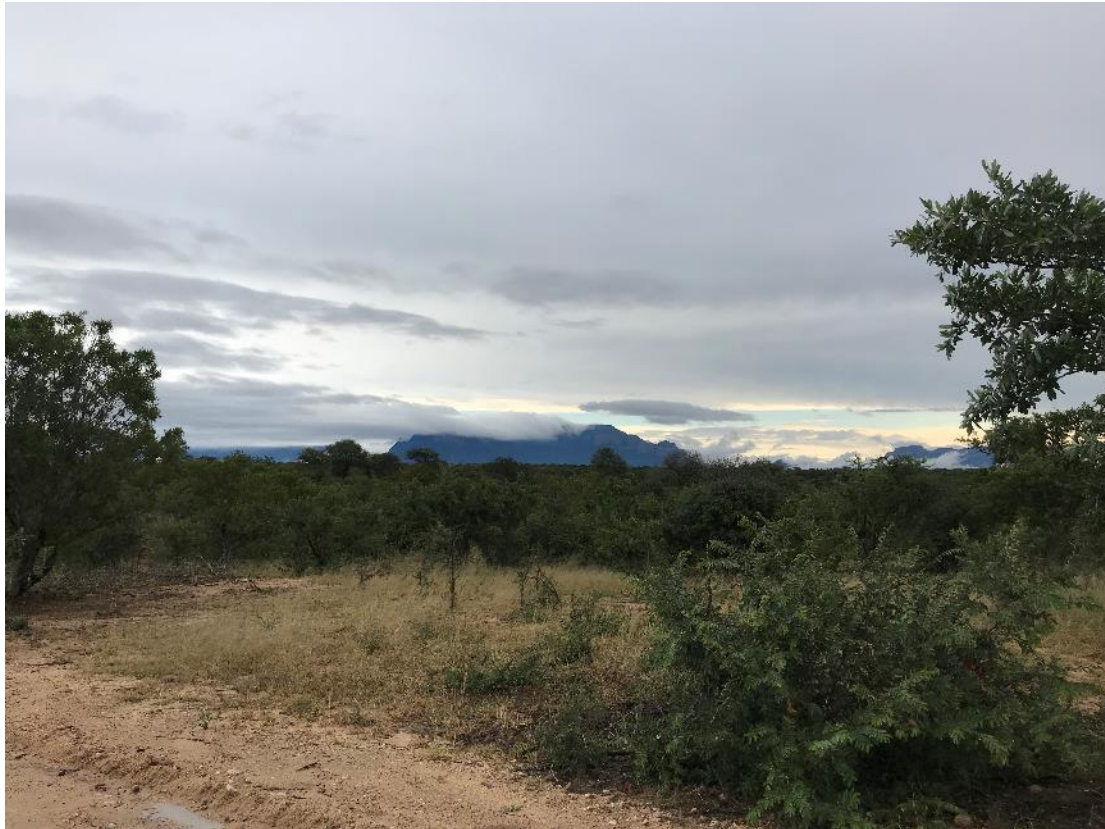
Figure 2: Topography of the Reserve and surrounds

The topography of the general area is flat to undulating with shallowly incised drainage lines. Most of the study area contains untransformed vegetation, but existing infrastructure is present within the KPGR.

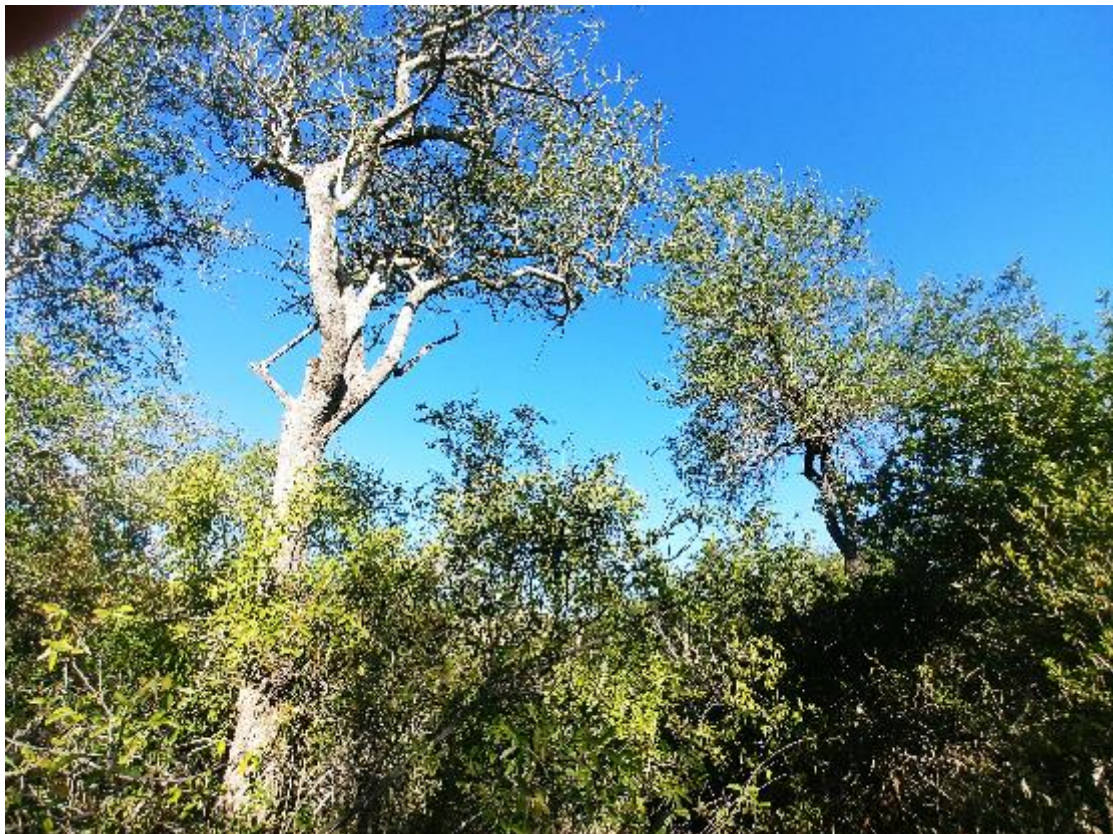
Figure 5: High VAC of the receiving environment

Overall, the Visual Absorption Capacity (VAC) of the site and surrounds is high due to the nature of the vegetation (i.e. thicket and woodland).
