Hydrogeological Assessment - Newcastle Landfill Site, KwaZulu-Natal

Report

GCS Project Number: 17-0212

HYDROGEOLOGICAL INVESTIGATION - NEWCASTLE LANDFILL

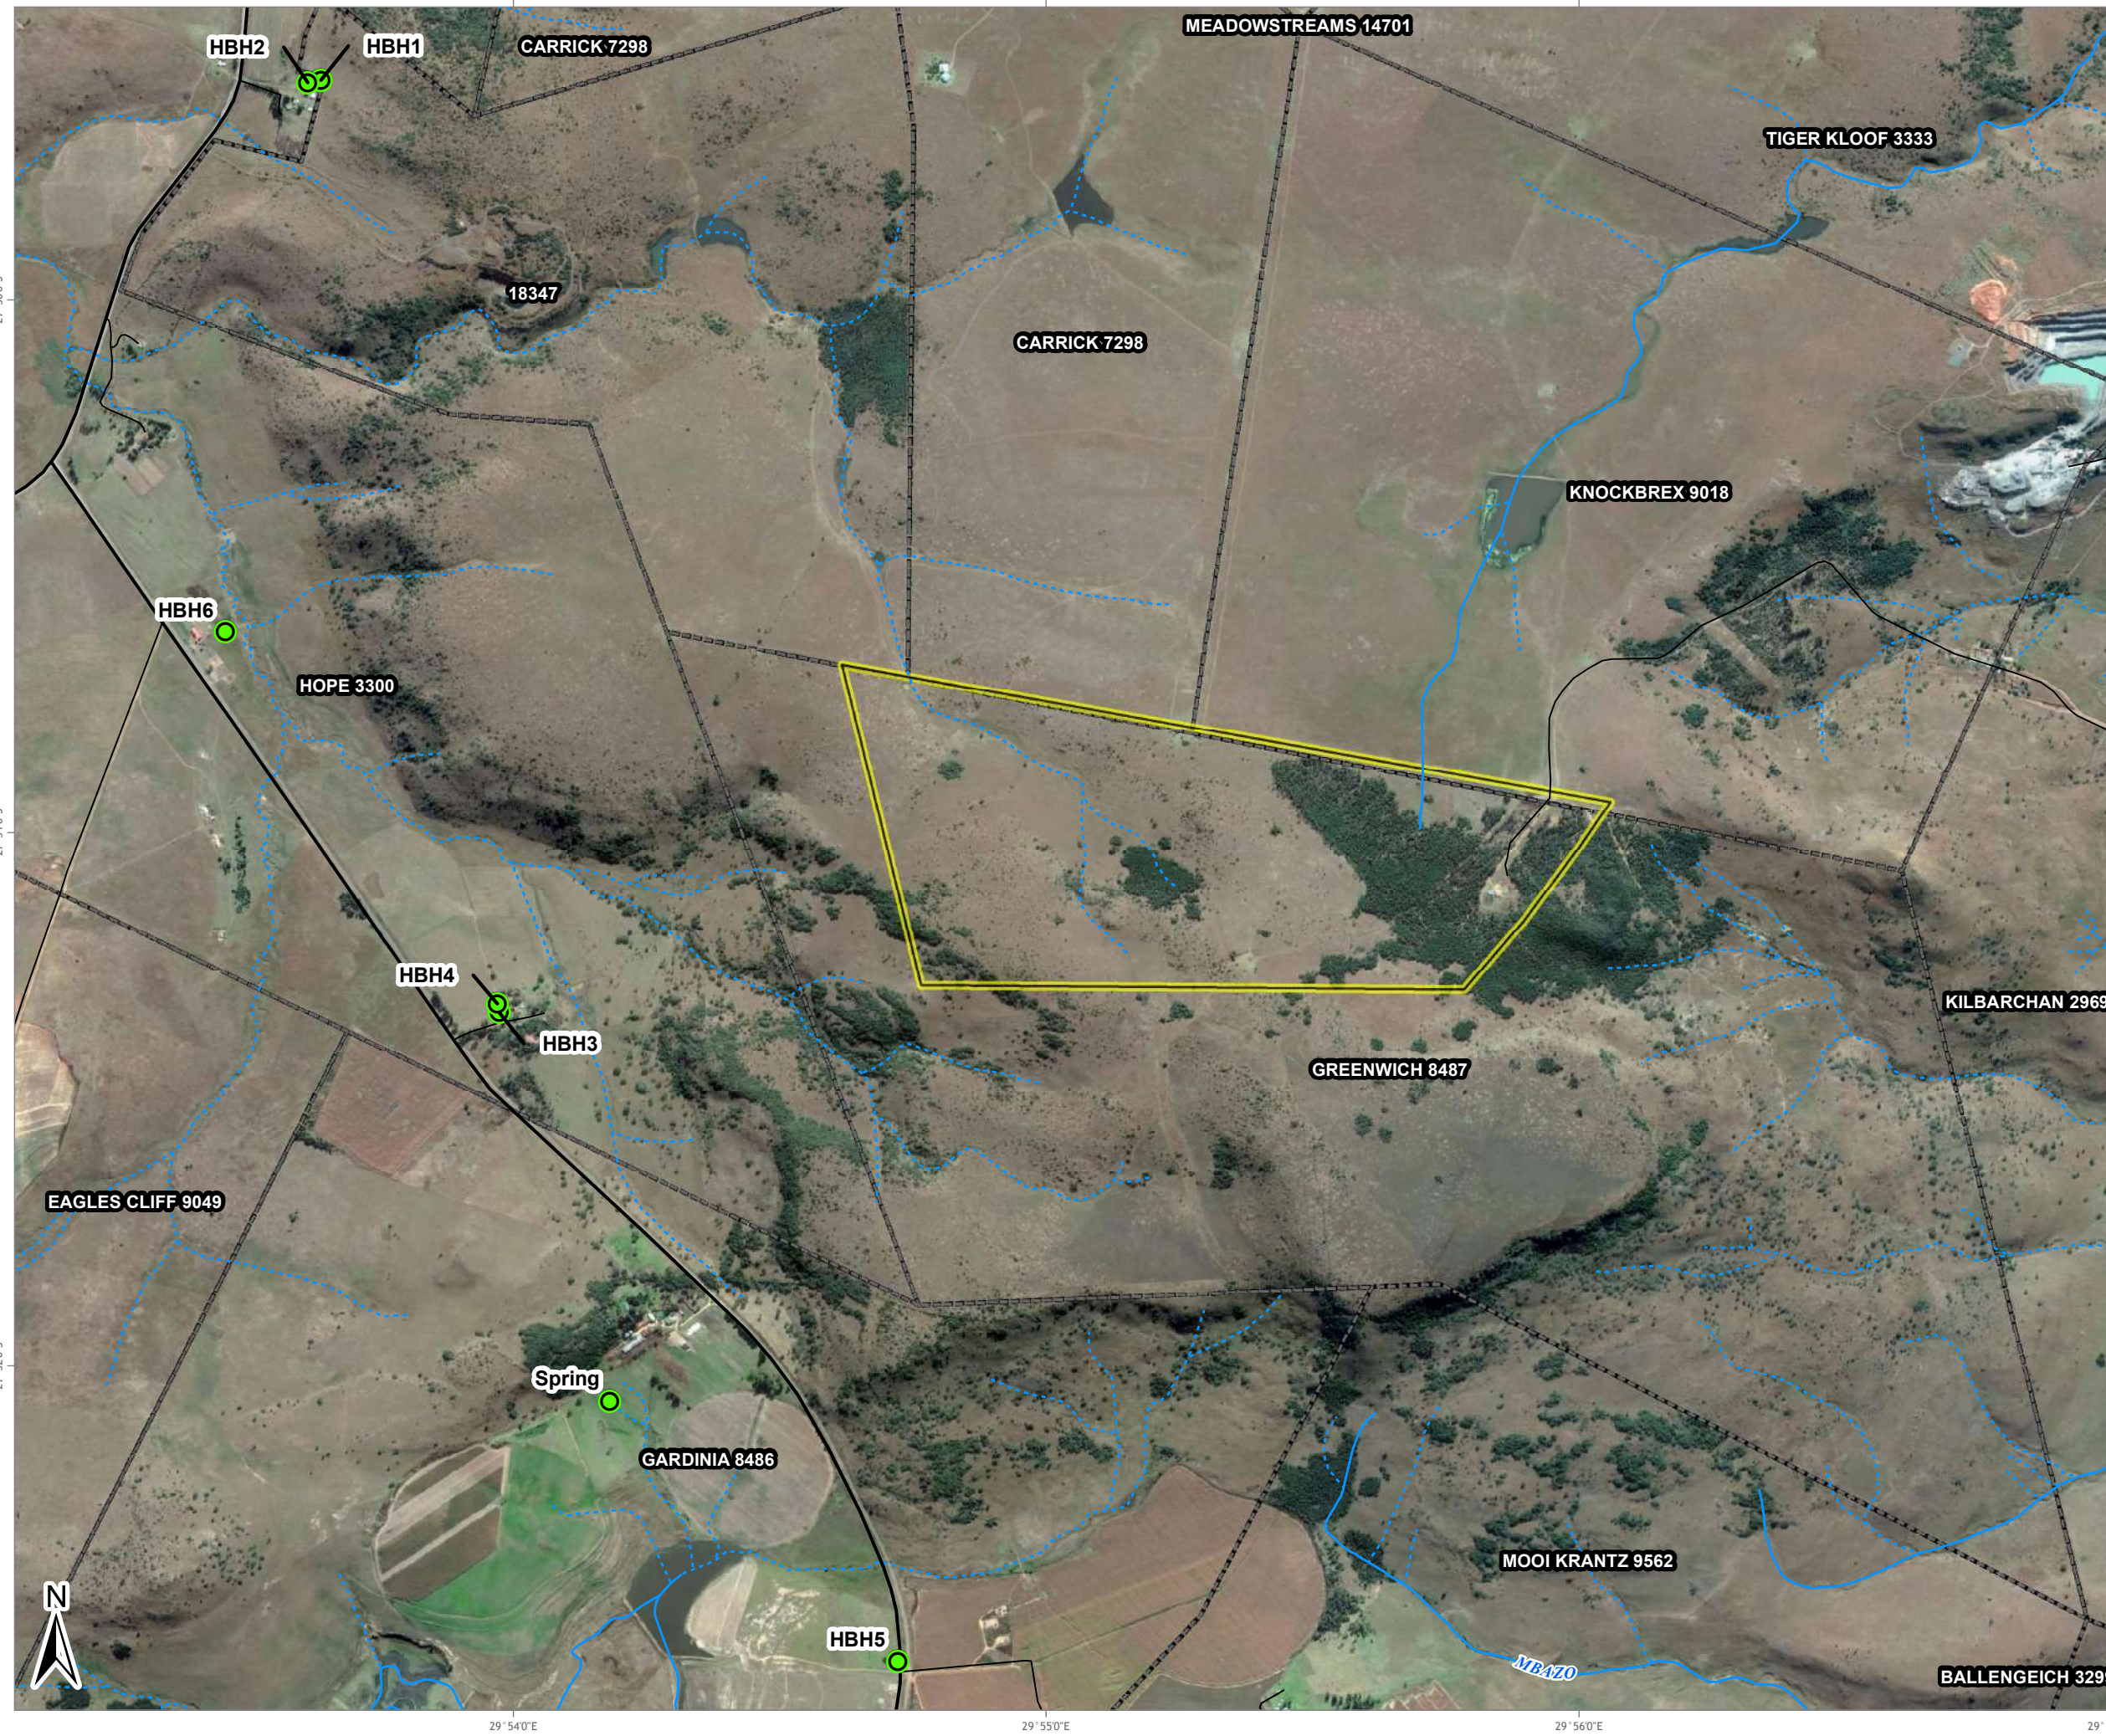
NEWCASTLE LANDFILL SITE: HYDROCENSUS BOREHOLES LOCALITY

HBH2, HBH5 and HBH6 were used for domestic purposes. A sulphur smell was noted in HBH2 and HBH6. HBH5 and HBH6 were also used for stock watering purposes. This sulphur smell can be associated with the coal beds of the Karoo Supergroup. The locations of these boreholes are presented in Figure 6-1.

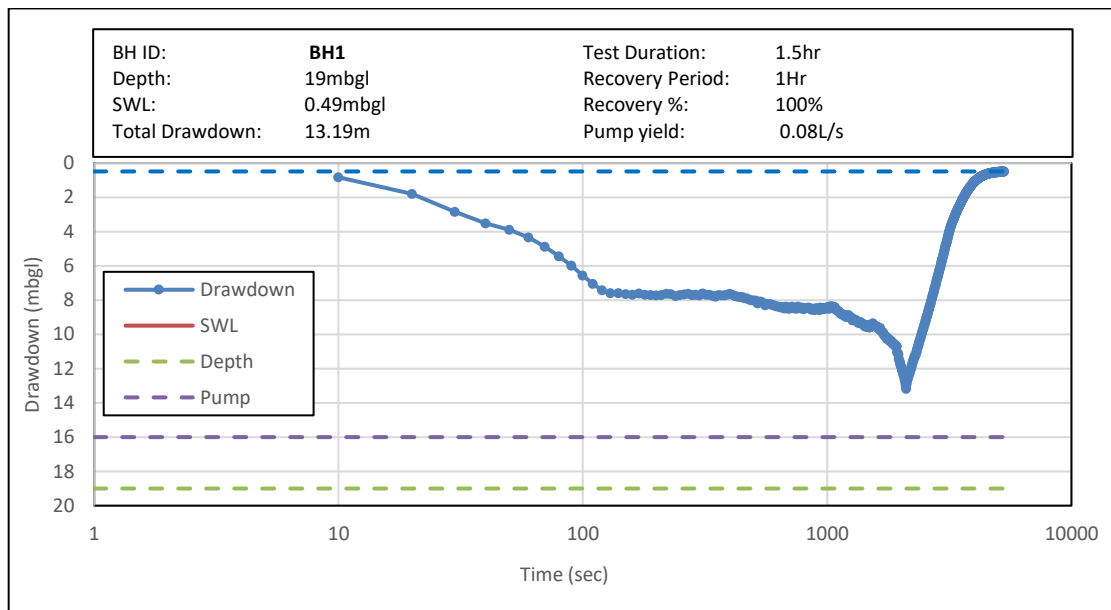
Figure 6-9: Aquifer Test Results - BH1

A CR test is a field experiment in which a well is pumped at a controlled rate and water-level response (drawdown) is measured in the pumped well. The response data from the pumping tests are used to estimate the hydraulic properties of aquifers.

The drawdown and recovery curves for each borehole are presented in Figure 6-9, Figure 6-10 and Figure 6-11.

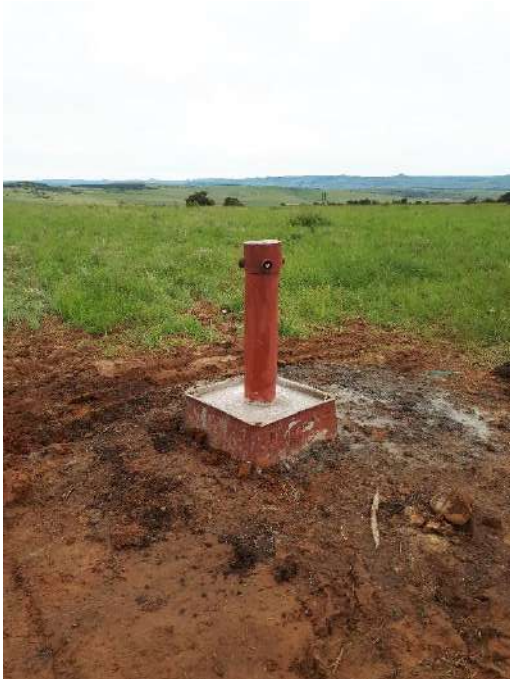
Photo No. 3

Description: Monitoring borehole, BH1

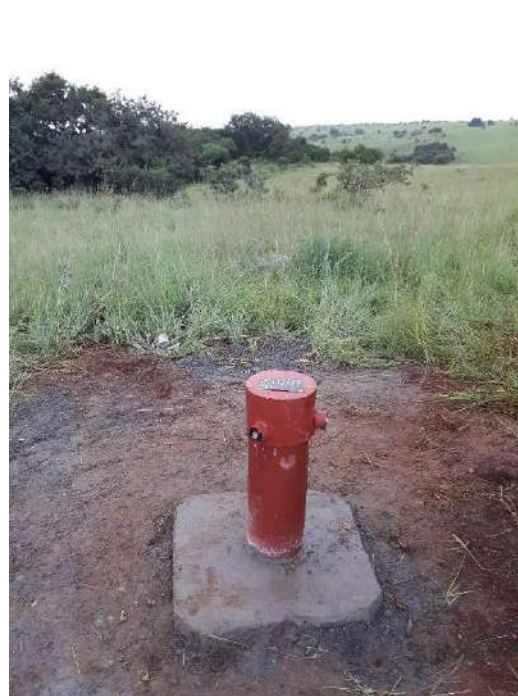
Photo No. 4

Description: Monitoring borehole, BH2

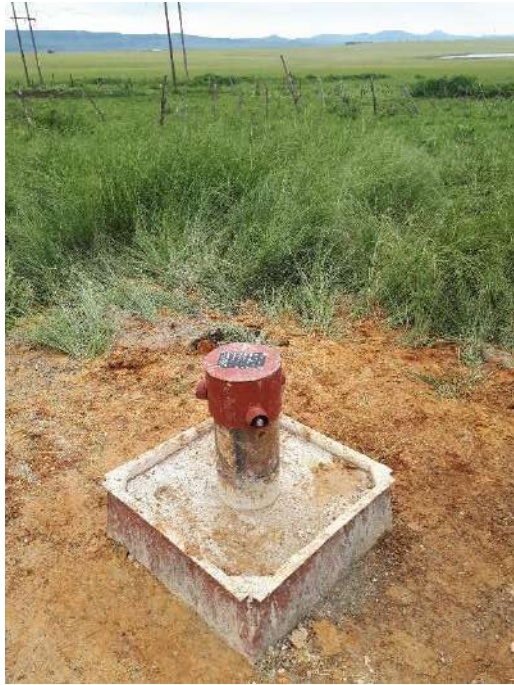
Photo No. 5

Description: Monitoring borehole, BH3

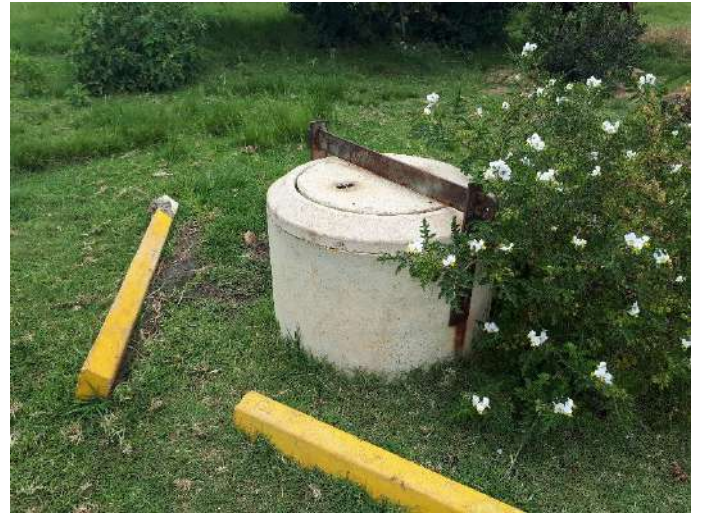
Photo No. 6

Description: Monitoring borehole, BH NL2
