# KWA THEMA SHOPPING CENTRE NEAR SPRINGS

## Geotechnical Investigation Report

DATE 18 November 2013

REFERENCE NUMBER 6796/13446

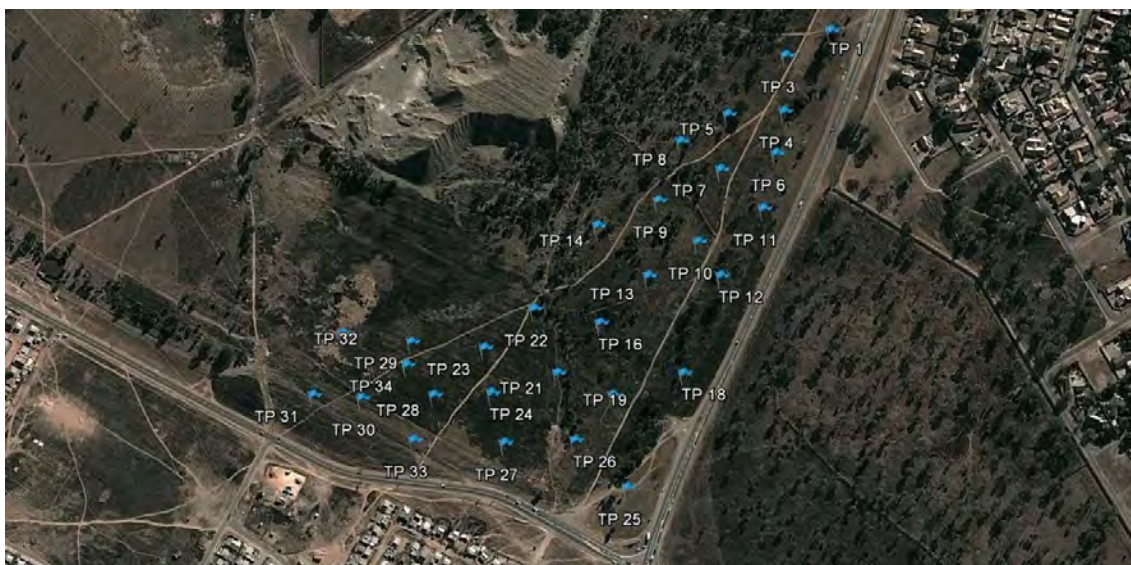
Figure 2: Site layout showing the test pit positions.

Figure 2 below shows the approximate position of the test pits which were investigated on the site.

Thirty four test pits were originally planned. However, due to time constrained only 30 test pits were excavated across the site to give an accurate representation of the entire site.

Co-ordinates and elevations noted on the profiles were taken using a GPS on site using the WGS 84 datum, hddd°mm'ss.s" grid.

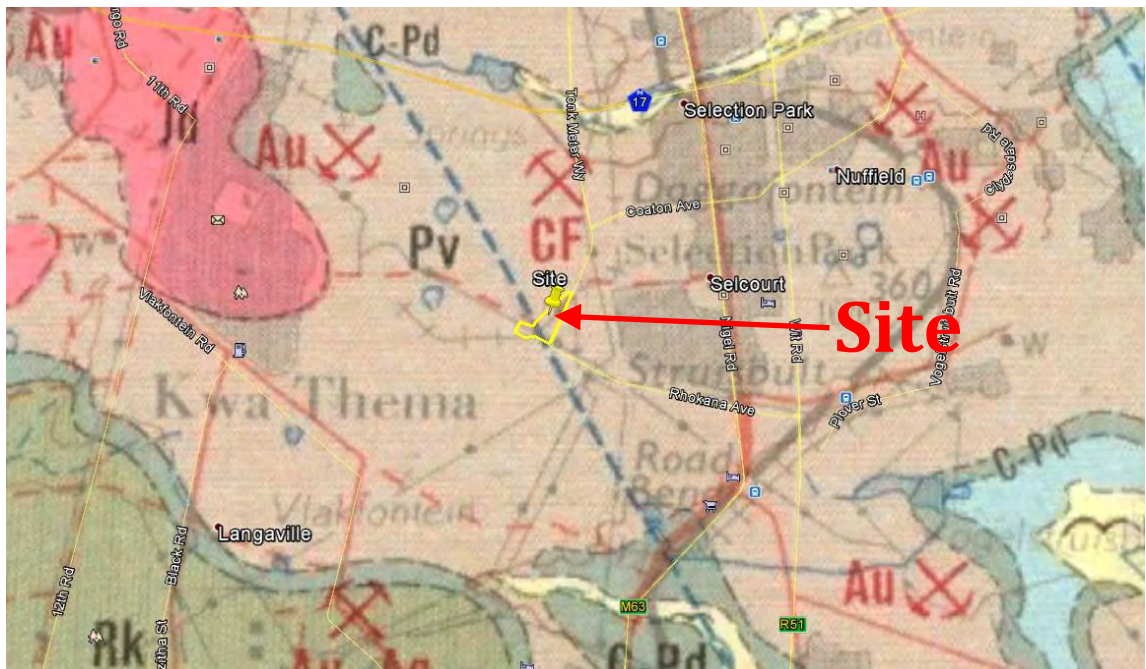
Figure 3: Geology overlain in Google Earth.

According to the 1:250 000 geological map 2628 EAST RAND the site is underlain by sandstone, shale and coal beds of the Vryheid Formation, Ecca Group, Karoo Supergroup.

Figure 2 below shows the geology of the area overlain in Google Earth.

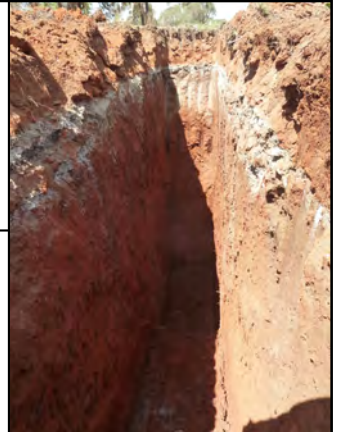
**Test Pit: TP 01**

Depth (m)	Sampling	Ground Water	Symbol	Description
0.1				<b>FIRM, CLAYEY SILT</b> Slightly moist, brown to red brown, firm, pinholed, clayey silt Fill (0.35 m)
0.2				
0.3				
0.4				<b>MEDIUM DENSE, SILTY GRAVEL</b> Dry, light grey with angular pebbles of all colours, medium dense, martrix supported, silty gravel Fill (0.5 m)
0.5				
0.6	D			<b>FIRM, FINE SANDY CLAYEY SILT WITH SLIGHT FERRUGINATION AT 1.9-2.1M</b> Slightly moist, redbrown mottled black, firm, pinholed, fine sandy clayey silt with slight ferrugination at 1.9-2.1m Transported (2.7 m)
0.7				
0.8				
0.9				
1.0				
1.1				
1.2				
1.3				
1.4				
1.5				
1.6				
1.7				
1.8				
2.7				<b>STIFF, GRAVELLY CLAYEY SILT</b> Slightly moist, orange brown mottled grey and red, stiff, intact, gravelly clayey silt Transported (3 m)
2.8				
2.9				
3.0				
3.1				
3.2				
3.3				
3.4

<b>Excavation Method:</b>	TLB
<b>Refusal:</b>	None
<b>Water Table:</b>	None

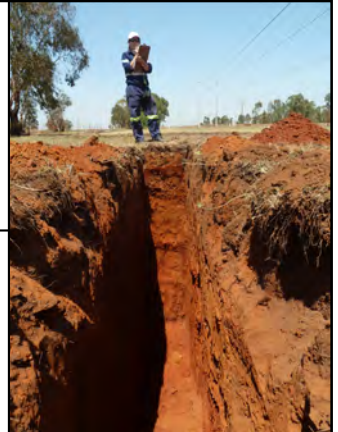
**Test Pit: TP 04**

Depth (m)	Sampling	Ground Water	Symbol	Description
0.1				<b>SOFT, FINE SANDY SILT</b> Dry, brown, soft, pinholed, fine sandy silt Transported (0.4 m)
0.2				
0.3				
0.4				
0.5				<b>FIRM, FINE SANDY SILT</b> Slightly moist, light brown, firm, pinholed, fine sandy silt Transported (1.3 m)
0.6				
0.7				
0.8				
0.9				
1.0				
1.1				
1.2				
1.3				
1.4				<b>FIRM, FINE SANDY CLAYEY SILT</b> Slightly moist, red brown mottled black, firm, pinholed, fine sandy clayey silt Transported (2.7 m)
1.5				
1.6				
1.7				
1.8				
1.9				
2.0				
2.1				
2.2				
2.3				
2.4				
2.5				
2.6				
2.7				
2.8				<b>STIFF, GRAVELLY SANDY SILT</b> Slightly moist, reddish brown mottled grey, black and yellow, stiff, pinholed, gravelly sandy silt Transported (3 m)
2.9				
3.0				
3.1				
3.2				
3.3				
3.4

<b>Excavation Method:</b>	TLB
<b>Refusal:</b>	None
<b>Water Table:</b>	None

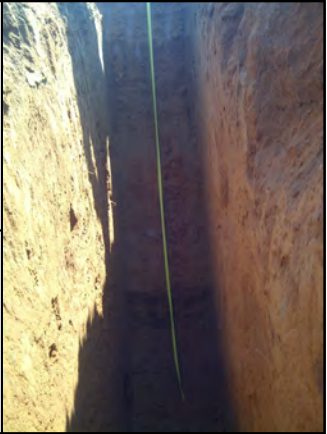
**Test Pit: TP 07**

Depth (m)	Sampling	Ground Water	Symbol	Description
0.1				<b>FIRM, CLAYEY SILT</b> Slightly moist, brown, firm, pinholed, clayey silt Transported
0.2				
0.3				
0.4				
0.5				
0.6				<b>FIRM, SANDY SILT</b> Slightly moist, light brown to orange, firm, pinholed, sandy silt Transported
0.7				
0.8				
0.9				
1.0				
1.1				
1.2				
1.3				
1.4				
1.5				
1.6				<b>FIRM TO STIFF, SANDY SILT WITH COBBLES OF QUARTZITE AND FERRUGINOUS</b> Slightly moist, light brown, firm to stiff, pinholed, sandy silt with cobbles of quartzite and ferruginous Residual shale
1.7				
1.8				
1.9				
2.0				
2.1				
2.2				
2.3				
2.4				
2.5				
2.6				
2.7				
2.8				
2.9				
3.0				
3.1				
3.2				
3.3				
3.4

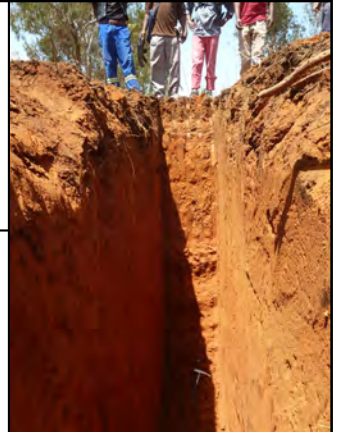
**Test Pit: TP 08**

Depth (m)	Sampling	Ground Water	Symbol	Description
0.1				<b>FIRM, SANDY SILT</b> Dry, brown, firm, pinholed, sandy silt Transported
0.2				
0.3				
0.4				
0.5	D			<b>FIRM TO STIFF, FINE SANDY SILT</b> Dry, light brown, firm to stiff, pinholed, fine sandy silt Transported
0.6				
0.7				
0.8				
0.9				
1.0				
1.1				
1.2				
1.3				
1.4				
1.5				
1.6				
1.7				
1.8				
1.9				
2.0				
2.1				
2.2				
2.3				
2.4				
2.5				
2.6				
2.7				
2.8				
2.9				
3.0				(3 m)
3.1				
3.2				
3.3				
3.4

<b>Excavation Method:</b>	TLB
<b>Refusal:</b>	None
<b>Water Table:</b>	None

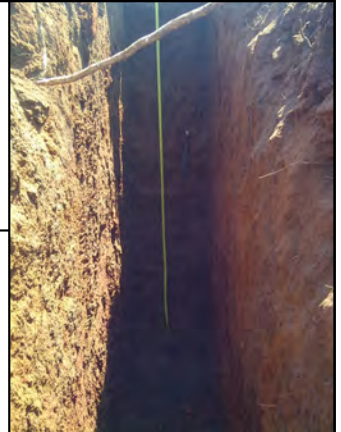
**Test Pit: TP 11**

Depth (m)	Sampling	Ground Water	Symbol	Description
0.1				<b>FIRM, CLAYEY SILT</b> Slightly moist, brown, firm, pinholed, clayey silt Transported
0.2				
0.3				
0.4				
0.5				
0.6				<b>SOFT TO FIRM, FINE SANDY SILTY CLAY</b> Slightly moist, light brown to yellowish, soft to firm, pinholed, fine sandy silty clay Transported
0.7				
0.8				
0.9				
1.0				
1.1				
1.2				
1.3				
1.4				
1.5				<b>SOFT, SILTY CLAY</b> Slightly moist, reddish brown mottled grey and black, soft, pinholed, silty clay Residual shale
1.6				
1.7				
1.8				
1.9				
2.0				
2.1				
2.2				
2.3				
2.4				
2.5				
2.6				
2.7				
2.8				
2.9				
3.0				
3.1				
3.2				
3.3				
3.4

<b>Excavation Method:</b>	TLB
<b>Refusal:</b>	None
<b>Water Table:</b>	None

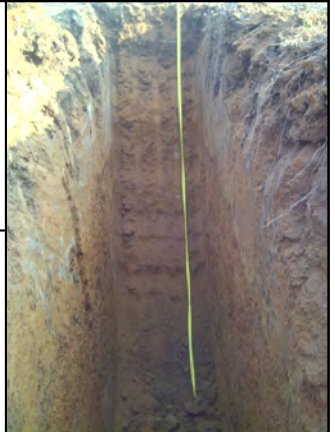
**Test Pit: TP 14**

Depth (m)	Sampling	Ground Water	Symbol	Description
0.1				<b>FIRM, CLAYEY SILT</b> Slightly moist, brown, firm, pinholed, clayey silt Transported
0.2				
0.3				
0.4				
0.5				
0.6				
0.7				
0.8				
0.9				<b>VERY DENSE, SANDY SILTY GRAVEL</b> Slightly moist, light brown, very dense, pinholed, sandy silty gravel Transported
1.0				
1.1				
1.2				
1.3				
1.4				
1.5				
1.6				
1.7				
1.8				
1.9				
2.0				
2.1				
2.2				
2.3				<b>Refused on: very dense sandy silty gravel</b>
2.4				
2.5				
2.6				
2.7				
2.8				
2.9				
3.0				
3.1				
3.2				
3.3				
3.4

<b>Excavation Method:</b>	TLB
<b>Refusal:</b>	2.2 m on very dense sandy
<b>Water Table:</b>	None

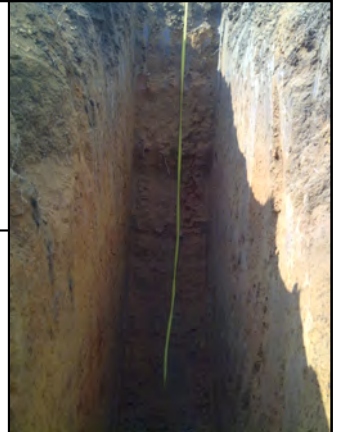
**Test Pit: TP 21**

Depth (m)	Sampling	Ground Water	Symbol	Description
0.1				<b>FIRM, CLAYEY SILT</b> Slightly moist, brown, firm, pinholed, clayey silt Transported
0.2				
0.3				
0.4				
0.5				
0.6				<b>FIRM, CLAYEY SILT</b> Slightly moist, yellow brown mottled black, firm, pinholed, clayey silt Transported
0.7				
0.8				
0.9				
1.0				
1.1				
1.2				
1.3				
1.4				
1.5				
1.6				<b>STIFF, GRAVELLY SILT</b> Slightly moist, yellow mottled red and grey, stiff, pinholed, gravelly silt Residual shale
1.7				
1.8				
1.9				
2.0				
2.1				
2.2				
2.3				
2.4				
2.5				
2.6				<b>Refused on: Residual shale</b>
2.7				
2.8				
2.9				
3.0				
3.1				
3.2				
3.3				
3.4

<b>Excavation Method:</b> TLB
<b>Refusal:</b> 2.6 m on Residual shale
<b>Water Table:</b> None

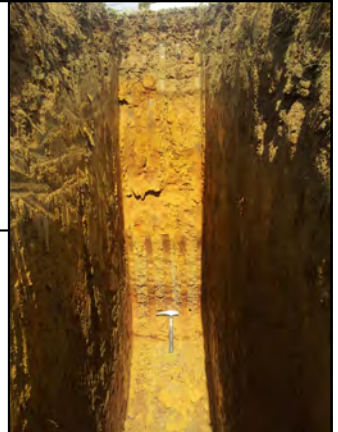
**Test Pit: TP 23**

Depth (m)	Sampling	Ground Water	Symbol	Description
0.1				<b>FIRM, SANDY SILT</b> Dry, brown, firm, pinholed, sandy silt Transported (0.5 m)
0.2				
0.3				
0.4				
0.5				
0.6				<b>FIRM TO STIFF, FINE SANDY SILT</b> Dry, light brown, firm to stiff, pinholed, fine sandy silt Transported (0.7 m)
0.7				
0.8				<b>MEDIUM DENSE BECOMING VERY DENSE, SANDY SILTY FERRUGINOUS GRAVEL</b> Dry, yellow brown, medium dense becoming very dense, pinholed, sandy silty ferruginous gravel Transported (2 m)
0.9				
1.0				
1.1				
1.2				
1.3				
1.4				
1.5				
1.6				
1.7				
1.8				
1.9				
2.0				<b>STIFF, GRAVELLY SANDY SILT</b> Slightly moist, reddish brown mottled grey, black and yellow, stiff, pinholed, gravelly sandy silt Transported (2.6 m)
2.1				
2.2				
2.3				
2.4				
2.5				<b>Refused on: Stiff gravelly sandy silt</b>
2.6				
2.7				
2.8				
2.9				
3.0				
3.1				
3.2				
3.3				
3.4

<b>Excavation Method:</b>	TLB
<b>Refusal:</b>	2.6 m on Stiff gravelly
<b>Water Table:</b>	None

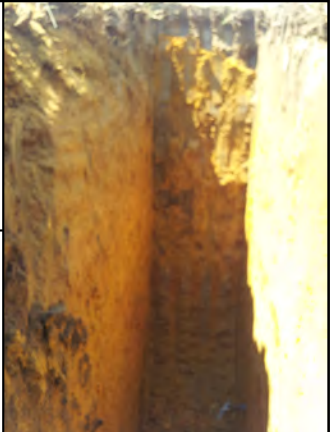
**Test Pit: TP 26**

Depth (m)	Sampling	Ground Water	Symbol	Description
0.1				<b>FIRM, SANDY SILT</b> Dry, brown, firm, pinholed, sandy silt Transported <div style="text-align: right;">(0.5 m)</div>
0.2				
0.3				
0.4				
0.5				
0.6				<b>FIRM, FINE SANDY SILT</b> Dry, light brown, firm, pinholed, fine sandy silt Transported <div style="text-align: right;">(1.4 m)</div>
0.7				
0.8				
0.9				
1.0				
1.1				
1.2				
1.3				
1.4				<b>MEDIUM DENSE BECOMING VERY DENSE, SANDY SILTY FERRUGINOUS GRAVEL</b> Dry, yellow brown, medium dense becoming very dense, pinholed, sandy silty ferruginous gravel Transported <div style="text-align: right;">(2.2 m)</div>
1.5				
1.6				
1.7				
1.8				
1.9				
2.0				
2.1				
2.2				
2.3				
2.4				
2.5				
2.6				
2.7				
2.8				
2.9				
3.0				
3.1				
3.2				
3.3				
3.4

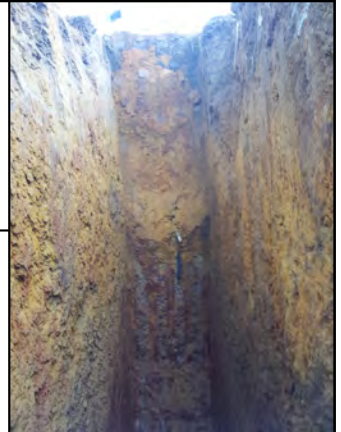
**Test Pit: TP 29**

Depth (m)	Sampling	Ground Water	Symbol	Description
0.1				<b>FIRM, SANDY SILT</b> Slightly moist, brown, firm, pinholed, sandy silt Transported  (0.6 m)
0.2				
0.3				
0.4				
0.5				
0.6				
0.7				<b>FIRM, SANDY CLAYEY SILT</b> Slightly moist, light orange brown, firm, pinholed, sandy clayey silt Transported  (1.5 m)
0.8				
0.9				
1.0				
1.1				
1.2				
1.3				
1.4				
1.5				
1.6				<b>STIFF, GRAVELLY SANDY SILT</b> Slightly moist, reddish brown mottled grey, black and yellow, stiff, pinholed, gravelly sandy silt Transported  (3 m)
1.7				
1.8				
1.9				
2.0				
2.1				
2.2				
2.3				
2.4				
2.5				
2.6				
2.7				
2.8				
2.9				
3.0				
3.1				
3.2				
3.3				
3.4

<b>Excavation Method:</b>	TLB	<b>Notes:</b>	Raining
<b>Refusal:</b>	None		
<b>Water Table:</b>	None

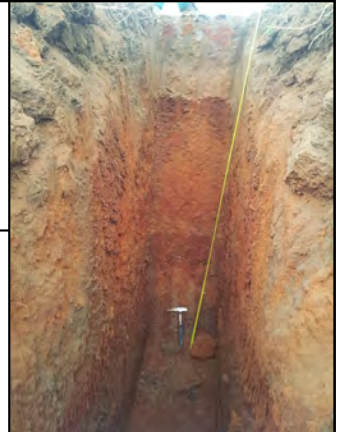
**Test Pit: TP 30**

Depth (m)	Sampling	Ground Water	Symbol	Description
0.1				<b>FIRM, SANDY SILT</b> Slightly moist, brown, firm, pinholed, sandy silt Transported
0.2				
0.3				
0.4				
0.5				
0.6				<b>SOFT, SANDY CLAYEY SILT</b> Slightly moist, light orange brown, soft, pinholed, sandy clayey silt Transported
0.7				
0.8				
0.9				
1.0				
1.1				
1.2				
1.3				
1.4				
1.5				
1.9				<b>STIFF, CLAYEY SILT WITH FERRUGINATION</b> Slightly moist, red brown, stiff, pinholed, clayey silt with ferrugination Transported
2.0				
2.1				
2.2				
2.3				
2.4				
2.5				
2.6				
2.7				
2.8				
2.9				
3.0				
3.1				
3.2				
3.3				
3.4

<b>Excavation Method:</b> TLB
<b>Refusal:</b> None
<b>Water Table:</b> None

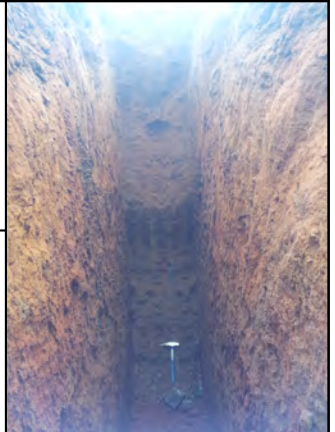
**Test Pit: TP 31**

Depth (m)	Sampling	Ground Water	Symbol	Description
0.1				<b>FIRM, SANDY SILT</b> Slightly moist, brown, firm, pinholed, sandy silt Transported
0.2				
0.3				
0.4				
0.5				<b>FIRM, CLAYEY SILT</b> Slightly moist, redbrown, firm, pinholed, clayey silt Transported
0.6				
0.7				
0.8				
0.9				
1.0				
1.1				
1.2				
1.3				
1.4				
1.5				
1.6				
1.7				
1.8				
1.9				
2.0				
2.1				(0.4 m)
2.2				<b>VERY DENSE, SANDY SILTY FERRUGINOUS GRAVEL</b> Dry, yellow brown, very dense, pinholed, sandy silty ferruginous gravel Transported
2.3				
2.4				
2.5				
2.6				
2.7				
2.8				
2.9				
3.0				
3.1				
3.2				(2.1 m)
3.3				(3 m)
3.4

<b>Excavation Method:</b>	TLB
<b>Refusal:</b>	None
<b>Water Table:</b>	None

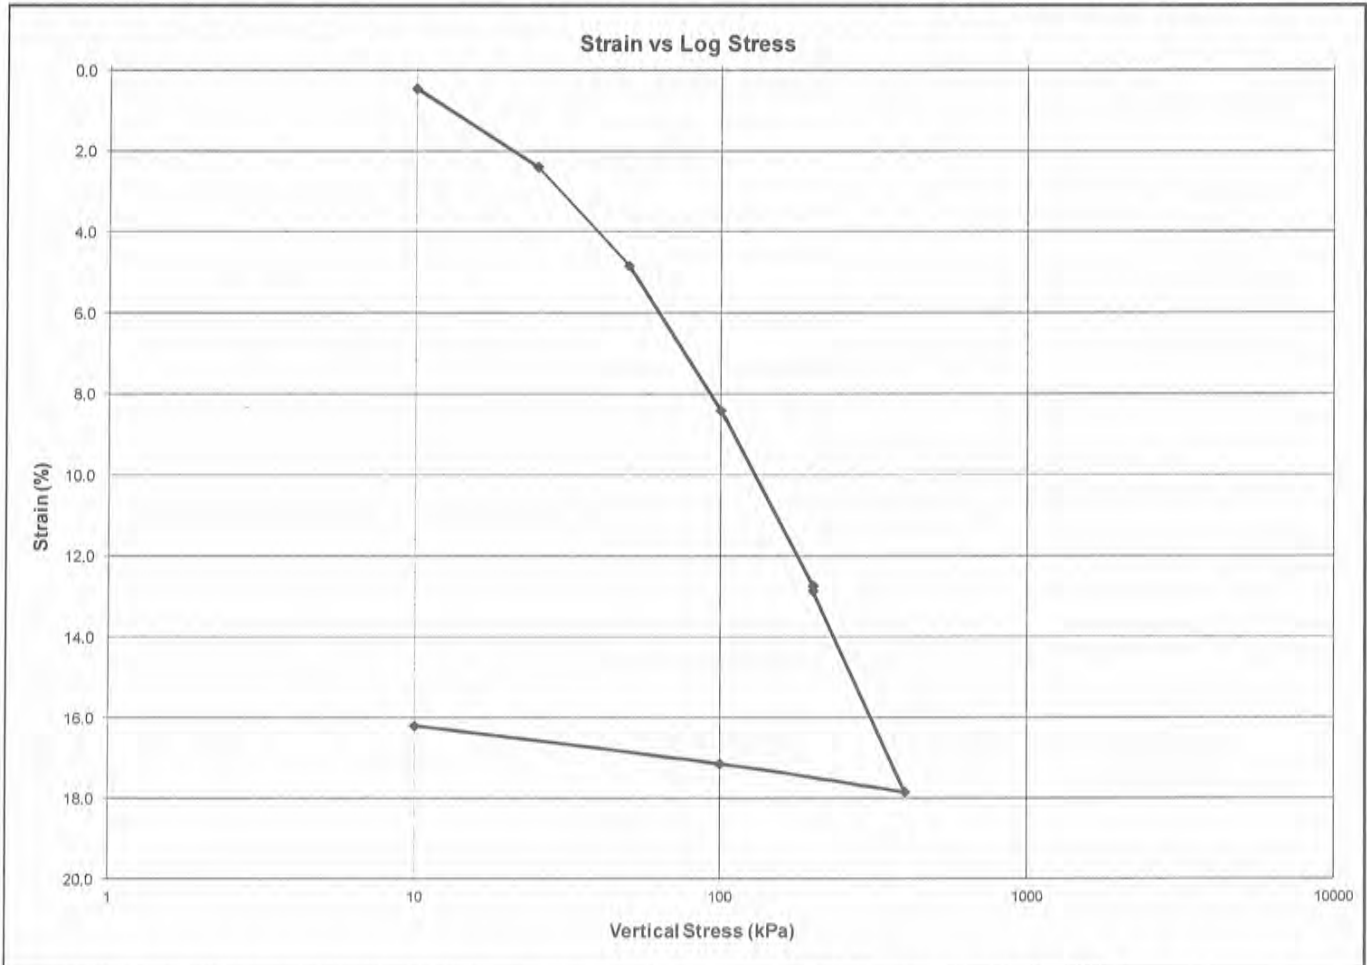
Sample Parameters	Unit	Value	Remarks	Test Remarks
Moisture Content	Before Test	15.8	Complete test specimen	Soaked @ 200kPa
	After Test	22.6	Complete test specimen	Collapse Potential: 0.13%
Dry Density	Kg/m <sup>3</sup>	1369		
Void Ratio	-	0.936		
Degree of Saturation	%	44.7		
Initial Specimen Height	mm	25.4		
Relative Density (SG)	-	2.650	Assumed

Test Parameters											
Vertical Stress	kPa	10	25	50	100	200	200	400	100	10	
Time Elapsed	hr	1	1	1	1	1	24	1	1	1	
H <sub>100</sub>	mm	25.284	24.792	24.171	23.263	22.166	22.132	20.867	21.046	21.285	
Strain	%	0.455	2.396	4.837	8.413	12.733	12.865	17.846	17.140	16.200	
Void Ratio	-	0.927	0.890	0.842	0.773	0.690	0.687	0.591	0.604	0.622	
Mv (1/Mpa)	-	-	1.3	1.001	0.751	0.472	-	0.286	0.029	0.126

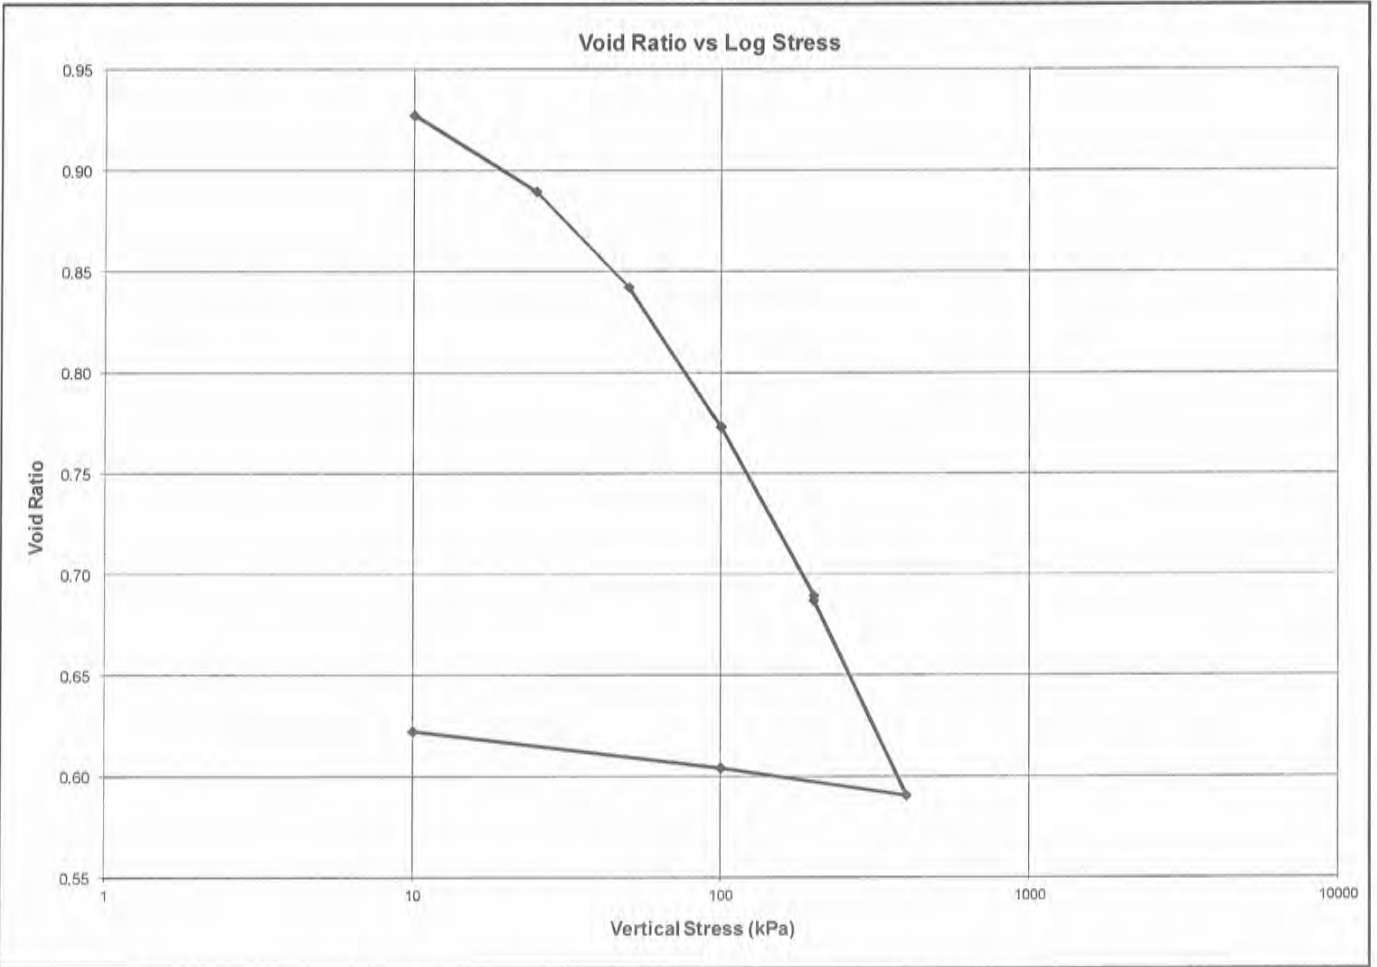
Sample Parameters	Unit	Value	Remarks	Test Remarks	
Moisture Content	Before Test	%	15.8	Complete test specimen	Soaked @ 200kPa
	After Test	%	22.6	Complete test specimen	Collapse Potential: 0.13%
Dry Density	Kg/m <sup>3</sup>	1369			
Void Ratio	-	0.936			
Degree of Saturation	%	44.7			
Initial Specimen Height	mm	25.4			
Relative Density (SG)	-	2.650	Assumed

Test Parameters											
Vertical Stress	kPa	10	25	50	100	200	200	400	100	10	
Time Elapsed	hr	1	1	1	1	1	24	1	1	1	
H <sub>100</sub>	mm	25.284	24.792	24.171	23.263	22.166	22.132	20.867	21.046	21.285	
Strain	%	0.455	2.396	4.837	8.413	12.733	12.865	17.846	17.140	16.200	
Void Ratio	-	0.927	0.890	0.842	0.773	0.690	0.687	0.591	0.604	0.622	
Mv (1/MPa)	-	-	1.3	1.001	0.751	0.472	-	0.2858	0.029	0.126
