**FAUNAL, FLORAL, WETLAND AND AQUATIC
ASSESSMENT AS PART OF THE ENVIRONMENTAL
ASSESSMENT AND AUTHORISATION PROCESS FOR THE
PROPOSED THARISA MINE DEVELOPMENT PROJECT,
NORTH WEST PROVINCE**

SECTION E – Aquatic Assessment

Prepared by: Scientific Aquatic Services
Report author S. van Staden (Pr. Sci. Nat)
M. Hanekom
A. Mileson
Report Reference: SAS 213199
Date: November 2013

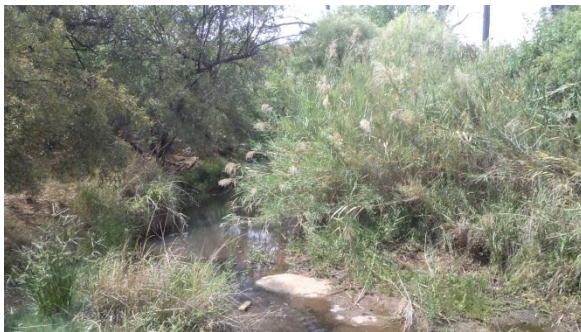
Figure 3: 2013 Upstream Site A indicating good habitat and sufficient flow.

- Some general impact below the upstream site A along the N4 highway may be impacting on the Sterkstroom River (Figure 3). It is recommended that an additional biomonitoring site be included in the 2014 biomonitoring period until the N4 development has been completed, in order to distinguish between impacts on the Sterkstroom River emanating from the N4 and impacts emanating from Tharisa Mine. Refer to Figure 1 for the location of the proposed additional A1 biomonitoring site.

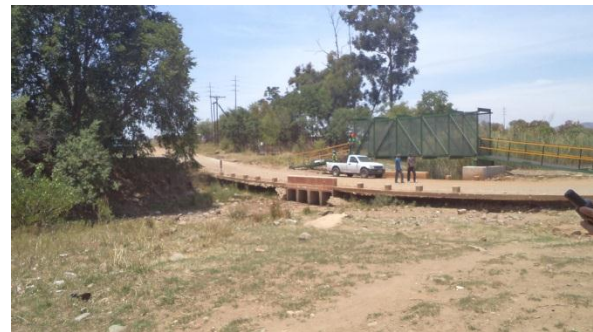
- The November site visit indicated that the downstream site B1 was dry (Figure 4). However, during August there was sufficient water to conduct biomonitoring (CS 2013).

Figure 4: 2013 Downstream Site B1 was dry during the November site visit.

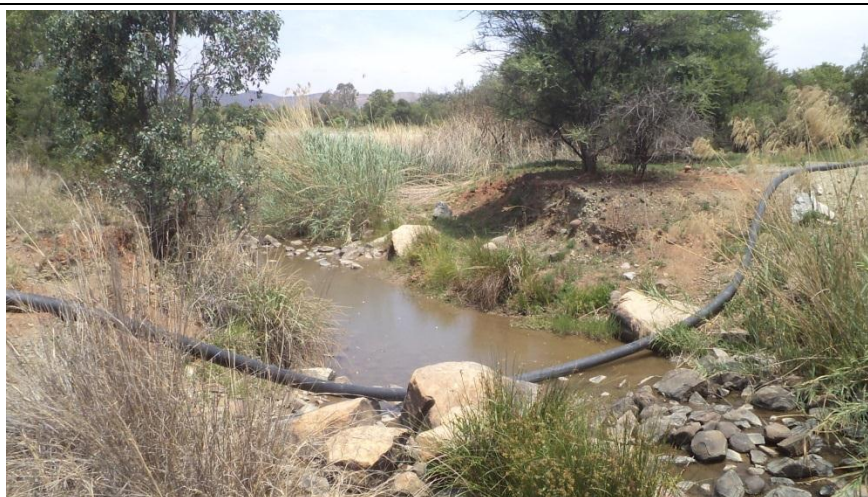
- Additional visual records indicate that the Tharisa Mine does not abstract any water from the Sterkstroom River and is managing its water in a closed system between the west open pit and east open pit areas, which are respectively situated west and east of the Sterkstroom River (Figure 5).

Figure 5: Pipe transferring water from west pit to HERNIC Open pit over the Sterkstroom River

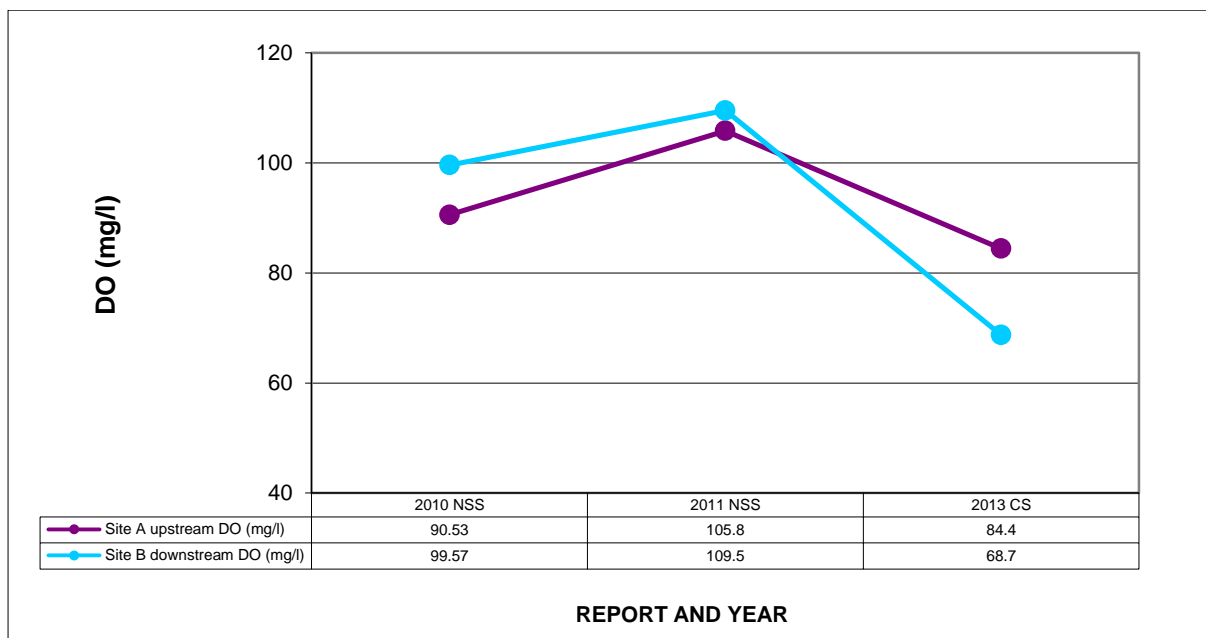
- The reduction in the concentration of dissolved oxygen at site B1 could be caused by the reduction of the volume of water available for the saturation concentration of dissolved oxygen. In addition the downstream site during this survey comprise of a pool of water which may lower the DO concentration through the presence of oxygen-scavenging attributes and suspended particles.

- Actions due to Tharisa mining activities may also attribute to the reduction of the DO where the possible presence of oxidizable organic matter, either of natural origin (detritus) or originating in waste discharges, can lead to reduction in the concentration of dissolved oxygen in surface waters (DWAf 1996 Vol 7).
-

Figure 7: Upstream and downstream DO temporal variables measured for years 2010, 2011 and 2013.

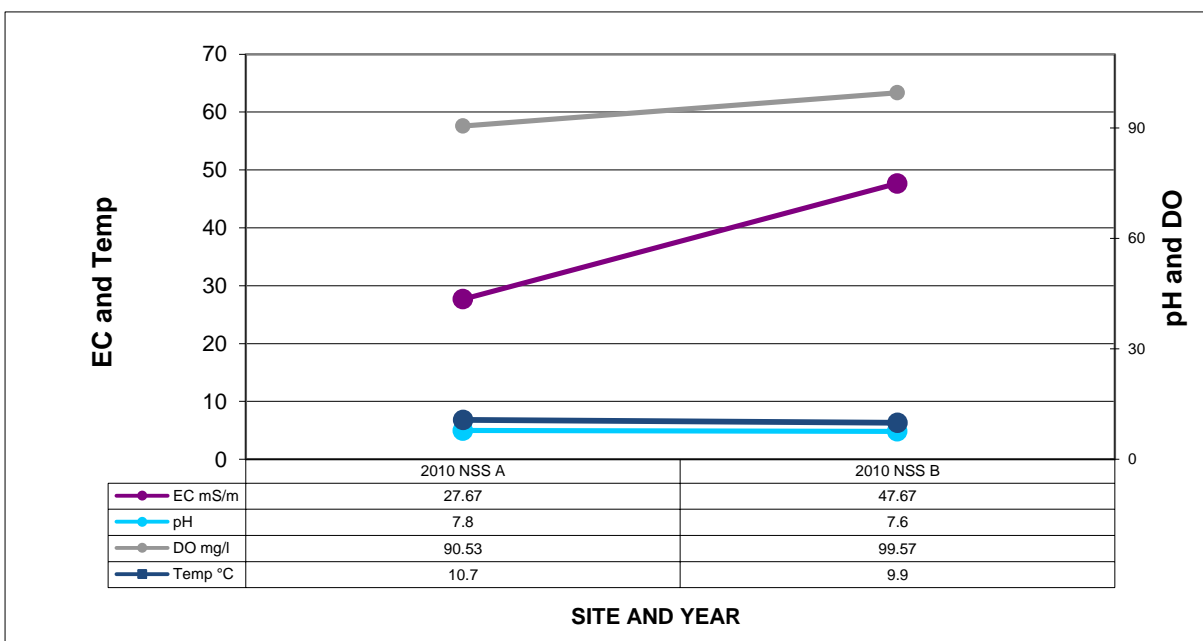
- Downstream of the Tharisa Mine it is evident that there has been a 71% increase in the EC. Spatially between the two sites (A and B) this increase exceeds TWQR guidelines (DWAF 1996 Vol 7).
- The observation is most likely resulting from agricultural and anthropogenic activities taking place between the two sites, as well as potential mining related activities which have taken place since 2008. Such activities may lead to amplified concentration of dissolved salts introduced to the system, especially under low flow conditions during the time of assessment.
- The pH decreased by less than 2% between the up and downstream sites. This change is within the 5% change from reference conditions (DWAF 1996 Vol 7).
- It is unlikely that the observed change in pH will lead to reduced aquatic ecological integrity.

- Dissolved oxygen concentration increased 9% in a downstream direction and this change is, however, within the target water quality objective for aquatic ecosystems (DWAF 1996 Vol 7).
- Limited variation in temperature was observed between the sites and the temperature can be regarded as normal for the time of day and time of year when sampling took place and the variation in stream volume at the two points.
- Overall for the 2010 documented results (NSS 2011) the *in-situ* pH, DO and temperature water quality variables remain constant and within the TWQR guideline (DWAF 1996 Vol 7) and should not pose a risk to aquatic biota. The EC values for the 2011 survey exceeds TWQR guidelines (DWAF 1996 Vol 7) and may have impacted on the receiving ecosystem.

Figure 10: Spatial In-situ water quality variables measured between the upstream and downstream sites for year 2010

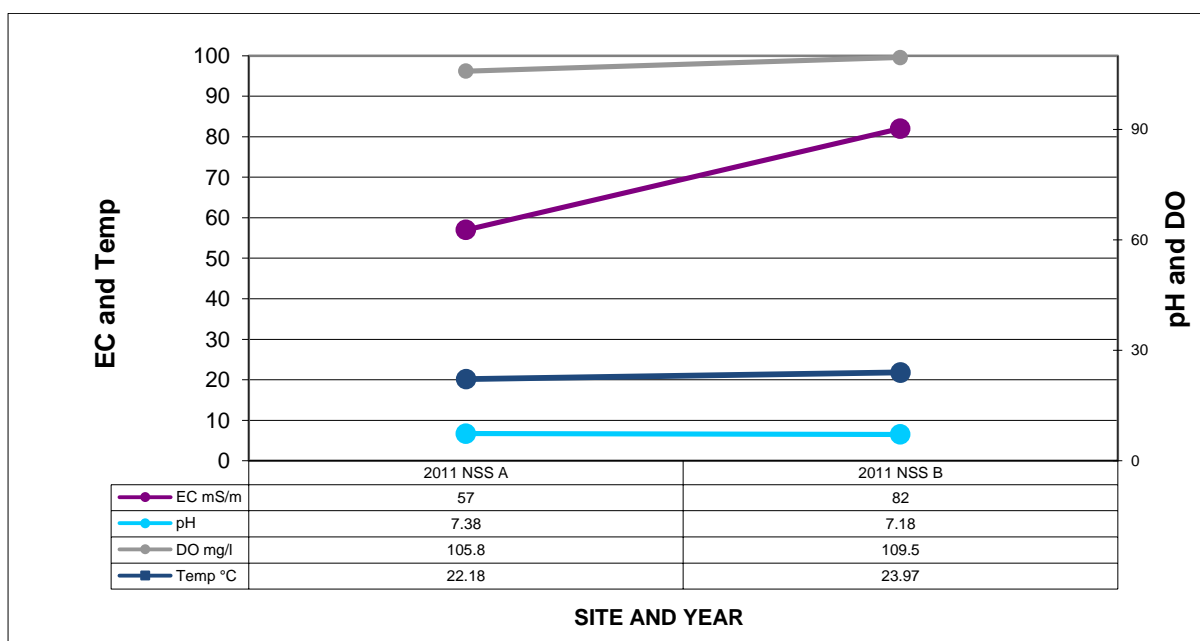
- Spatially the EC increased in a downstream direction by 43%, indicating a potential source of pollution occurring between these sites at the time of sampling.
- The EC at both sites during the 2011 biomonitoring survey exceeds the reference EC taken from the upstream A site for the 2008 baseline study (NSS 2008) by more than 15% and thus does not meet TWQR guideline recommendations (DWAF 1996 Vol 7).
- Since 2008, the 2011 the EC has increased more than 3x the reference EC at the upstream site. This may be due to upstream impacts such as anthropogenic and agricultural activities taking place in the system.

- This observation is most likely as a result from agricultural, anthropogenic and Tharisa Mine related activities taking place between the two sites which may lead to increased concentration of dissolved salts introduced to the system, especially under low flow conditions during the time of assessment.

- In general from the 2011 documented results (NSS 2011) the *in-situ* pH, DO and temperature water quality variables remain constant and within the TWQR guideline (DWAF 1996 Vol 7) and should not pose a risk to aquatic biota. The EC values, however, for the 2011 survey exceeds TWQR guidelines (DWAF 1996 Vol 7) and may have impacted on the receiving ecosystem.

Figure 11: Spatial In-situ water quality variables measured between the upstream and downstream sites for year 2011

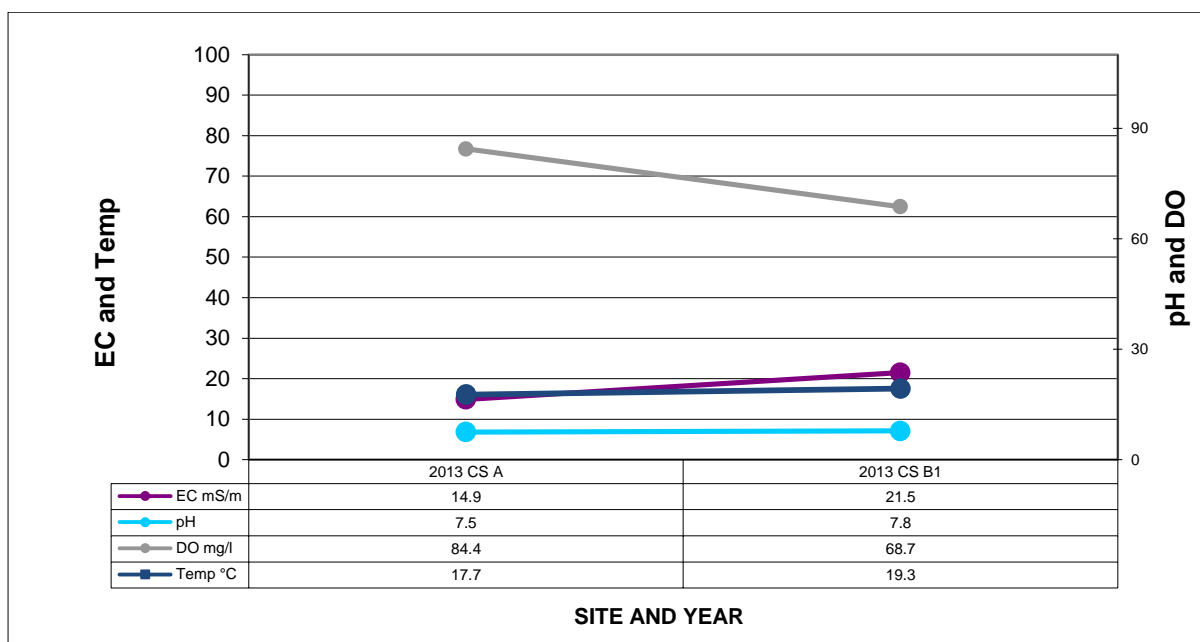
- This observation is most likely as a result from agricultural, anthropogenic and Tharisa Mine related activities taking place between the two sites which may lead to an increased concentration of dissolved salts introduced to the system, especially under low flow conditions.

- The pH increased by less than 1% between the up and downstream sites. This change is within the 5% change from the guideline stipulated and these pH readings are well within the 6.5 and 9 pH guideline recommendations (DWAF 1996 Vol 7).

- Overall the results from the 2013 documented results (CS 2013) the EC values for the 2013 survey exceeds TWQR guidelines (DWAF 1996 Vol 7) and may impact on the receiving ecosystem. The other *in-situ* pH, DO and temperature water quality variables remain constant and within the TWQR guideline (DWAF 1996 Vol 7) and should not pose a risk to aquatic biota.

Figure 12: Spatial In-situ water quality variables measured between the upstream and downstream sites for year 2013.

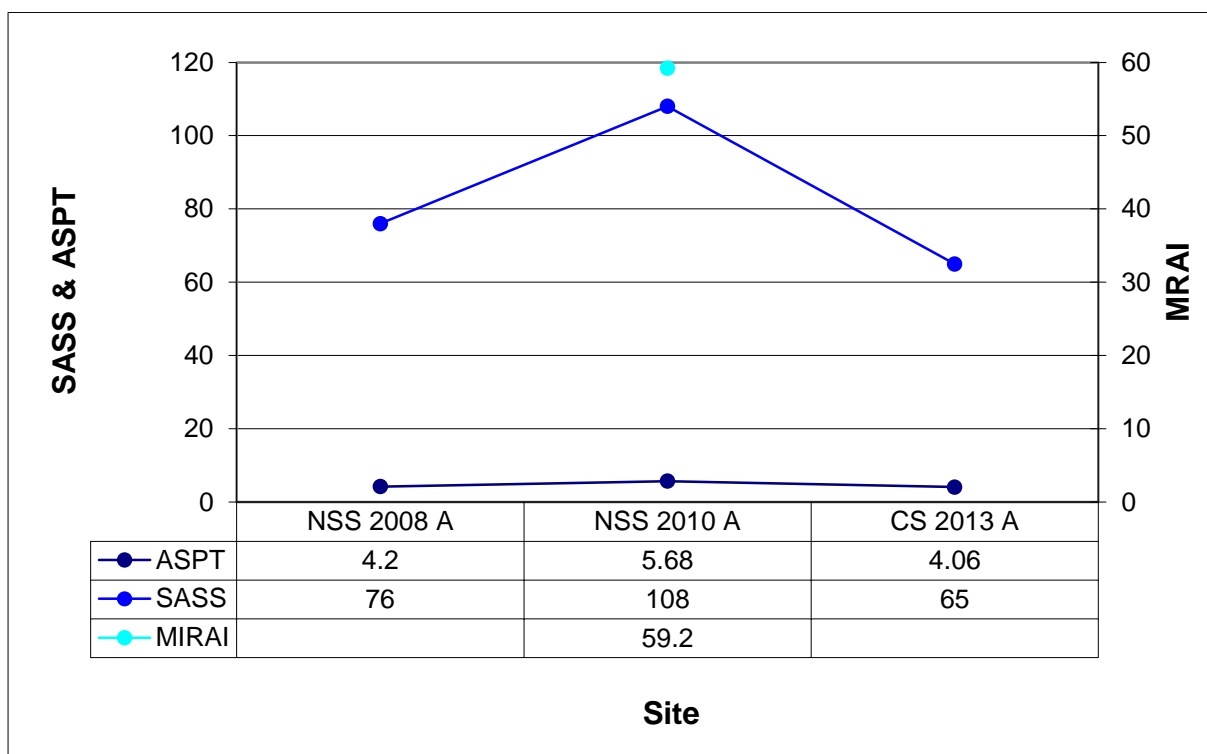
Figure 15: Longer term change in the system along the Sterkstroom River for the upstream sites between 2008, 2010 and 2013 during the low flow period.

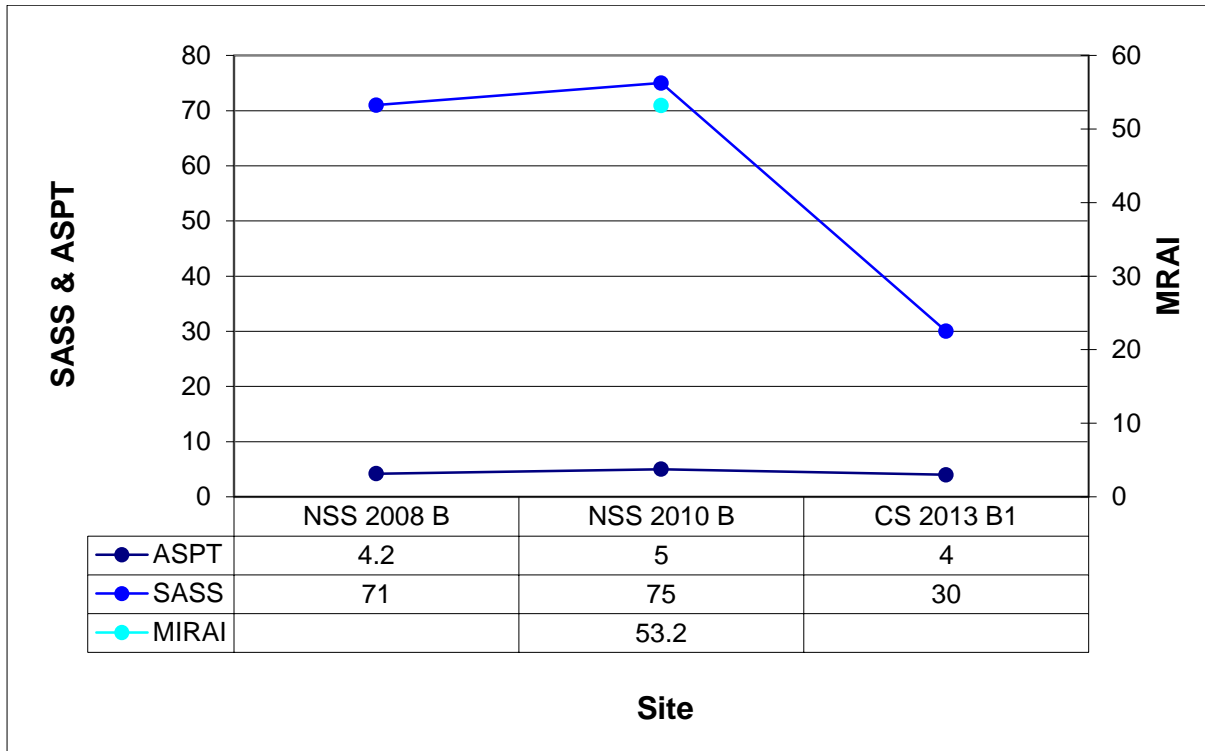
Figure 16: Longer term change in the system along the Sterkstroom River for the downstream sites between 2008, 2010 and 2013 during the low flow period

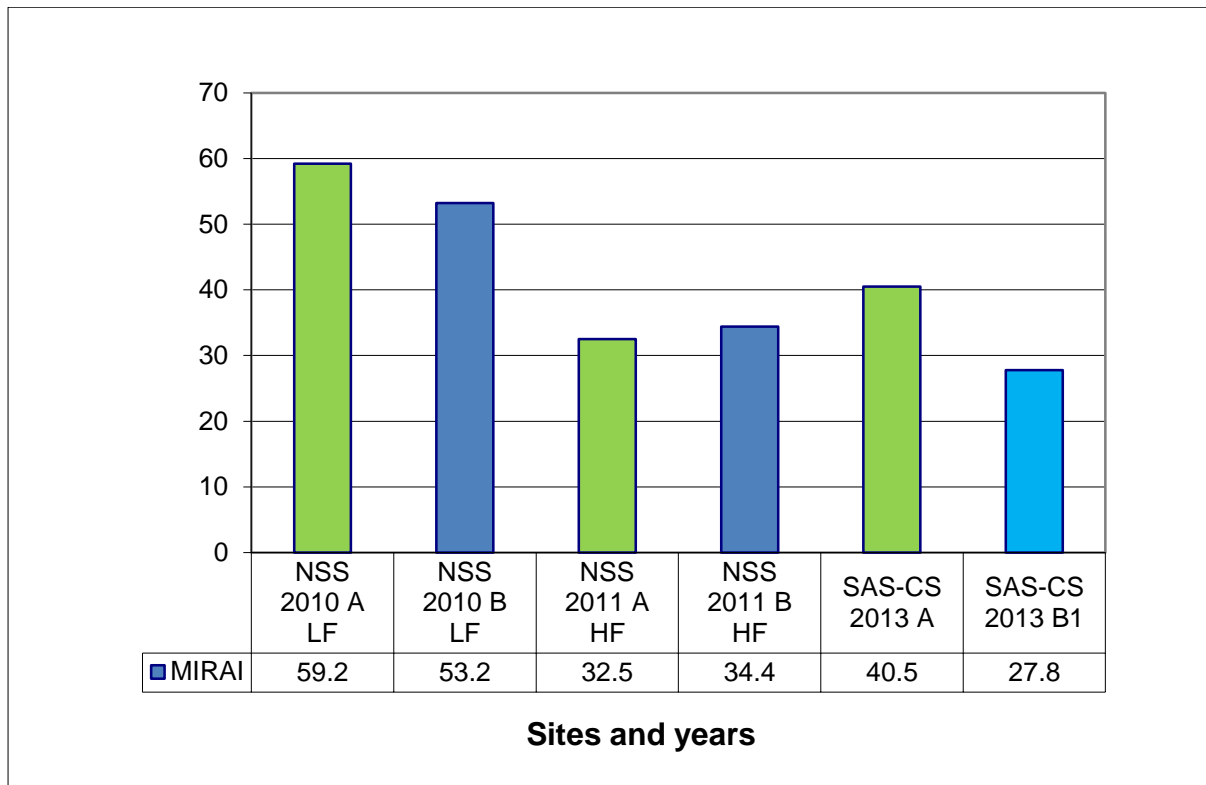
- The MIRAI data for years 2011 and 2013 indicates that the aquatic macro-invertebrate community in this section of the Sterkstroom River has suffered a general loss in integrity throughout the area when compared to the reference score of 2010 across high and low flow periods (Figure 17).
- The baseline MIRAI reference classification for both upstream and downstream sites for 2010 indicated moderately modified class D. For both upstream and downstream sites the classification deteriorated to class E (critically modified) during the 2011 and 2013 assessments.
- The changes in MIRAI may be due to mine related activities, however, another contributing factor may be flow alteration within the Sterkstroom system.
- The new downstream site B1 also indicated a MIRAI classification of critically modified class E with a low score of 27.8 (refer to light blue bar in Figure 17).

Figure 17: MIRAI data along the Sterkstroom River for the sites between 2010, 2011 and including the CS 2013 SASS data which has been updated to MIRAI for 2013 by SAS.
