Mulilo Struisbult Photovoltaic Energy Plant (PV2) Alien Invasive Plant Management Plan

Copperton, Northern Cape

February 2022

Report Name	Mulilo Struisbult PV2 Alien Invasive Plant Management Plan
Reference	Mulilo Struisbult PV2 – AIP Plan
Submitted to/Client

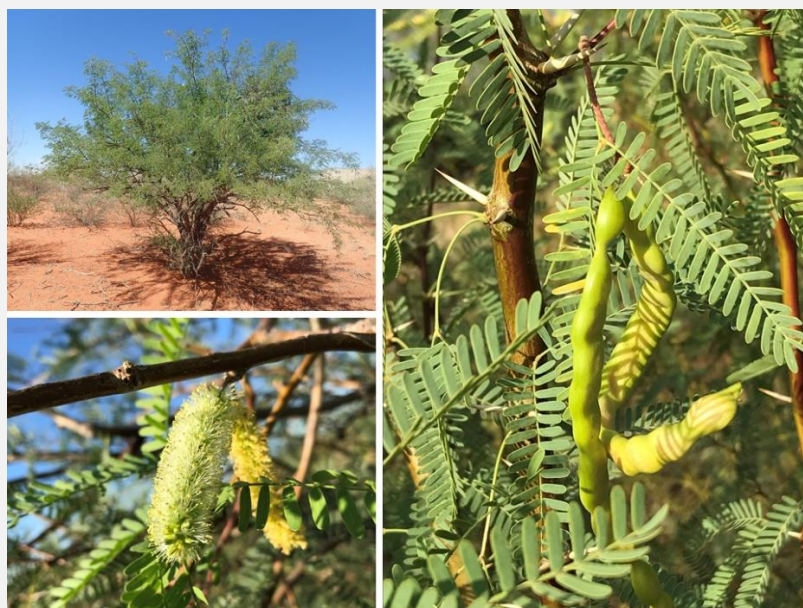
Prosopis glandulosa - Honey mesquite

Description: A multi-stemmed acacia-like shrub or small tree up to 10m high with paired, straight spines/thorns and reddish-brown branchlets. Dark green leaves with leaflets 10-25mm long. Yellow flower spikes from June to November. Yellowish to purplish, slender, straight, woody pods. The pods are poisonous, and the pollen is a respiratory tract irritant.

Problems Caused: Prosopis trees are extravagant users of readily available ground-water and dense stands could seriously affect the hydrology of the ecosystems they invade. Dense stands compete with and replace indigenous woody and grassland species. Dense stands produce few pods and thus replace natural pasturage without providing pods in return. Dense stands are virtually impenetrable, restricting the movement of domestic and wild animals and causing injuries

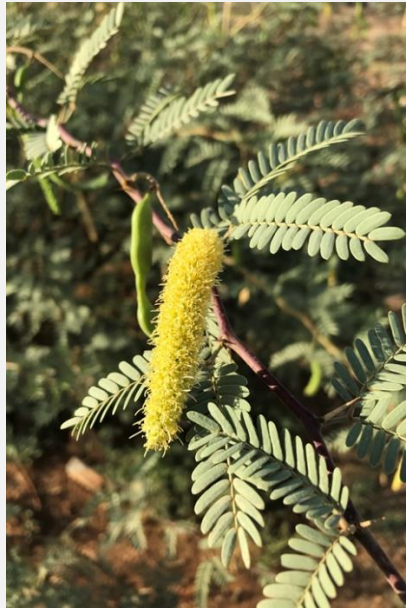
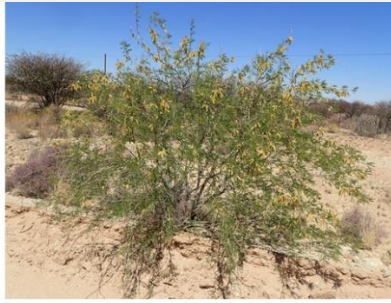
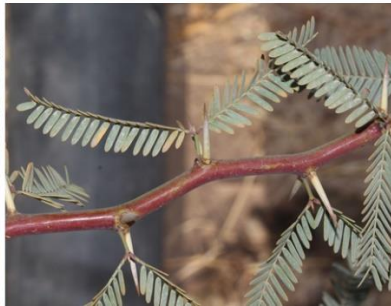
Prosopis velutina - Velvet mesquite

Description: Similar to *P. glandulosa*. A deciduous multi-stemmed shrub or small tree with a spreading crown and crooked branches leading to feathery, velvety dark green leaves up to 12 cm long. Leaves have 12-20 pairs of short, hairy and closely spaced leaflets. Branches have short, yellow-white thorns up to 2.5 cm and generally occur in pairs. Flowers are cream-coloured yellow with long white stamens.

Problems Caused: *P. velutina* is thought to have negative effects on water availability, but the exact effects of this species on the level of water tables has yet to be fully elucidated. *Prosopis* species also outcompete the important and indigenous *Vachellia Karroo* and *Vachellia erioloba* trees.

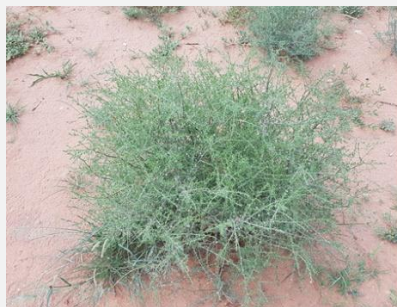
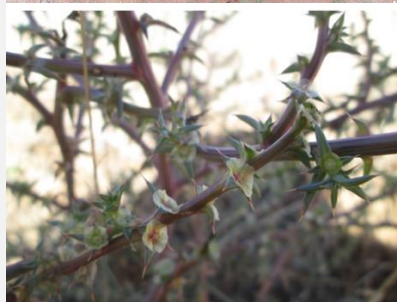
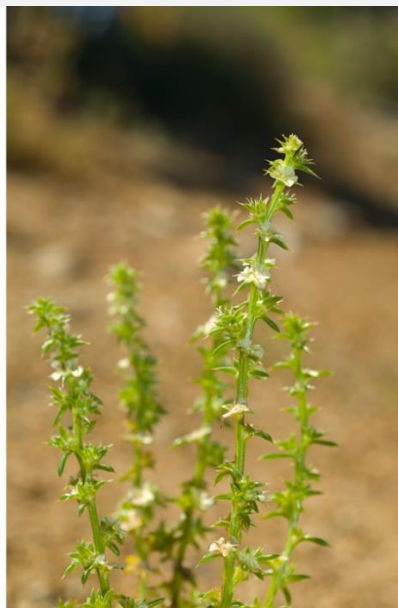
Salsola kali - Tumbleweed

Description: Annual weed that begins life as a typical multiple branched bush, which then takes on a spherical form. Leaves are alternate; blades linear, 1-2 mm wide and fleshy. Flowers appear from Sept. to April and are inconspicuous, white, yellowish or greenish, cup shaped, in the leaf axils.

Problems Caused: The plant displaces native plants and competes for space, water, and nutrients. It is highly problematic, tough, and unpalatable, also clogging up storm water channels. It can rapidly colonise new areas, especially overgrazed, bare, and eroded soil. It is unpalatable leading to selective grazing.

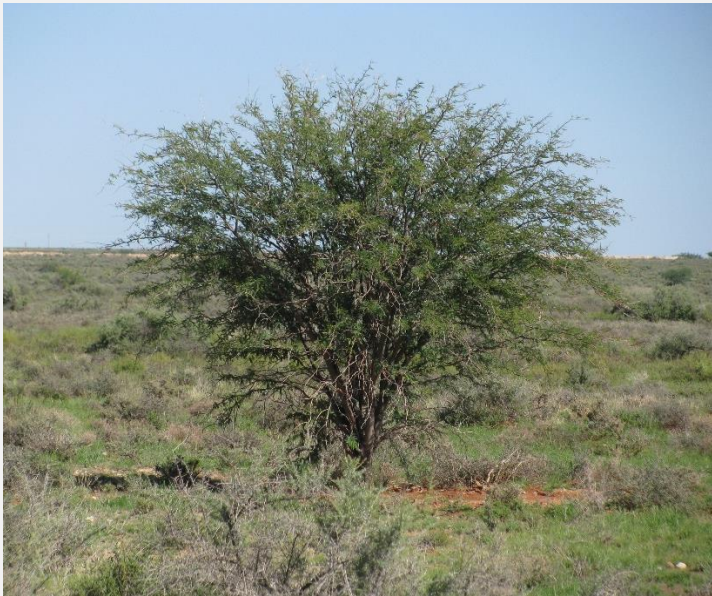
<p>Multi-stemmed acacia-like shrub or small tree up to 10m high with paired, straight spines and reddish-brown branchlets. Dark green leaves with leaflets 10-25mm long. Yellow flower spikes from June to November. Yellowish to purplish, slender, straight, woody pods.</p> <p>Similar species: The indigenous <i>Vachellia karroo</i> tree also occurs in the region. The tree flowers in summer and the flowers are small, yellow and pompom/rounded in shape.</p>	<p>Cut stump close to ground (<10 cm) and wipe the exposed stump surface to remove saw dust prior to application. Immediately apply registered herbicide to the entire cut surface using a paint brush. Kaput 100 Gel is a proven effective herbicide in the treatment of <i>Prosopis</i> sp. Refer to product label sheet for all details and special instructions.</p> <p>Pull or dig out entire root system if mechanised equipment is available (chain and tractor or bulldozer).</p>
