***Rapid Land Release Program: NHBRC Phase 1  
Geotechnical Investigation for Ennerdale Extension 9,  
Gauteng: Final Report***

***Client: Glad Africa & GDHS***

***Reference: 19-0866.02R03***

***Dated: 7 November 2019***

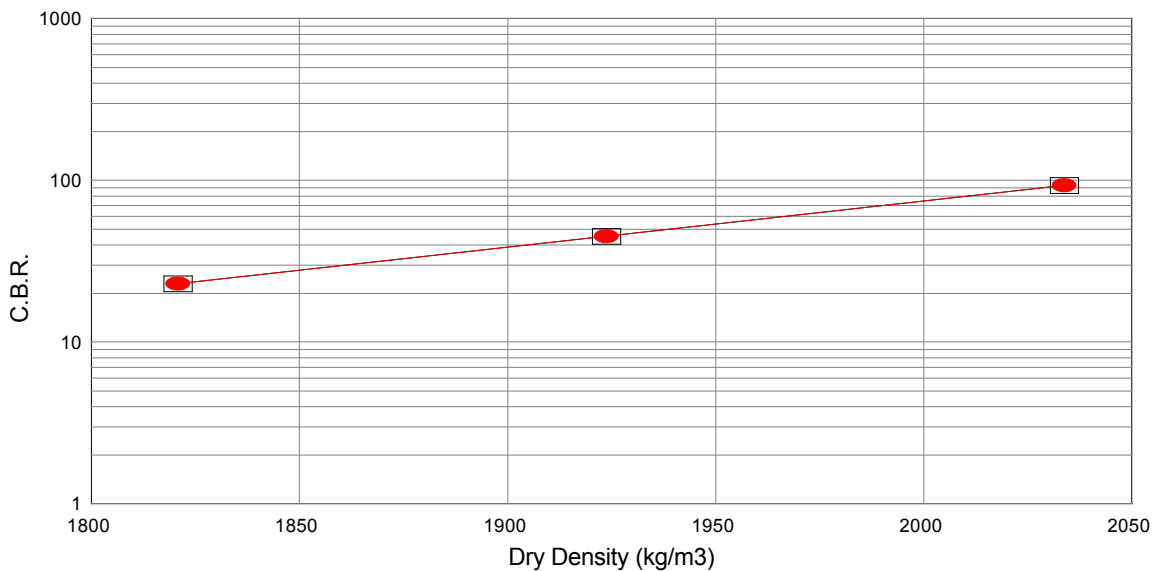
Percentage Mod AASHTO	90	93	95	98	100
CBR	23	35	46	68	88

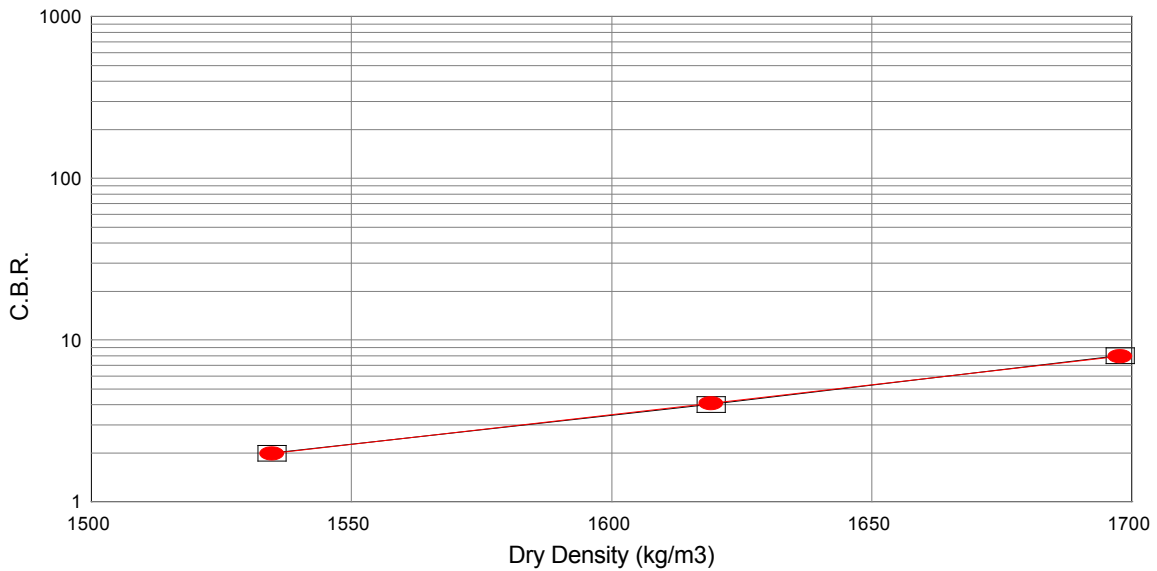
Percentage Mod AASHTO	90	93	95	98	100
CBR	2	3	4	7	9

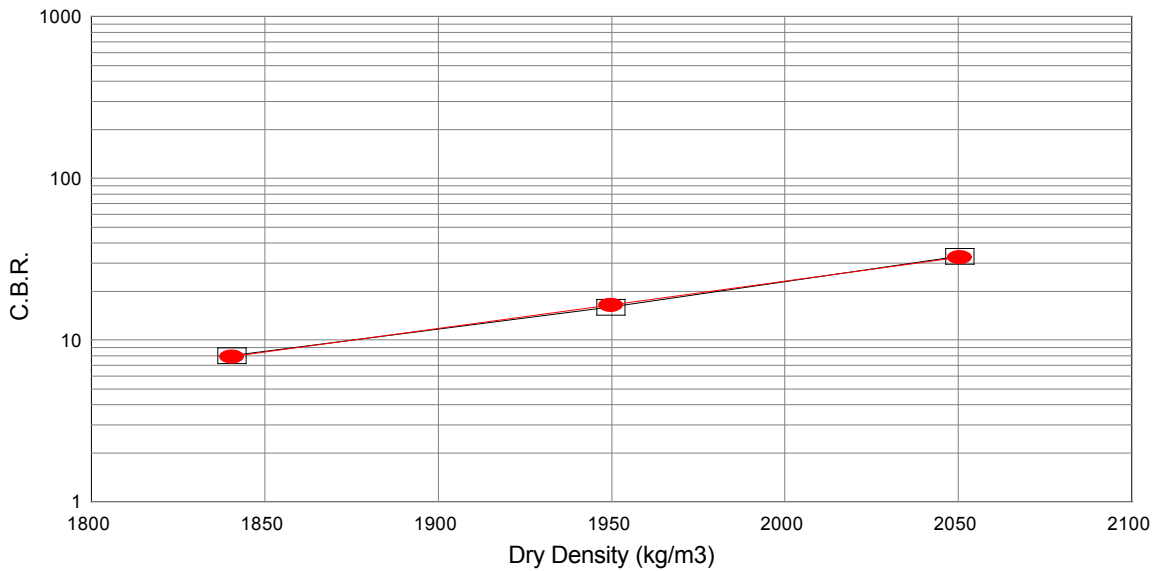
Percentage Mod AASHTO	90	93	95	98	100
CBR	8	12	16	24	32

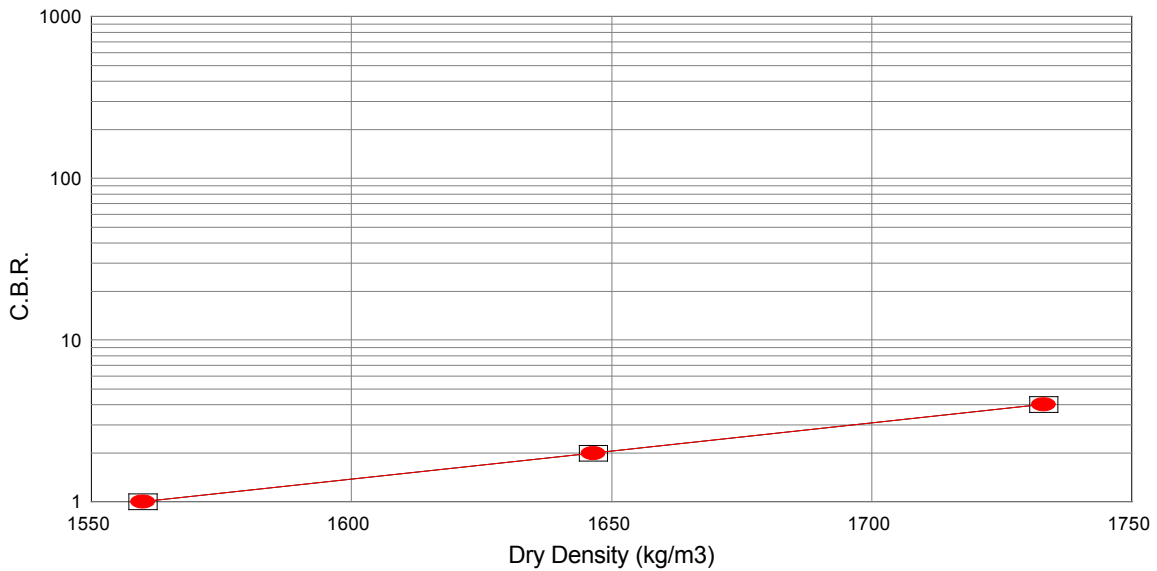
Percentage Mod AASHTO	90	93	95	98	100
CBR	1	1	2	3	4

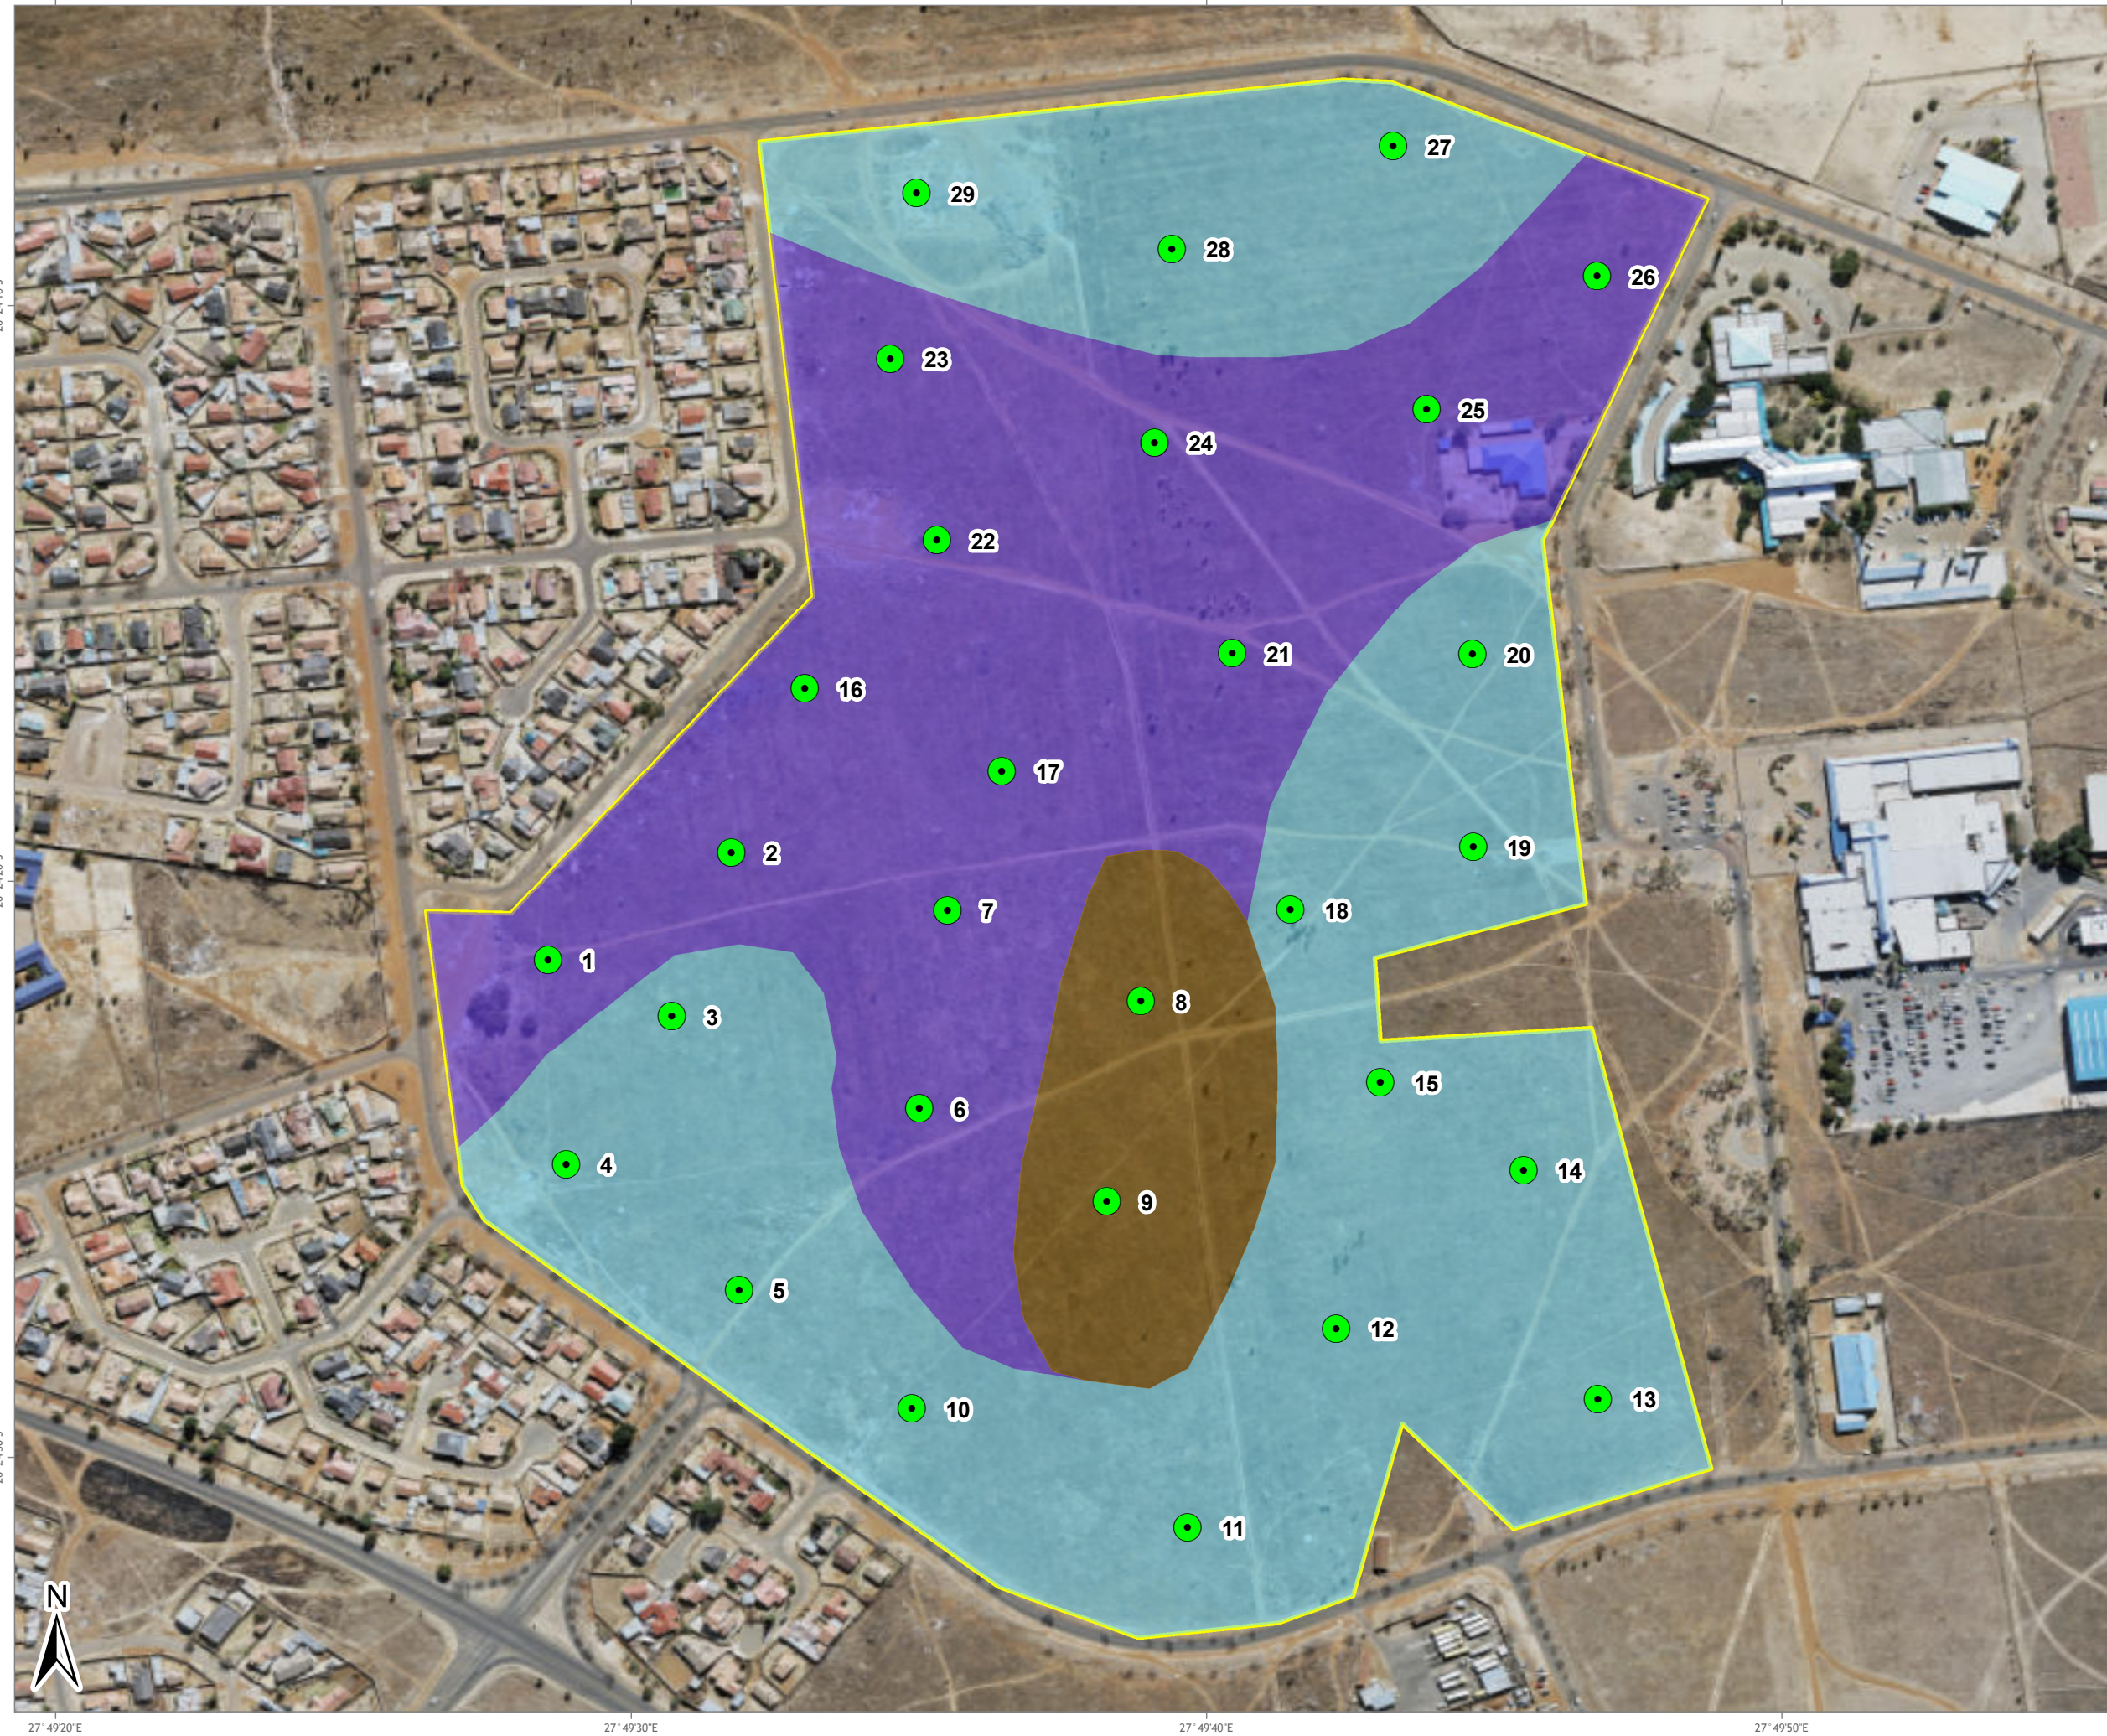
# RAPID LAND RELEASE PROGRAM - ENNERDALE EXT 9 TEST PIT PLAN AND NHBRC CLASSIFICATIONS

- Test Pits
- Ennerdale Ext 9
- NHBRC**
- H - Heave < 7.5 mm
- H1 - Heave 7.5 - 15 mm
- H2 - Heave 15 - 30 mm
