# Report on Geotechnical and Geohydrological Investigations for the Proposed Decommissioning (Closure) of a Waste Landfill at Shakaville, KwaDukuza Local Municipality, KwaZulu-Natal Province

20 November 2017

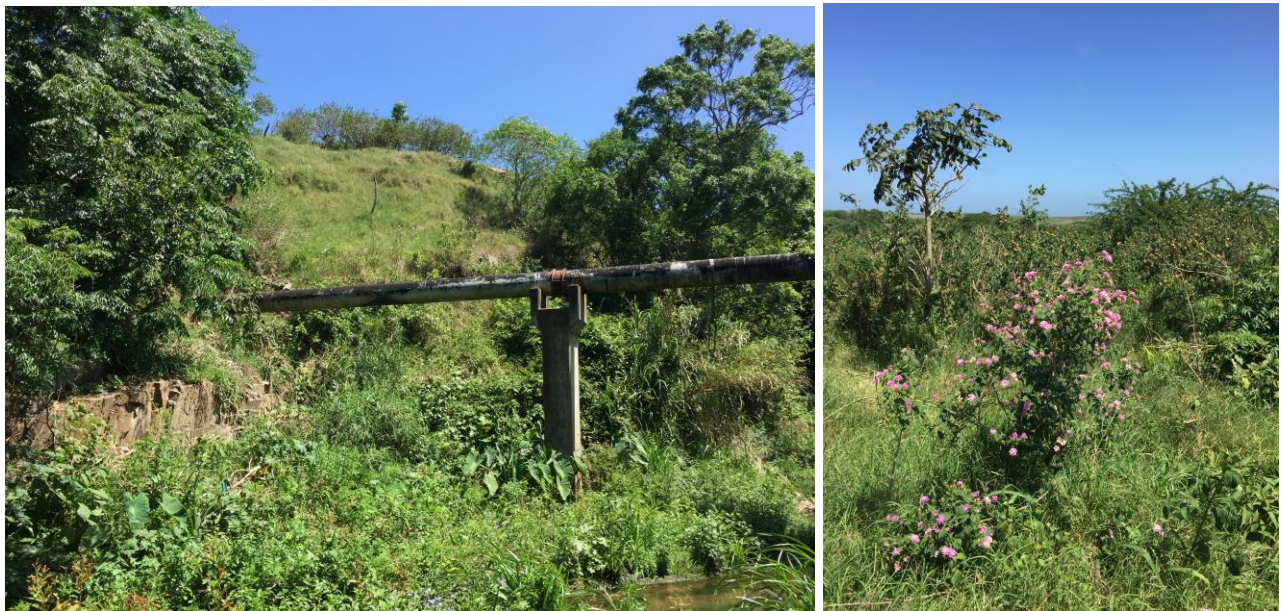
Figure 3: Typical vegetation covering the slope of the landfill as well as on the of the river (left) and on top of the landfill (right).

The landfill seems to have naturally rehabilitated itself as it is overgrown by alien vegetation and weeds since the stoppage of dumping operations. Figure 3 shows an example of the existing vegetation.

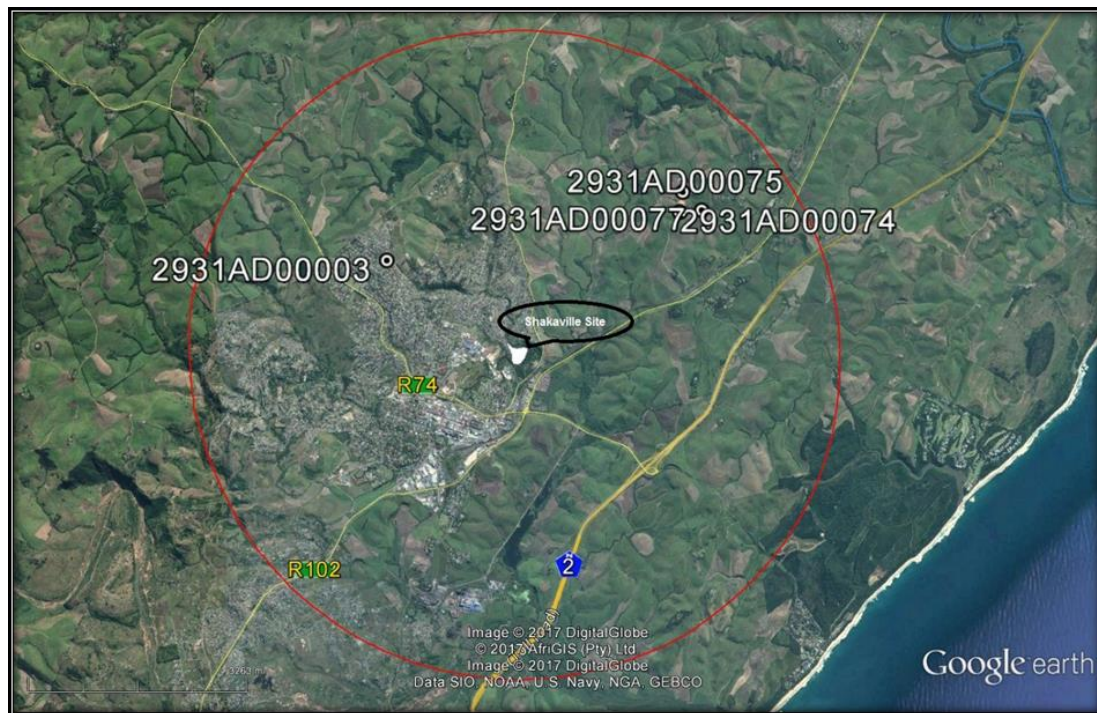
Figure 7: NGA boreholes relative to landfill site.

in very close proximity to the site but generally show an intergranular and fractured type aquifer. The water strikes are generally deeper than 30mbgl and are likely to be encountered between the two layers of rock. Recharge values range between 75 and 110 mm/annum and the groundwater levels are expected between 31 to 40 mbgl.

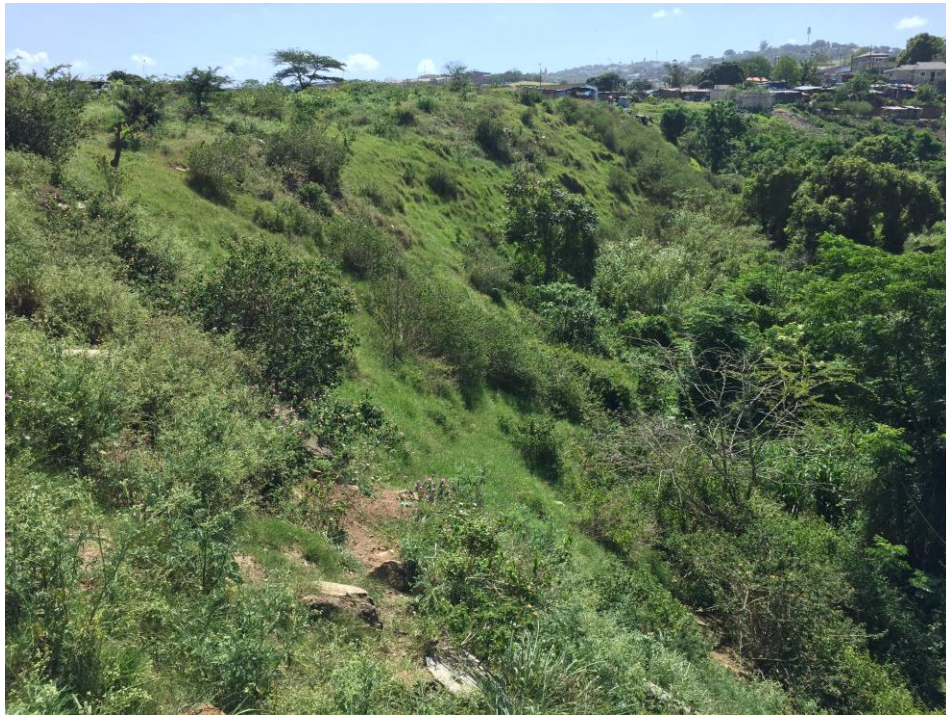
From the site walkover and investigations, the side slopes appear stable (Figure 8) due to the vegetation now in place. In the unlikely event that the waste body becomes deeply saturated, the risk of internal slope failure may present still itself.

Figure 8: Vegetated landfill slope looking northwestwards.

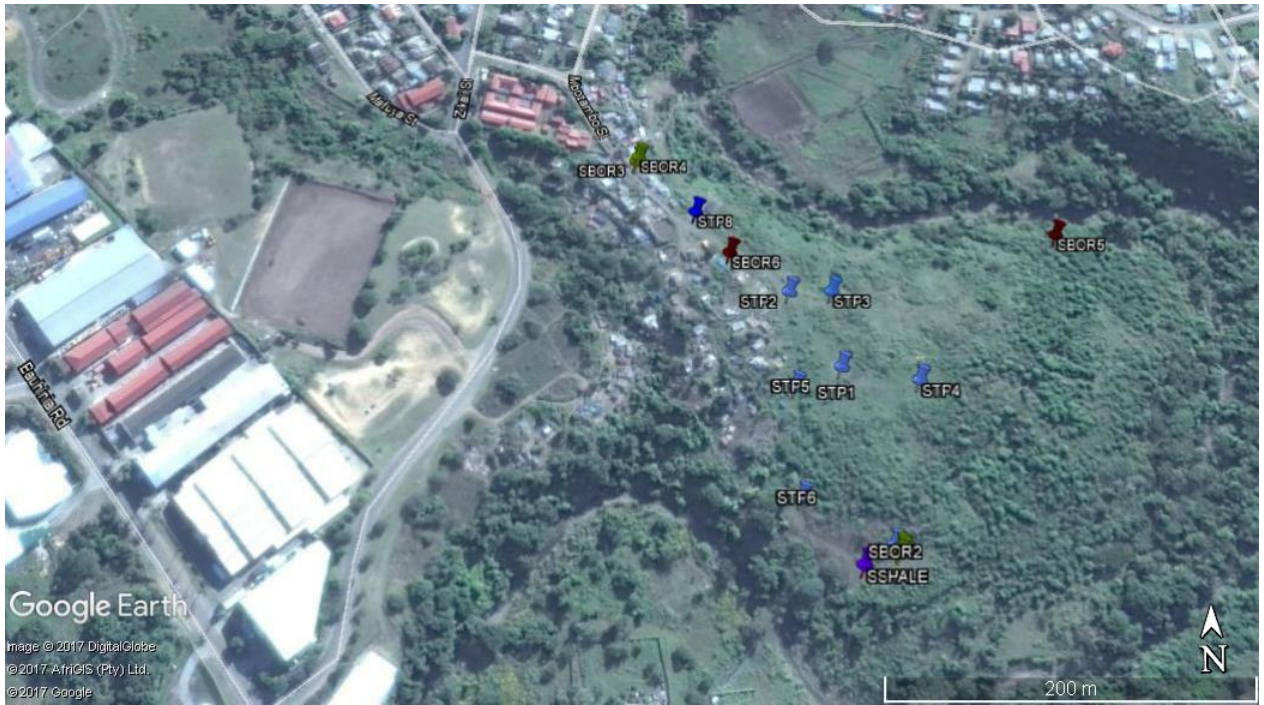
Site mapping shows that there is surface exposure of shale rock as per geological map. Figure 10 show the location of outcropping shale as well as sub-surface exposure of shale and weathered dolerite rock from test pit excavations. The weathered rocks are the product and source of the soils found on the site.

Eight (8) test pits (STP1 to STP8) were excavated using a Tractor Loader Backhoe (Volvo BL31B) on 3 November 2017 (Figure 10). The test pit GPS coordinates and related information are presented in Table 4.

Figure 10: Location of 8 test pits (blue), Monitoring boreholes (green), unknown boreholes (brown) and shale geological exposures (navy).

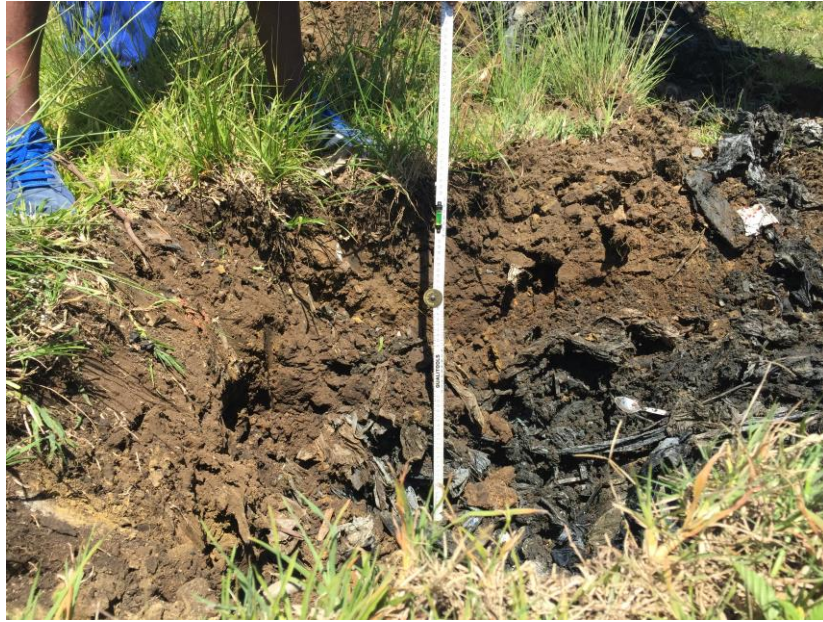
Figure 11: STP1 test pit profile showing soil cover over waste.

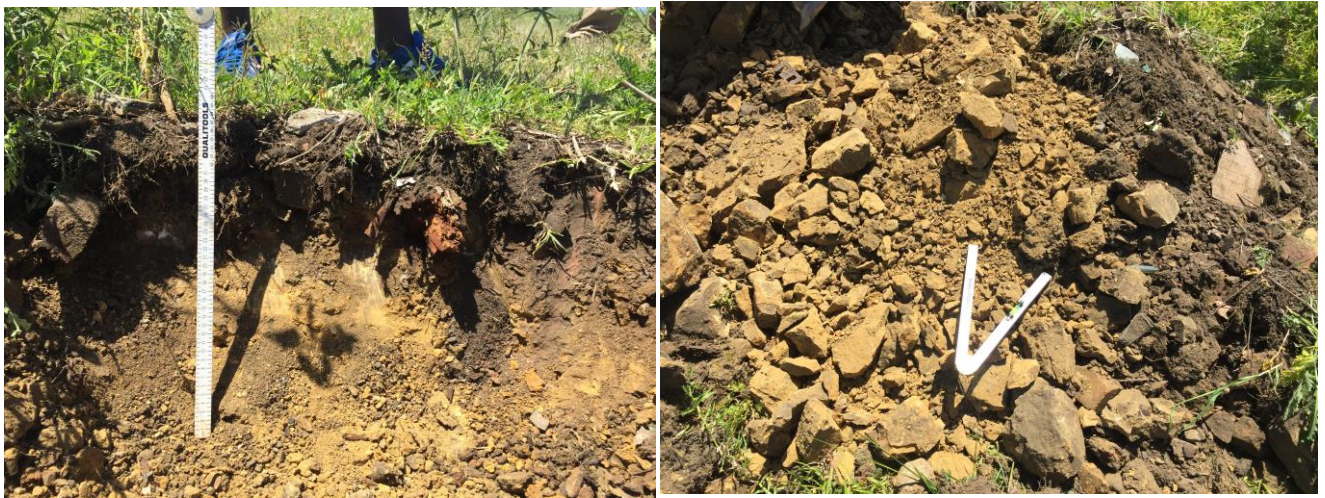
Figure 12: STP2 test pit profile showing sub-surface shale.

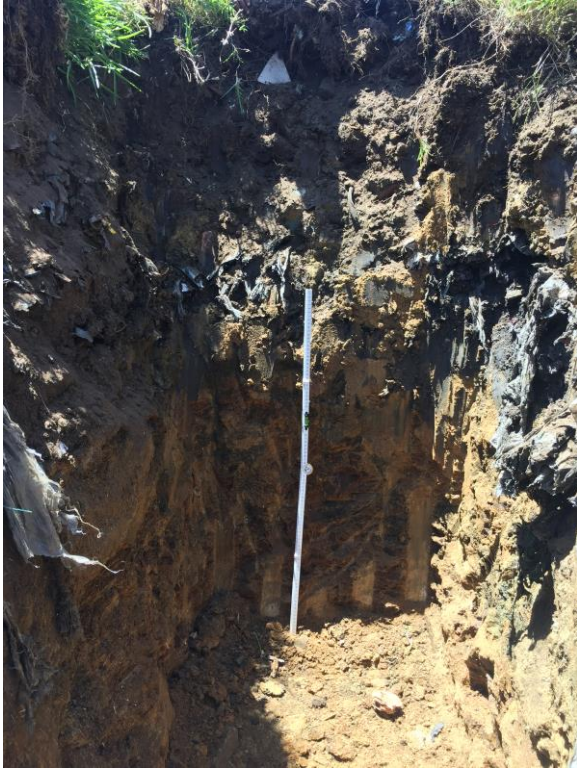
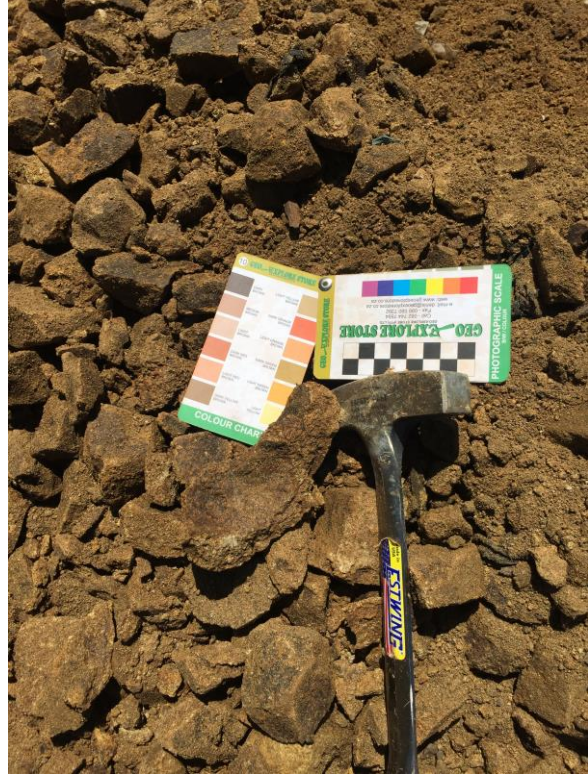
Figure 13: STP3 test pit profile showing weathered dolerite.

Test Pit ID	Sample No	Depth To-From (m)	USCS	Dry Density (kg/m <sup>3</sup> )	Optimum Moisture Content (%)	Head of Water (cm)	Coefficient of Permeability (m/s)
STP3	SSTP3001	1-2	SC	1592	N/A	N/A	2.2x10 <sup>-8</sup>
STP8	SSTP8001	0.7-1.4	CL	1902	N/A	N/A	4.8x10 <sup>-10</sup>

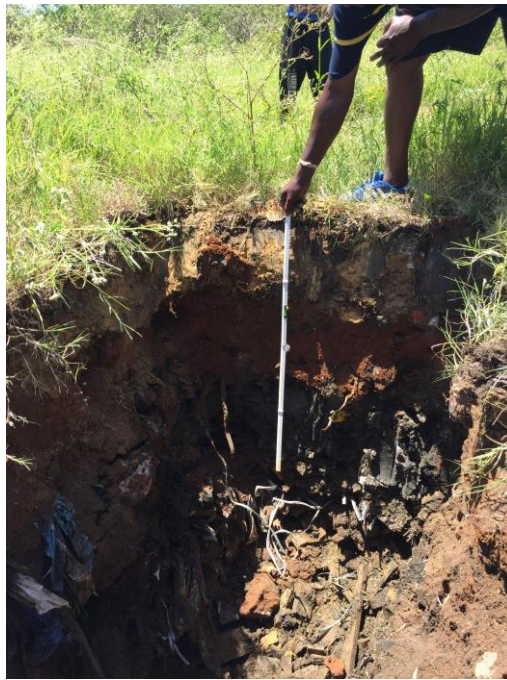
Figure 14: STP4 test pit profile showing capping soil over waste.

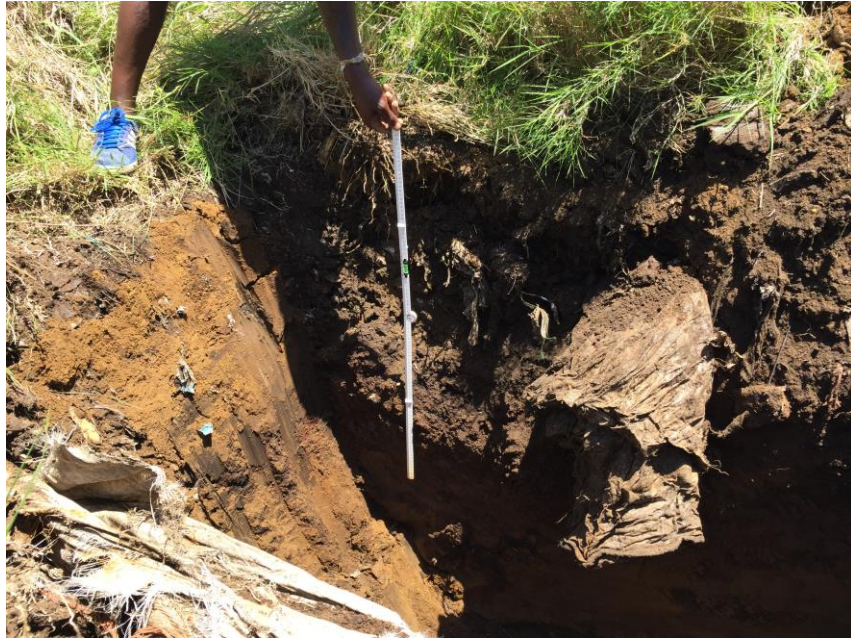
Figure 15: STP5 test pit profile showing capping soil over waste.

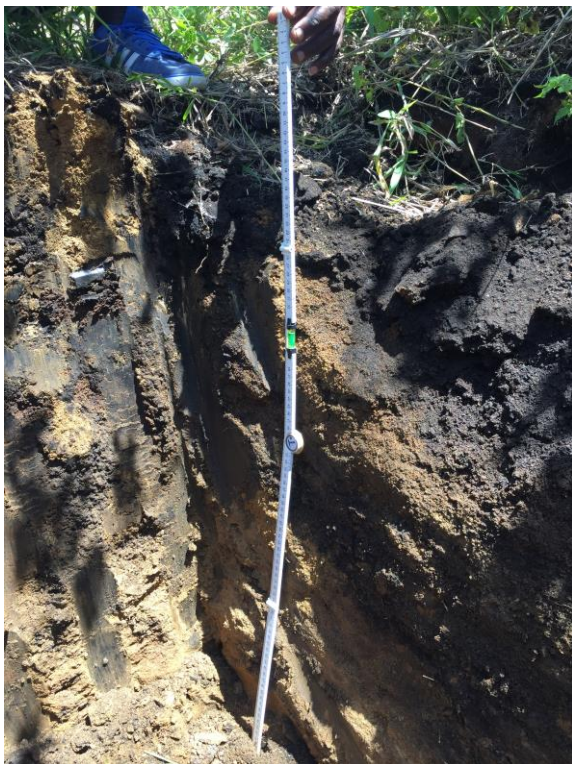
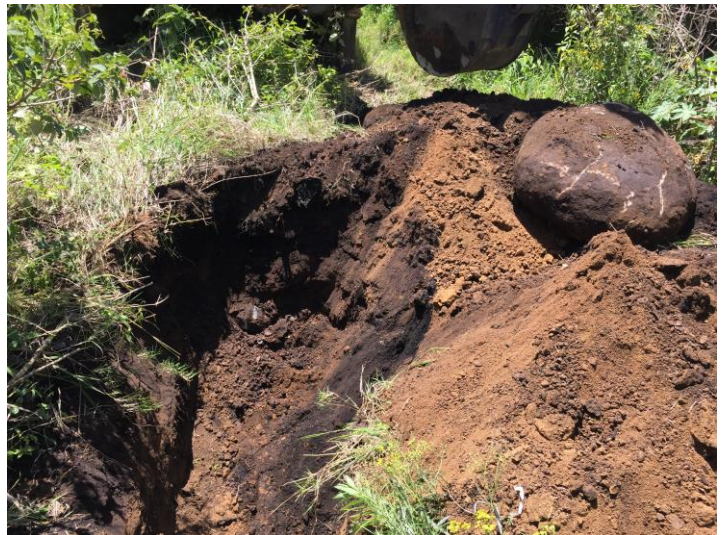
Figure 16: STP6 test profile.

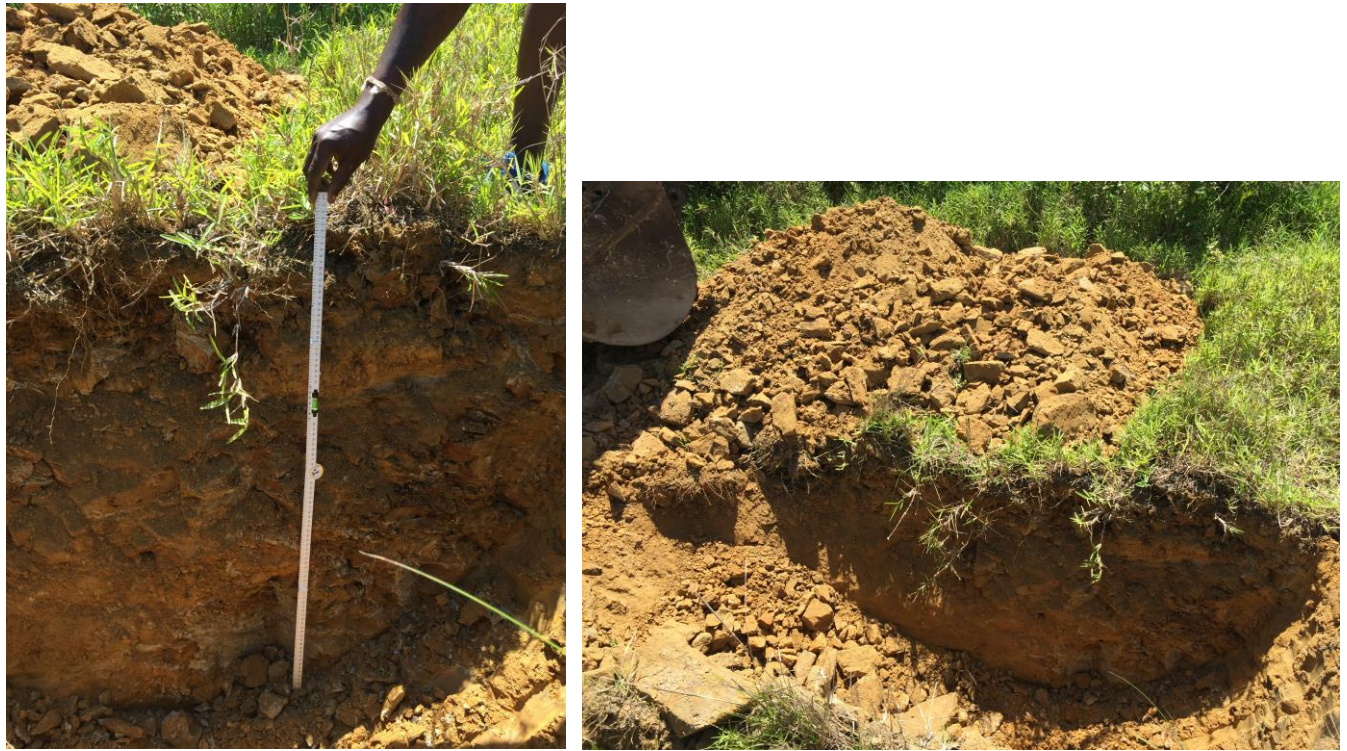
Figure 17: STP7 test pit profile showing subsurface shale.

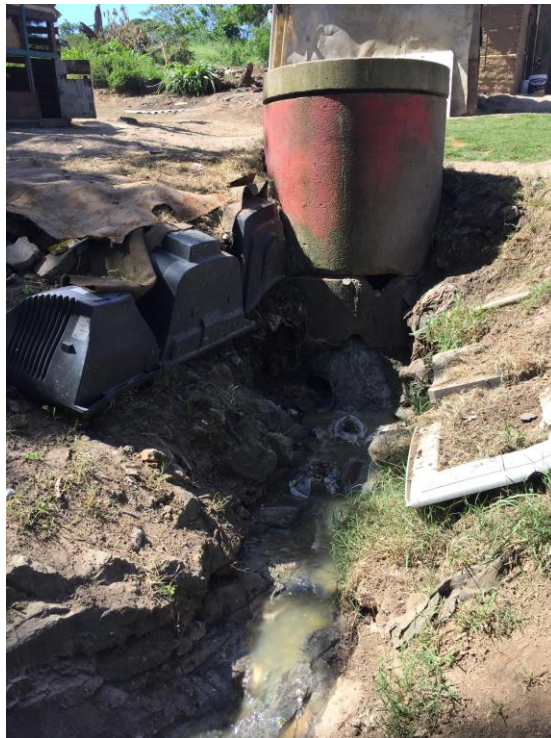
The site is bound by streams and the Mbuzana River on the south east and south west of the site respectively and they run adjacent to the toe of the landfill thereby posing a possibly the leachate runoff from the landfill. Similarly, there is serious pollution into the river systems the sources being the local informal settlement poor sanitation conditions. These two factors present a major risk of water contamination. Figure 19 shows an example of an existing burst sewage pipe.

Figure 19: A burst sewage pipe leaking straight into a stream.

- There is serious pollution into the proximal river system currently taking place, sources being the local informal settlement's poor sanitation conditions as well as possibly the leachate run-off from the landfill. A leachate collection and cut-off drain is required at the toe of the landfill.

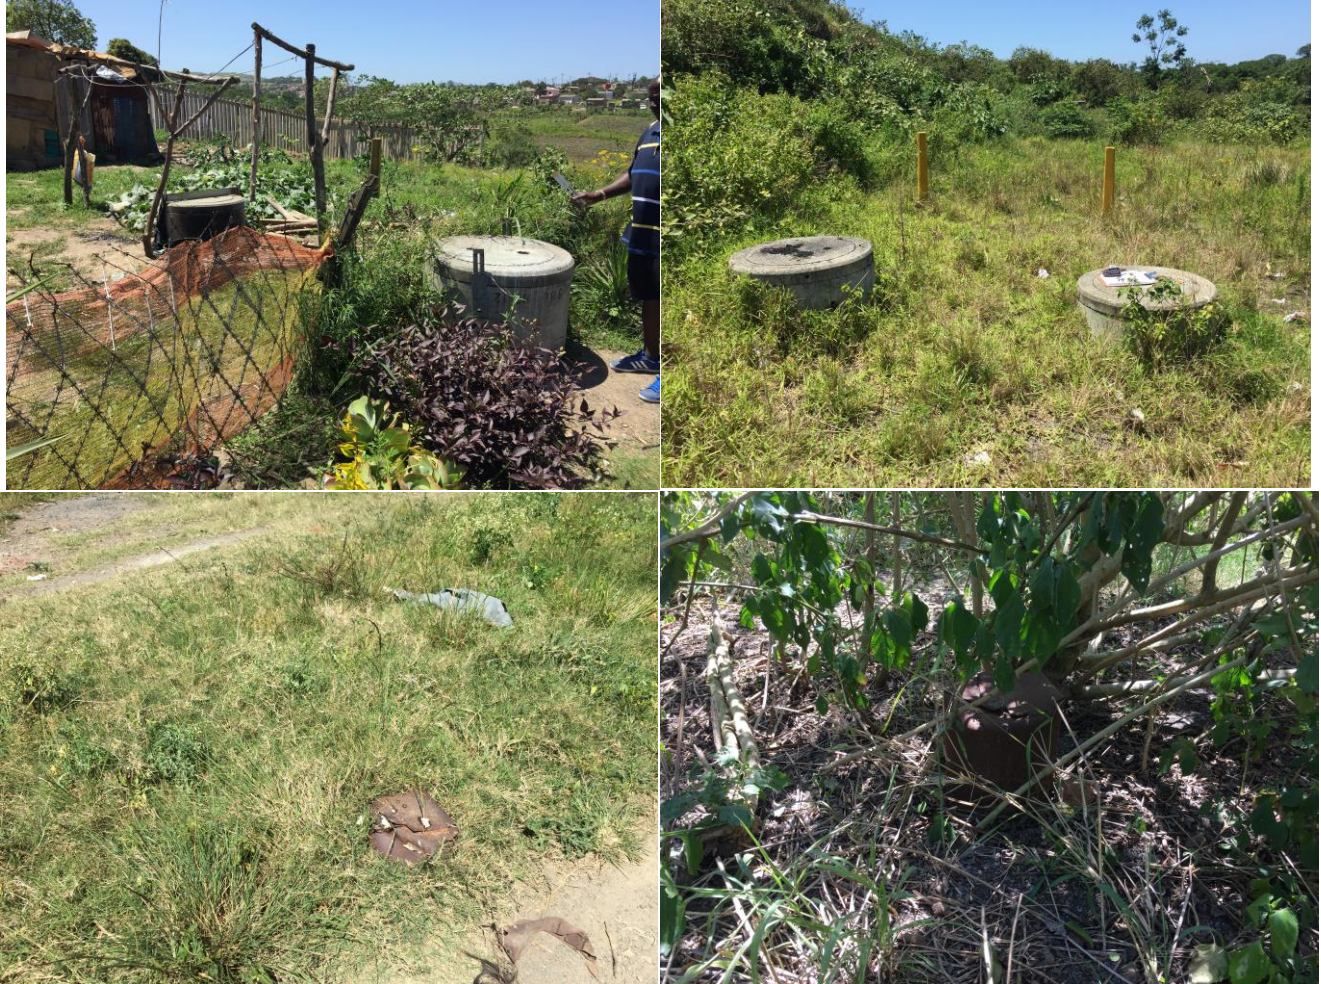
Figure 20: Sealed x2 monitoring boreholes (top) and x2 drilled boreholes (bottom).

detailed information available for these monitoring as well as the other 2 boreholes. It is recommended that these boreholes are accessed and tested as part of the recommended borehole monitoring scope, prior to the drilling of any new holes.

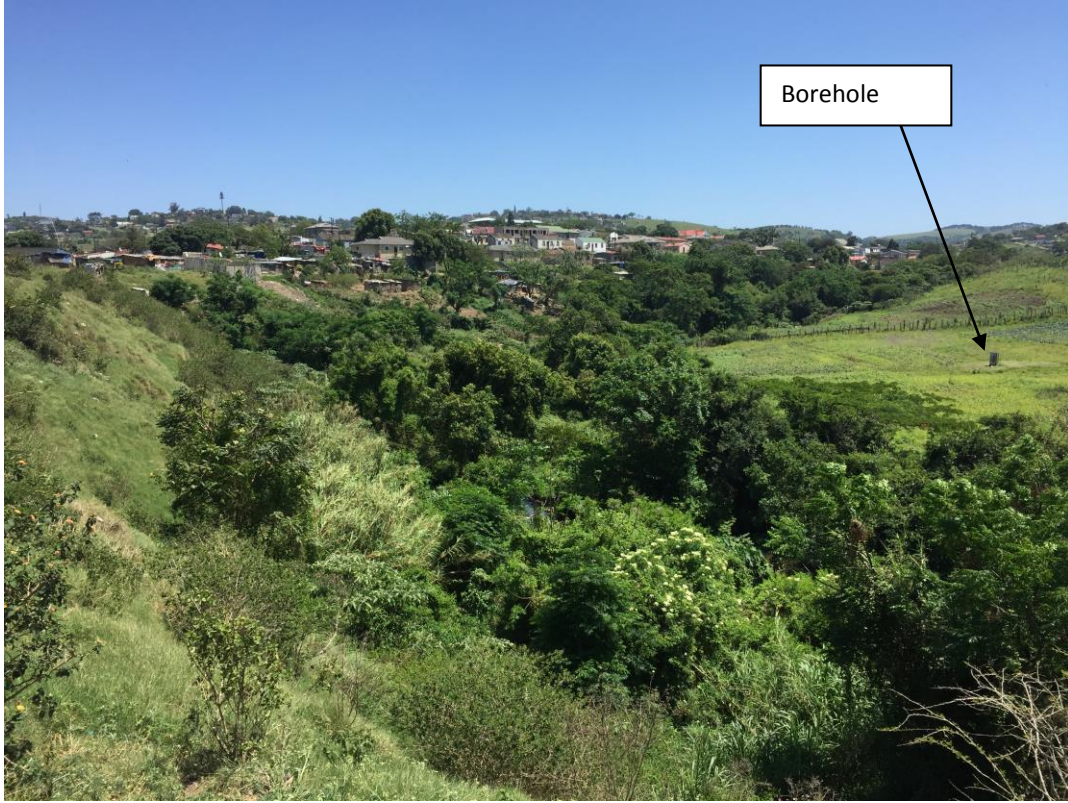
A private borehole (not in the NGA list of boreholes with 5 km radius) was also identified (Figure 21). It is said to be owned by a local farmer for irrigation purposes. Due to access reasons, a GPS location could not be taken. In future it could also serve as a potential monitoring borehole together with the others existing.

Figure 21: Location of a local farmers borehole on the east side of the landfill and across the stream

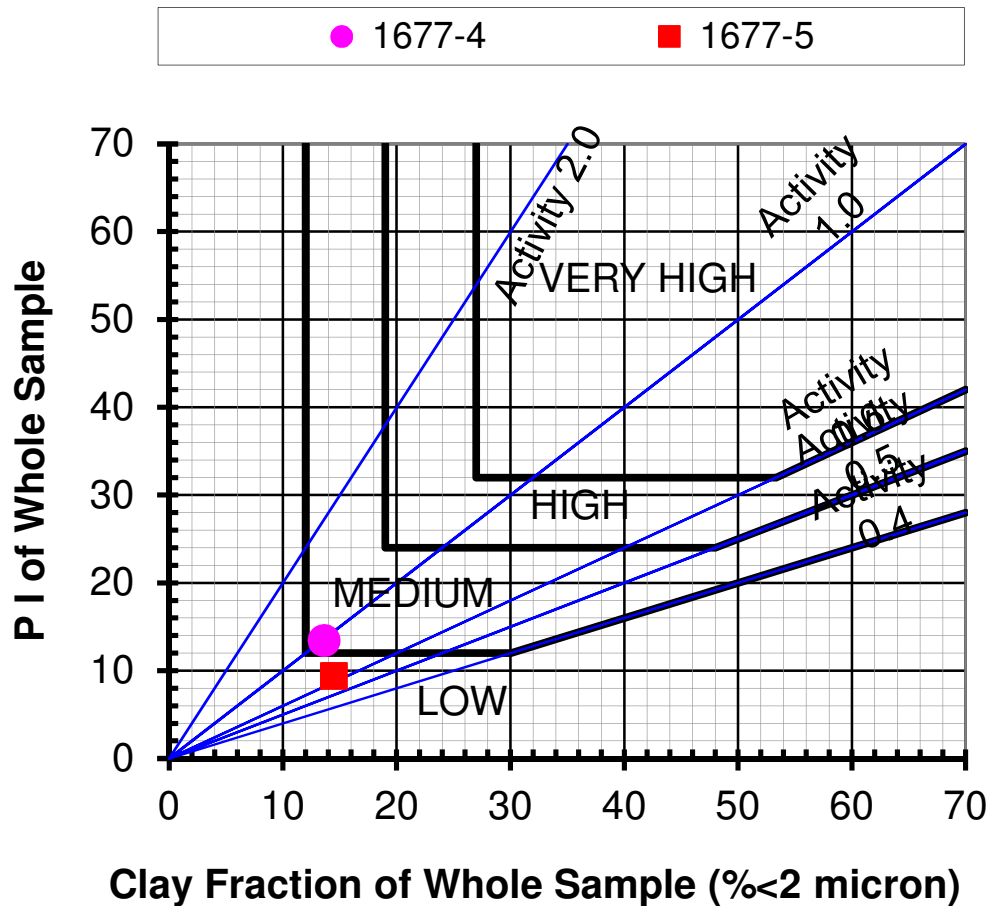
## Activity Diagram After D H van der Merwe

Sample	Clay Frac	PI
1677-4	13.6	13.4
1677-5	14.5	9.4
