eMadlangeni Waste Landfill Site

Engineering Needs Assessment and Preliminary Closure Design Report

22 December 2017

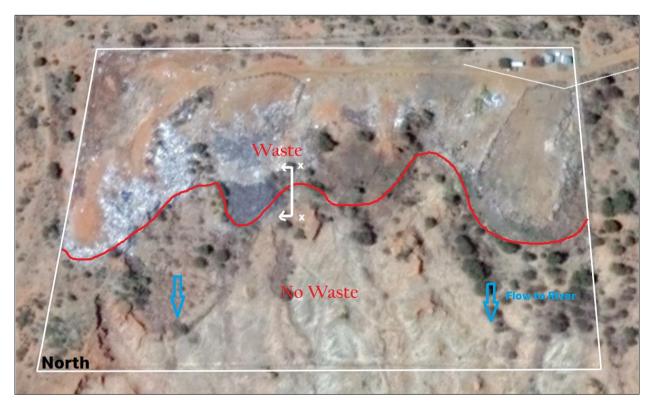
Figure 2: Waste Site Layout

The eMadlangeni landfill receives general waste from areas located within the eMadlangeni Local Municipality. **Figure 2** shows a general layout of the site. Waste disposal took place to the extent that the area in the top of the image is filled with waste and is slowly encroaching on the bottom area (towards the Dorpspruit) by means of end tipping and pushing the waste downhill. About half of the 6Ha fenced area is covered with waste. The site entrance shown to the top right of the image and the site is fenced along the shape of the shown polygon in the image.

Figure 3 shows the rough cross section X-X indicated in the image above. Waste is typically end pushed from point B to point A and left to stand at the natrual angle of repose which is in the order of 45° or 1V:1H. The elevation between point A and B ranges from 2m to about 10m in places.

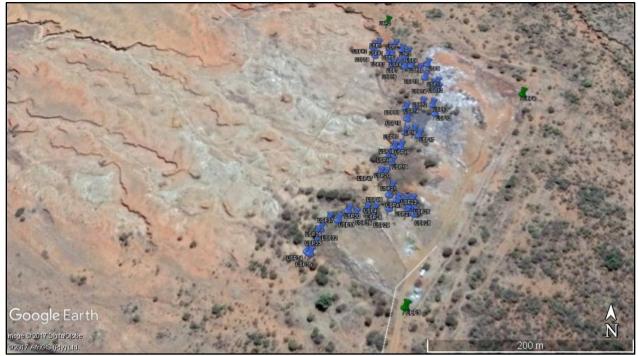
Figure 5: GPS Data Points taken during site visit

The rehabilitated landfill slope should not exceed gradient of 1V:4H and this design was done to allow for run off from the slope whilst maximizing slope stability. The slope shall not exceed a vertical height of 12m with a drainage bench being placed at a maximum height of 6m. The drainage bench will thus probably not be required for the full slope of the capped landfill and this would have to be confirmed during detail design of the facility with a full topographical survey. The drainage bench should be at least 800mm wide and sloped at 2% to allow for run off. A cut to fill operation and landscaping would have to be done in order to obtain the final landform.

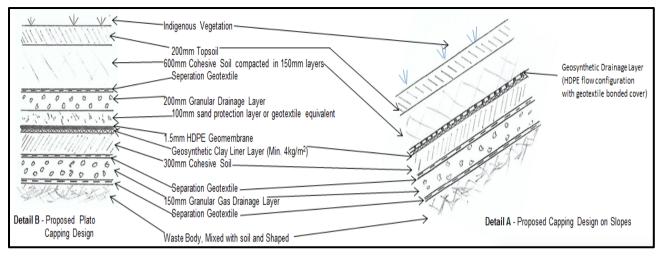
Figure 6: Proposed capping design

The description of the proposed design layers for the capping of the landfill plateau and side slopes is described here beginning from the waste body and ending at the final (top) layer. **Figure 6** shows the proposed capping layers on the plateau and side slopes of the landfill and results in a maximum layer works thickness of about 1,500mm depending on the final geosynthetic options chosen. Full descriptions are given for the layer works on the landfill top and also hold true for side slope layer works where applicable.

The various levels of the capping are described as follows:

- Waste Body: The final waste body is to be shaped as per the design drawings and compacted as well as possible with the equipment used during construction. It should be mixed with soil material where possible and shaped to a final profile that is as smooth as practically possible.

- **Separation Geotextile:** The separation geotextile separates the waste body from the capping layers and should be a non-woven geotextile with a typical thickness of about 2.5mm and unit weight of at least 1.5kg/m². This layer assists in preventing fine particles from the layer works entering the waste body.

- **150mm Granular Gas Drainage Layer:** This is a landfill gas venting layer having a minimum thickness of 150mm and consisting of single sized stone or gravel of between 25mm and 50mm in size. This layer needs to be connected to a gas management system with gas vents being installed in key areas.

- **Cohesive Soil Layer:** This is a support layer to the below drainage system and should be 300mm thick consisting of in situ material compacted to a minimum density of 95% Standard Proctor maximum dry density at a water content of Proctor optimum to optimum +2%.

- **Geosynthetic Clay Liner (GCL):** A GCL is two geotextile layers with a layer of bentonite in the middle that acts as a containment barrier. The GCL should have minimum mass per unit

- HDPE Geomembrane Layer (Plateau only): The High Density Polyethylene (HDPE) Geomembrane (GM) sheet needs to be in direct contact with the GCL and needs to be manufactured by a reputable company and installed according to the Engineer's specifications contained in the construction QA/QC plan. The thickness specified shall be minimum thickness, as measured with the SABS Specification 1526 test method. This layer is only considered for eh top of the landfill cover and not the side slopes.

- Sand Protection Layer (Plateau only): The protection layer is placed directly above the GM to protect it from mechanical damage and can be in the form of a 100mm layer of fine to medium silty sand or a geotextile equivalent able to provide similar protection to the GM. If the geotextile options is chosen during detail design the total ballast layer above the GCL/GM composite should be carefully designed to still ensure full and proper contact between the GCL and GM. This layer is not required for the side slopes.

- Granular Drainage Layer (Plateau only): This system is provided to detect and remove any water leakage that has penetrated the layers above it. The granular drainage layer should consist of a 200mm thick layer of granular material (crushed stone) having a size of between 38mm and 50mm with perforated HDPE pipes installed at 20m intervals on the plateau of the landfill to direct leakage to the leachate collection system and sump.

- Geocomposite Drainage Layer (Slopes only): There are a number of products on the market that could potentially be used here. The final design should replicate the specifications of a geocomposite drainage system similar to the ABG Pozidrain® product which consists of a high strength flexible polyethylene cuspated drainage core (at least 4mm thick) with a non-woven geotextile filter fabric bonded onto one or either side. The geotextile filters a wide range of materials and is bonded to the core to ensure that it does not deform into the drainage channels under the load of the backfill material. The drainage composite allows fluids and gases to percolate into the core whilst supporting the backfill material. The

- Cohesive Soil Layer: This is a support layer to the below drainage system and should be 600mm thick consisting of in situ material compacted to a minimum density of 95% Standard Proctor maximum dry density at a water content of Proctor optimum to optimum +2%. The layers are to be placed and compacted in 150mm layers and also assist in providing the required pressure for the GCL/HDPE composite to function optimally. As indicated in the Geotechnical report the soils on site are predominantly weathered shales with a clay content and fairly low permeability. This soil will work well in conjunction with the other layers of the capping system.

- **Topsoil Layer:** This needs to be a minimum of 200mm topsoil layer to assist in the establishment of vegetative cover as soon as possible. The layer needs to be optimally compacted to assist plant growth and can contain a mixture of hydro seeding if required.

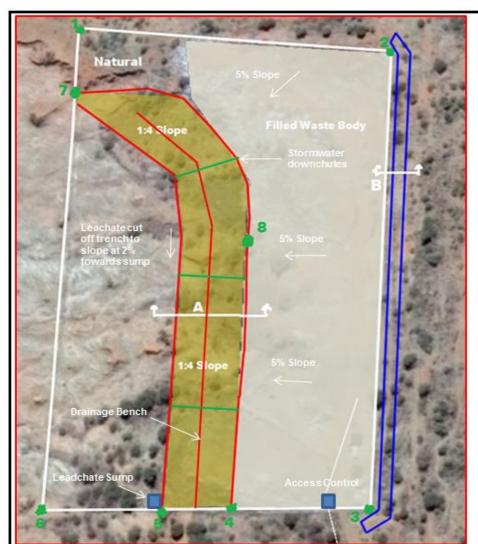
Point	Elevation (m)	Description
1	1,252	Fence, North Corner
2	1,263	Fence, North East Corner
3	1,261	Fence, South Corner
4	1,258	Top of Consolidated Waste, South
5	1,247	Bottom of rehabilitated slope
6	1,247	Fence, West Corner
7	1,254	Top of Slope, North
8	1,259	Top of Consolidated Waste Central

- Toe Drain 7 Leachate Collection Trench to be installed from point 7 to point 5
- Elevations in table are post rehabilitation levels
- Drainage bench on slopes at max 6m, 800mm wide sloped at 2%
- Points 4,5 and 7 to tie in with natural ground levels

The final elevations of the capped landfill are shown on **Drawing EMA – 001** in **Annexure A**. They were designed to best align with the natural topography of the site. Although a topographical survey was not done, the Geotechnical expert took GPS coordinates and elevations at key points on site as shown in **Figure 5**. These data points were used in the design of the final capping layout and elevations.

The site slopes naturally from south-east to north-west and the final elevations at the fence line to the south-east of the site should tie in with the natural ground level in that area. The capped waste body should then slope gradually towards the top of the slope at a 5% gradient to facilitate run off and prevent ponding of rain water etc.
