Aquatic Ecology Assessment for the proposed Palmietkuilen Project

Aquatic Ecology Specialist Report

Project Number:

CNC4065

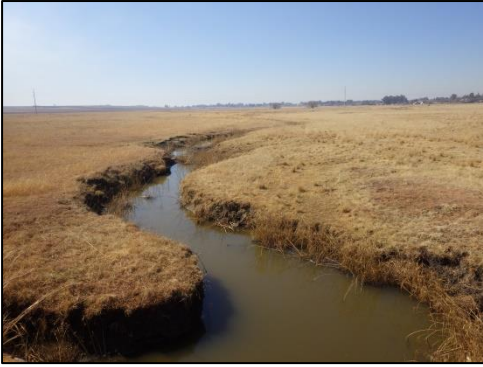
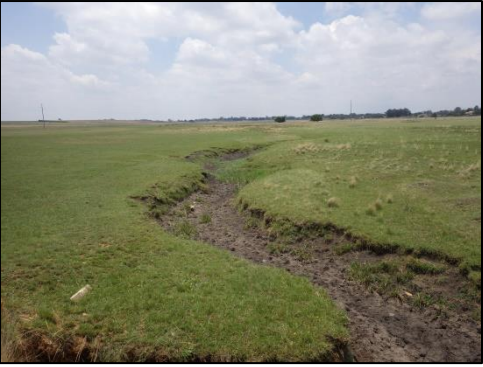
Site	August 2016	November 2016
PK1

Table 6-3: Photographs obtained from the sites during August and November 2016

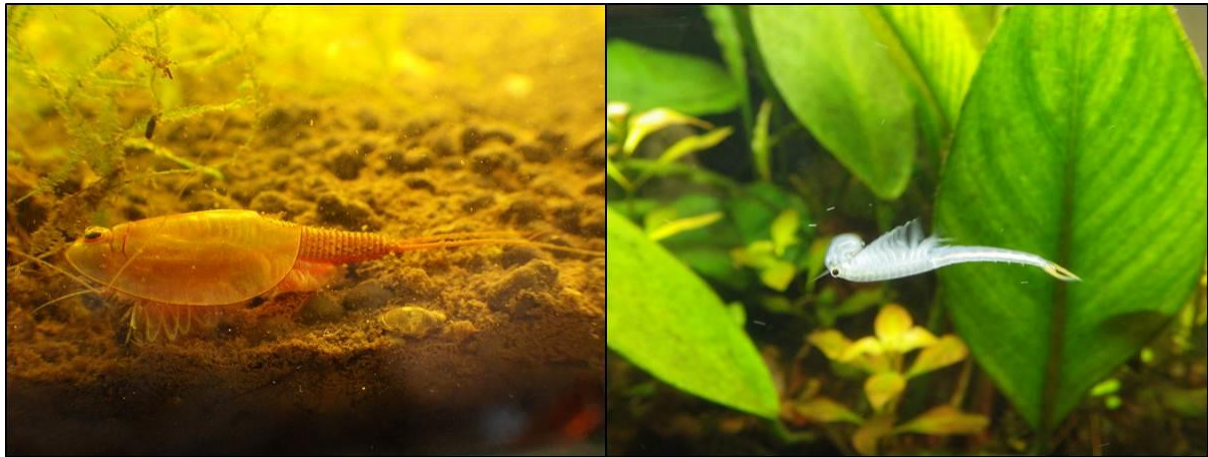
Although zooplankton species are not typically included in macroinvertebrate indices, it is noted that zooplankton taxa at the site PK5 were diverse and abundant and included two large groups of taxa belonging to the class Branchiopoda. These taxa included *Triops* and *Branchipodosis* as illustrated below (Figure 7-1).

Figure 7-1: Zooplankton observed at PK5 during the November 2016 survey (left: *Triops spp.*; Right: *Branchipodosis spp.*)

Although these taxa are not regarded as being sensitive, they are rare and ecologically important (Soininen *et al.*, 2007). Due to the presence and richness of zooplankton at the site, PK5 is regarded as being unique on a catchment scale and will be further assessed in Section 8.
