Mulilo Struisbult Photovoltaic Energy Plant (PV2) Ecological Walkdown Report

Copperton, Northern Cape

February 2022

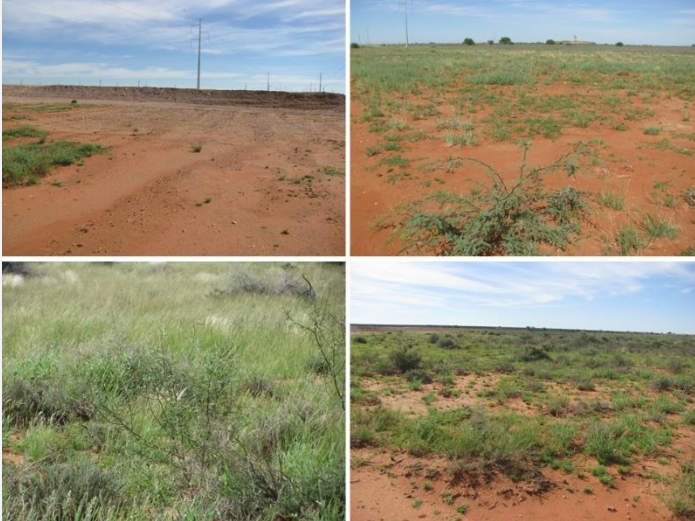
Reference Area	Comments and recommendations	Photographs
P01	<p>Findings: Southern portions of area located over drainage line; some riparian vegetation recorded with dense grasses. Northern portions significantly disturbed through extensive clearing activities. Sapling <i>Prosopis glandulosa</i> (Honey Mesquite) trees observed, the species is a NEMBA listed Alien Invasive Plant (AIP).</p> <p>Sensitivity: Southern riparian areas classified as 'High' sensitivity; northern disturbed areas classified as 'Low' sensitivity.</p> <p>Recommendations: Avoid riparian areas due to habitat sensitivity. Remove all AIP as per AIP Management Plan (TBC, 2022a). High erosion and dust pollution potential throughout the open areas, mitigate through the appropriate rehabilitation as per the Re-vegetation and Habitat Rehabilitation Plan (TBC, 2022b).</p>

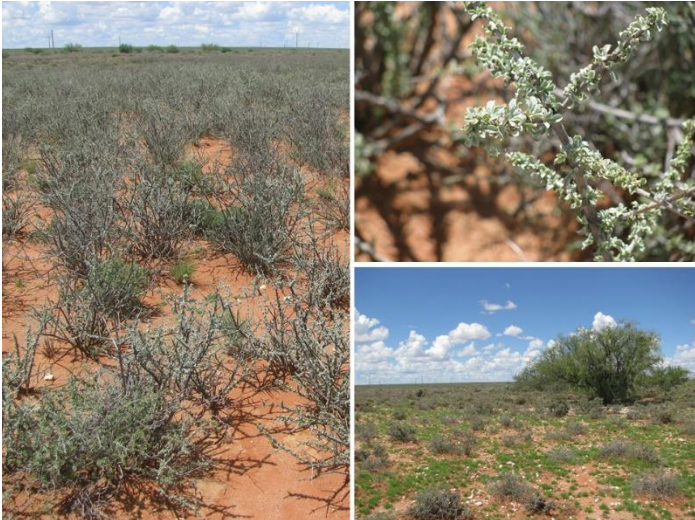
P02	<p>Findings: No specific ecological constraints were recorded. Extensive portions of <i>Rhigozum trichotomum</i> dominated shrubland. Mature Honey Mesquite AIP observed.</p> <p>Sensitivity: Largely of a 'Medium' sensitivity, healthy populations of indigenous shrubs.</p> <p>Recommendations: Minimise habitat disturbance, rehabilitate according to Re-vegetation and Habitat Rehabilitation Plan. Remove all AIP as per AIP Management Plan. No changes to placement of infrastructure required.</p>

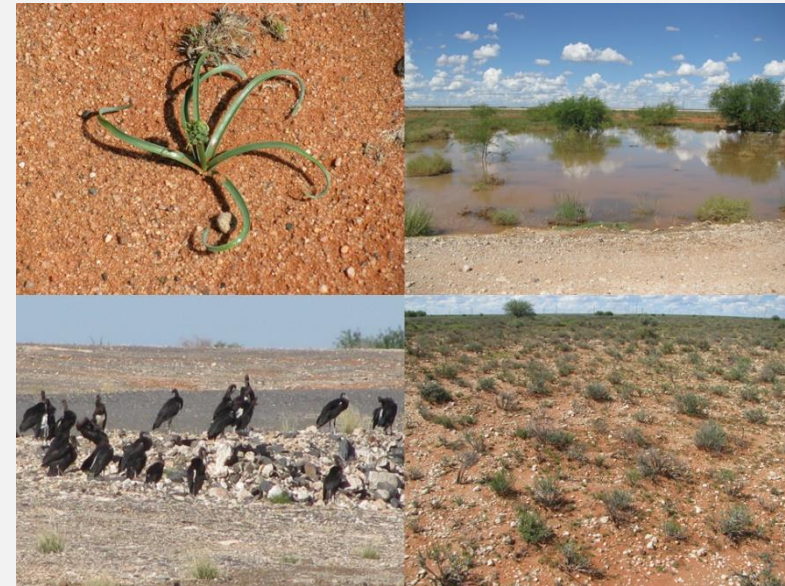
P03

Findings: Open water wetland depression observed, surrounded by sparse *Rhigozum trichotomum* and *Salsola tuberculata* shrubland to the north. Disturbed portions of cleared land to the south, where a large population of the red-listed *Ciconia abdimii* (Abdim's Stork) was recorded (listed as Near Threatened nationally and protected provincially). Small to large Honey Mesquite AIP trees recorded across the area. Small *Albuca* sp. observed.

Sensitivity: 'High' sensitivity around the wetland to 'Medium' sensitivity northwards. Locally observed SSC fauna (such as the red-listed Abdim's Stork, Ludwig's Bustard, Martial Eagle) will utilise the wetland for water.

Recommendations: Avoid sensitive wetland area. Any disturbance to the north must be followed by the appropriate rehabilitation as per the Re-vegetation and Habitat Rehabilitation Plan. Abdim's Stork populations to be avoided and must not be disturbed, any nests sighted must be immediately reported to a bird specialist. Remove all AIP as per AIP Management Plan, do not contaminate water with herbicide – remove waterborne AIP via mechanical pull-out or dig-out methods. Any *Albuca* species that will be affected by the development should be translocated as per the Plant Rescue and Protection Plan (TBC, 2022c).

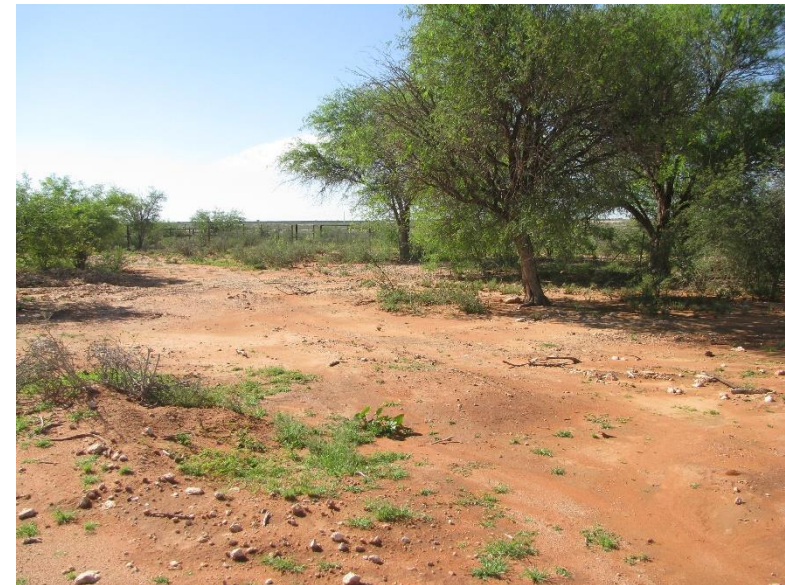
P04

Findings: No specific ecological constraints were recorded. Highly disturbed vegetation communities adjacent to roadways with numerous mature Honey Mesquite AIP observed.

Sensitivity: Classified as a 'Low' sensitivity area.

Recommendations: No changes to placement of infrastructure required. Remove all AIP as per AIP Management Plan. Recommended placement of speed bumps along these portions of roadway to minimise disturbance to foraging SCC bird species recorded in the area (as relevant to the nearby wetland depressions). High erosion and dust pollution potential, mitigate through the use of speed bumps and adequate re-vegetation as per Re-vegetation and Habitat Rehabilitation Plan.

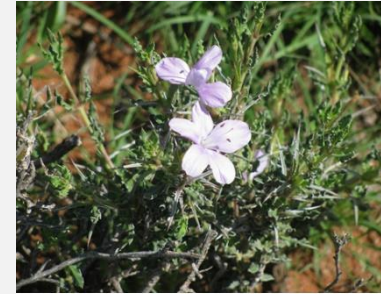
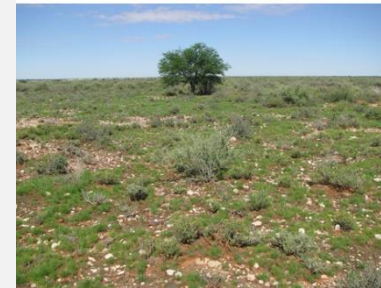
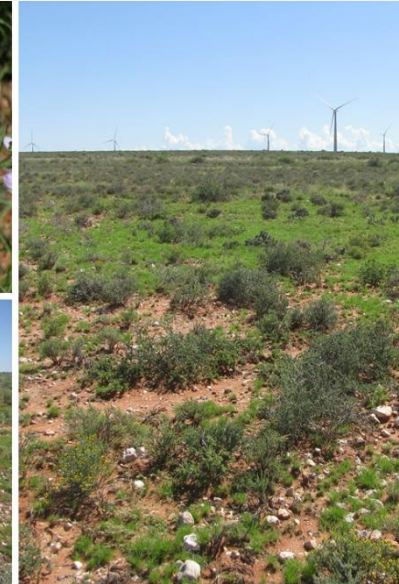
P05

Findings: No specific ecological constraints were recorded. Vast flat landscape populated by *Rhigozum trichotomum*, *Salsola tuberculata*, and *Pentzia incana* shrubs. Small flowering *Barleria rigida* shrublets recorded. Individual mature Honey Mesquite AIP observed.

Sensitivity: 'Low' to 'Medium' sensitivity area due to the diversity of indigenous vegetation present across vast expanses.

Recommendations: No changes to placement of infrastructure required. Remove all AIP as per AIP Management Plan. Disturbances should be followed by the appropriate rehabilitation as per the Re-vegetation and Habitat Rehabilitation Plan.

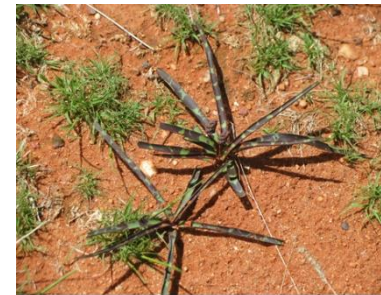
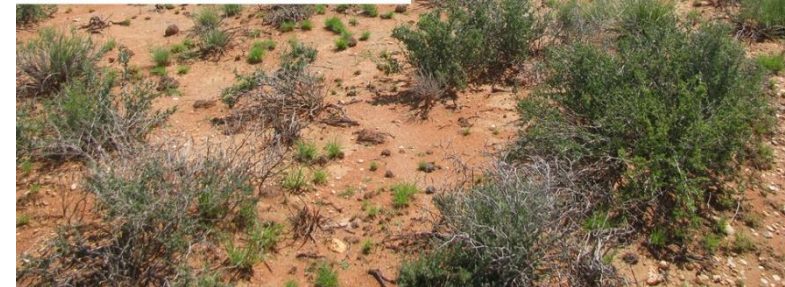
P06

Findings: No specific ecological constraints were recorded. Similar vegetation community to P02 and P05. Several *Ledebouria* sp. observed.

Sensitivity: 'Low' to 'Medium' sensitivity area due to the diversity of indigenous vegetation present across vast expanses.

Recommendations: No changes to placement of infrastructure required. Remove any AIP as per AIP Management Plan. Disturbances should be followed by the appropriate rehabilitation as per the Re-vegetation and Habitat Rehabilitation Plan. Avoid wetland depression towards the south of the area. Any *Ledebouria* sp. that will be affected by the development should be translocated in line with the Plant Rescue and Protection Plan.
