Integrated Environmental Impact Assessment for the Proposed Palmietkuilen Mining Project near Springs, Gauteng

Rehabilitation, Decommissioning and Mine Closure Plan

Project Number: CNC4065

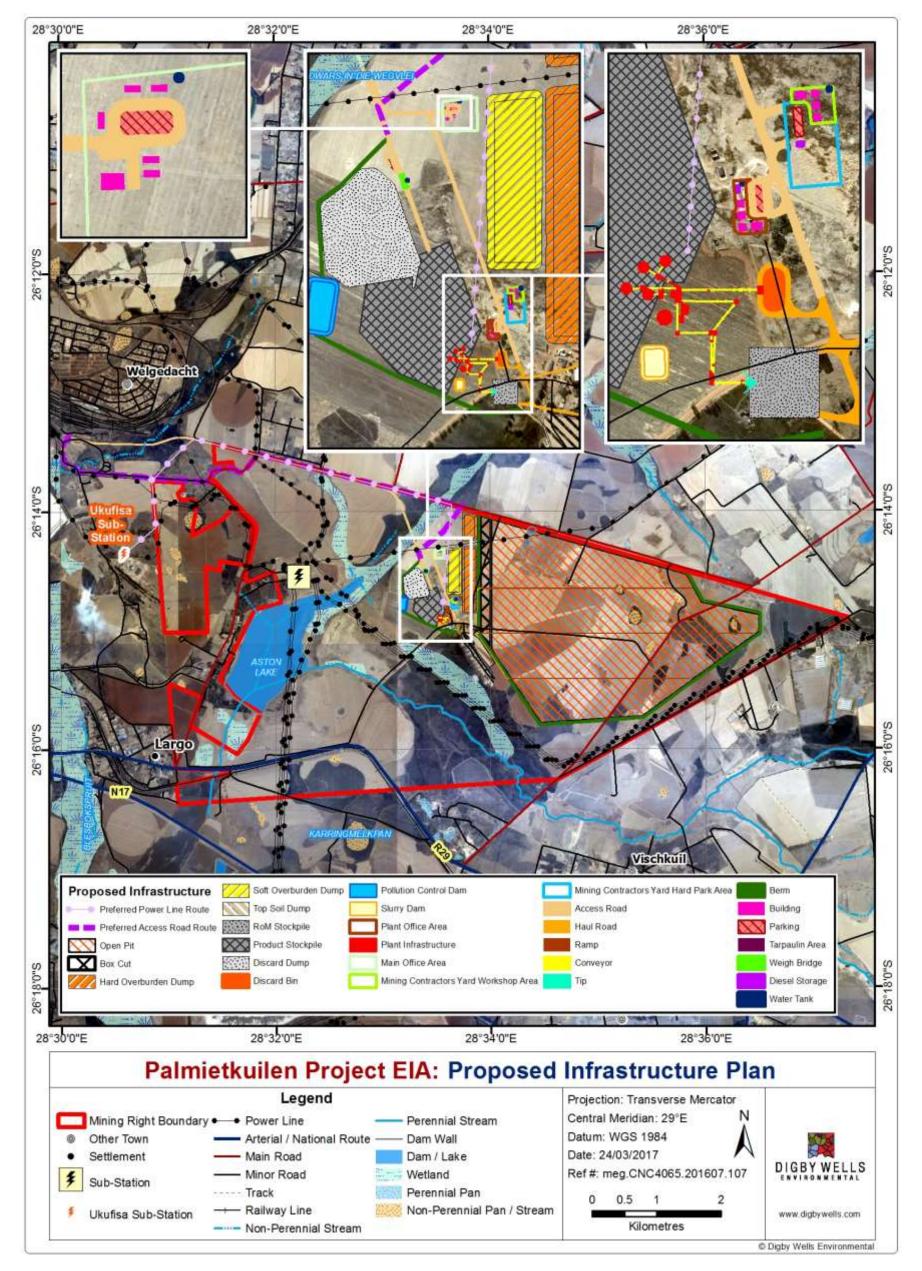
Figure 1-4: Proposed Infrastructure Plan

The proposed mine would require additional infrastructure and services to support the proposed mining operation. Figure 1-4 below shows the proposed project infrastructure layout. The supporting infrastructure associated with the proposed Project is discussed in subsections below.
