# ***Shakaville Waste Landfill Site***

**Engineering Needs Assessment  
and Preliminary Closure Design  
Report**

*Project Name:* **Closure of Shakaville Waste Landfill Site**

*Prepared for:* **GA Environment (Pty) Ltd**

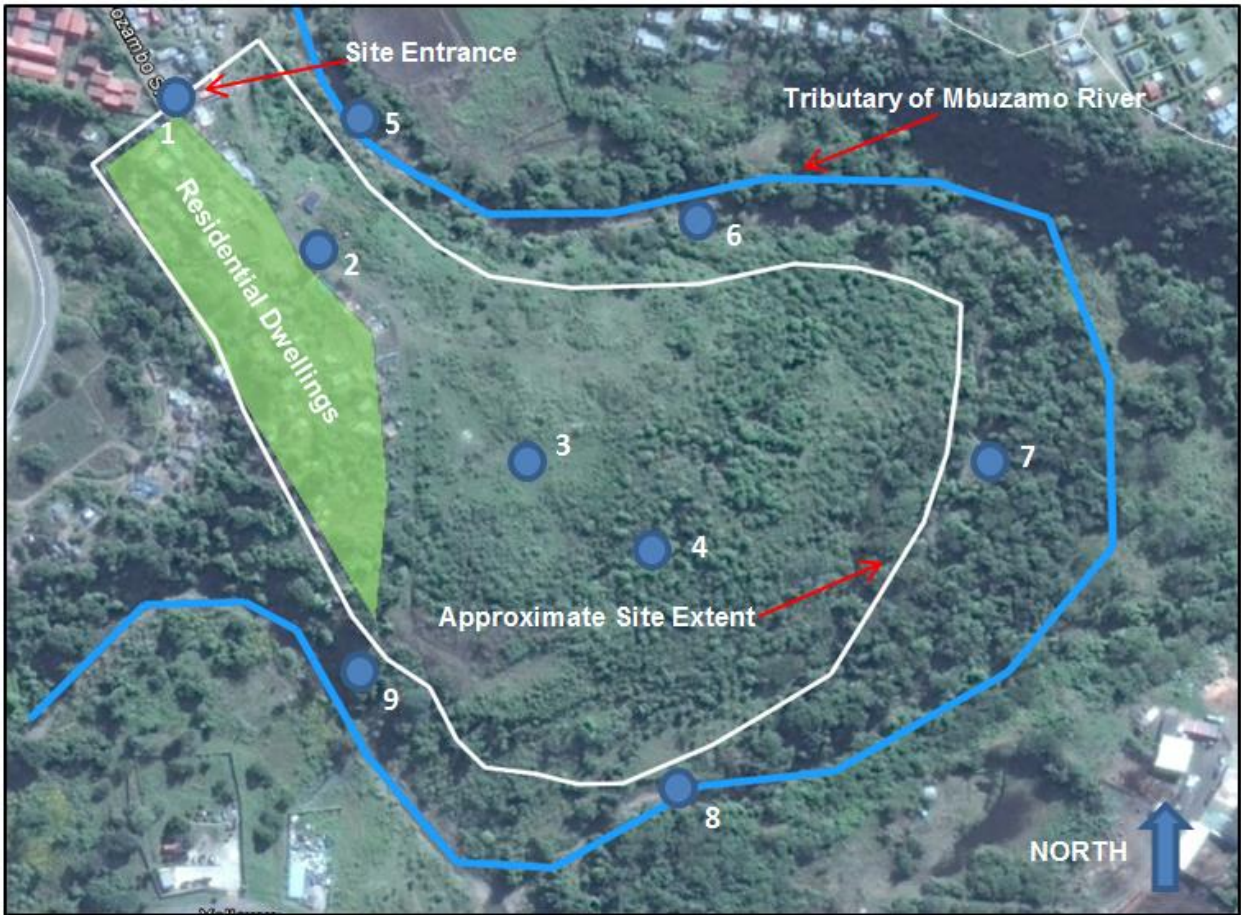
Figure 2: Waste Site Layout

**Figure 2** shows a general layout of the site with elevations at key areas shown in **Table 1**. It seems as if historic waste disposal took place in a manner where waste was dumped on the plateau and pushed over the edge towards the river. This method of disposal has resulted in the slope of the disposed waste being more than 20m high in some places at a natural angle of repose in the order of 45°.

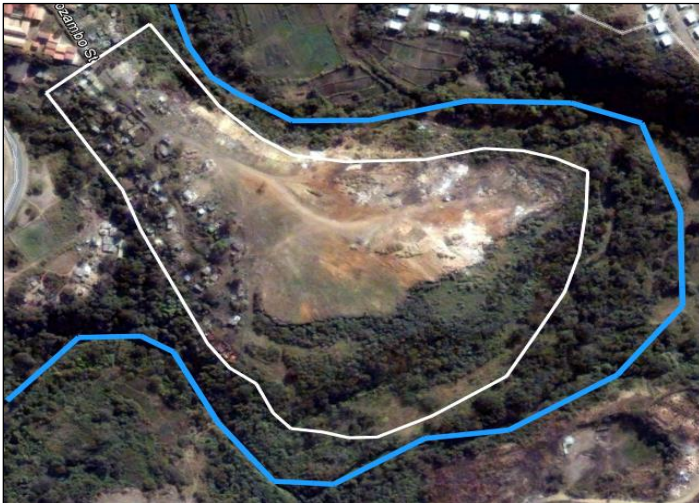
**Figure 3: Shakaville Landfill Aerial Image (2006)**

Waste dumping was actively taking place in 2006 with the working face focused to the east of the site.

In order to better understand the historic waste dumping on site it is worth observing the Google Earth® images from 2006 to present shown in **Figures 3 to 5**.

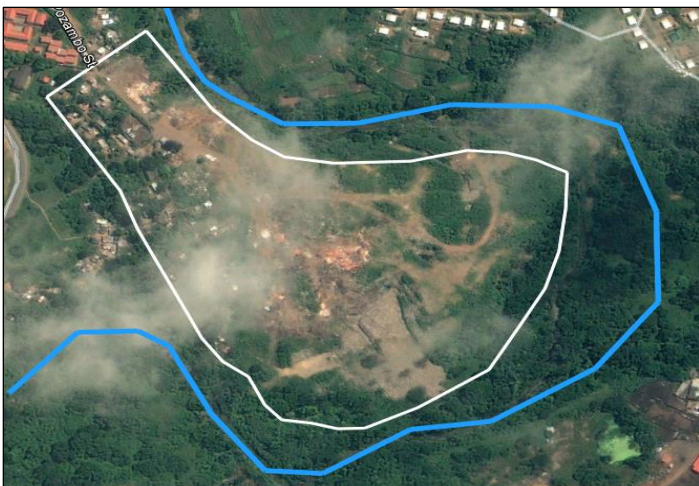
**Figure 4: Shakaville Landfill Aerial Image (2010)**

In 2010 it appears as if waste dumping has stopped although some exposed waste is still visible in the western portion of the site.

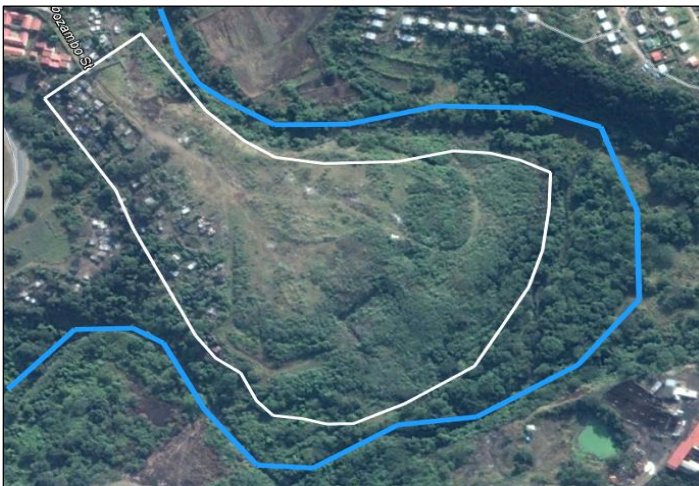
**Figure 5: Shakaville Landfill Aerial Image (2013)**

The 2013 image indicates that no waste dumping had taken place for some time since the vegetation had already taken significant shape.

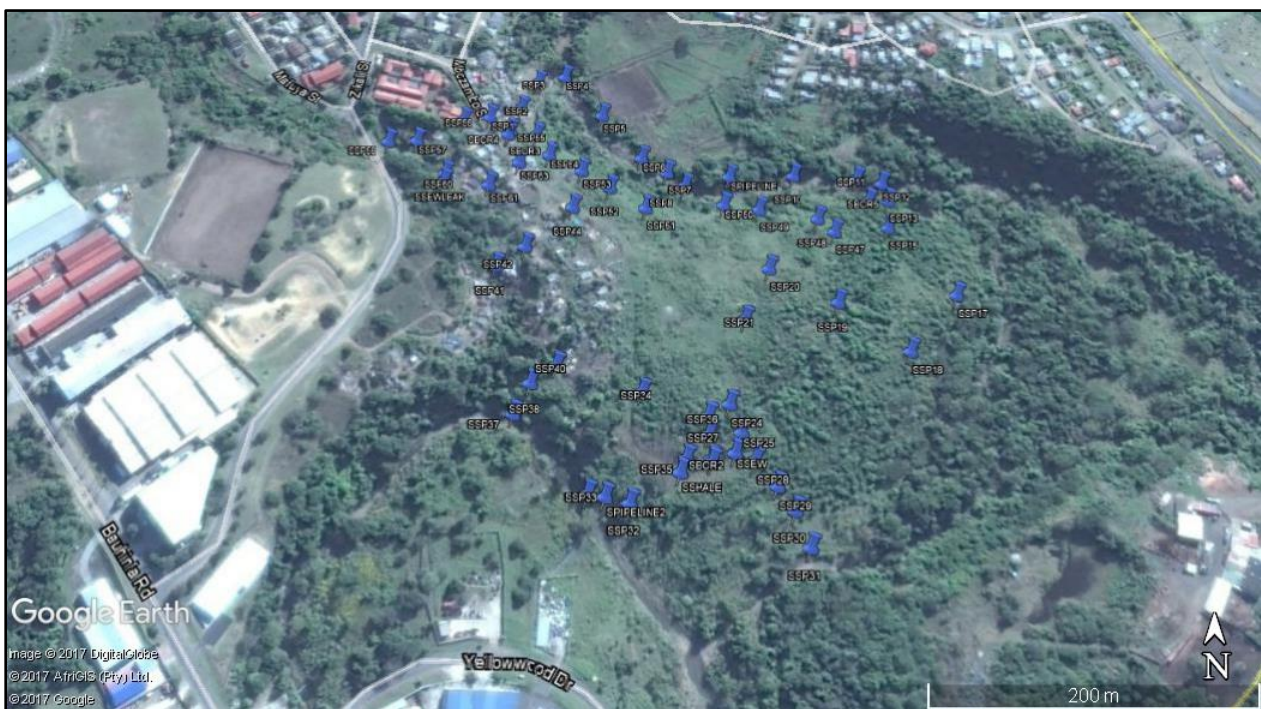
**Figure 7: GPS Data Points taken during site visit**

A topographical survey was done before the Envitech report in 2013 but during the November 2107 site visit the Geotechnical specialist also took GPS coordinates and elevations to confirm the topography of the site as confirmed in the Geotechnical Report (**Figure 7**).

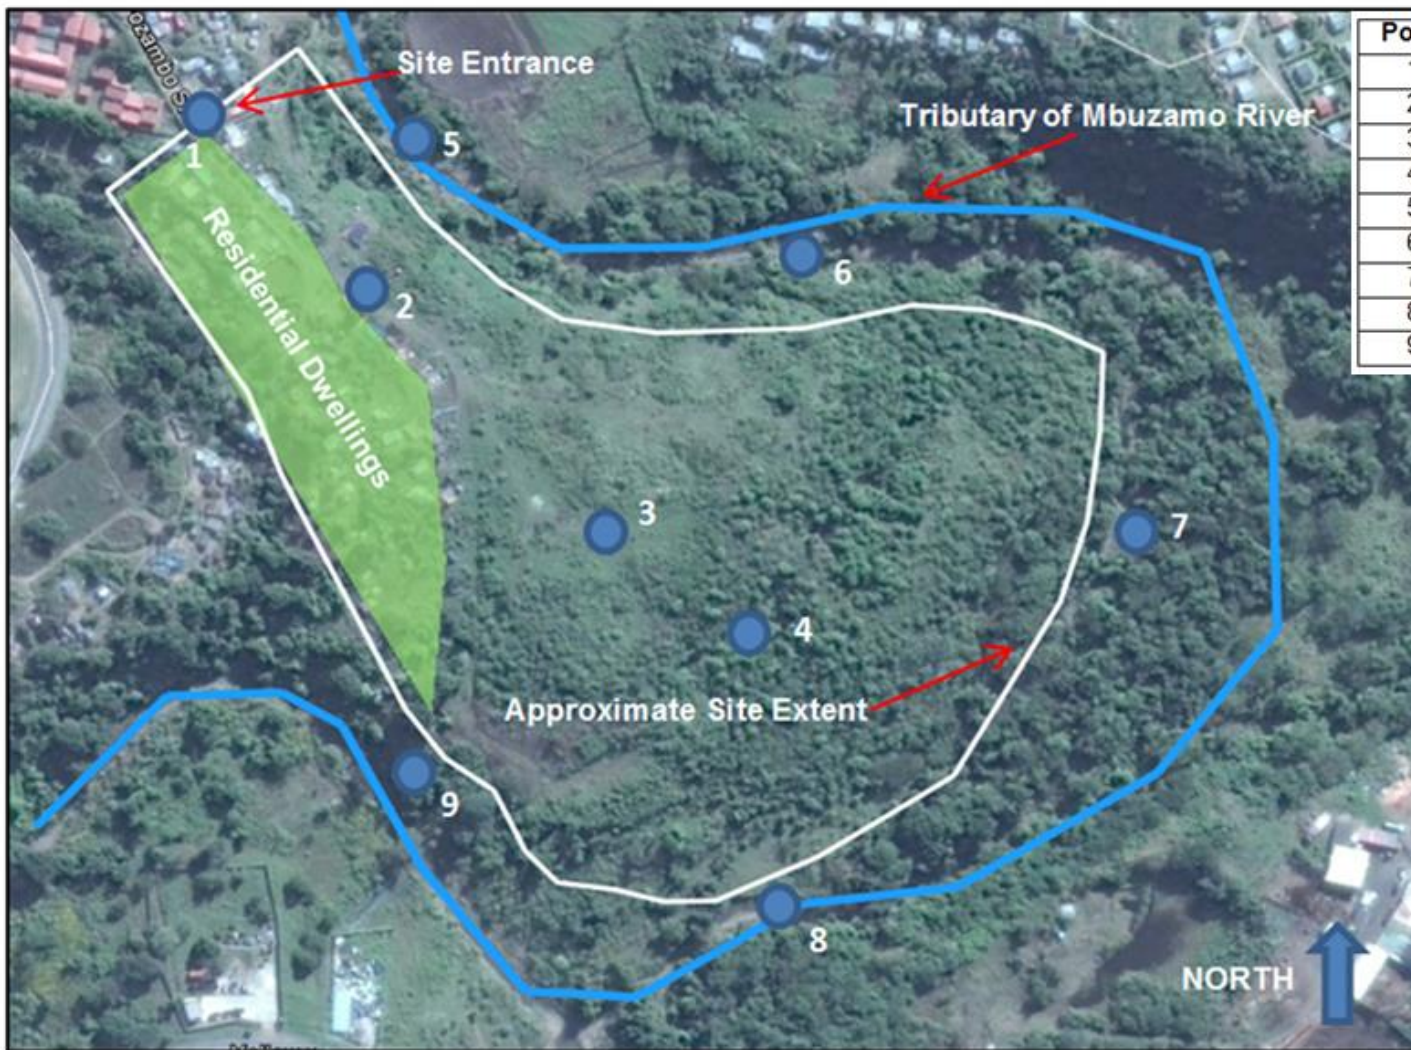
Point	Elevation (m)	Description
1	49	Entrance Area
2	42	End of road access
3	44	Highest Point
4	36	Edge of Slope
5	30	Bottom of Slope (River Level)
6	26	Bottom of Slope (River Level)
7	22	Bottom of Slope (River Level)
8	19	Bottom of Slope (River Level)
9	17	Bottom of Slope (River Level)
