From: Vanessa Stippel <vanessa@prismems.co.za>
Sent: Friday, 11 September 2020 12:14
Cc: De Wet Botha <dewet@prismems.co.za>
Subject: 21637 | Notification of Public Review of EIA Report and WULA Technical Report | Proposed Development of Riverside View Extension 84, City of Johannesburg, Gauteng (GAUT 002/17-18/E2040)

Steyn City Properties (Pty) Ltd. plans to develop Riverside View Ext 84 on portions 185 and 124 (a Portion of Portion 11) of the farm Diepsloot 388 JR within Ward 96 of the City of Johannesburg, Gauteng Province. The proposed development form parts of the Steyn City Parkland Residence which has been designed to be a modern, mixed land use and mixed income development. The extent of the proposed development is approximately 29.4 ha and the site will be developed into three separate erven. The proposed use zones of these erven are as follows:

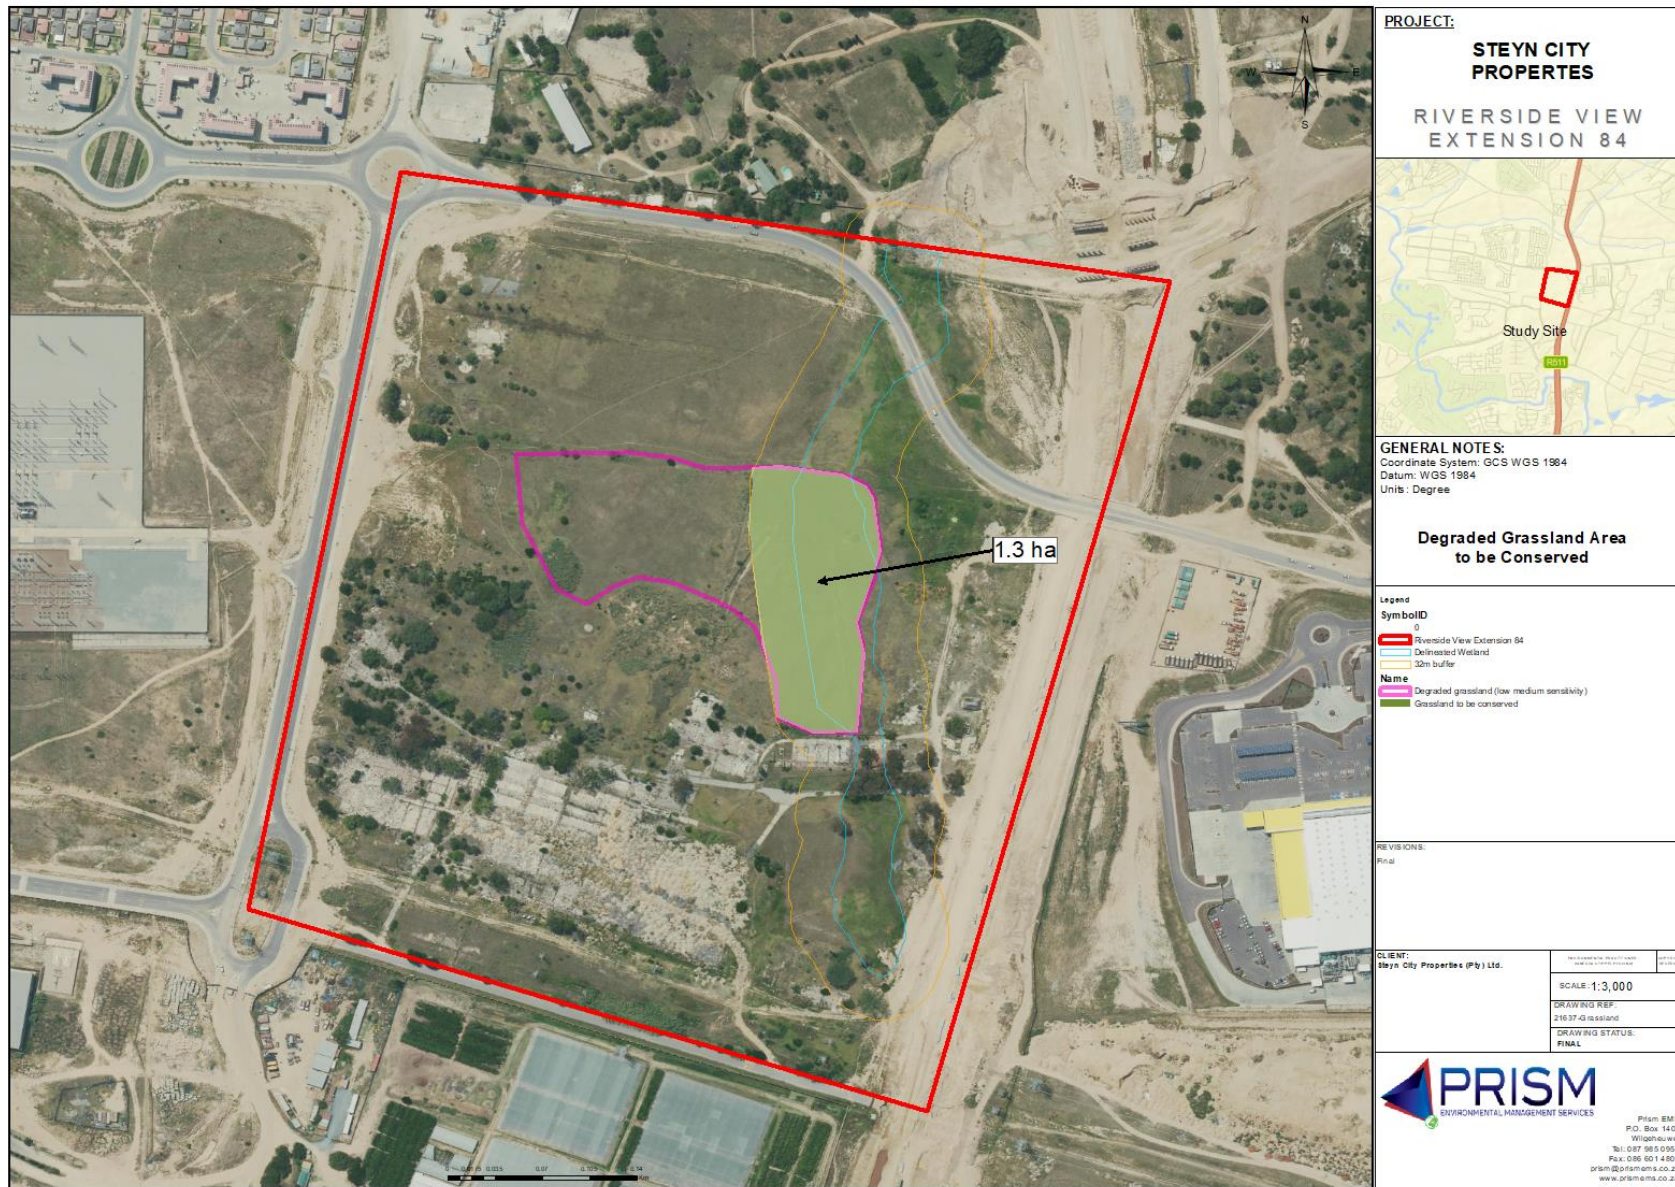
Figure 1: Grassland area within wetland and wetland buffer

Whilst the COJ comments note that the grassland is degraded they fail to acknowledge that the specialist did a sensitivity analysis of the site and indicated that this area has a **low medium** sensitivity. Furthermore, as indicated in **Figure 1** below, this low-medium/degraded grassland area falls partly in the wetland buffer area and thus approximately half of this area (around 1.2 ha) will be conserved).

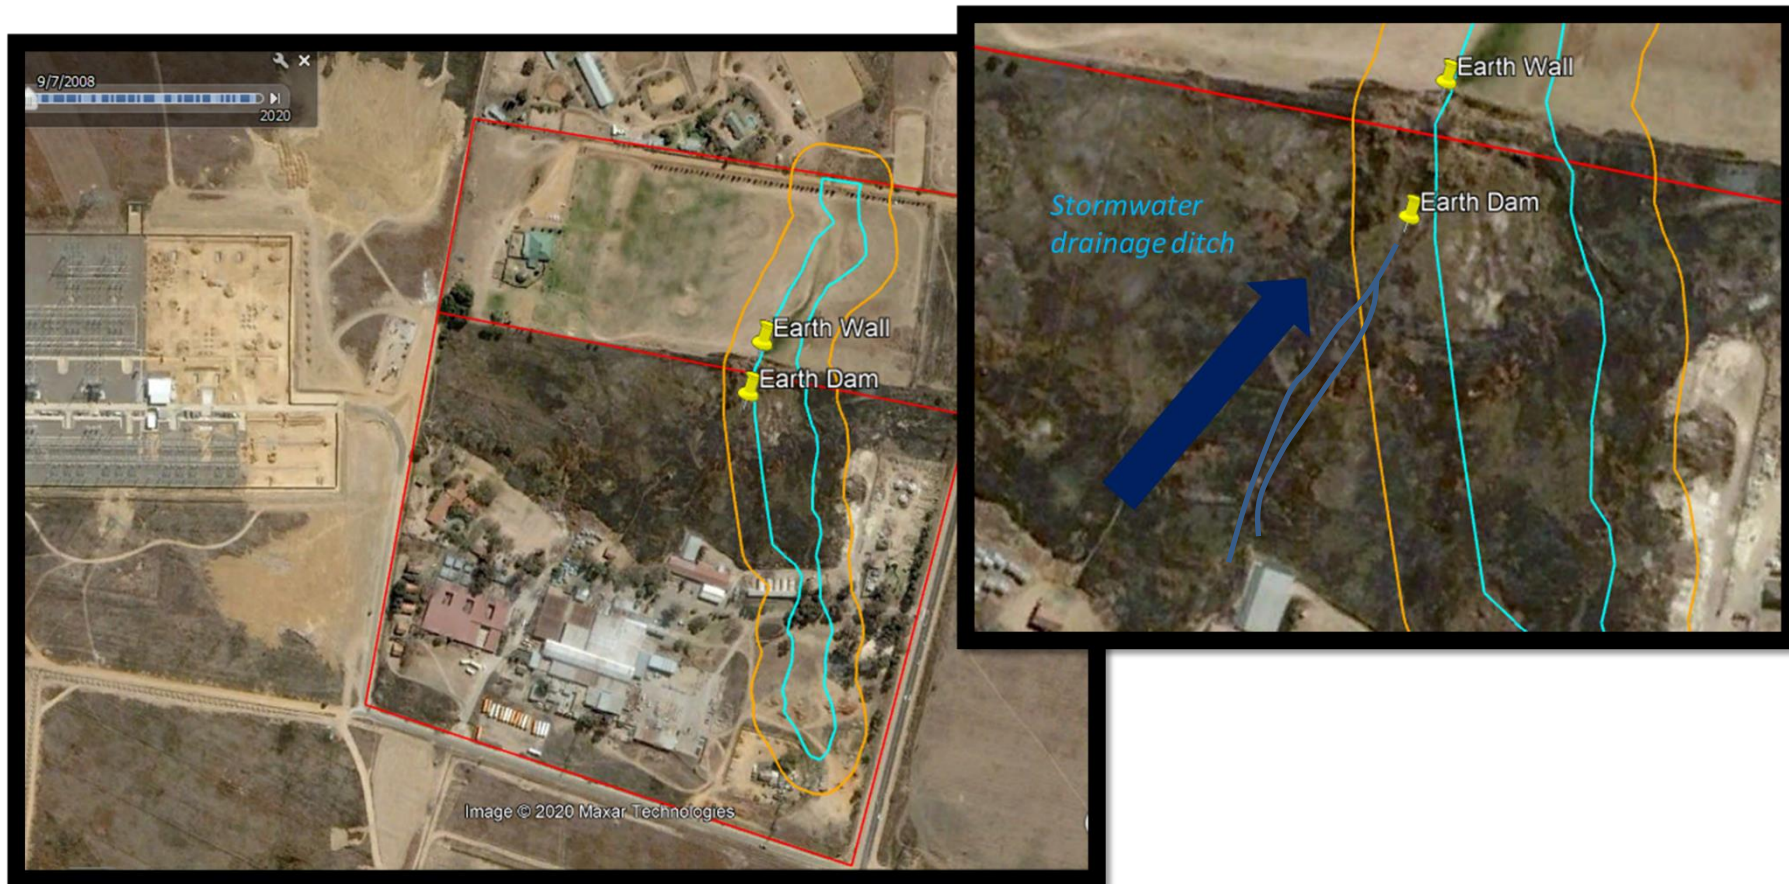
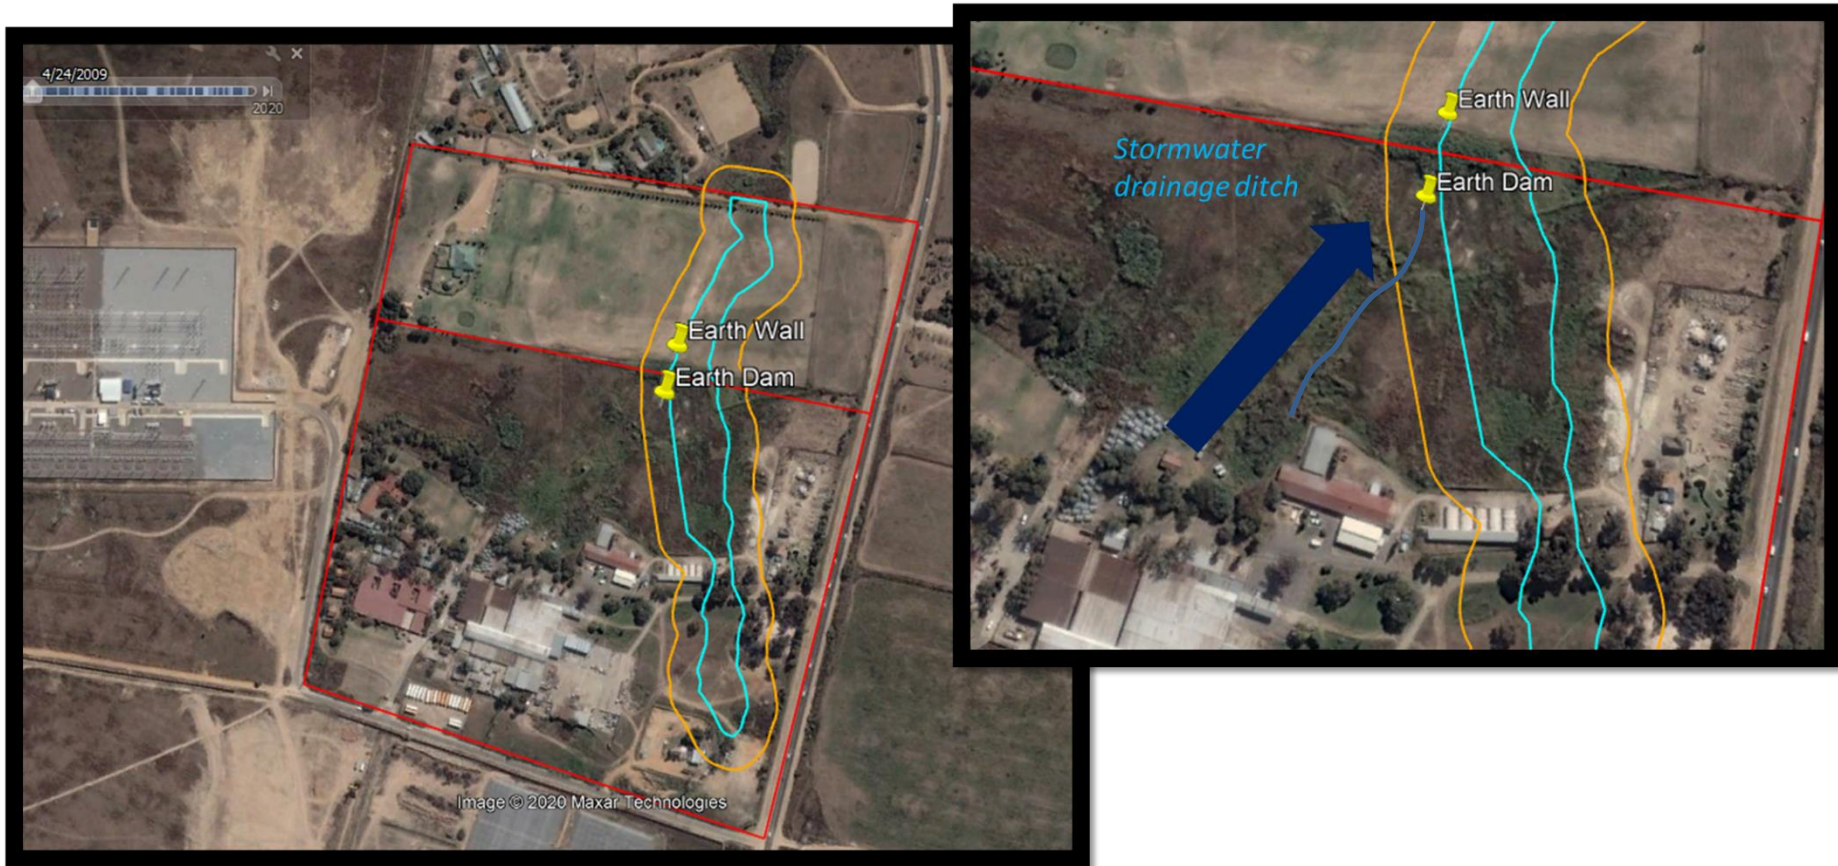
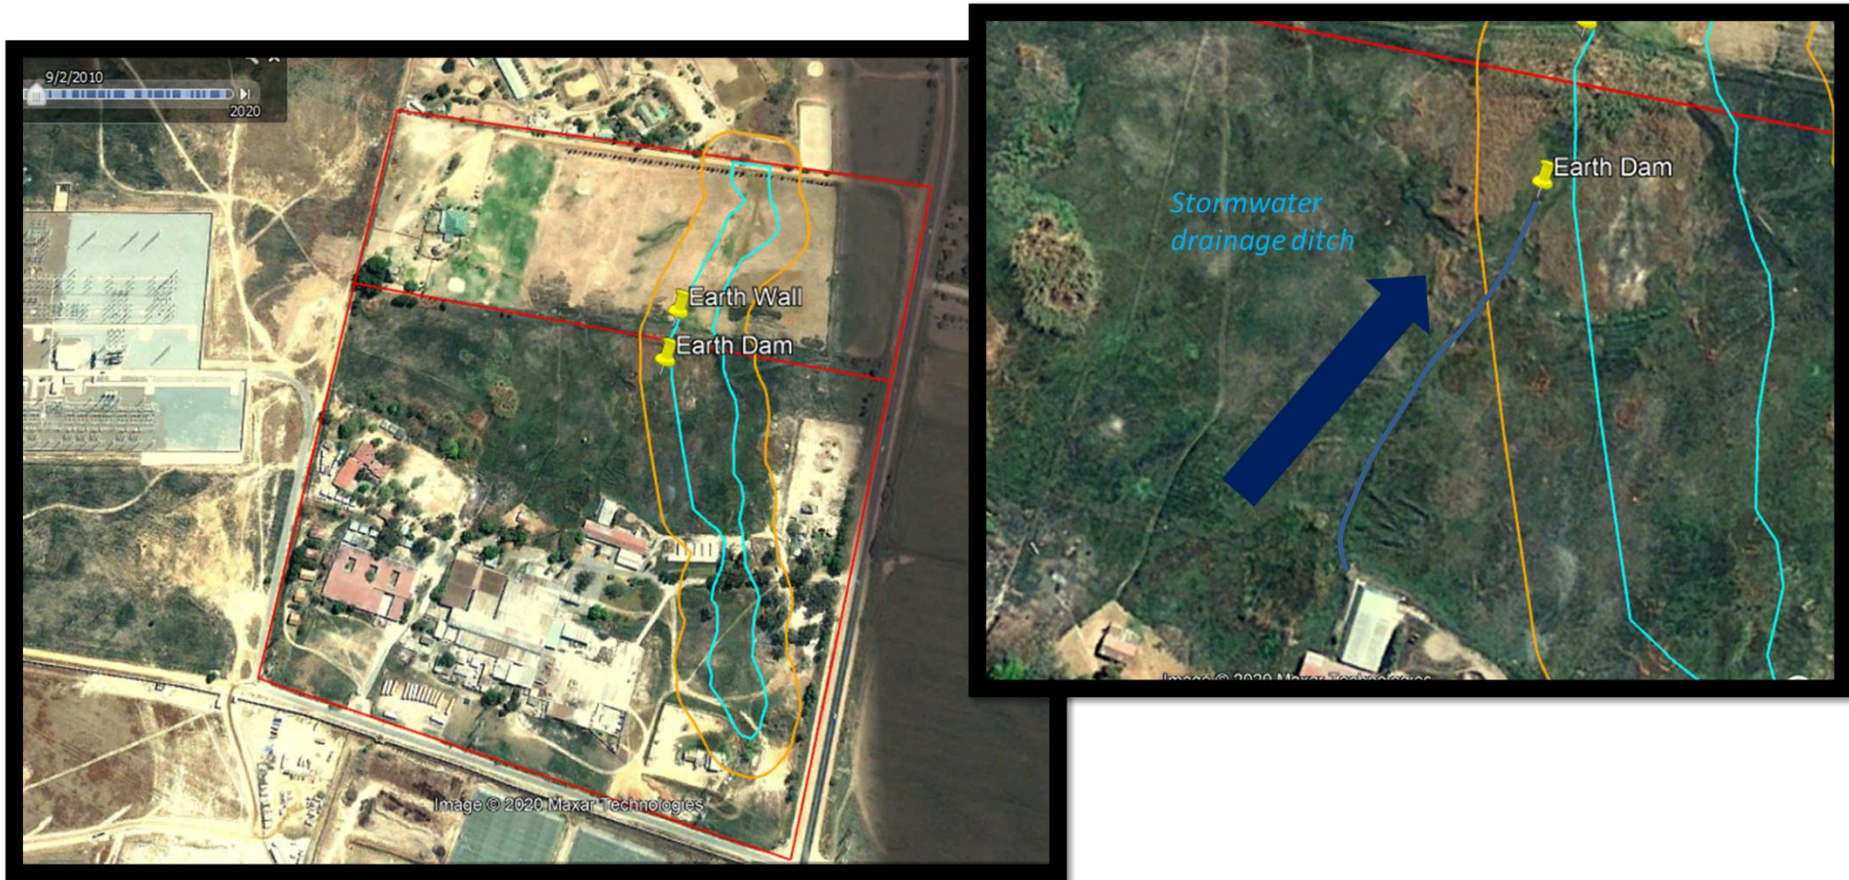
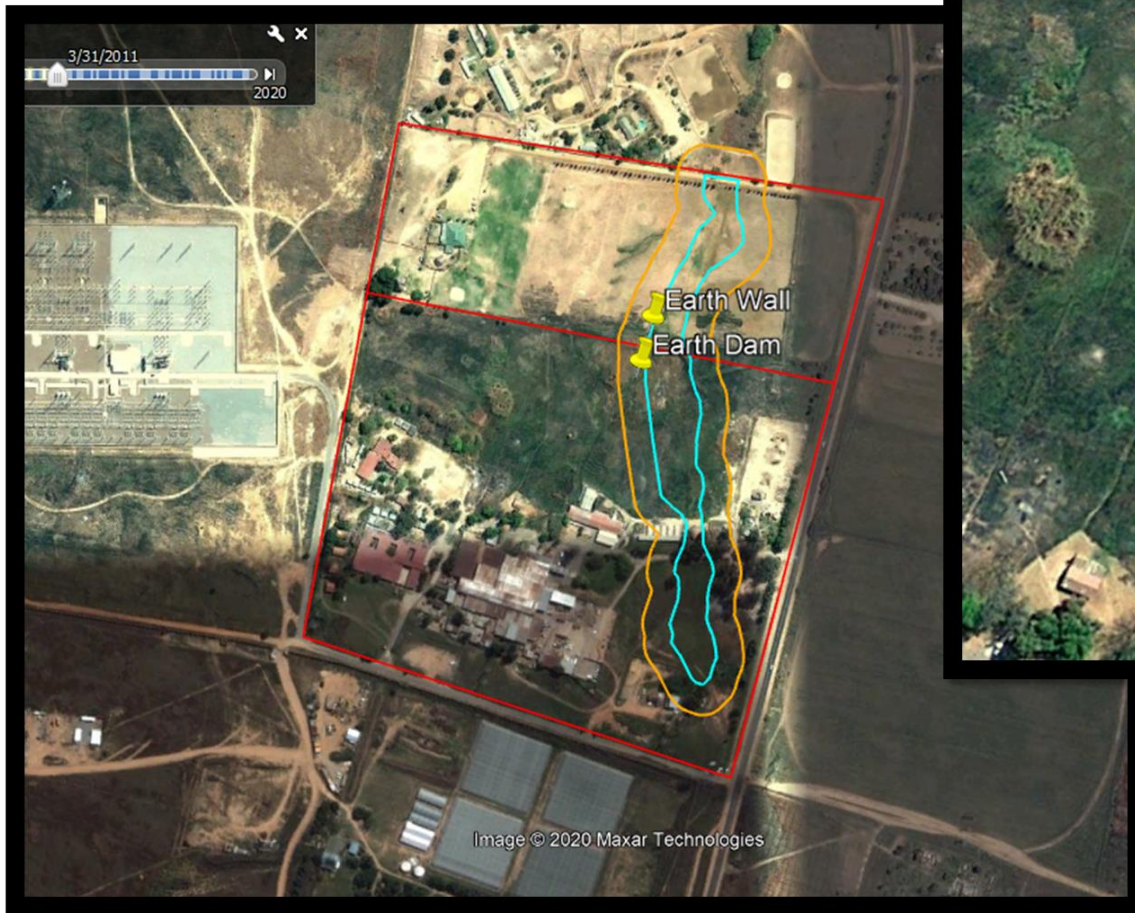
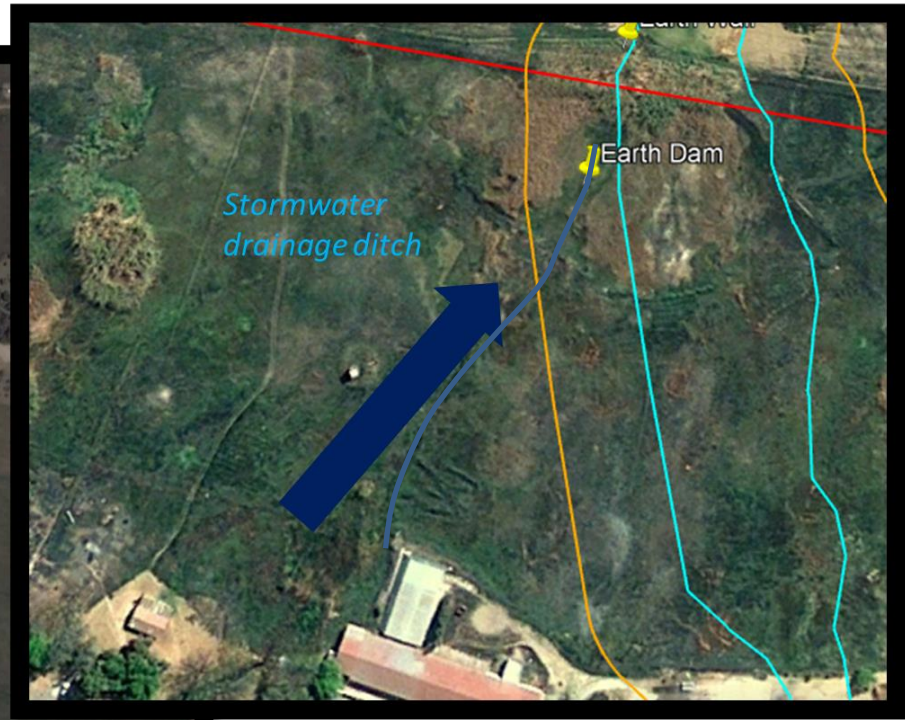
Figure 2: Google Earth Imagery from July 2008

Figure 3: Google Earth Imagery from April 2009

Figure 4: Google Earth Imagery from February 2010

Figure 5: Google Earth Imagery from March 2011

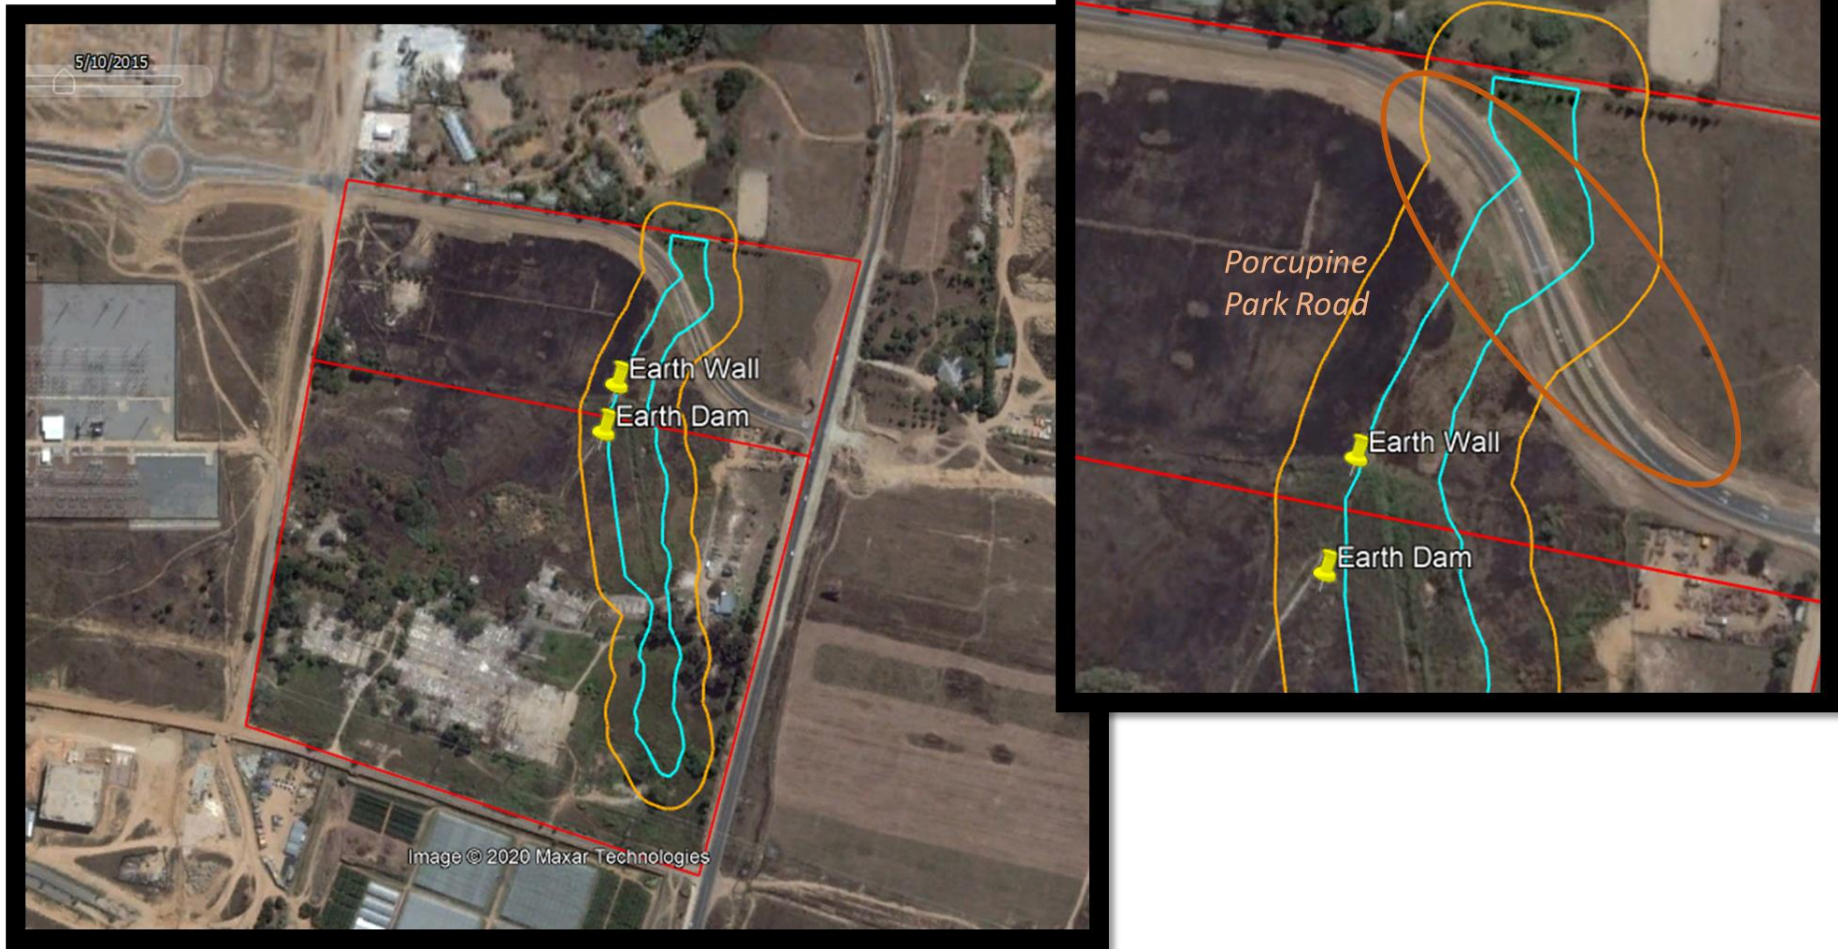
Figure 6: Google Earth Imagery from October 2011

Figure 7: Google Earth Imagery from April 2012

Figure 8: Google Earth Imagery from May 2015

Furthermore, whilst the school and old buildings on Portion 185 were demolished, the platforms they were built on remain in place and thus still channel stormwater. The artificial source of water referred to by the Biodiversity and Wetland Specialists relate to this stormwater. The earth dam also occurs within the degraded grassland area identified by the specialist.

Lastly in 2015, Porcupine Park Road was constructed and crosses the wetland to the north of Portion 124.

Figure 6, 7 and 8 below provide the Google Earth Imagery from this time.

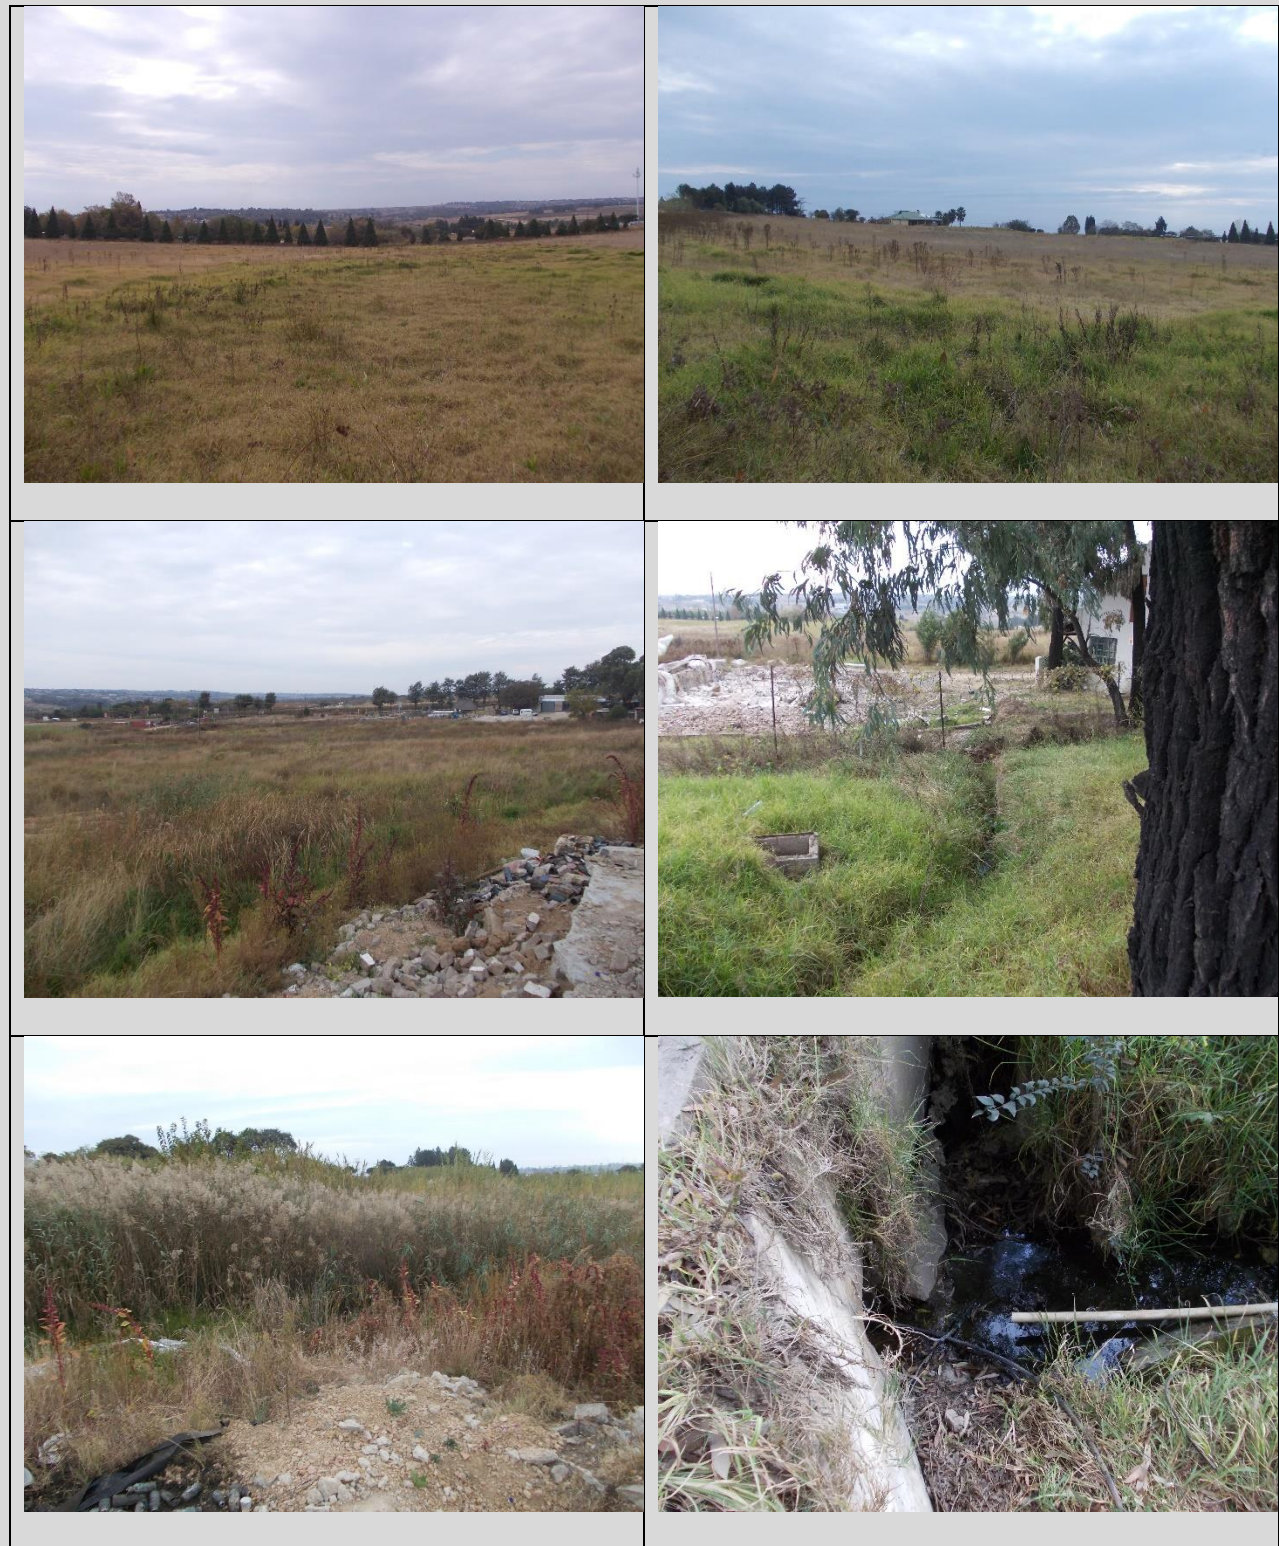
Figure 9: Photos from Initial Site Assessment (circa 2014)

Initial site assessment was undertaken in 2013/2014 and show the degraded state of the site. **Figure 9** below provides the photographs undertaken at this time.

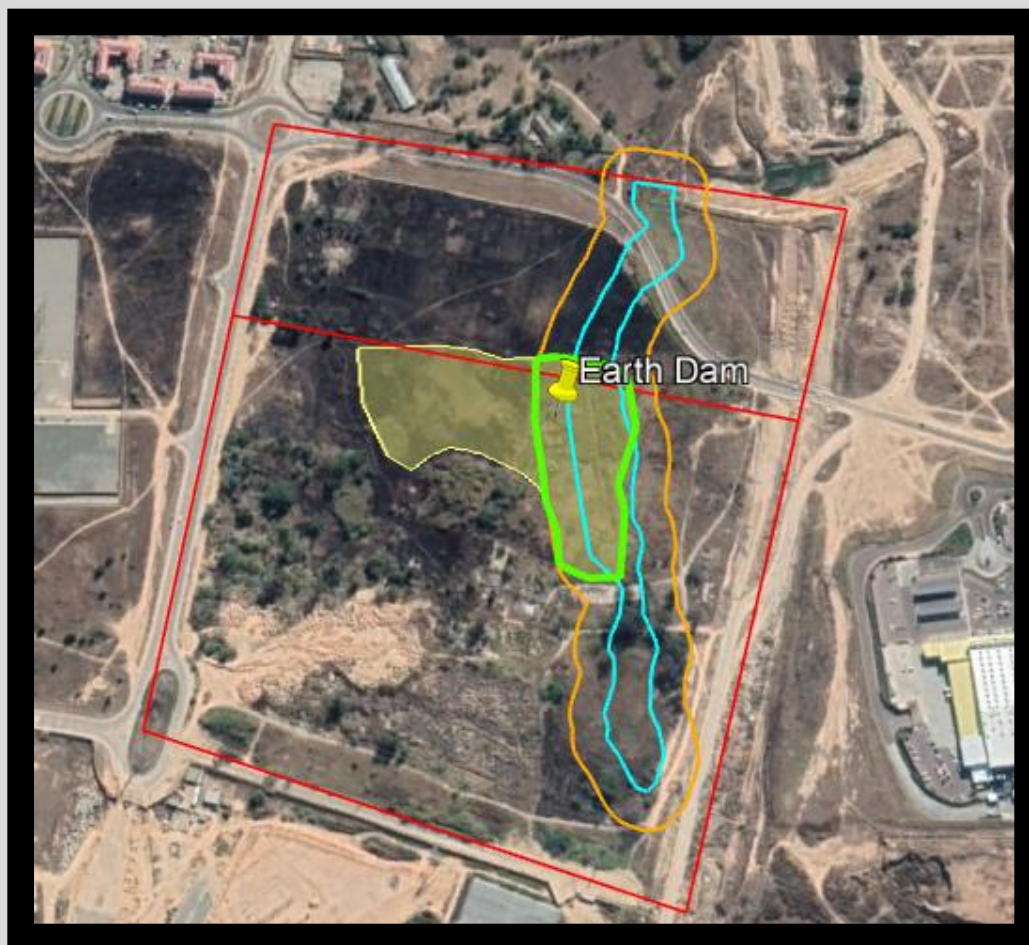
Figure 10: Location of earth dam within degraded grassland

Furthermore, it should be noted that the earth dam occurs within the degraded grassland area which was identified by the Biodiversity Baseline and Impact Assessment and shows its artificial nature.

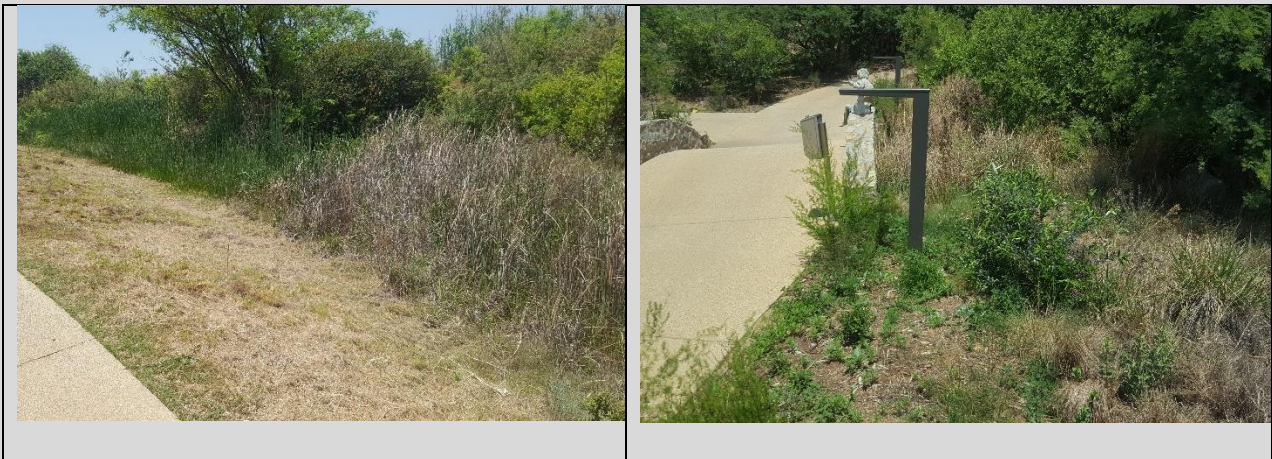
Figure 11: Steyn City Wetland Rehabilitation

Further to the comments, it should be noted that the development will involve the rehabilitation of the wetland and associated wetland buffer in line with the Aquatic Resources Rehabilitation Plan. The current state of the wetland was found to be low and the wetland is highly modified. The wetland and buffer, once rehabilitated will be similar to the wetland systems included in the main Steyn City development (Refer to **Figure 9**).

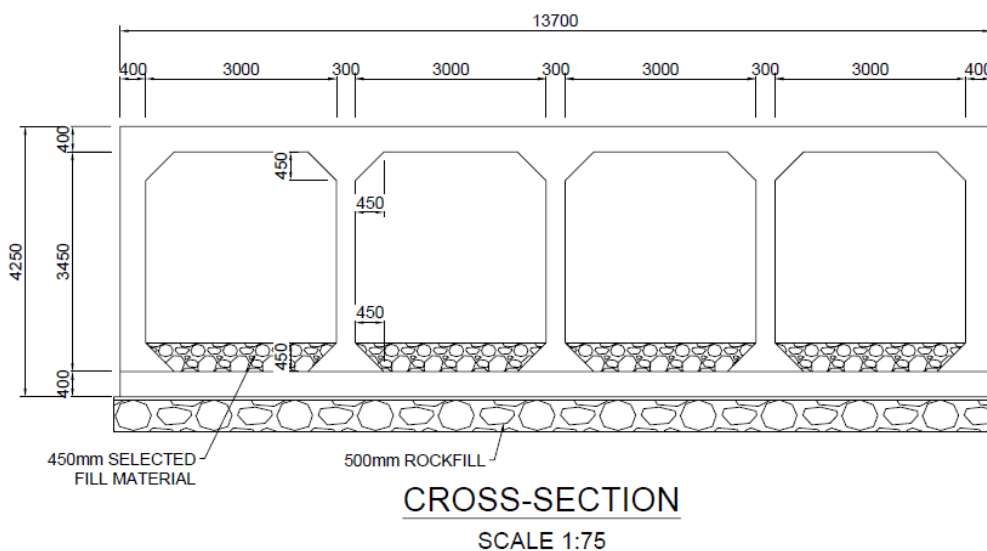
Figure 12: Typical cross section

Whilst conceptually a span bridge appears to reduce the impact, this is more in relation to riparian areas. From discussions with the Wetland Specialist and Engineers, it should be noted that due to the nature of the wetland and surface flows, the pillars would need to be sunk to a level were a greater impact would be experienced. Instead, the engineers (in consultation with the specialist) have recommended a culvert which rests on a “raft” of stone which will allow for continued subsurface flow and avoid intersection with the lateral interflow. This reduces the impact to the wetland and wetland habitat. **A span bridge is therefore not recommended from a wetland perspective.**

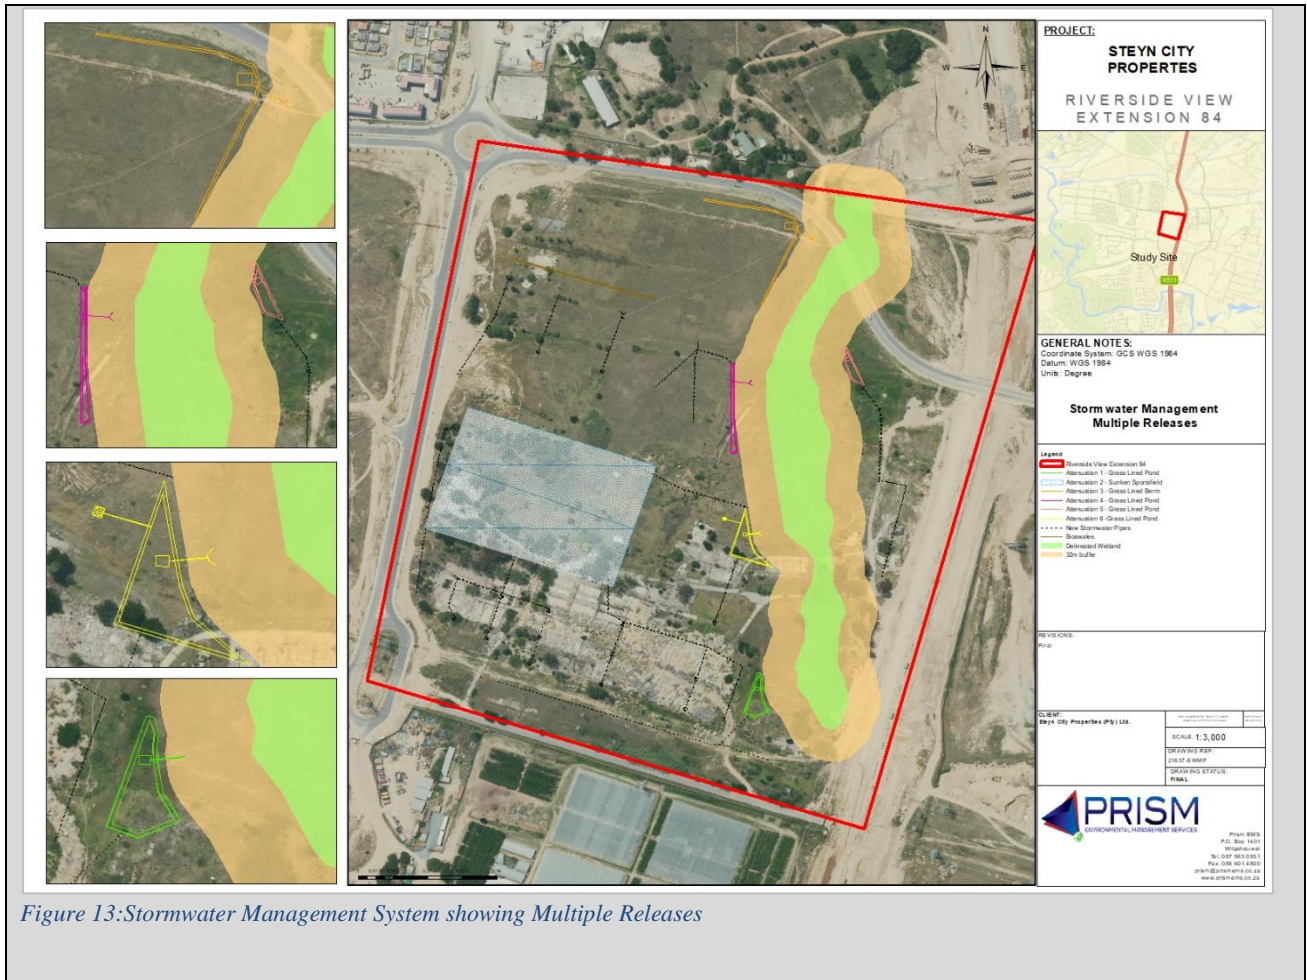
Figure 13: Stormwater Management System showing Multiple Releases

Figure 13 provides an overview of this plan and highlights that there are 6 separate releases along the wetland buffer at separate locations. It is not necessary to include multiple releases from each attenuation due to the fact that the site has been separated into small catchments and each catchment has its own release. It therefore has the same effect as having multiple releases from the same attenuation.

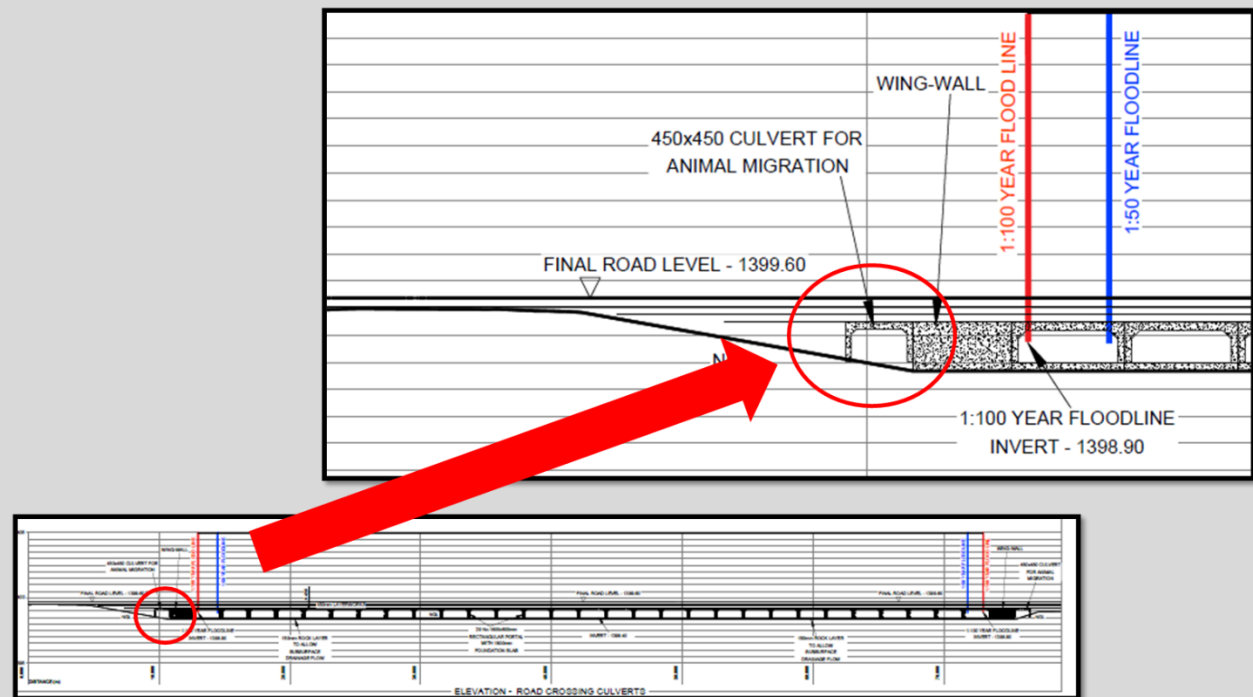
Figure 1: Proposed Wetland Crossing

As per Page 12 of the Stormwater Management Plan (Tekciv, 2020) that was included in the Appendix 14.6.9, "A road-bridge will be constructed which allows for the 1:100 year flow of 8.7 m³/s to pass under the road. The bridge is to be constructed of pre-cast portal culverts and will extend the full width of the flood line. To cater for animal crossings, smaller culverts will be placed above the flood line to allow for migration.

Please refer to **Figure 1** below which indicates the proposed wetland crossing including the smaller culverts which cater for animal crossings outside the floodline.

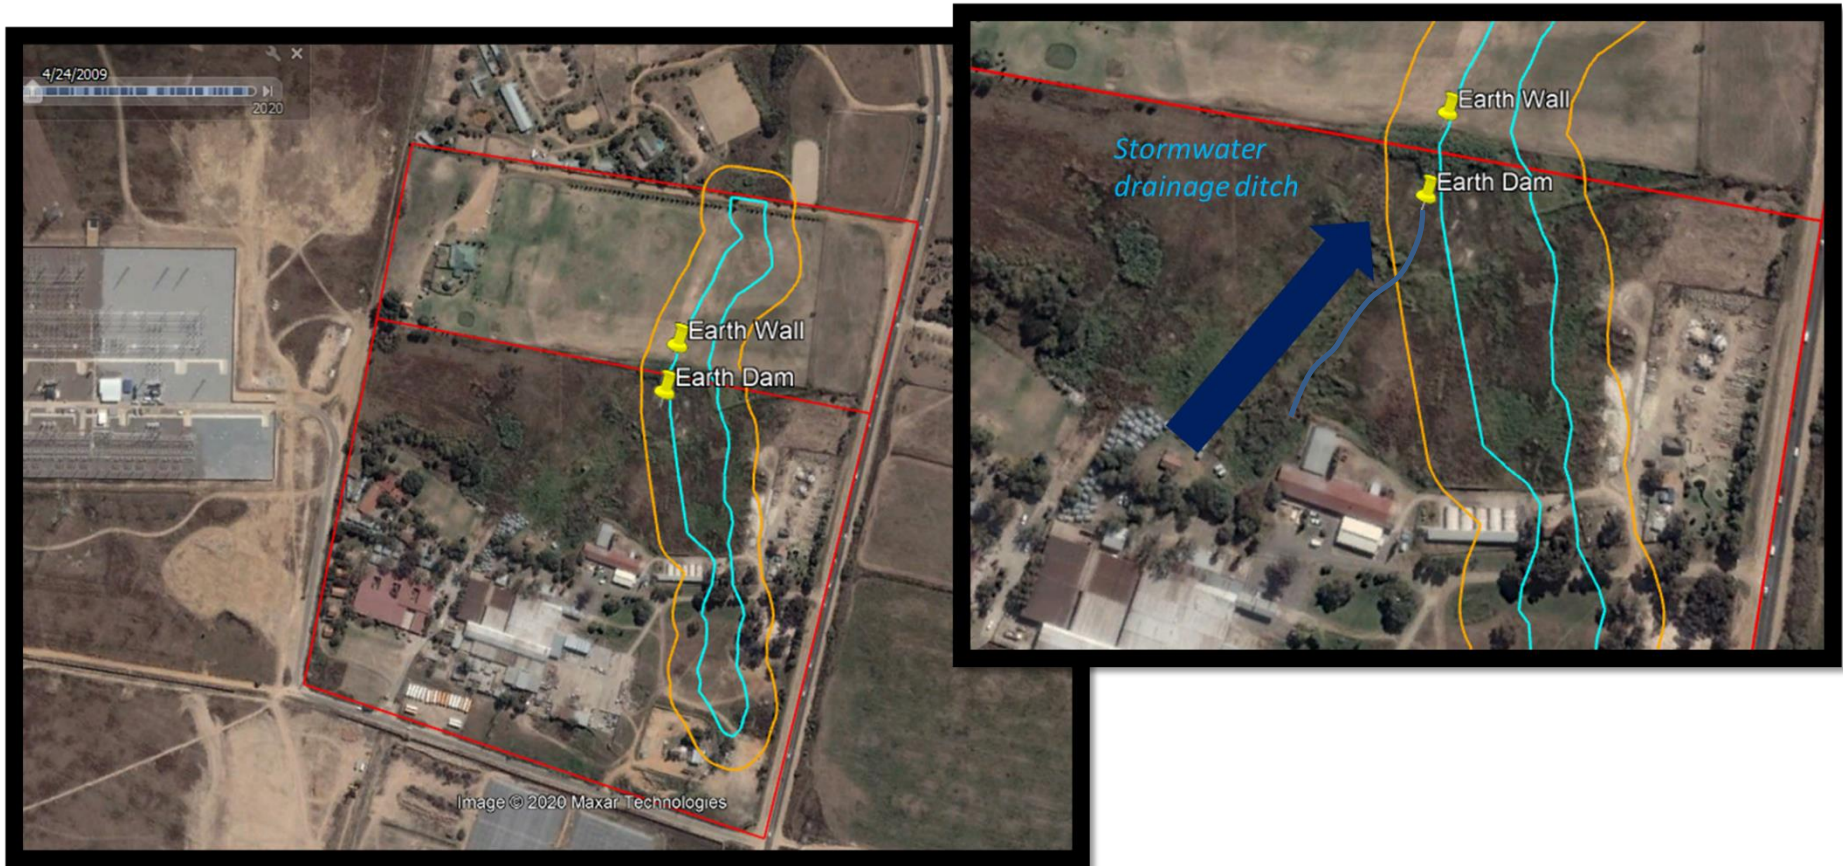
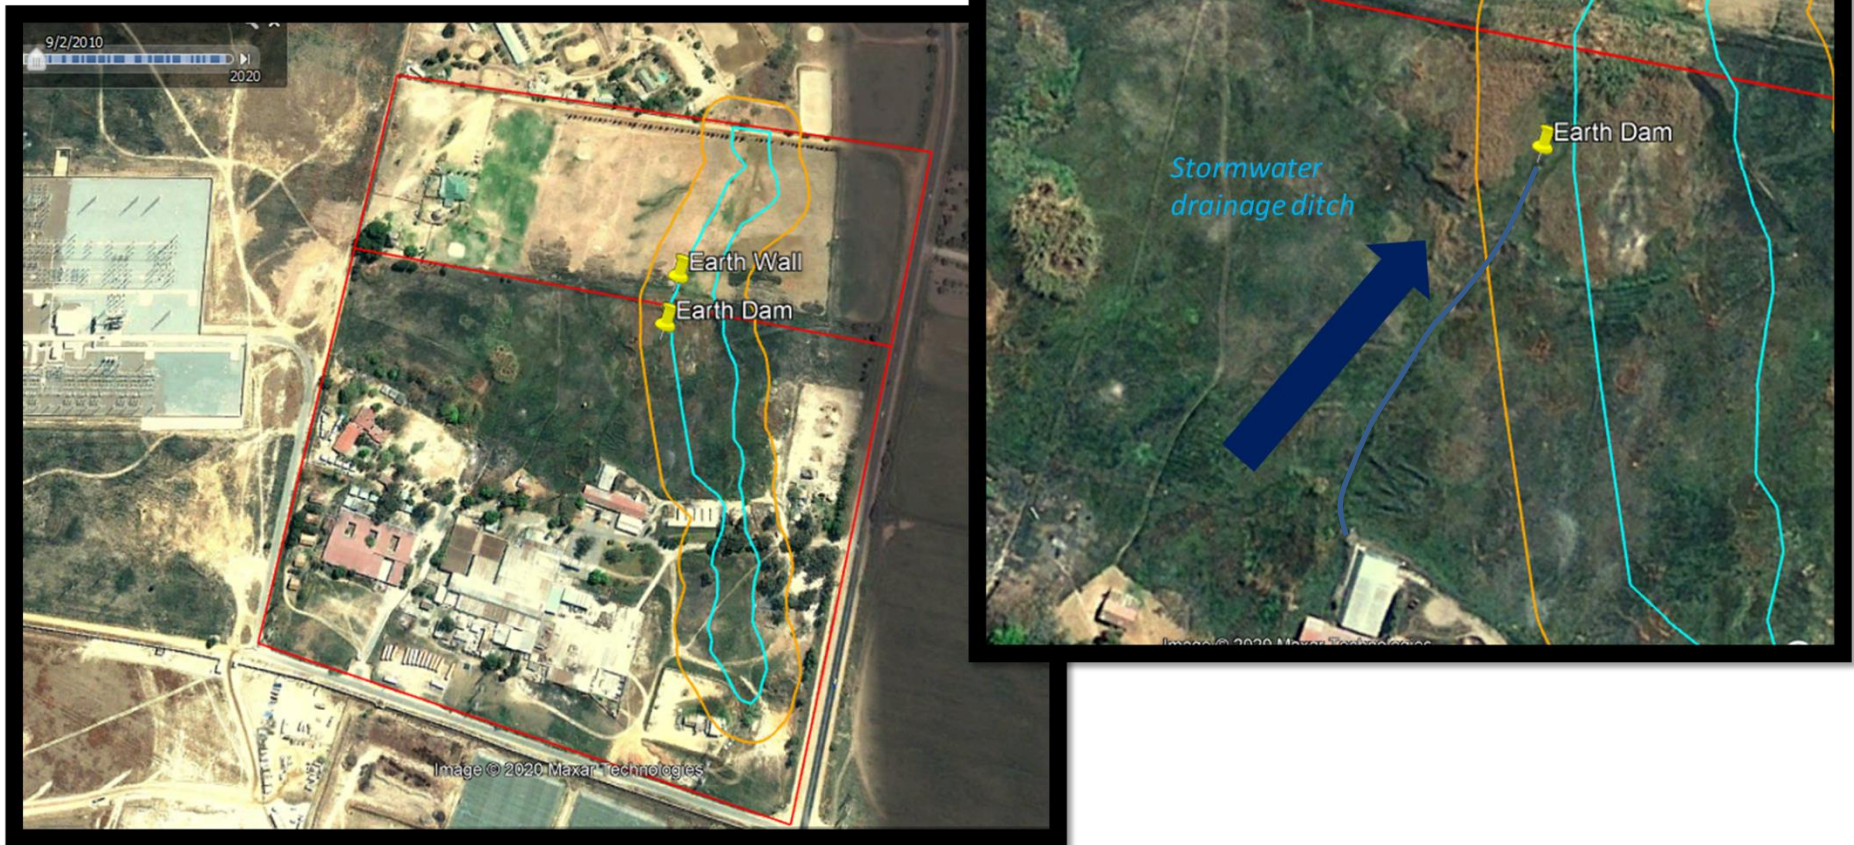
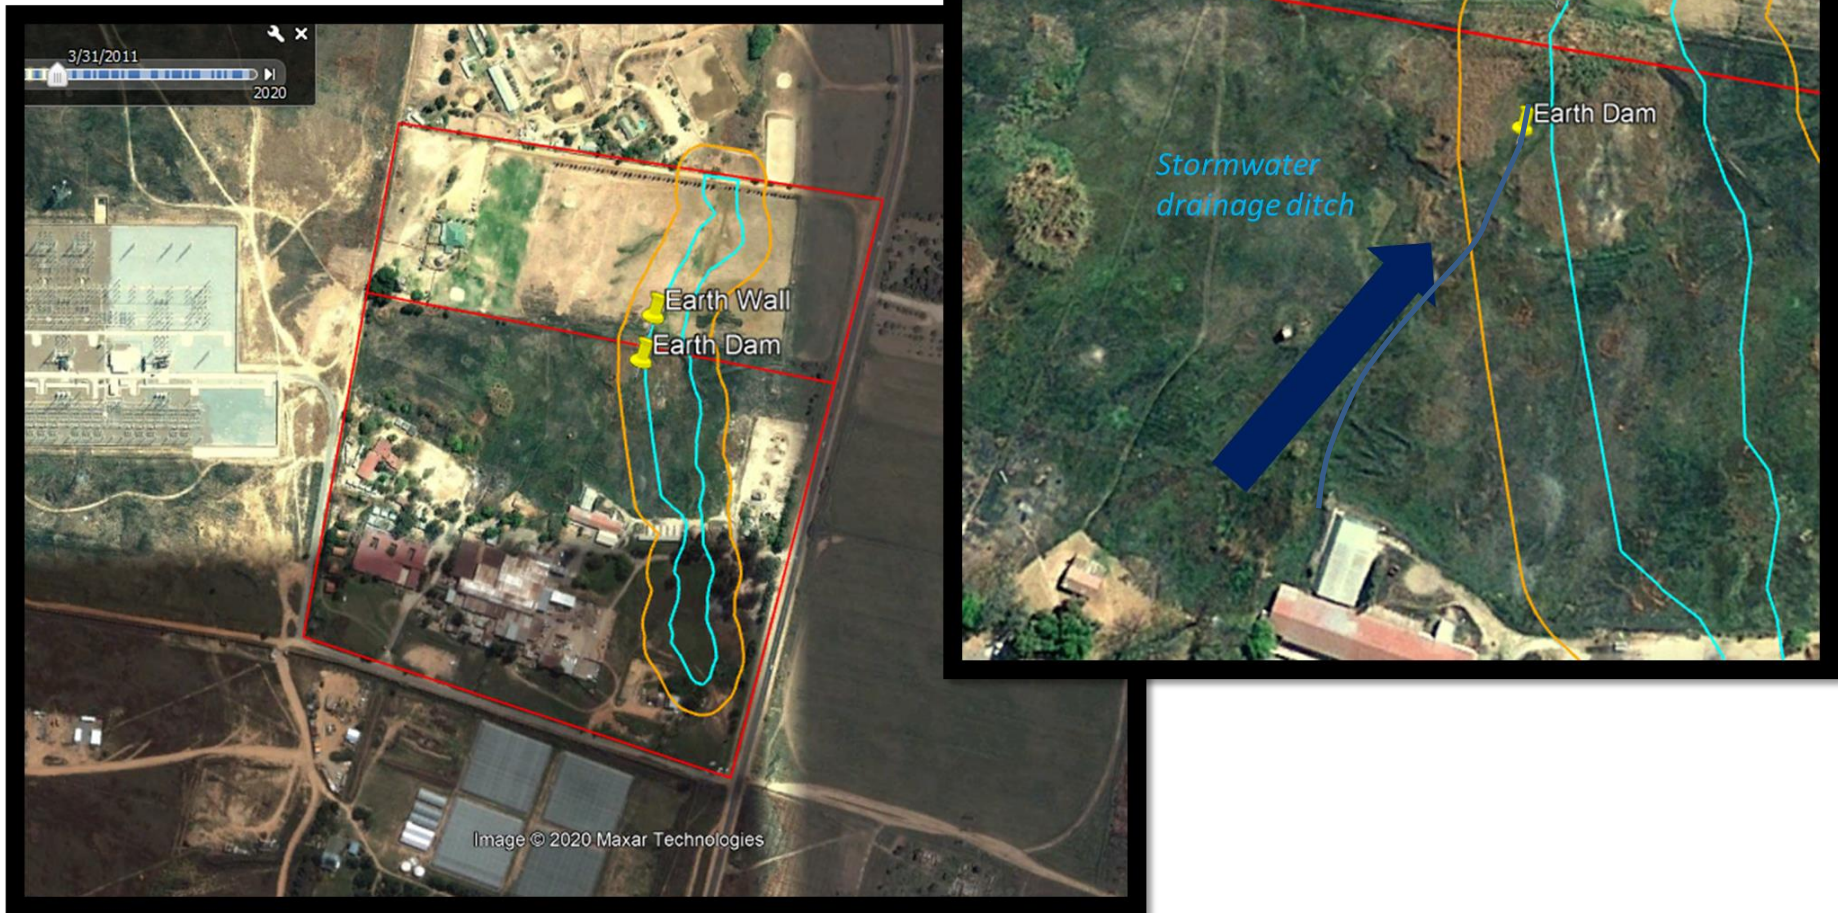
Figure 2: Google Earth Imagery from July 2008

Figure 3: Google Earth Imagery from April 2009

Figure 4: Google Earth Imagery from February 2010

Figure 5: Google Earth Imagery from March 2011
