From: Vanessa Stippel <vanessa@prismems.co.za>
Sent: Friday, 11 September 2020 12:14
Cc: De Wet Botha <dewet@prismems.co.za>
Subject: 21637 | Notification of Public Review of EIA Report and WULA Technical Report | Proposed Development of Riverside View Extension 84, City of Johannesburg, Gauteng (GAUT 002/17-18/E2040)

Steyn City Properties (Pty) Ltd. plans to develop Riverside View Ext 84 on portions 185 and 124 (a Portion of Portion 11) of the farm Diepsloot 388 JR within Ward 96 of the City of Johannesburg, Gauteng Province. The proposed development form parts of the Steyn City Parkland Residence which has been designed to be a modern, mixed land use and mixed income development. The extent of the proposed development is approximately 29.4 ha and the site will be developed into three separate erven. The proposed use zones of these erven are as follows:

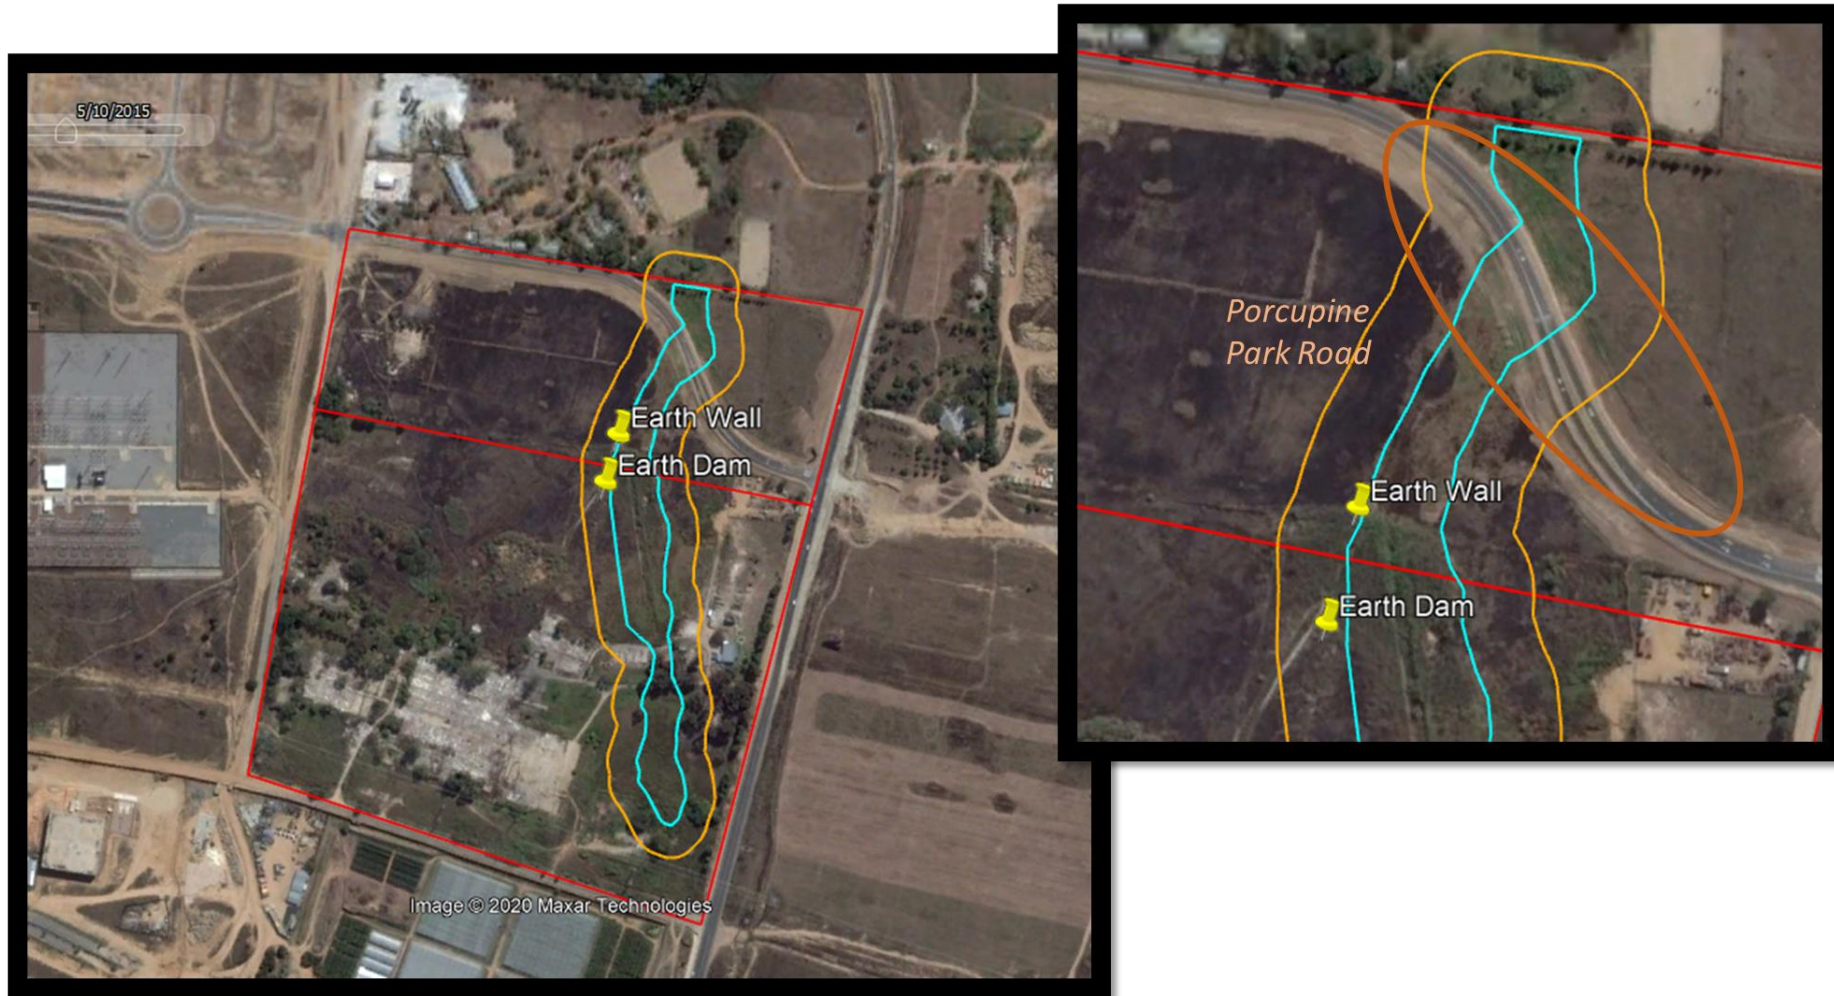
Figure 6: Google Earth Imagery from October 2011

Figure 7: Google Earth Imagery from April 2012

Figure 8: Google Earth Imagery from May 2015

Lastly in 2015, Porcupine Park Road was constructed and crosses the wetland to the north of Portion 124.

Figure 6, 7 and 8 below provide the Google Earth Imagery from this time.

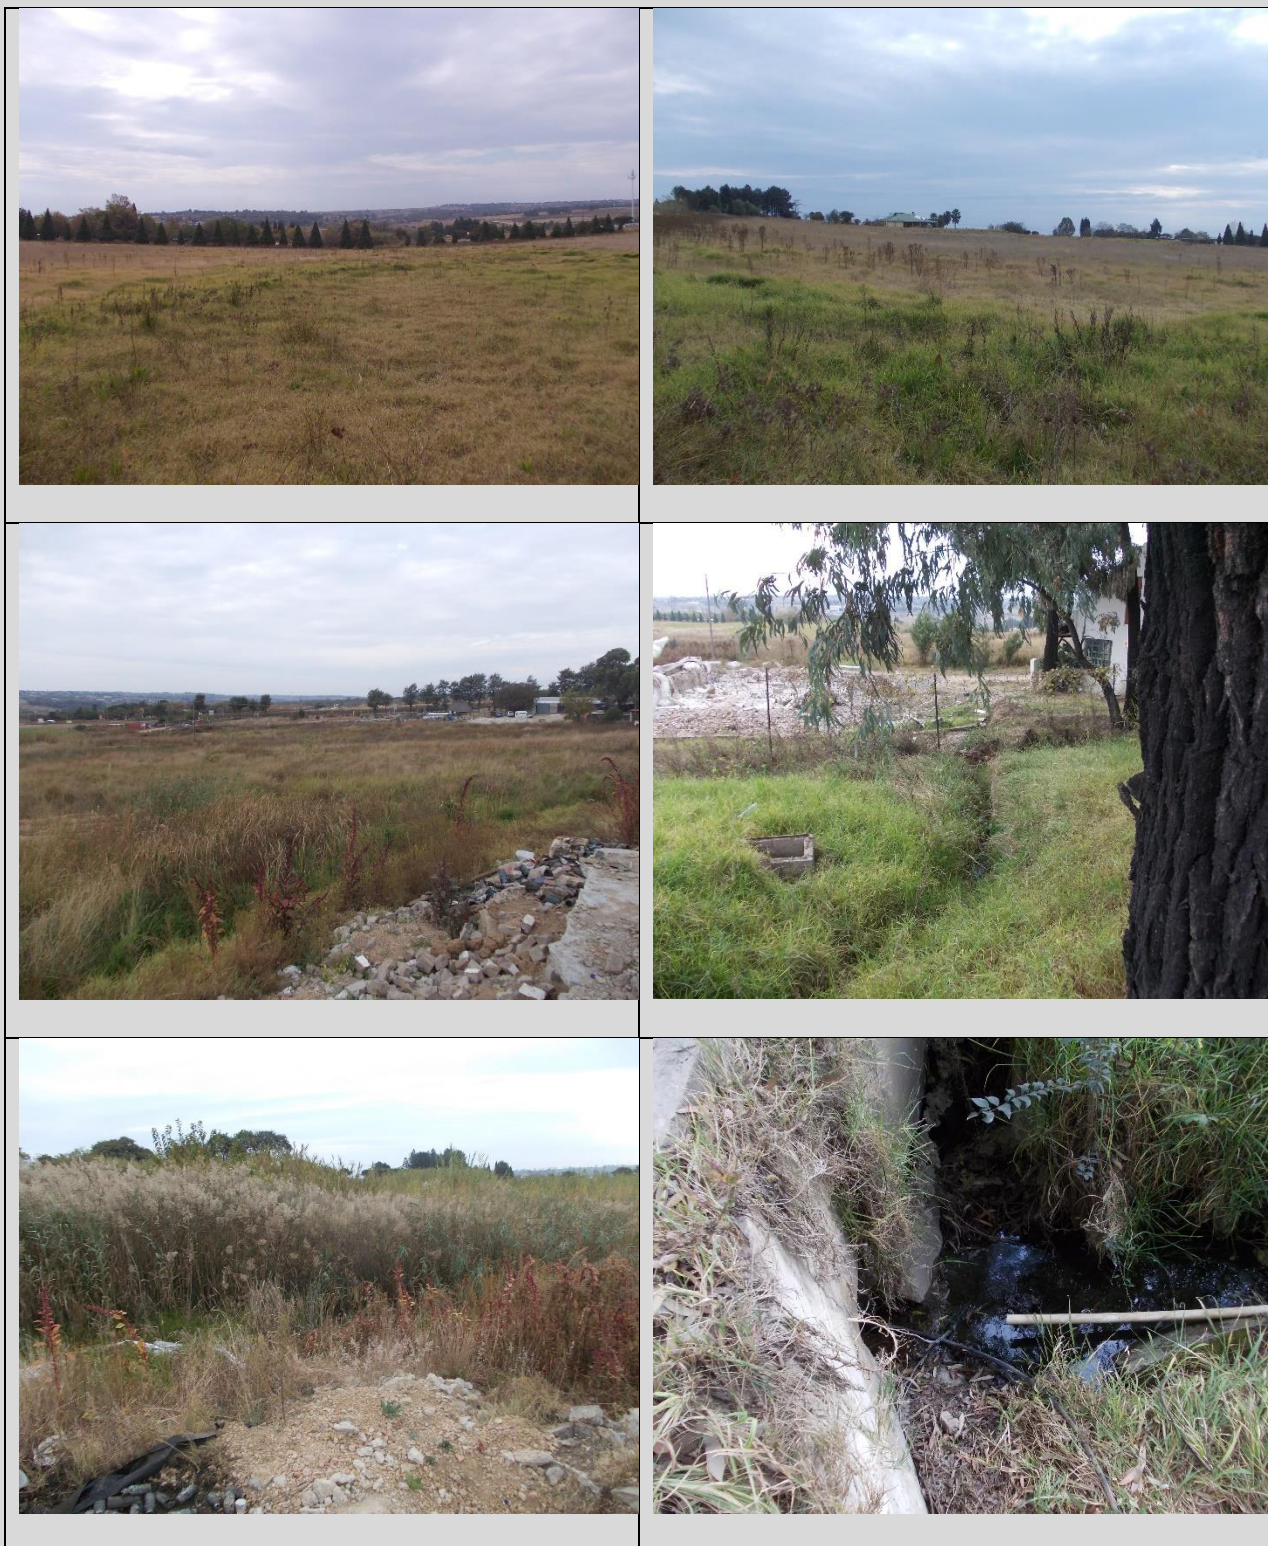
Figure 9: Photos from Initial Site Assessment (circa 2014)

Initial site assessment was undertaken in 2013/2014 and show the degraded state of the site. **Figure 9** below provides the photographs undertaken at this time.

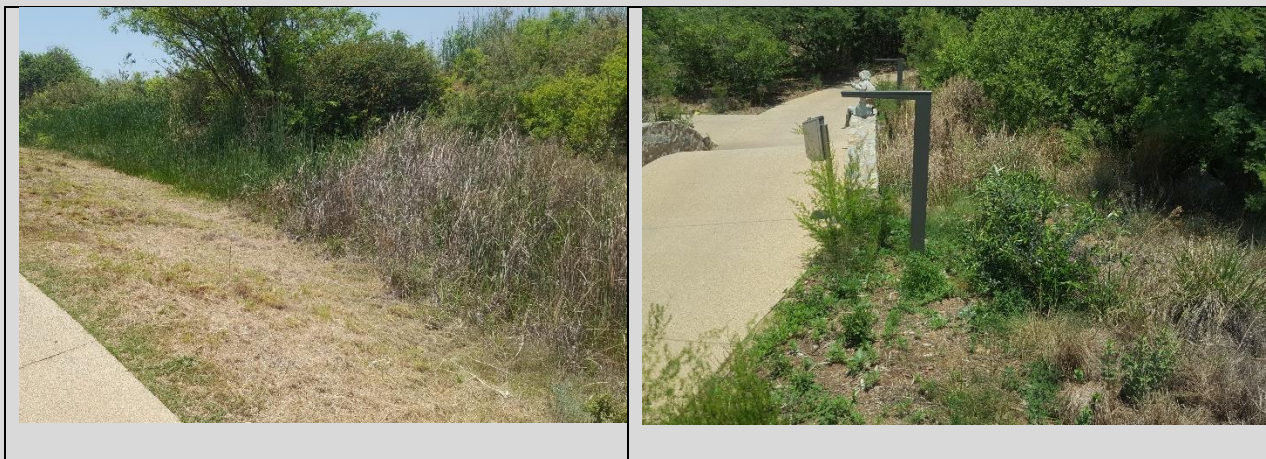
Figure 11: Steyn City Wetland Rehabilitation

Further to the comments, it should be noted that the development will involve the rehabilitation of the wetland and associated wetland buffer in line with the Aquatic Resources Rehabilitation Plan. The current state of the wetland was found to be low and the wetland is highly modified. The wetland and buffer, once rehabilitated will be similar to the wetland systems included in the main Steyn City development (Refer to **Figure 11**).
