Report | 1107

Report on a Phase 1 Geotechnical Site Investigation on Portion 124 of the farm Diepsloot 388-JR, Johannesburg, Gauteng Province.

Prepared for: CENTURY PROPERTY DEVELOPMENTS

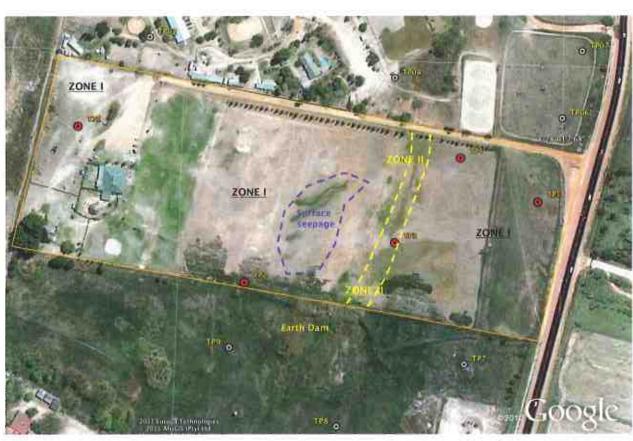
Figure 2: Test Pit positions & Geotechnical Zoning Ptn 124 Diepsloot 388-JR Midrand

The test pit positions from this investigation as well as those available from adjacent investigations on Holding 185 to the south and the Remainder of Portion 11 of the farm Diepsloot to the north, are also indicated on the site plan (Figure 2, Appendix A). Parts of the site were not accessible to the TLB due to wet surface conditions.

The site has been classified into two Site Class Designation zones (Figure 2), based on the above constraints and the criteria as set out in the NHBRC (1999) guideline document of which the appropriate tables have been included in Appendix A. The classification and foundation recommendations are based on results from this and other nearby investigations.
