1040

Report on a Phase 1 Geotechnical Site Investigation on  
Portion 185 of the farm Diepsloot 388-JR, Johannesburg,  
Gauteng Province.

Prepared for: CENTURY PROPERTY DEVELOPMENTS

**December 2010**

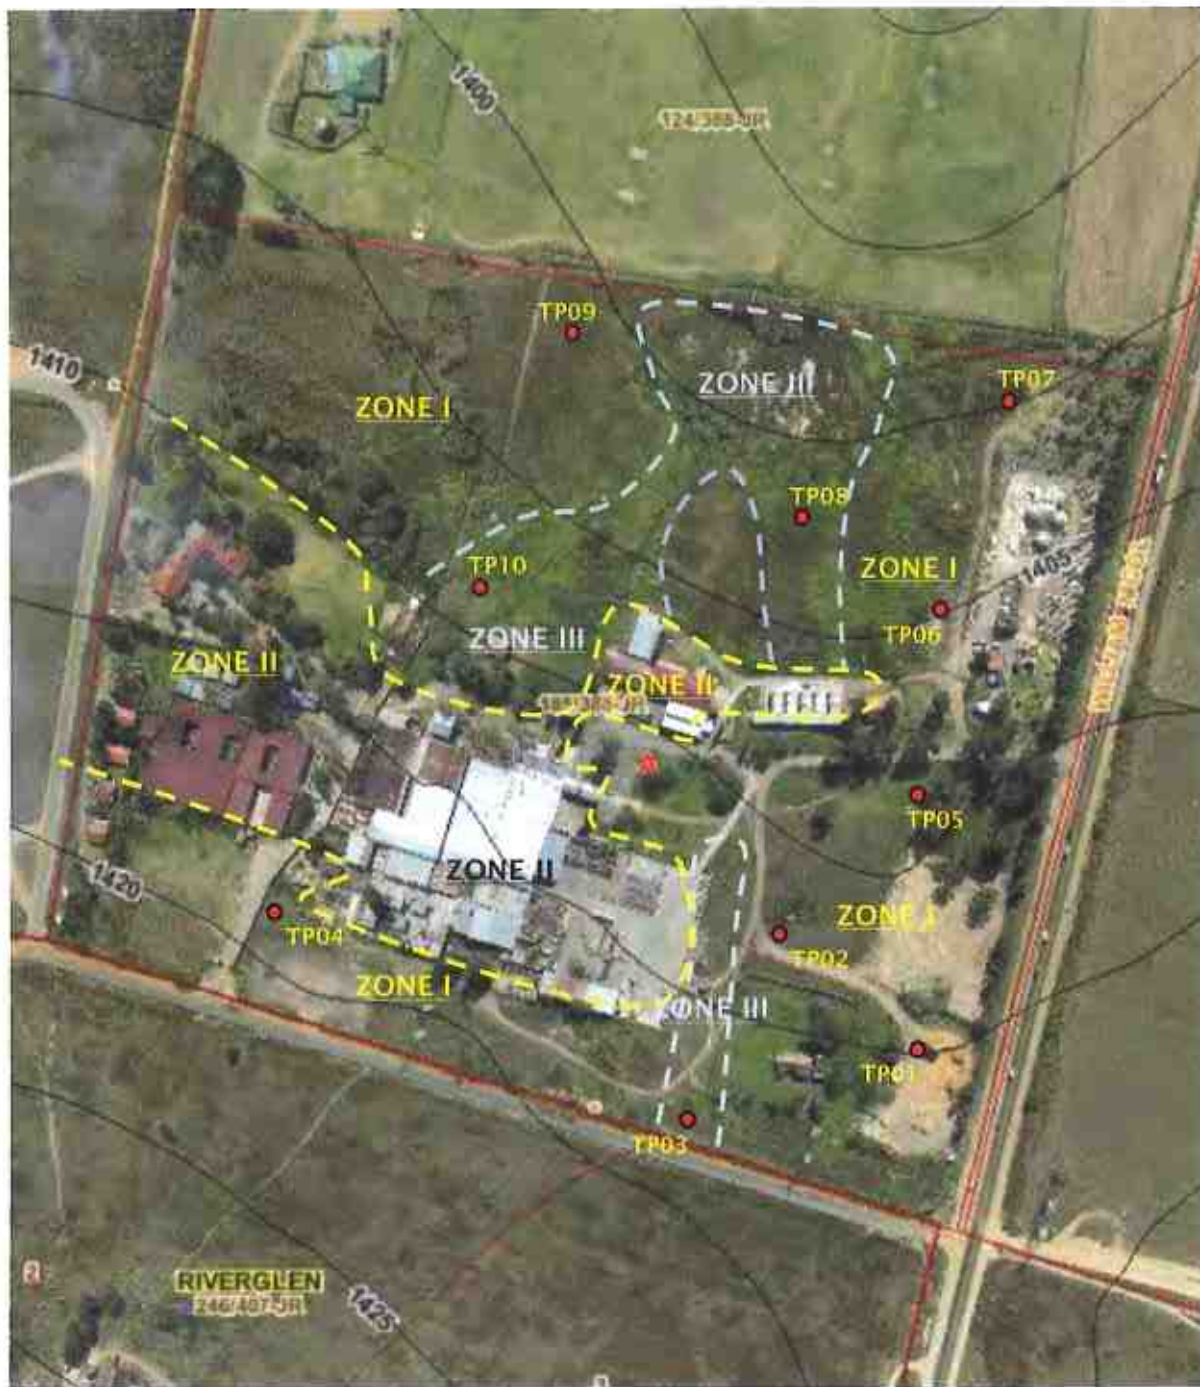
Figure 2: Test Pit positions & Geotechnical Zoning Ptn 185 Diepsloot 388-JR Midrand  
 © Johannesburg City

The test pits were excavated in accessible positions and are deemed representative of the sub-surface conditions prevailing on this holding. The test pit positions are indicated on the site plan (Figure 2, Appendix A). No test pits were excavated inside the school area as no measures were in place to control noise or children during formal school activities. Large areas of the site are also inaccessible to a TLB due to buildings and covered surface areas.

The site has been classified into three Site Class Designation zones (Figure 2), based on the above constraints and the criteria as set out in the NHBRC (1999) guideline document of which the appropriate tables have been included in Appendix A. The classification and foundation recommendations are based on results from this and other nearby investigations.

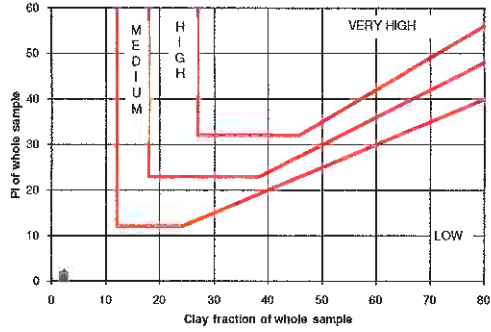
## POTENTIAL EXPANSIVENESS

ATTERBERG LIMITS (TMH 1 A2 - A4)		
Liquid Limit	16	13
Plasticity Index	2	3
Linear Shrinkage (%)	1.0	0.5
Grading Modulus	1.42	1.25
Classification	A-2-4 (0)	A-2-4 (0)
Unified Classification	SM	SM
Chart Reference
