# Aquatic Baseline & Risk Assessment for the proposed Tetra4 Cluster 2 Project

## Virginia, Free State Province

April 2022

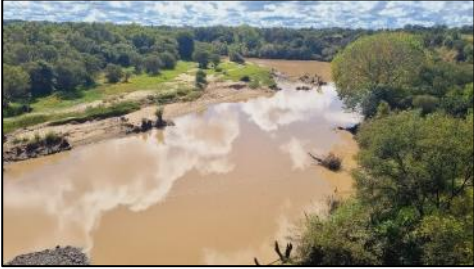
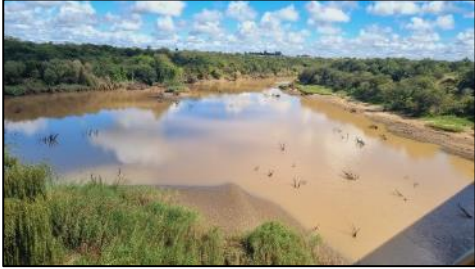
Site	Upstream	Downstream
<b>Sand River</b>		
S1

<b>Comments</b>	Upstream Sand River site. Substrate dominated by sand and scattered stones of current. Debris within the channel provides cover features for aquatic biota. Flooding conditions during sampling.	
<b>GPS-coordinates</b>	28° 5'55.27"S 26°50'2.40"E	
S2

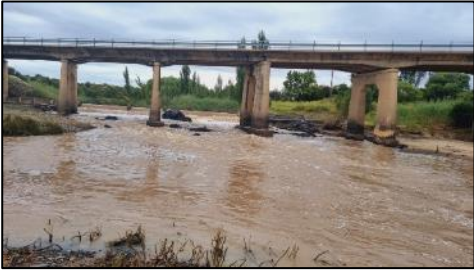
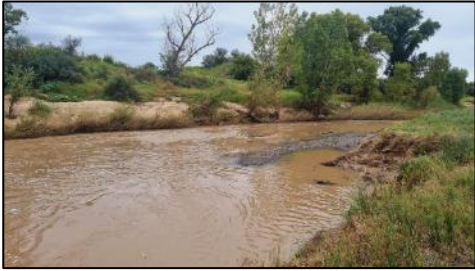
<b>Comments</b>	Midstream Sand River site. Flooding conditions during sampling. Substrate dominated by sand and portions of bedrock.	
<b>GPS-coordinates</b>	28° 7'4.26"S 26°43'9.48"E	
S3

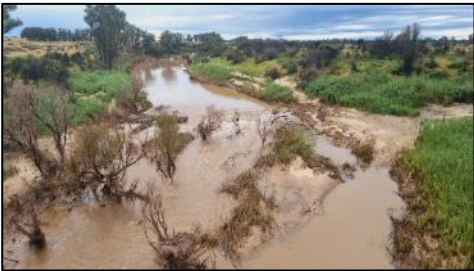
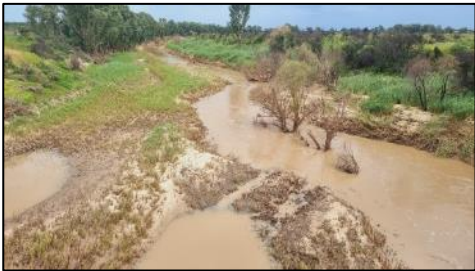
<b>Comments</b>	Downstream Sand River site. Flooding conditions during sampling. Instream habitat limited, predominantly sand substrate.	
<b>GPS-coordinates</b>	28° 7'21.92"S 26°35'7.29"E

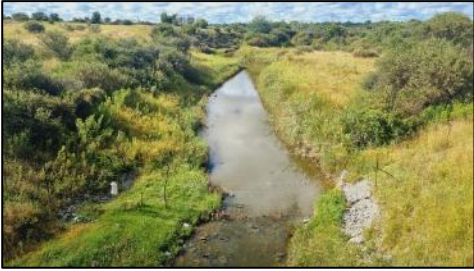
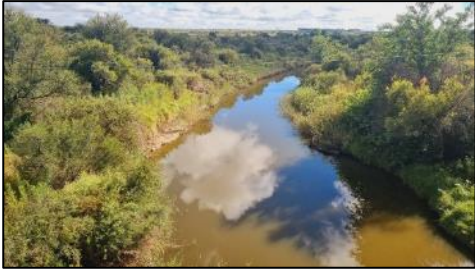
Site	Upstream	Downstream
<b>Doring River</b>		
D1

<b>Comments</b>	Upstream Doring River site. Limited instream habitat diversity and hydraulic biotopes.	
<b>GPS-coordinates</b>	28°11'17.45"S 26°47'53.81"E	
D2

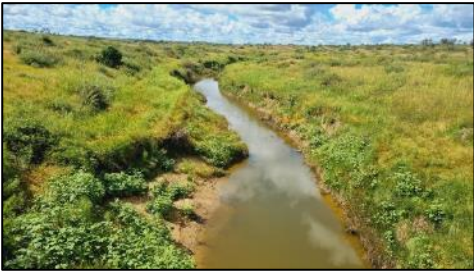
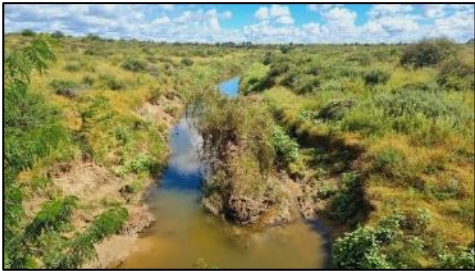
<b>Comments</b>	Downstream Doring River site. Limited instream habitat diversity and hydraulic biotopes.	
<b>GPS-coordinates</b>	28° 7'36.76"S 26°43'57.13"E	
<b>Palmietkuilspruit</b>		
P1

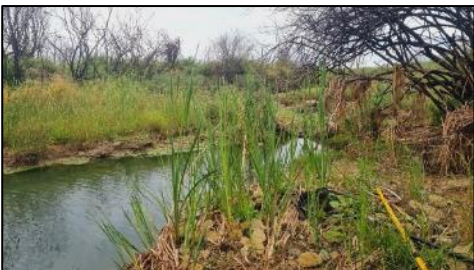
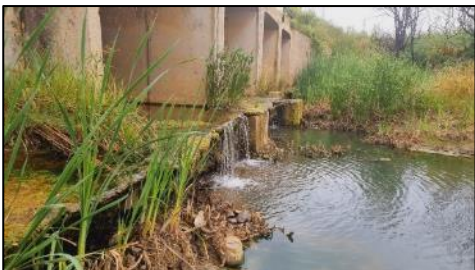
<b>Comments</b>	Reference site on the Palmietkuilspruit. Diverse habitat including stones and marginal vegetation.	
<b>GPS-coordinates</b>	28°10'30.53"S 26°36'57.33"E

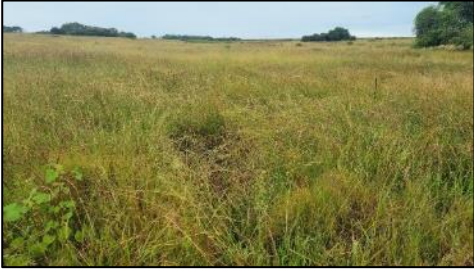
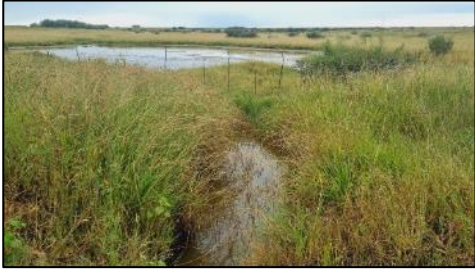
Site	Upstream	Downstream
<b>Boschluispruit</b>		
B0

<b>Comments</b>	Upstream site on Boschluispruit, characteristic of wetland system.	
<b>GPS-coordinates</b>	28°15'12.51"S 26°42'31.37"E	
B3

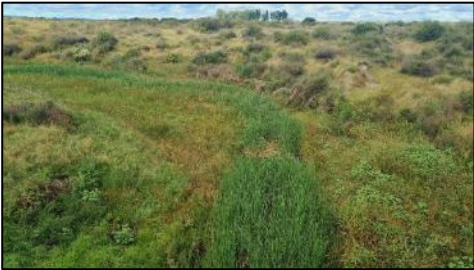
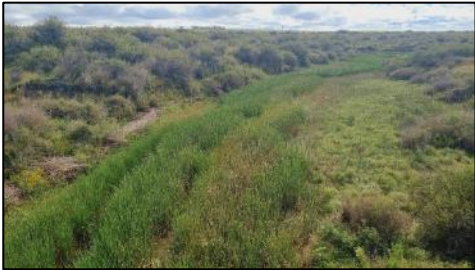
<b>Comments</b>	Wetland system in downstream reaches of Boschluispruit	
<b>GPS-coordinates</b>	28° 9'20.92"S 26°44'39.94"E	
<b>Ephemeral Tributaries</b>		
K1

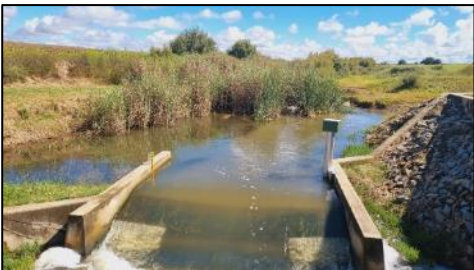
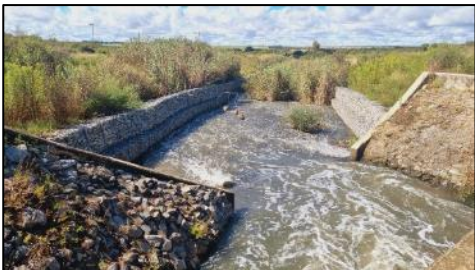
<b>Comments</b>	Site downstream of mining activities, outside of project area. Flows into the Sand River upstream of project area.	
<b>GPS-coordinates</b>	28° 5'36.28"S 26°48'20.94"E

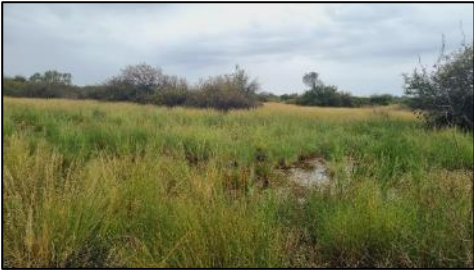
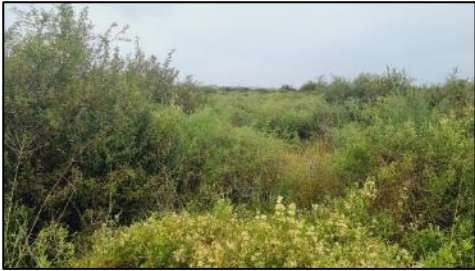
Site	Upstream	Downstream
T0

Comments	Ephemeral tributary. Site limited to a standing pool.	
GPS-coordinates	28° 9'35.66"S 26°40'29.93"E	
T1

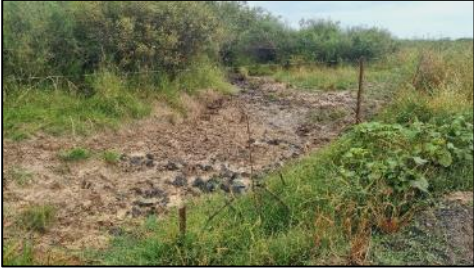
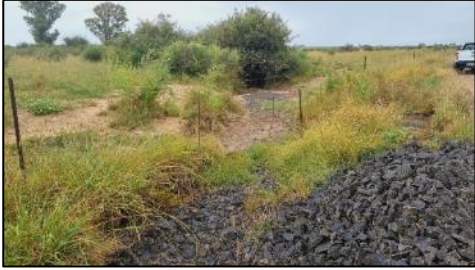
Comments	Ephemeral tributary with limited surface water	
GPS-coordinates	28° 9'6.98"S 26°40'11.16"E

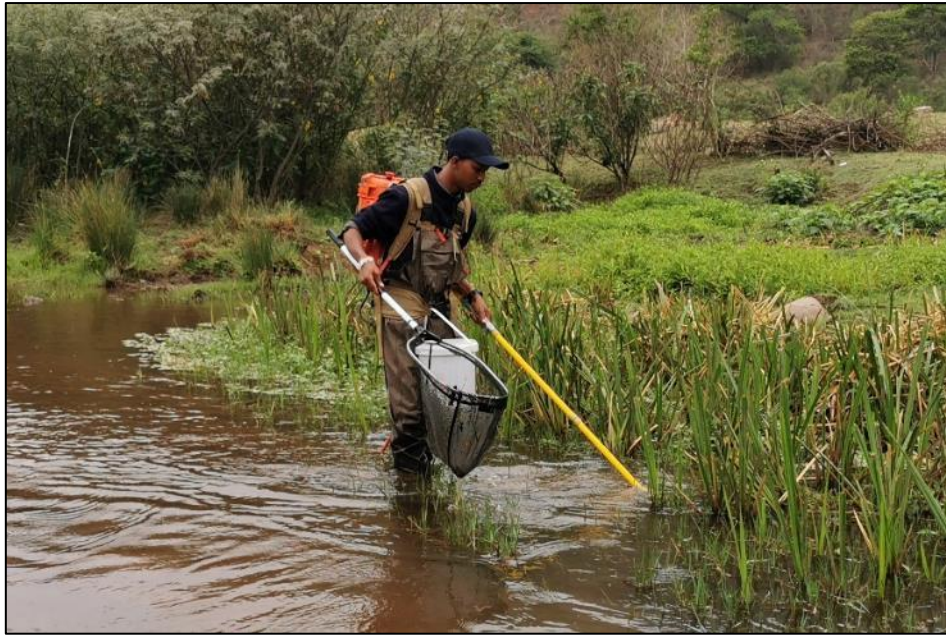
Figure 4-3 Example of methodology used to catch fish species (KZN, 2019).

Fish were sampled through electroshocking (Figure 4-3). All fish were identified in the field and released at the point of capture, in order not to cross fish populations. Fish species were identified using the guide *Freshwater Fishes of Southern Africa* (Skelton, 2001). The identified fish species were compared to those expected to be present for the quaternary catchment. The expected fish species list for the project area was developed from a literature survey to compare to the sampled species at site. Different fish species represent different sensitivities to water chemistry, habitat and flow which considered as part of the Fish Response Assessment Index (FRAI) (Kleynhans *et al.*, 2007 and Skelton 2001).

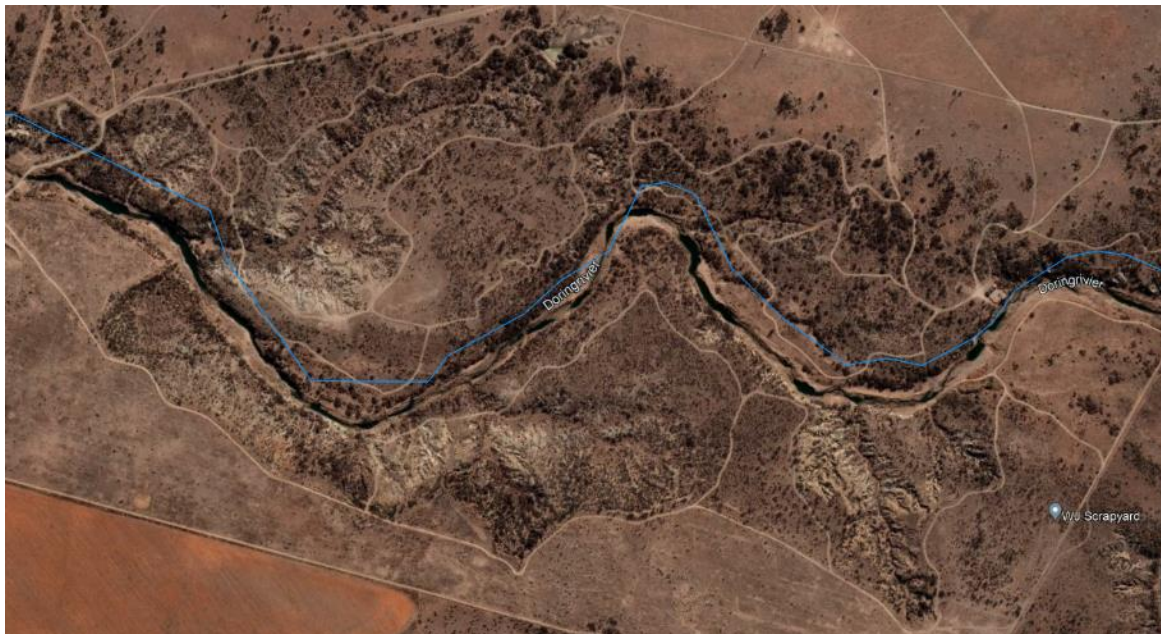
Instream habitat modifications within the catchment was noted at all sites, and particularly increased sediment deposits within the Doring and Sand Rivers. The source of the increased sediment yield can be attributed to the erosion of channel edges within the Doring and Sand River catchments, compounded by dryland agricultural activities (Figure 6-1 and Figure 6-2). The soils observed within the river banks was noted to be composed of highly erodible soils which is further contributing towards the erosion and sedimentation in the watercourses. The erosion of bed and banks results in channelisation and reduced lateral movement of water into the riparian zone. The reduced lateral flow of water and physical disturbance of the riparian zone due to erosion has compromised the riparian zone integrity within the catchment.

Figure 6-1 Erosion within the Doring River catchment (Google Earth, 2021)

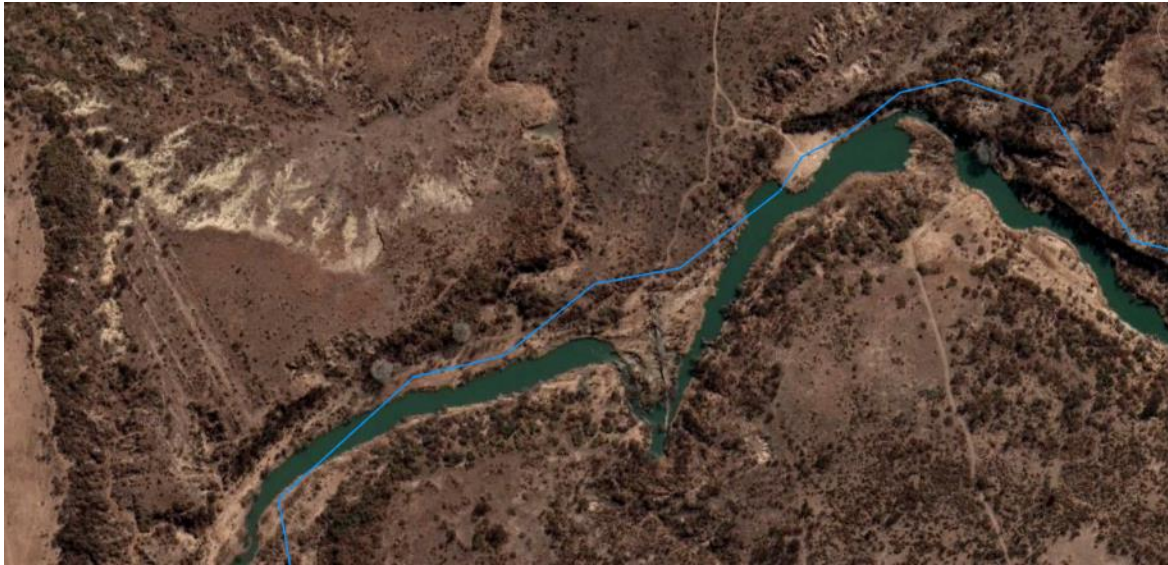
Figure 6-2 Erosion within the Sand River catchment (Google Earth, 2021)

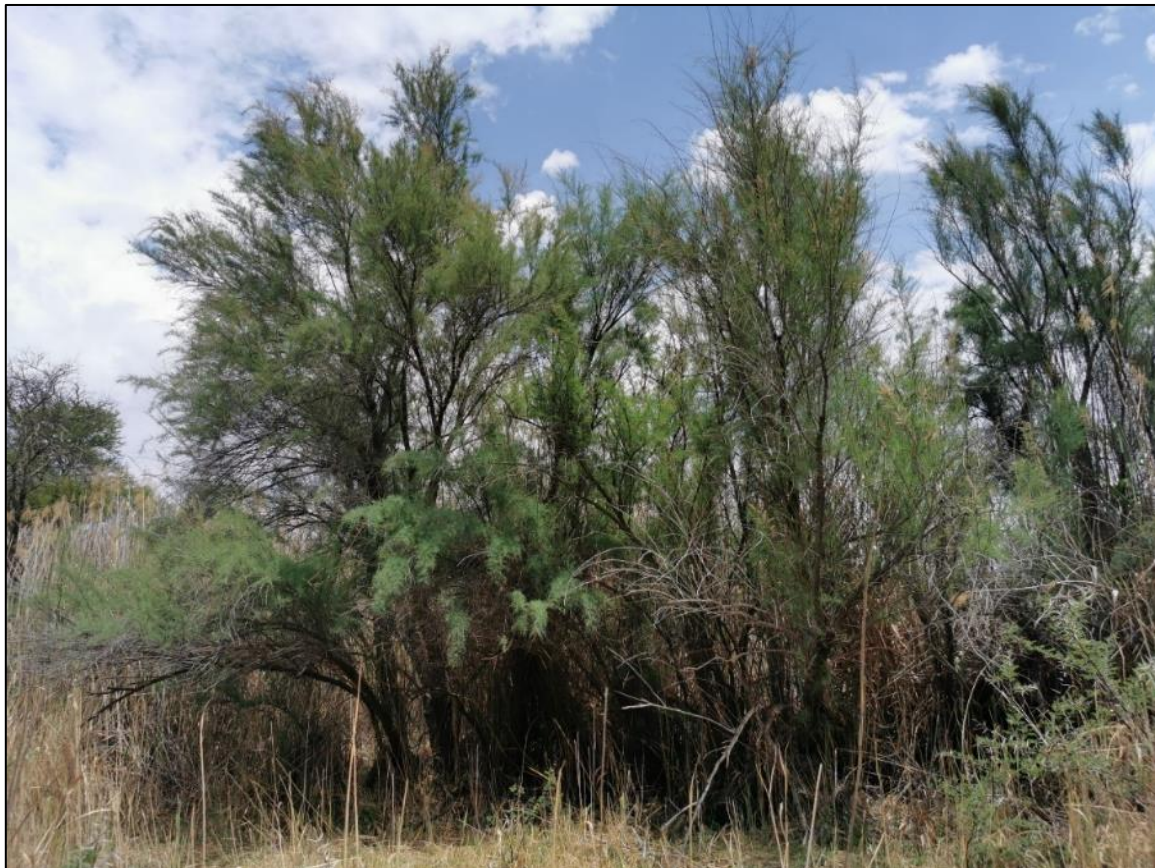
Similar aspects covered in the instream habitat assessment indicated above, the observation of woody invasive species (*Tamarix* sp.) were also observed in the bank-top vegetation which further contributed to the deteriorated ecological state (Figure 6-3). Additionally, anthropogenic activities within the riparian zone have contributed to a deteriorated ecological state, including residential areas and mining activities (Figure 6-4).

Figure 6-3 Illustration of *Tamarix* sp. in the bank-top vegetation of the Doring River

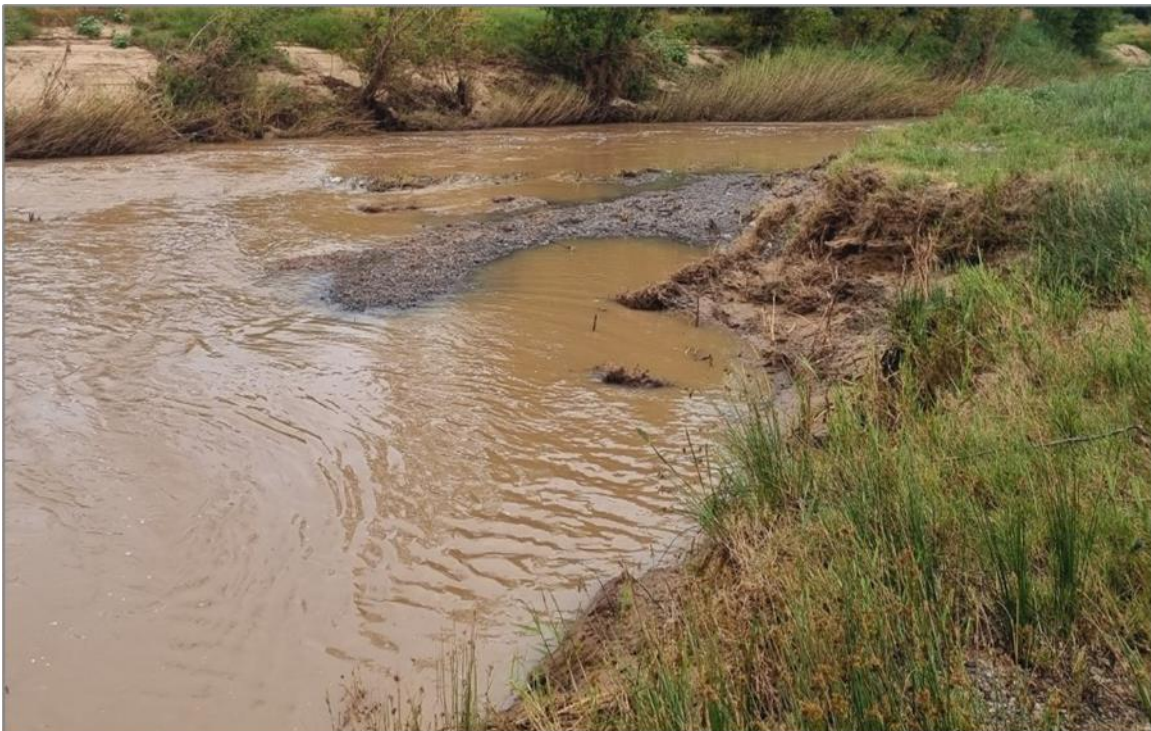
Figure 6-5 Habitat sampled at site S2 on the Sand River (March 2022)

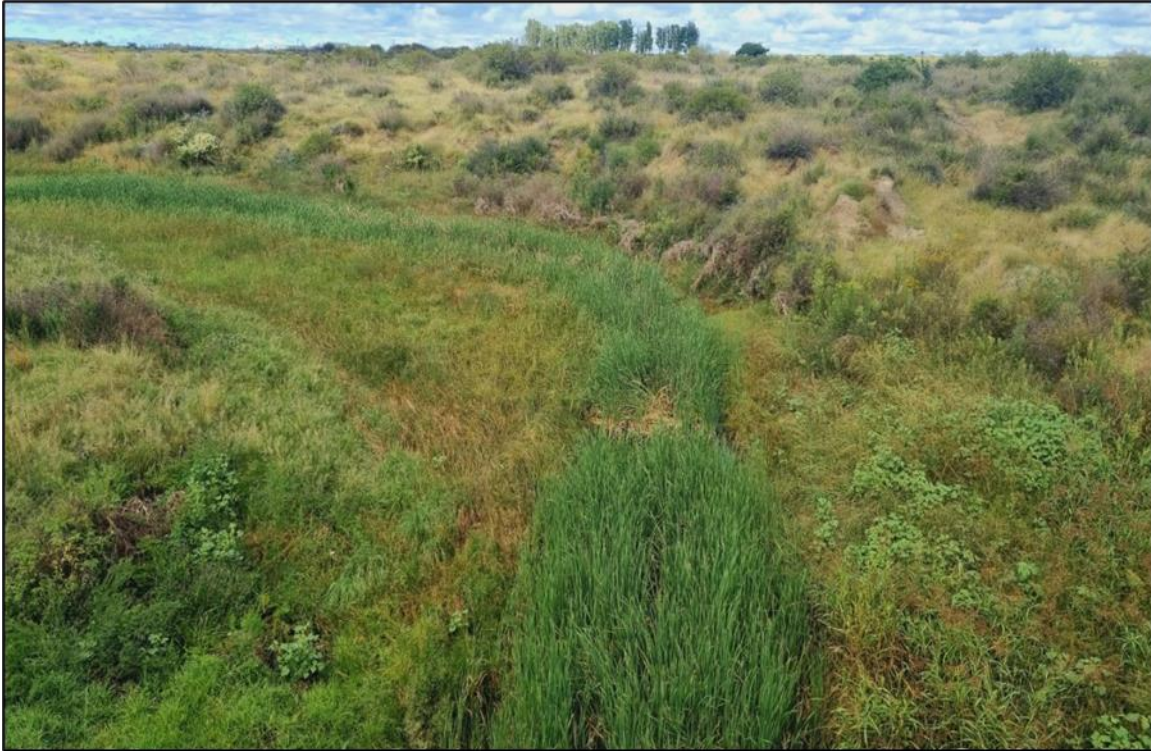
All sites bar B3 are considered to have habitat types capable of supporting a moderate diversity of macroinvertebrates and is therefore considered a hindrance on a highly diverse assemblage.

Figure 6-6 *Illustration of the reach type within the Boschluispruit (B3, March 2022)*

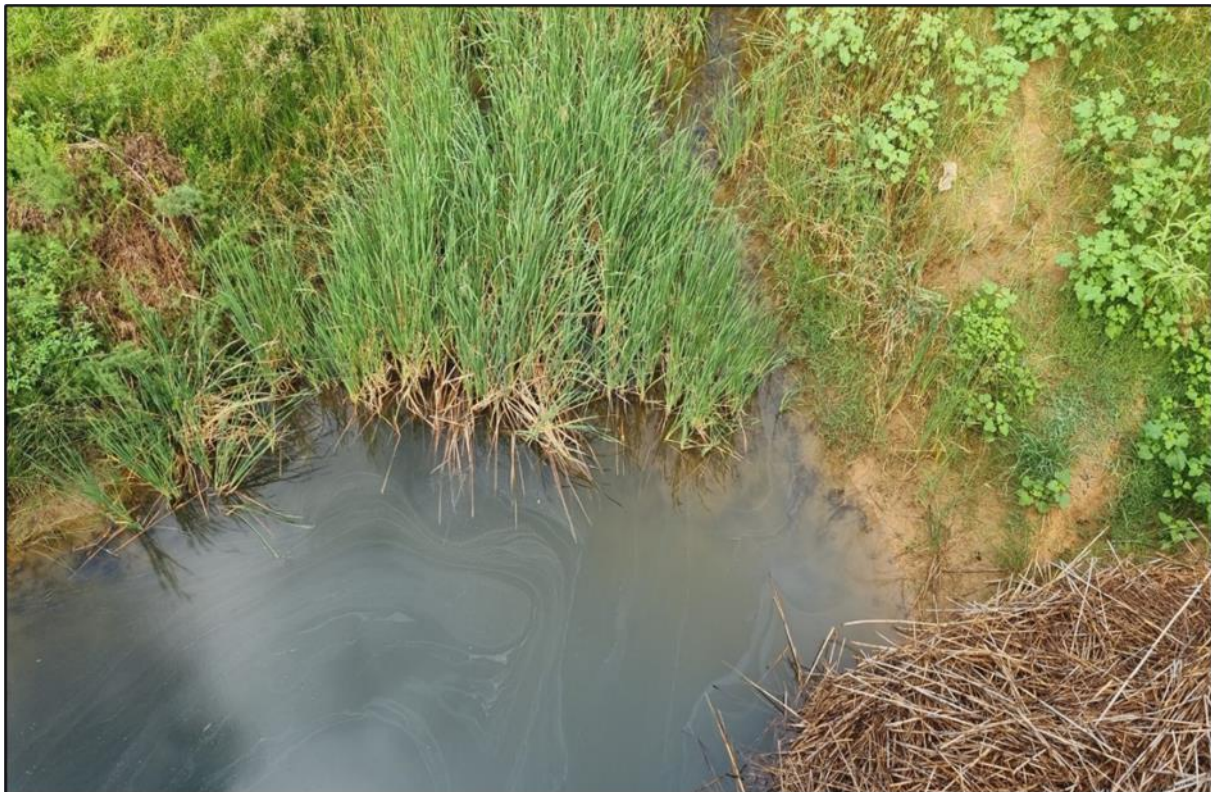
Figure 6-7 *Typical marginal vegetation within the Boschluispruit (B3, March 2022)*

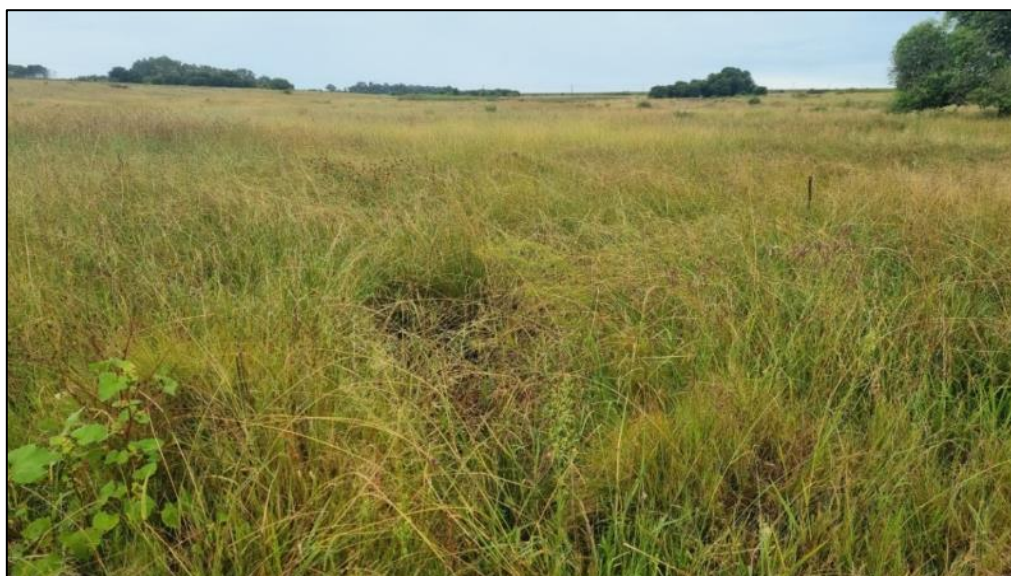
As noted in the geomorphological description of the project area, the watercourses considered in this assessment represented characteristic source zone waterbodies with wetlands. As can be observed in Figure 6-9, riparian vegetation was limited to features characteristic of wetlands. Given the wetland nature of the riparian vegetation, and relationships between wetland integrity within catchments and stable riverine conditions, the delineated wetlands as identified in TBC (2022) were used to derive the sensitive habitats. Riparian zones within the lower foothills of the Doring and Sand River were well defined and comprised of woody species Figure 6-10.

Figure 6-9 Typical headwater zone in the upper reaches of the Boschluispruit

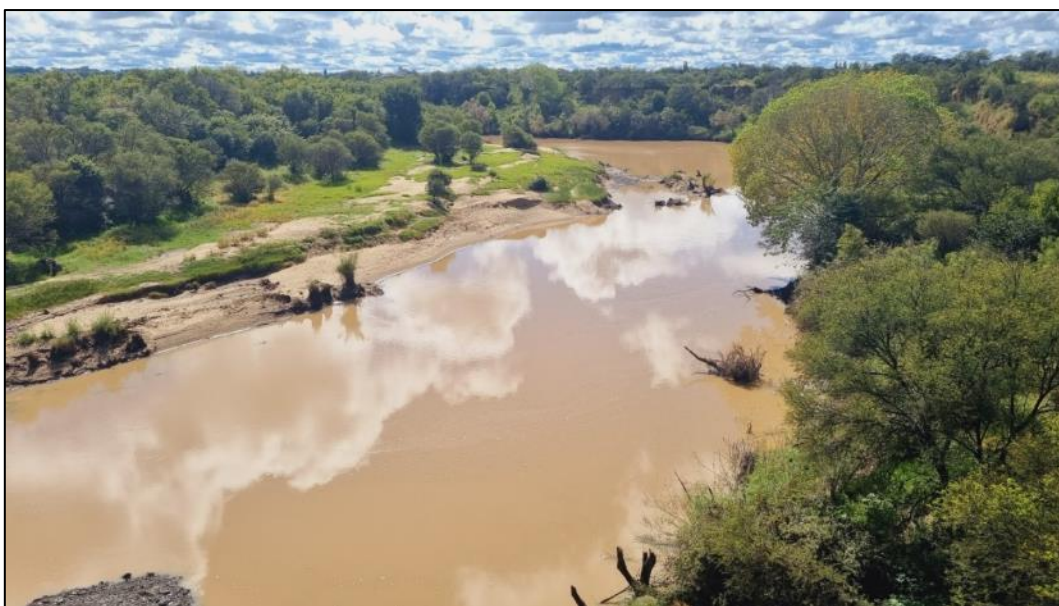
Figure 6-10 Typical lower foothills zone and well defined riparian zone within the Sand River
