Aquatic Baseline & Risk Assessment for the proposed Tetra4 Cluster 2 Project

Virginia, Free State Province

April 2022

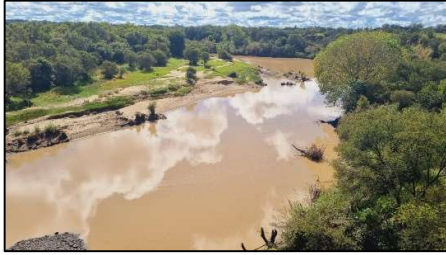
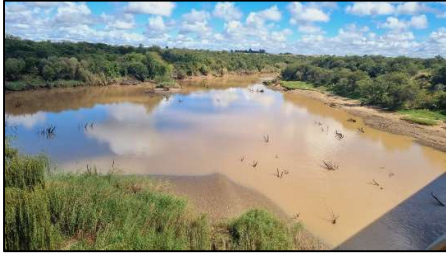
Comments	Upstream Sand River site. Substrate dominated by sand and scattered stones of current. Debris within the channel provides cover features for aquatic biota. Flooding conditions during sampling.	
GPS-coordinates	28° 5'55.27"S 26° 50'2.40"E	
S2

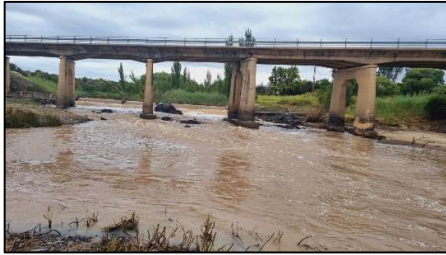
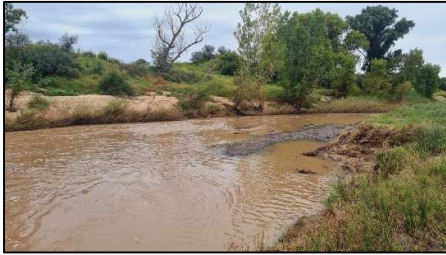
Comments	Midstream Sand River site. Flooding conditions during sampling. Substrate dominated by sand and portions of bedrock.	
GPS-coordinates	28° 7'4.26"S 26° 43'9.48"E	
S3

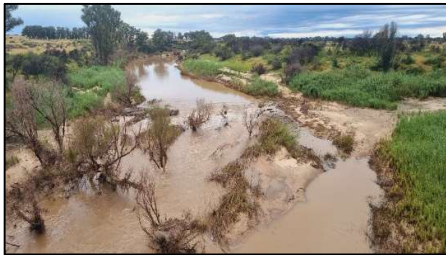
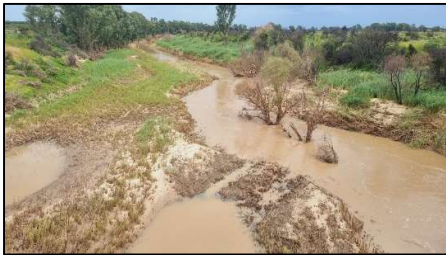
Comments	Downstream Sand River site. Flooding conditions during sampling. Instream habitat limited, predominantly sand substrate.	
GPS-coordinates	28° 7'21.92"S 26° 35'7.29"E

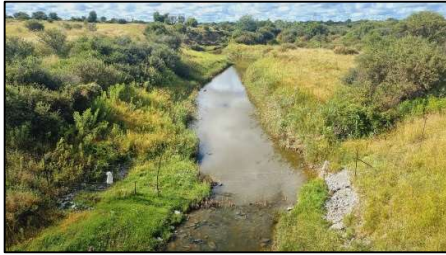
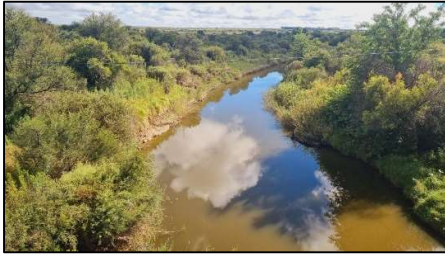
Comments	Upstream Doring River site. Limited instream habitat diversity and hydraulic biotopes.	
GPS-coordinates	28° 11'17.45"S 26° 47'53.81"E	
D2

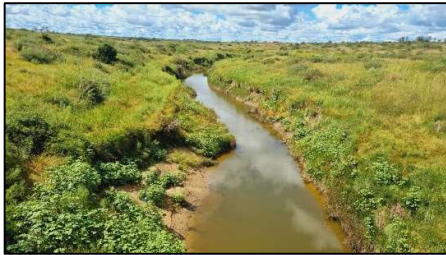
Comments	Downstream Doring River site. Limited instream habitat diversity and hydraulic biotopes.	
GPS-coordinates	28° 7'36.76"S 26° 43'57.13"E	
Palmietkuilspruit		
P1

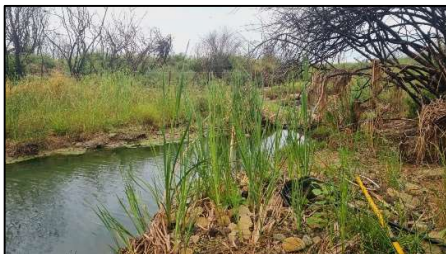
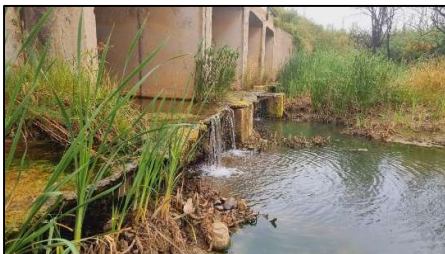
Comments	Reference site on the Palmietkuilspruit. Diverse habitat including stones and marginal vegetation.	
GPS-coordinates	28° 10'30.53"S 26° 36'57.33"E

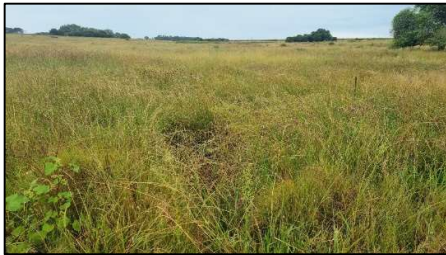
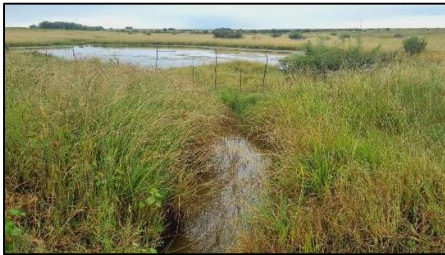
Comments	Upstream site on Boschluispruit, characteristic of wetland system.	
GPS-coordinates	28°15'12.51"S 26°42'31.37"E	
B3

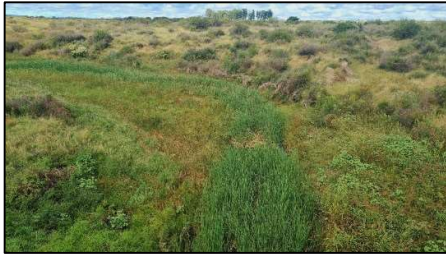
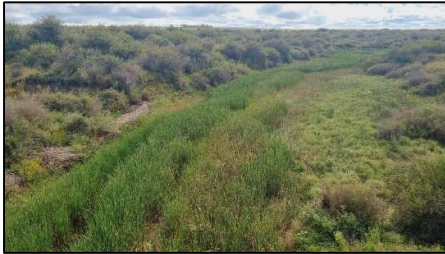
Comments	Wetland system in downstream reaches of Boschluispruit	
GPS-coordinates	28° 9'20.92"S 26°44'39.94"E	
Ephemeral Tributaries		
K1

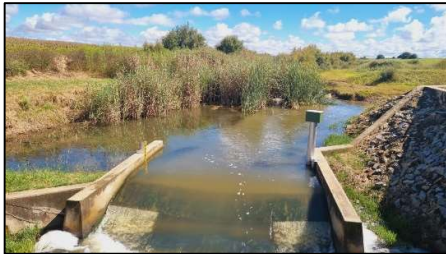
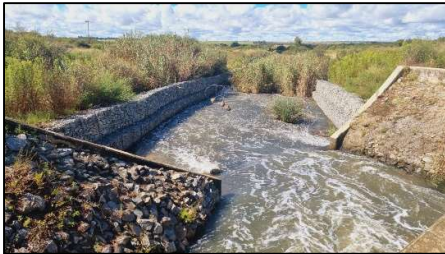
Comments	Site downstream of mining activities, outside of project area. Flows into the Sand River upstream of project area.	
GPS-coordinates	28° 5'36.28"S 26°48'20.94"E

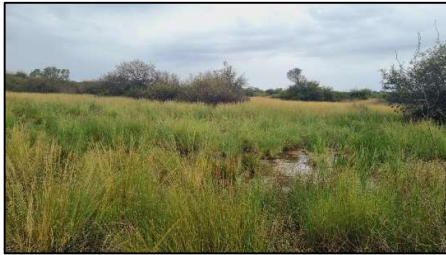
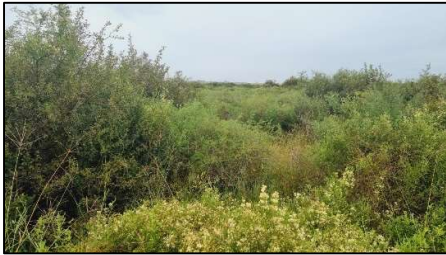
Comments	Ephemeral tributary. Site limited to a standing pool.	
GPS-coordinates	28° 9'35.66"S 26° 40'29.93"E	
T1

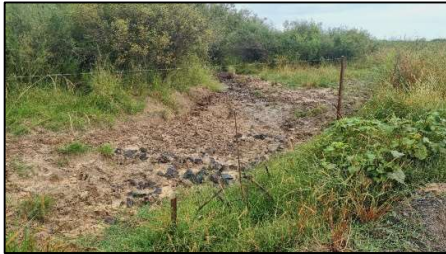
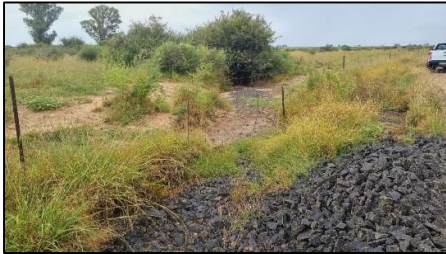
Comments	Ephemeral tributary with limited surface water	
GPS-coordinates	28° 9'6.98"S 26° 40'11.16"E

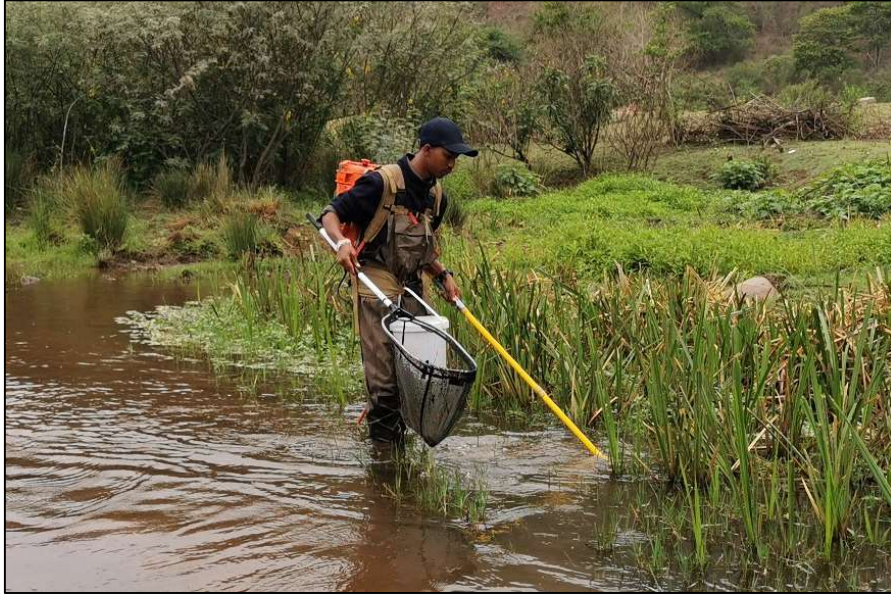
Figure 4-3 Example of methodology used to catch fish species (KZN, 2019).

Fish were sampled through electroshocking (Figure 4-3). All fish were identified in the field and released at the point of capture, in order not to cross fish populations. Fish species were identified using the guide *Freshwater Fishes of Southern Africa* (Skelton, 2001). The identified fish species were compared to those expected to be present for the quaternary catchment. The expected fish species list for the project area was developed from a literature survey to compare to the sampled species at site. Different fish species represent different sensitivities to water chemistry, habitat and flow which considered as part of the Fish Response Assessment Index (FRAI) (Kleynhans *et al.*, 2007 and Skelton 2001).

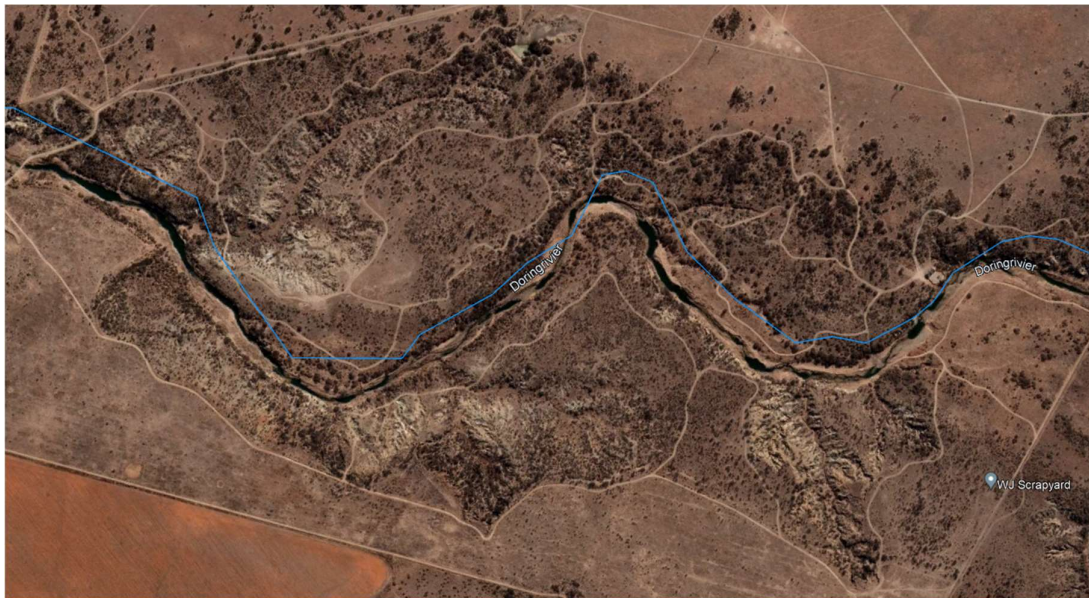
Figure 6-1 Erosion within the Doring River catchment (Google Earth, 2021)

Instream habitat modifications within the catchment was noted at all sites, and particularly increased sediment deposits within the Doring and Sand Rivers. The source of the increased sediment yield can be attributed to the erosion of channel edges within the Doring and Sand River catchments, compounded by dryland agricultural activities (Figure 6-1 and Figure 6-2). The soils observed within the river banks was noted to be composed of highly erodible soils which is further contributing towards the erosion and sedimentation in the watercourses. The erosion of bed and banks results in channelisation and reduced lateral movement of water into the riparian zone. The reduced lateral flow of water and physical disturbance of the riparian zone due to erosion has compromised the riparian zone integrity within the catchment.

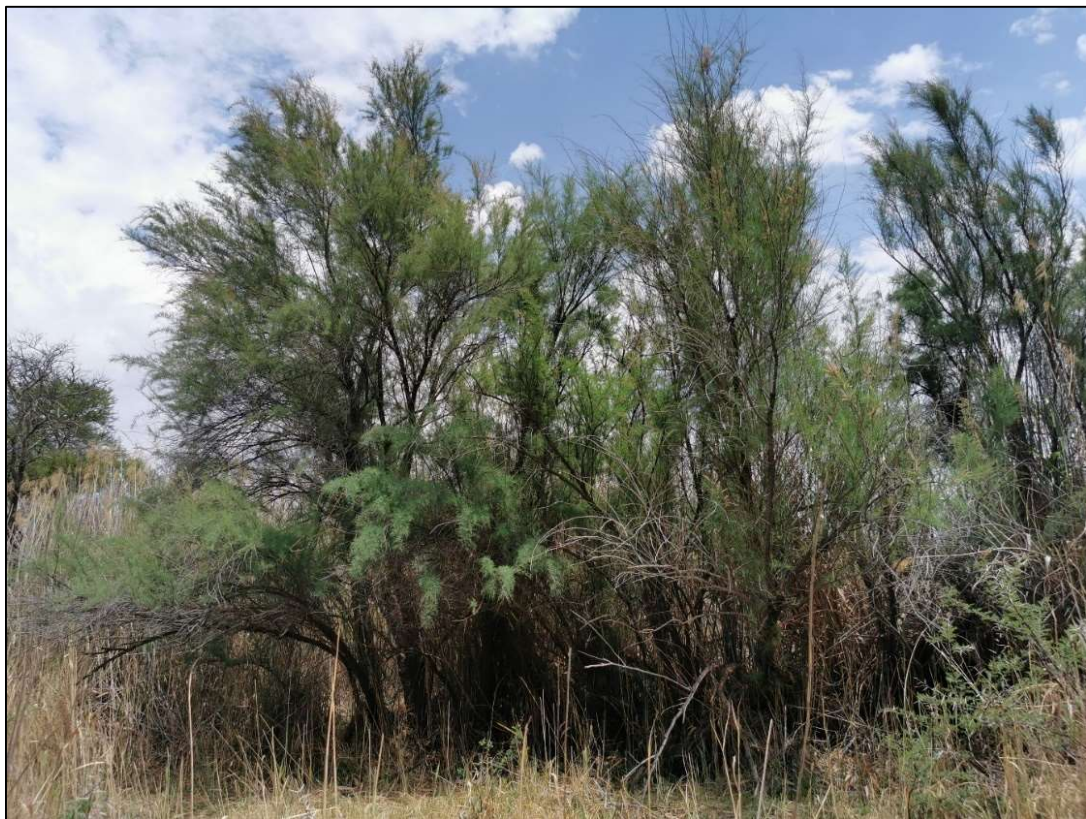
Figure 6-3 Illustration of *Tamarix* sp. in the bank-top vegetation of the Doring River

Similar aspects covered in the instream habitat assessment indicated above, the observation of woody invasive species (*Tamarix* sp.) were also observed in the bank-top vegetation which further contributed to the deteriorated ecological state (Figure 6-3). Additionally, anthropogenic activities within the riparian zone have contributed to a deteriorated ecological state, including residential areas and mining activities (Figure 6-4).

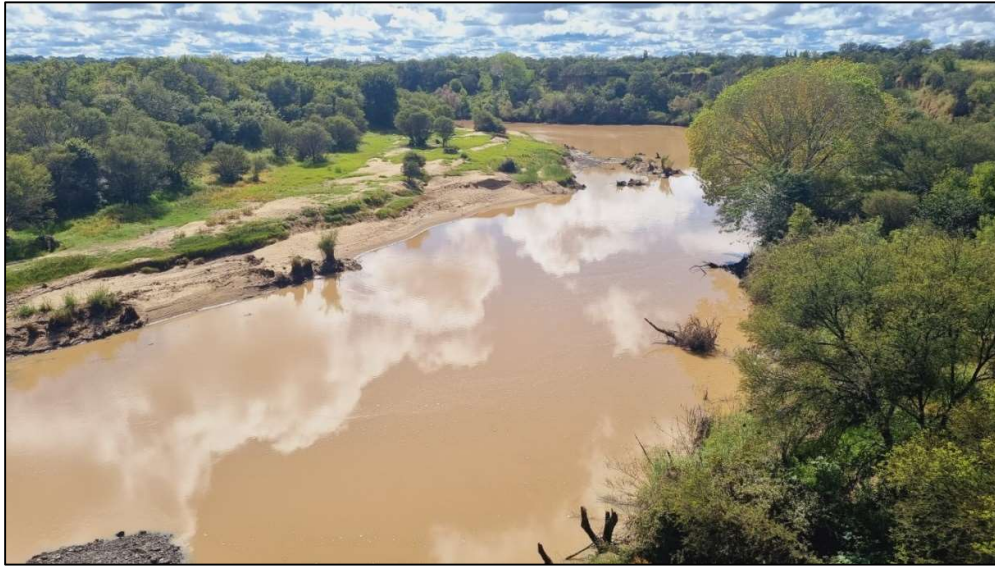
Figure 6-10 Typical lower foothills zone and well defined riparian zone within the Sand River

As noted in the geomorphological description of the project area, the watercourses considered in this assessment represented characteristic source zone waterbodies with wetlands. As can be observed in Figure 6-9, riparian vegetation was limited to features characteristic of wetlands. Given the wetland nature of the riparian vegetation, and relationships between wetland integrity within catchments and stable riverine conditions, the delineated wetlands as identified in TBC (2022) were used to derive the sensitive habitats. Riparian zones within the lower foothills of the Doring and Sand River were well defined and comprised of woody species Figure 6-10.
