# PORTION 260 OF THE FARM RIETFONTEIN 189-IQ, MULDRSDRIFT

## NEAR-SURFACE GEOTECHNICAL INVESTIGATION REPORT

Geotechnical Investigation and Report

Report Reference Number: 1911547/01

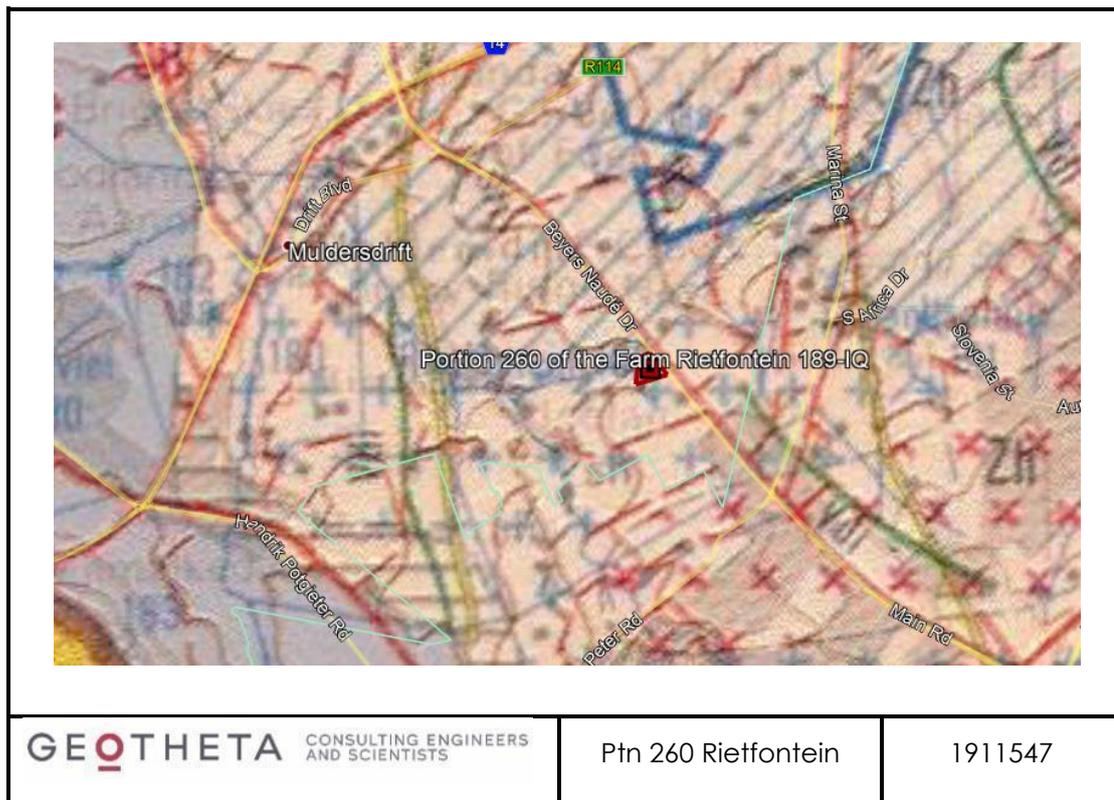
**Figure 2: Regional Geology**

- 10.1 Figure 2 indicates the regional geology of the area.
- 10.2 According to the 1:250 000 West Rand 2626 geological map, the site is underlain by grey, medium grained porphyritic granodiorite of the Swazian Era.
- 10.3 The residual materials of this rock formation are usually highly collapsible.
- 10.4 During the near-surface investigation, the typical soil strata encountered on site comprised a layer of topsoil underlain by loose to dense transported material overlying loose to dense residual material. Hardpan ferricrete was also encountered in test pit TP6.

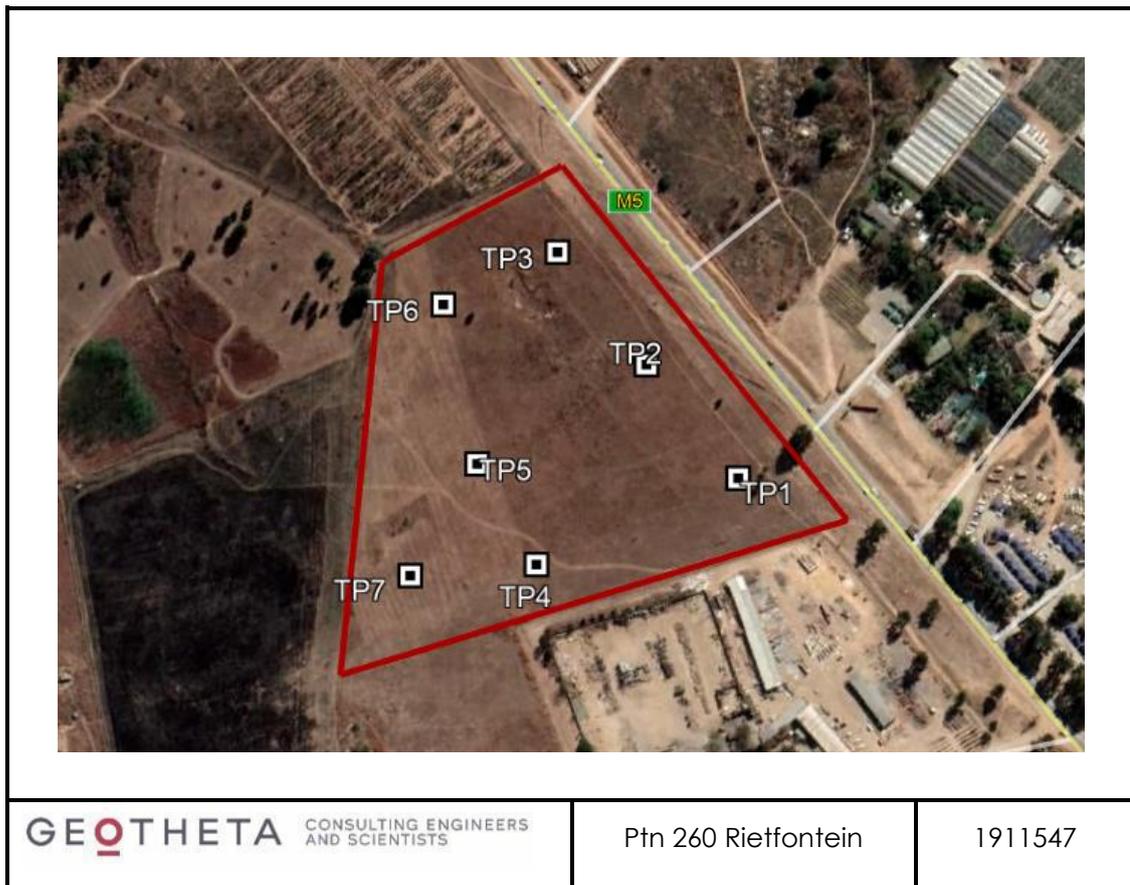
**Figure 3: Test Pit Positions**

- 12.2.1 No formal grid spacing was used in setting out the test pit positions. Positions were selected to adequately cover the site and to determine any variations in the site geology.
- 12.2.2 Seven test pits were excavated. The test pit positions are indicated in Figure 3.
- 12.2.3 The test pits were excavated with a JCB Tractor Loader Backhoe (TLB) and soil profiles were logged according to the standard method of Jennings, Brink and Williams (1973).
- 12.2.4 Test pit profiles and photographs are included in Appendix A and Appendix B respectively.

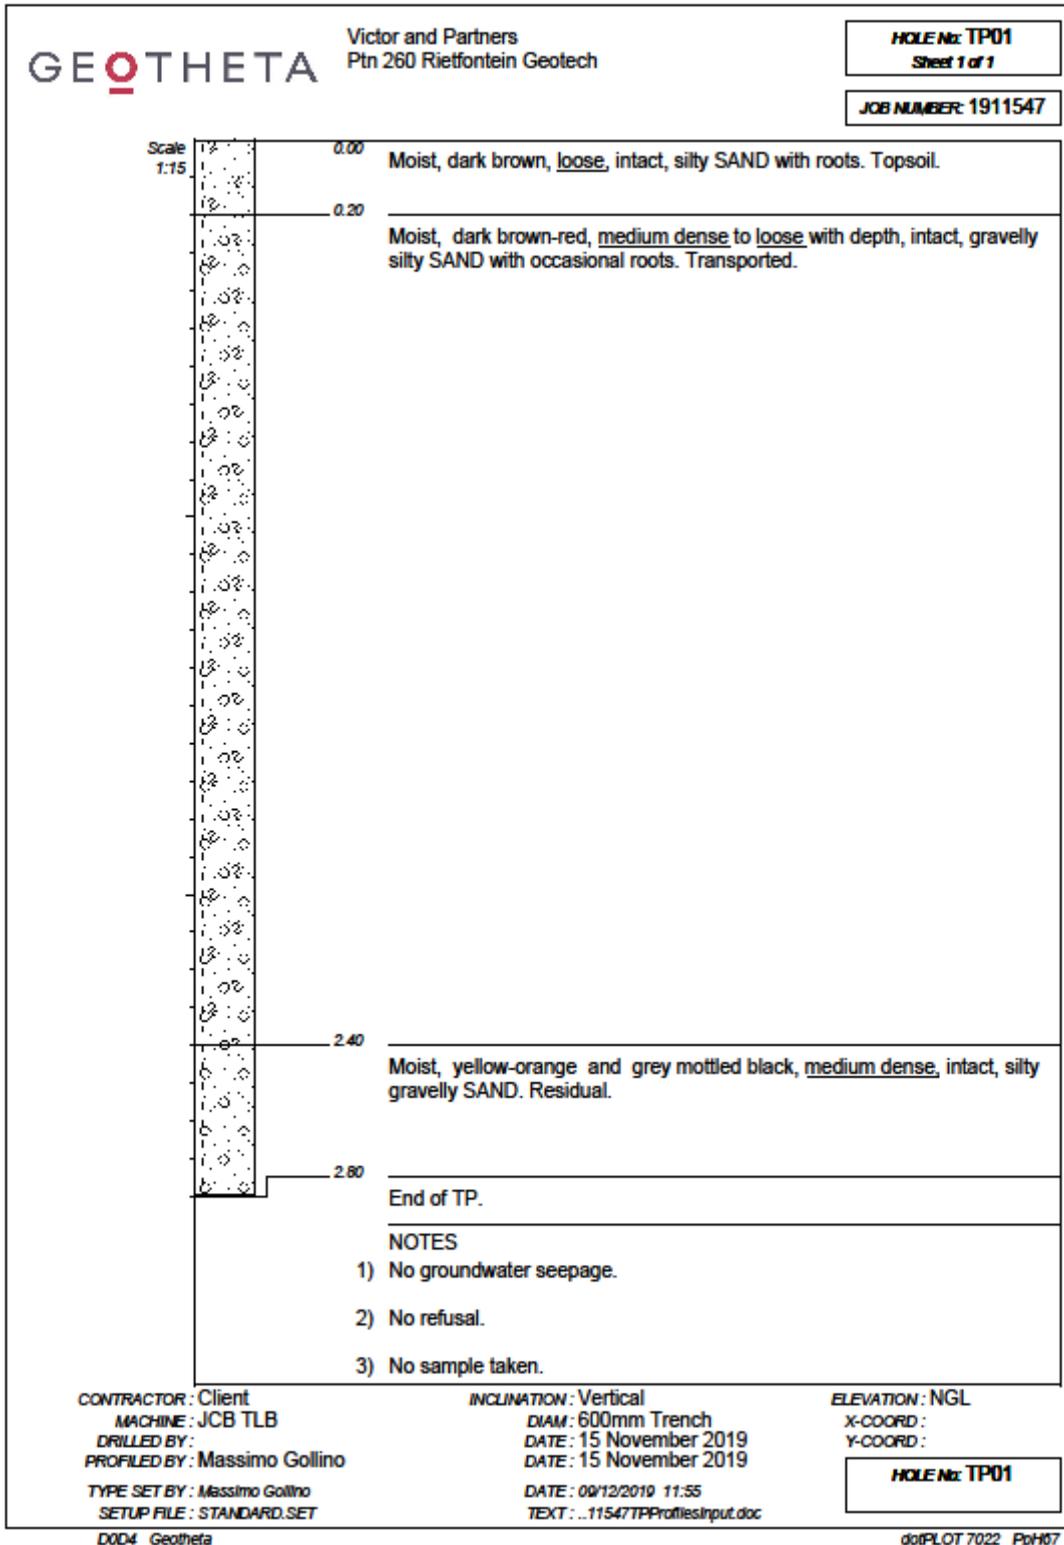
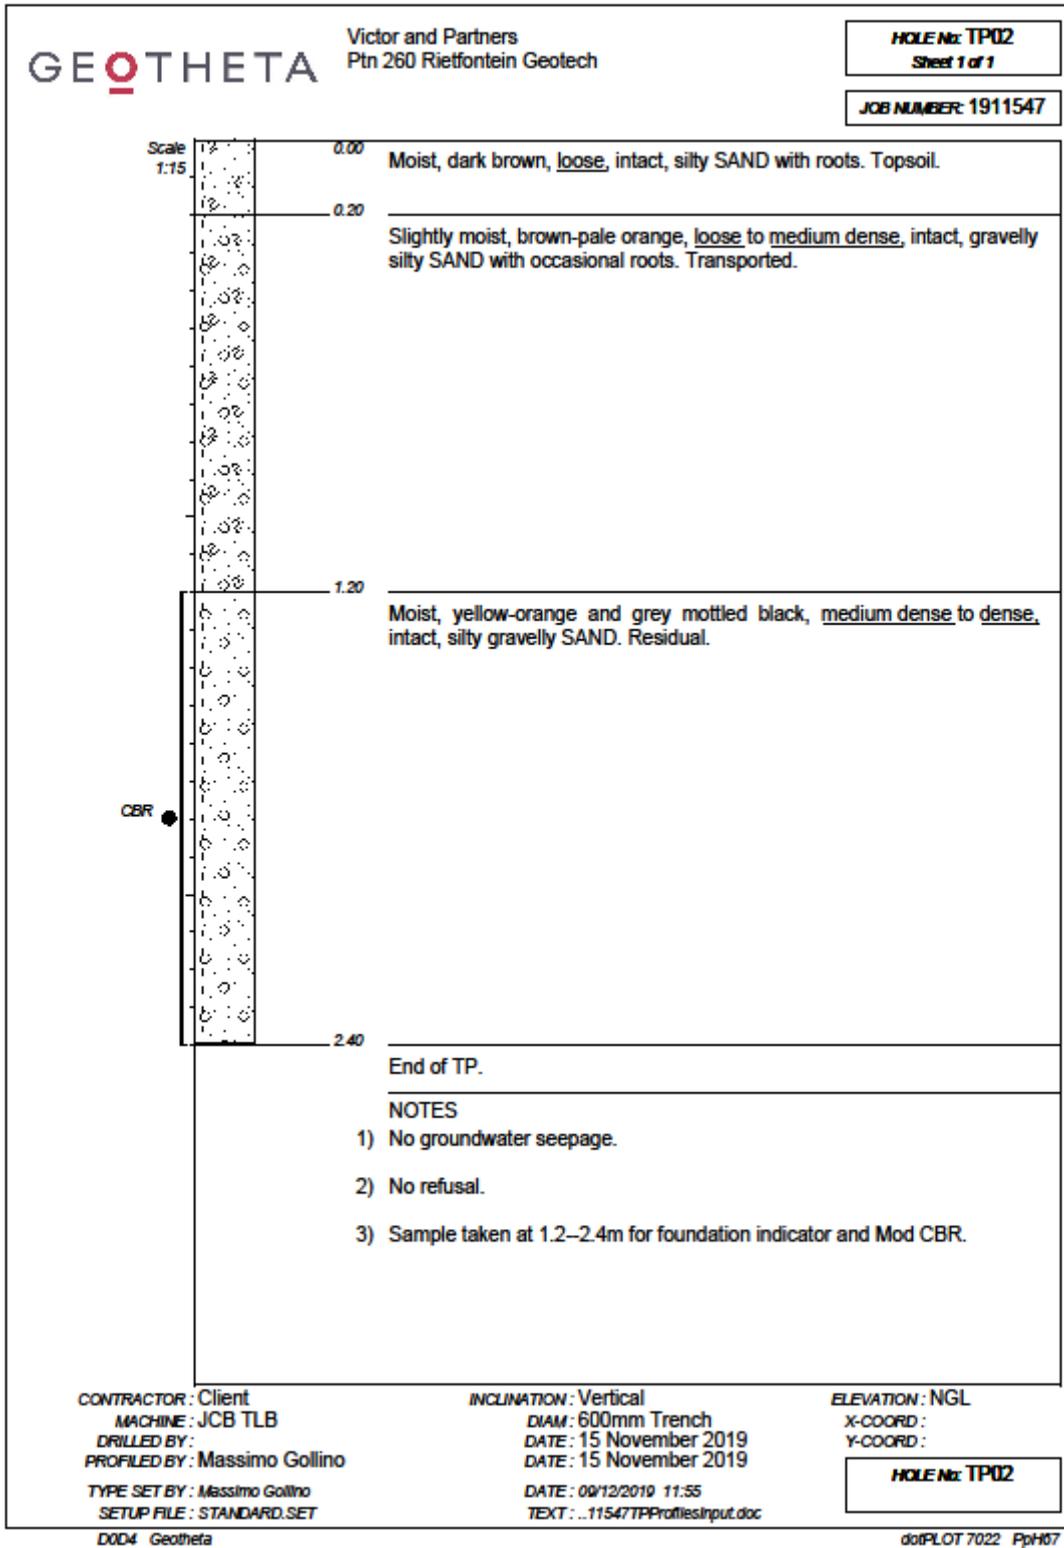
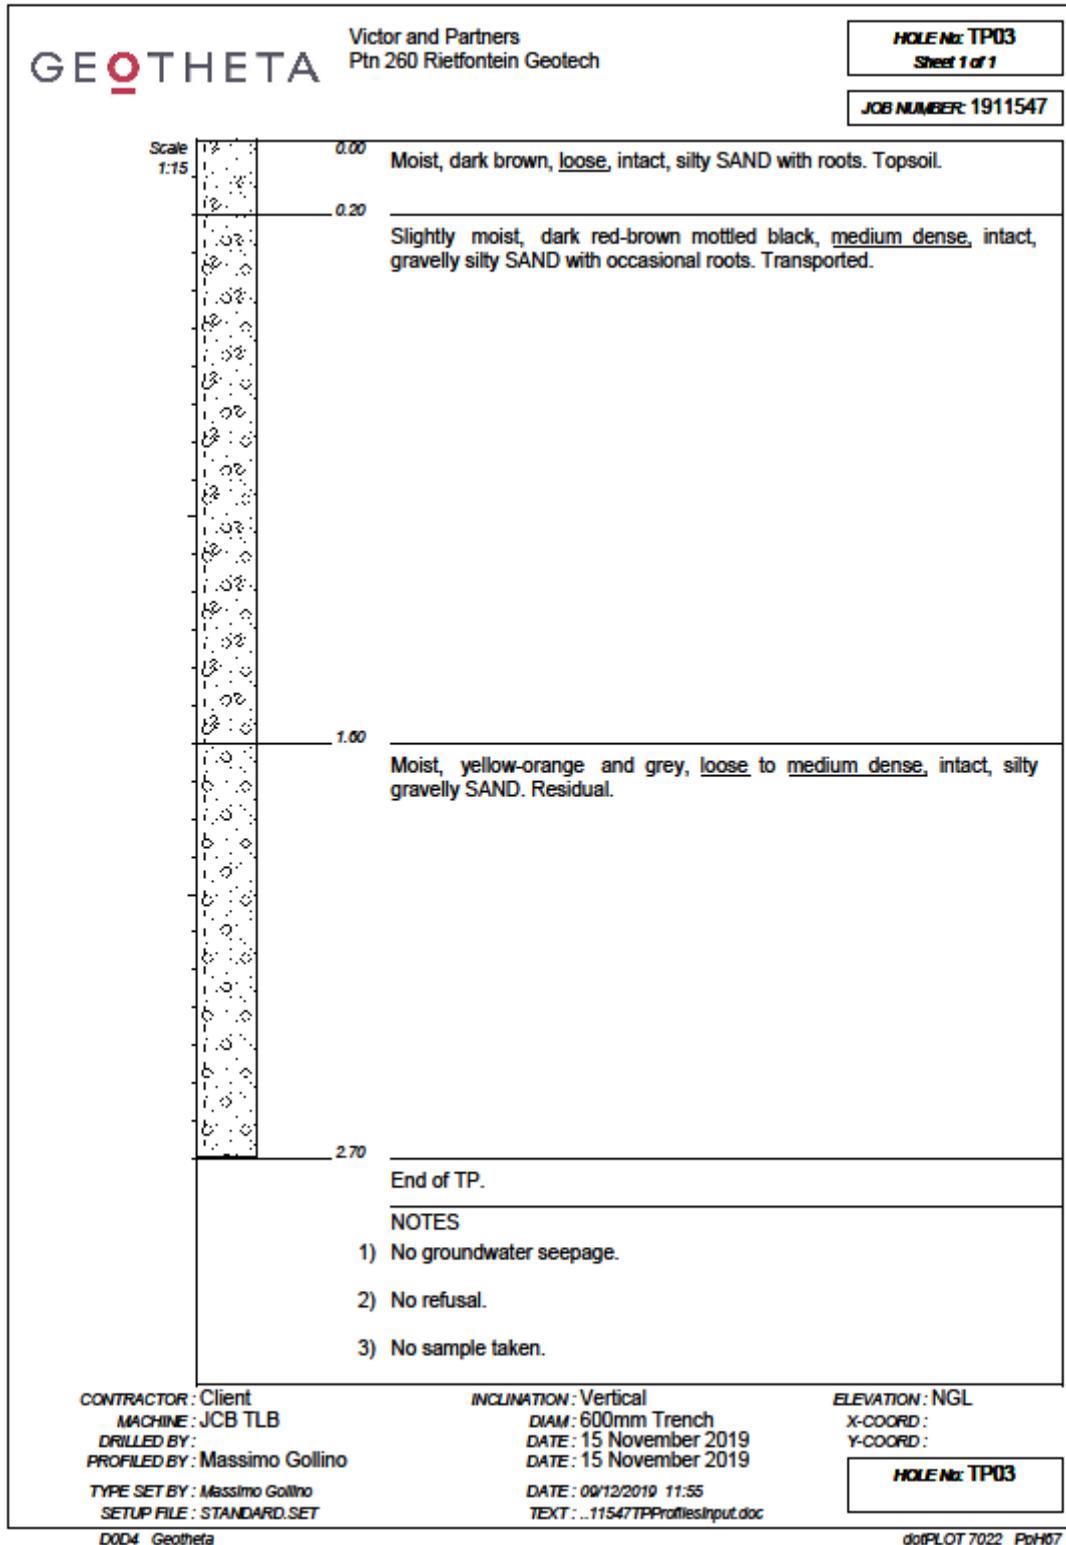
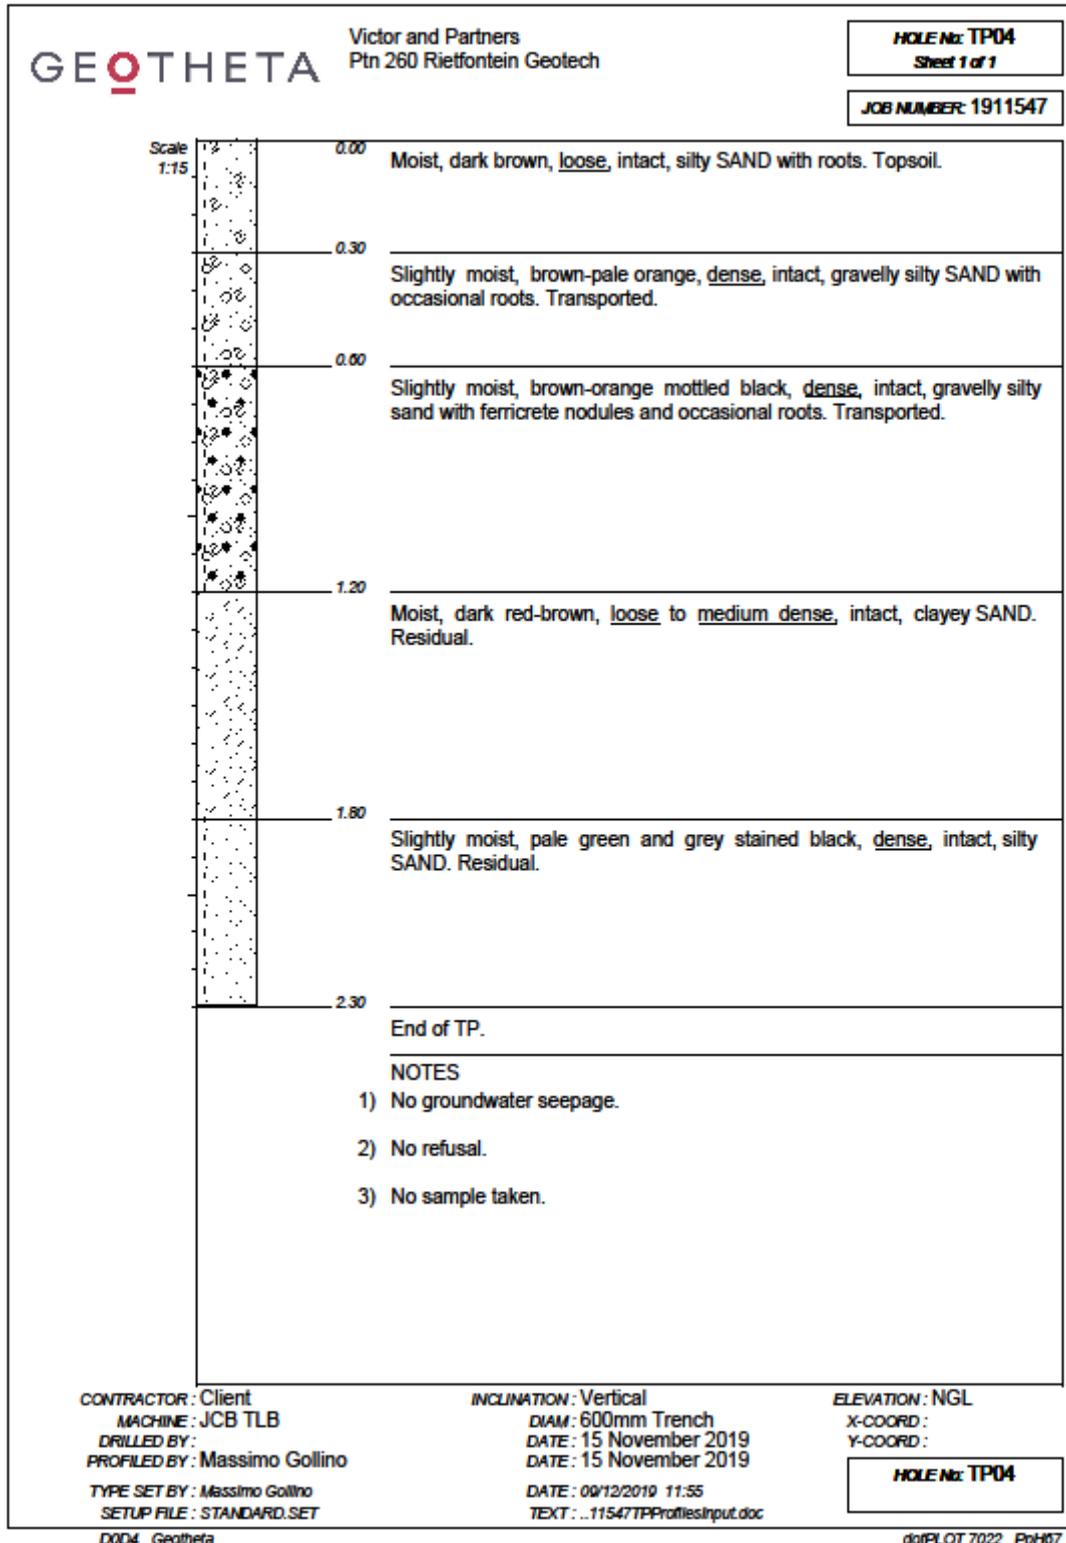
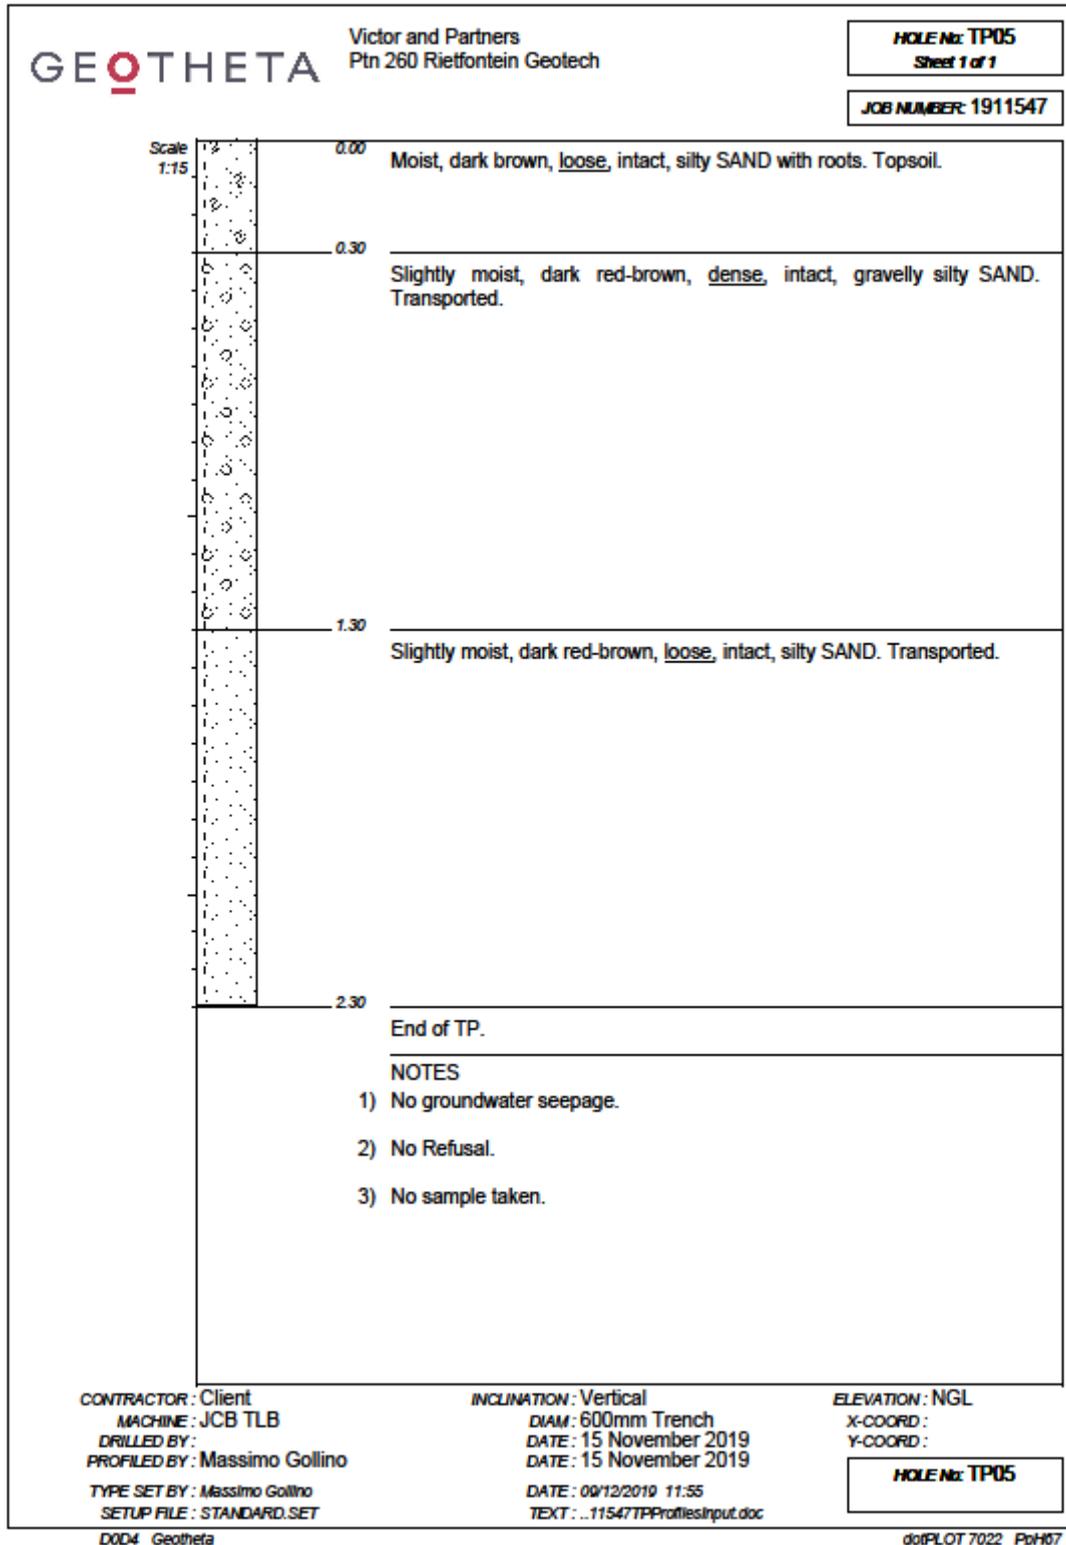
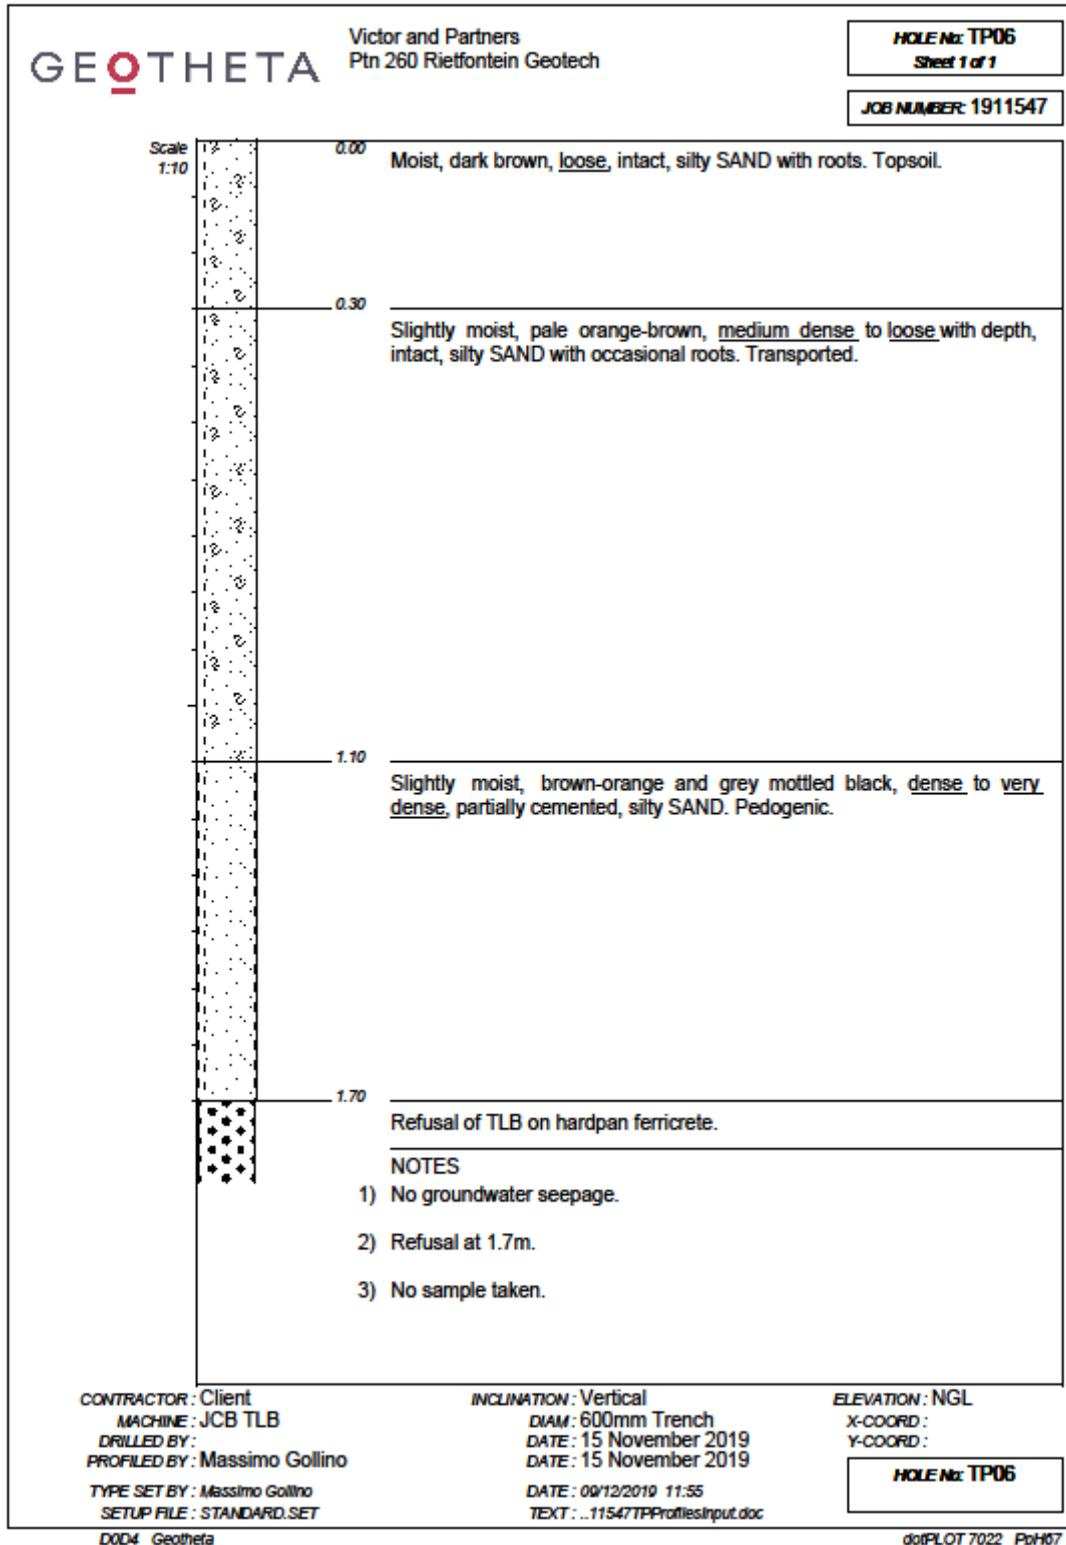
## **Appendix A: Test Pit Profiles**

Test Pit No	Topsoil	Transported Material	Residual Material	Test pit depth (m)
TP1	0 – 0.2	0.2 – 2.4	2.4 – 2.8	2.8 – Max reach
TP2	0 – 0.2	0.2 – 1.2	1.2 – 2.4	2.4 – Max reach
TP3	0 – 0.2	0.2 – 1.6	1.6 – 2.7	2.7 – Max reach
TP4	0 – 0.3	0.3 – 1.2	1.2 – 2.3	2.3 – Max reach
TP5	0 – 0.3	0.3 – 2.3		2.3 – Max reach
TP6	0 – 0.3	0.3 – 1.7		1.7 – Refusal
TP7	0 – 0.5	0.5 – 1.5	1.5 – 2.3	2.3 – Max reach

13.1.3 All test pits, with the exception of test pit TP6, were excavated until the maximum reach of the TLB at depths ranging from 2.3m to 2.8m below natural ground level. Test pit TP6 was excavated until refusal of the TLB on hardpan ferricrete at a depth of 1.7m below natural ground level.

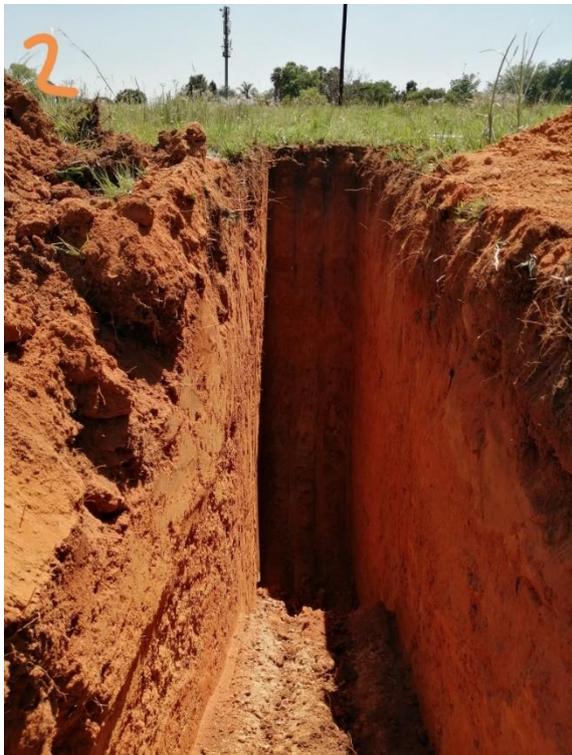
**TP 2**

- The residual material from test pit TP2 classified as a clayey sand (SC). The Plasticity Index is 13, the Liquid Limit 29 and the Linear Shrinkage 6.0. The value of the Grading Modulus is 1.91.
- The residual material plotted as LOW activity on the van der Merwe Activity Diagram.
- With a CBR value of 42 compacted to 95% MOD AASHTO, the material classifies as a G6 according to TRH14 specifications. The material tested is therefore suitable for structural fill.

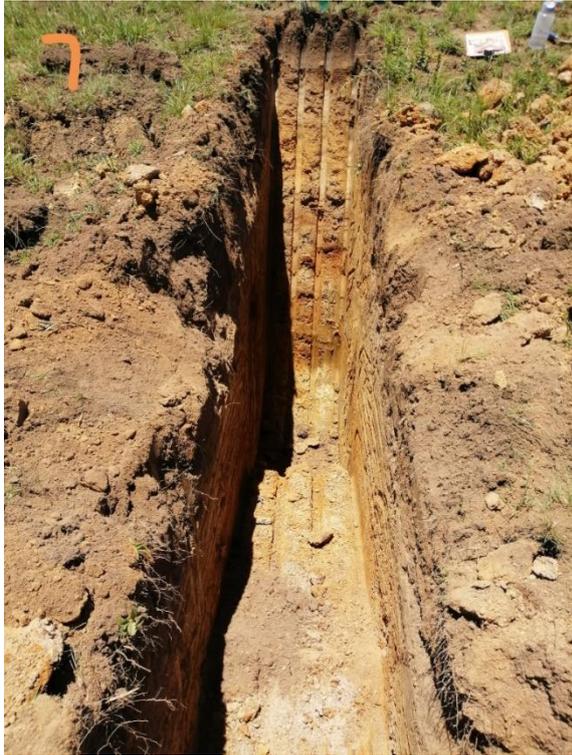
**TP7**

- The residual material from test pit TP7 classified as a clayey sand (SC). The Plasticity Index is 19, the Liquid Limit 40 and the Linear Shrinkage 8.0. The value of the Grading Modulus is 1.46.
- The residual material plotted as LOW activity on the van der Merwe Activity Diagram.

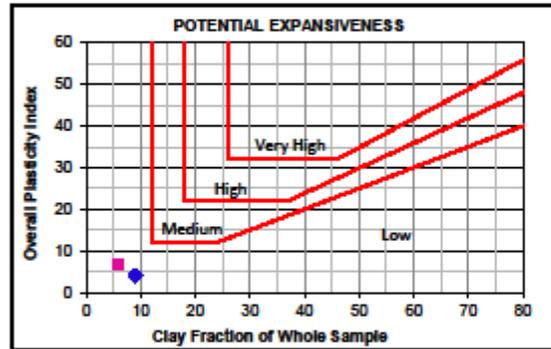
**FOUNDATION INDICATOR**

Percentage Passing	100 mm	100	100
	75 mm	100	100
	63 mm	100	100
	50 mm	100	100
	37.5 mm	100	100
	28 mm	100	100
	20 mm	100	100
	14 mm	100	100
	5 mm	82	98
	2 mm	59	85
	1 mm	40	65
	0.425 mm	28	37
	0.250 mm	28	37
	0.150 mm	24	35
0.075 mm	22	32	
Grading Modulus	1.91	1.46

Percentage Passing	0.080 mm	19	28
	0.040 mm	15	21
	0.020 mm	13	16
	0.008 mm	10	9
	0.002 mm	9	6
Gravel	%	41	15
Sand	%	40	59
Silt	%	10	20
Clay	%	9	6

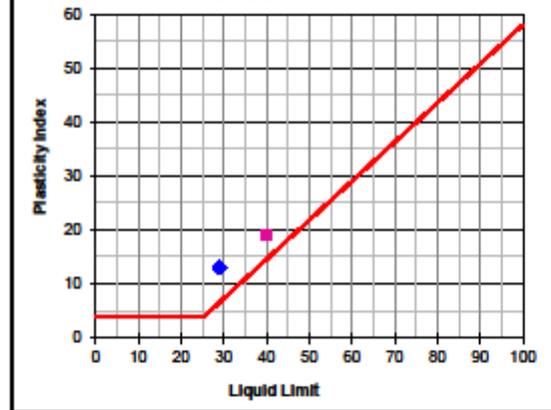
USC PLASTICITY CHART

Liquid Limit	%	29	40
Plasticity Index	%	13	19
Linear Shrinkage	%	6.0	8.0
Overall PI	%	4	7

HRB (AASHTO)	A-2-6(0)	A-2-6(2)
Unified (ASTM D2487)	SC	SC
Weston Swell @ 1 kPa

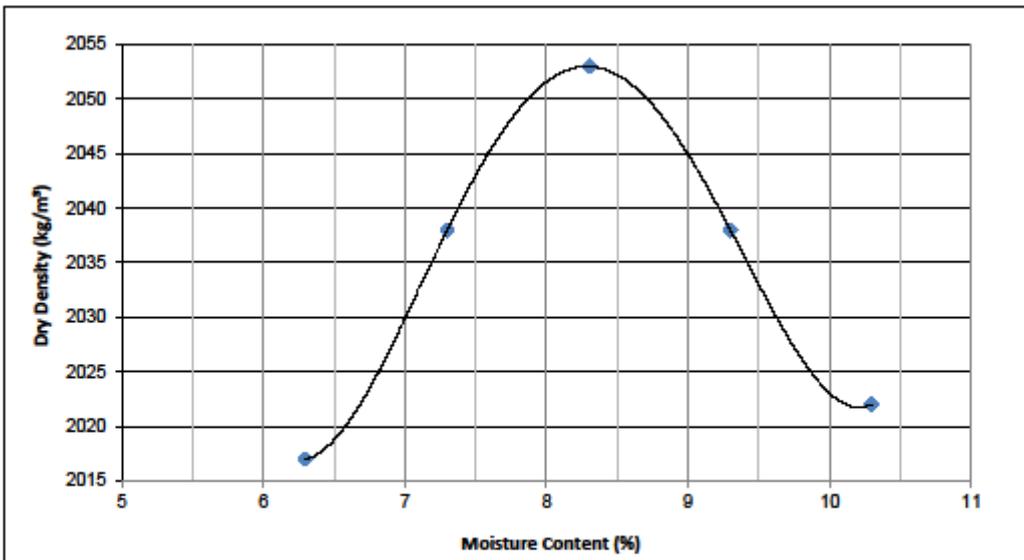
**MOISTURE DENSITY RELATIONSHIP**

Dry Density	kg/m <sup>3</sup>	2017	2038	2053	2038	2022	
Moisture Content	%	6.3	7.3	8.3	9.3	10.3

Max. Dry Density	kg/m <sup>3</sup>	2053
Optimum Moisture	%	8.3

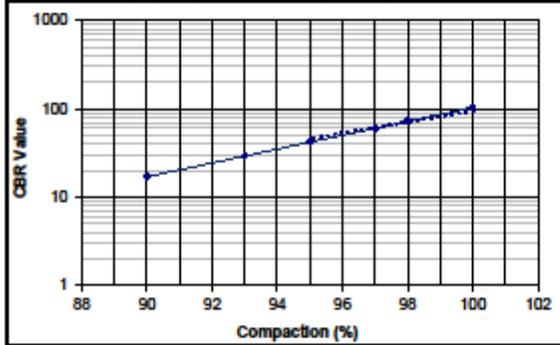
**CALIFORNIA BEARING RATIO (CBR) & ROAD INDICATOR REPORT**

Laboratory No.	1
Maximum Dry Density & Optimum Moisture Content	SANS 3001 GR30
MDD kg/m <sup>3</sup>	2053
OMC %	8.3
California Bearing Ratio	SANS 3001 GR40
Compaction Data	
Moisture %	8.3
Dry Density kg/m <sup>3</sup>	2083 1978 1874
Compaction %	100.0 95.0 90.0
Penetration Data	
CBR at	2.50 mm 94 46 17 5.00 mm 95 43 16 7.50 mm 88 39 15
Swell %	0.1 0.2 0.3
Final Moisture (%)	10.5 12.3 15.5

Interpolated CBR Data	
CBR	100% 104
	98% 73
	97% 61
	95% 42
	93% 29
	90% 17
	SANS3001 Midpoint 66

Classifications	
HRB (AASHTO)	A-2-6(0)
COLTO	G7
TRH14	G6
