APPENDIX A
LOCALITY MAP

BA: Proposed Constructure of a 17km 132kV from existing Mbumbu Traction to new Tsakani Substation

**PRELIMINARY ECOLOGICAL ASSESSMENT SURVEY
FOR THE PROPOSED
MBUMBU-TSAKANI 17KM 132KV POWER LINE AND
NEW TSAKANI SUBSTATION;
NORTHERN REGION,
ESKOM DISTRIBUTION DIVISION
BASIC ASSESSMENT REPORT**

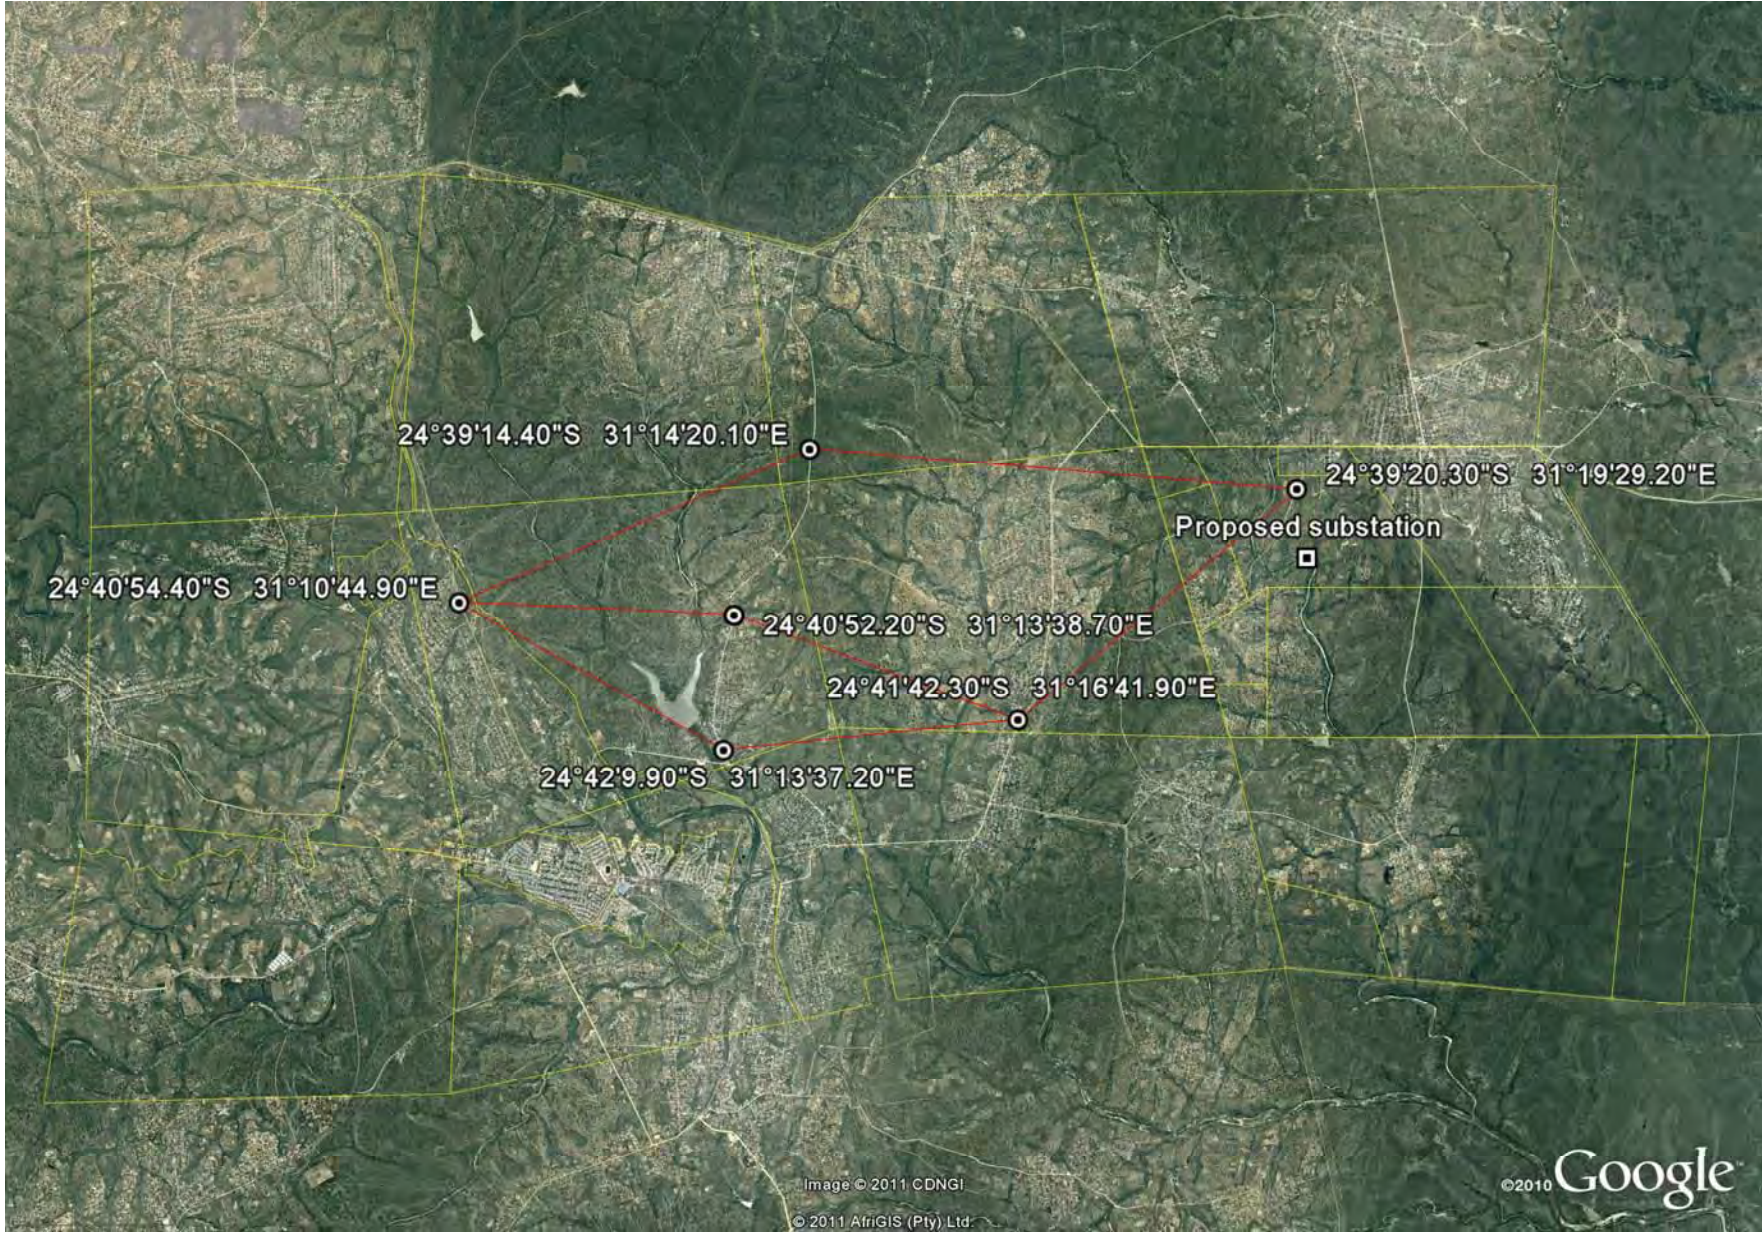
Figure 1: Google Earth image indicating the proposed site layout, as well as various GPS coordinates along the line options (Source: SSI).

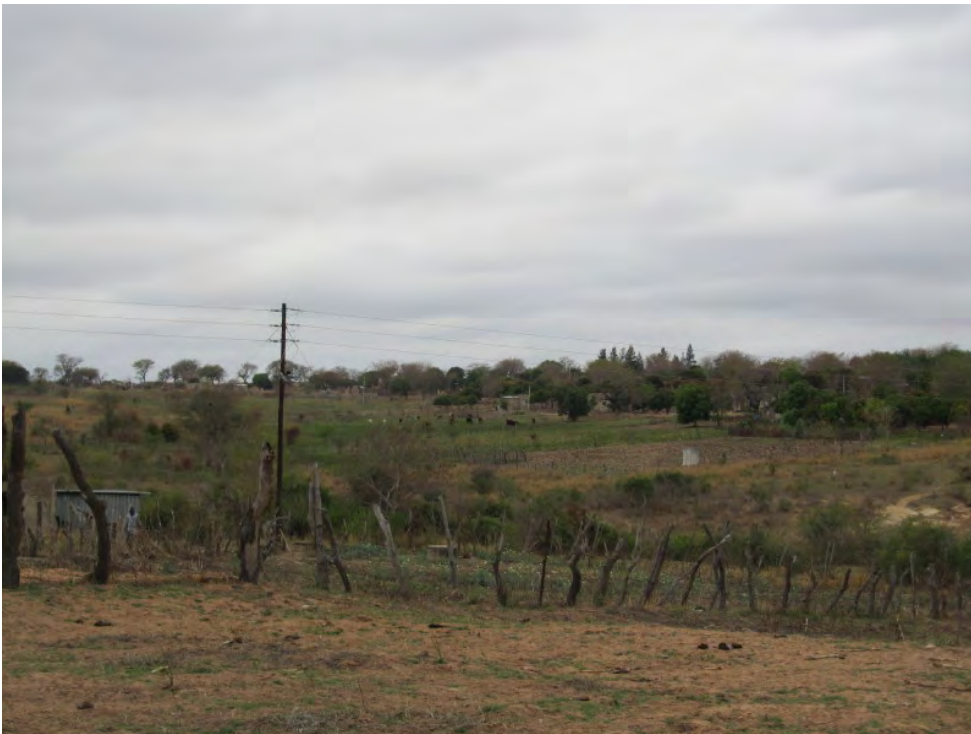
Figure 3: Some small scale arable lands and pastures in the study area.

However, there are no large areas of cultivated lands on site, but merely some small areas of rural subsistence agriculture. Some areas have been cleared of woody vegetation and pasture planted, for grazing by livestock. Relevant bird species that may be attracted to these areas include Secretarybird, Abdim's Stork and White Stork. More common species such as Francolins, Egrets, Herons and Ibises, will frequent these areas.

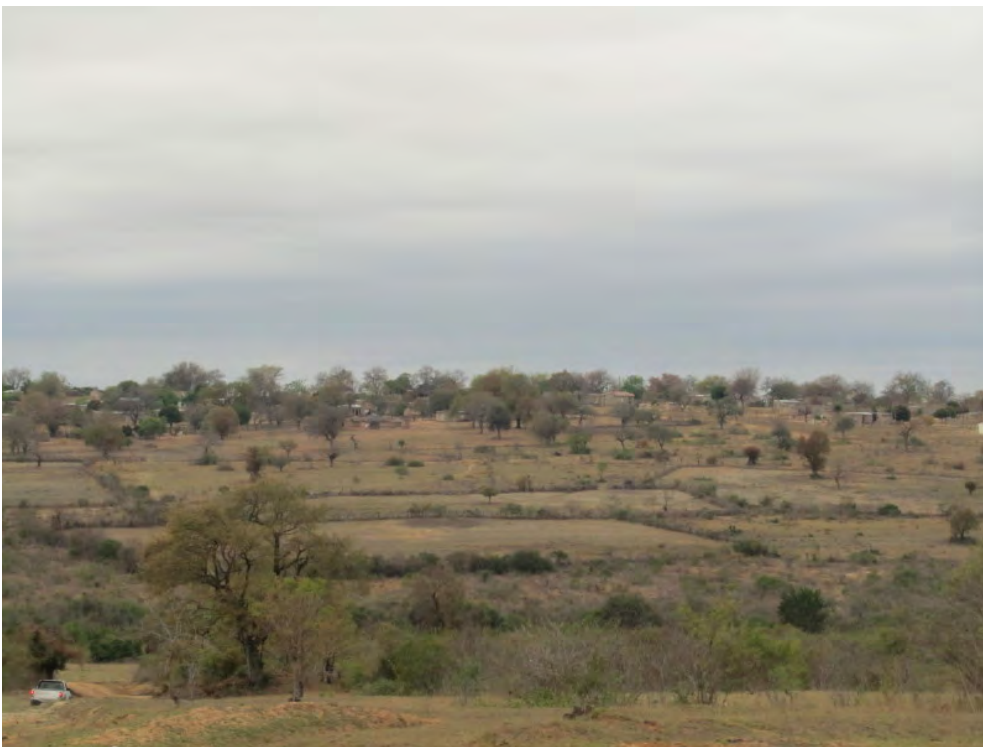
Figure 4: The patchy landscape is visible showing woodland areas as well as grassland patches, in areas that appear to have been cleared for agriculture and/or grazing.

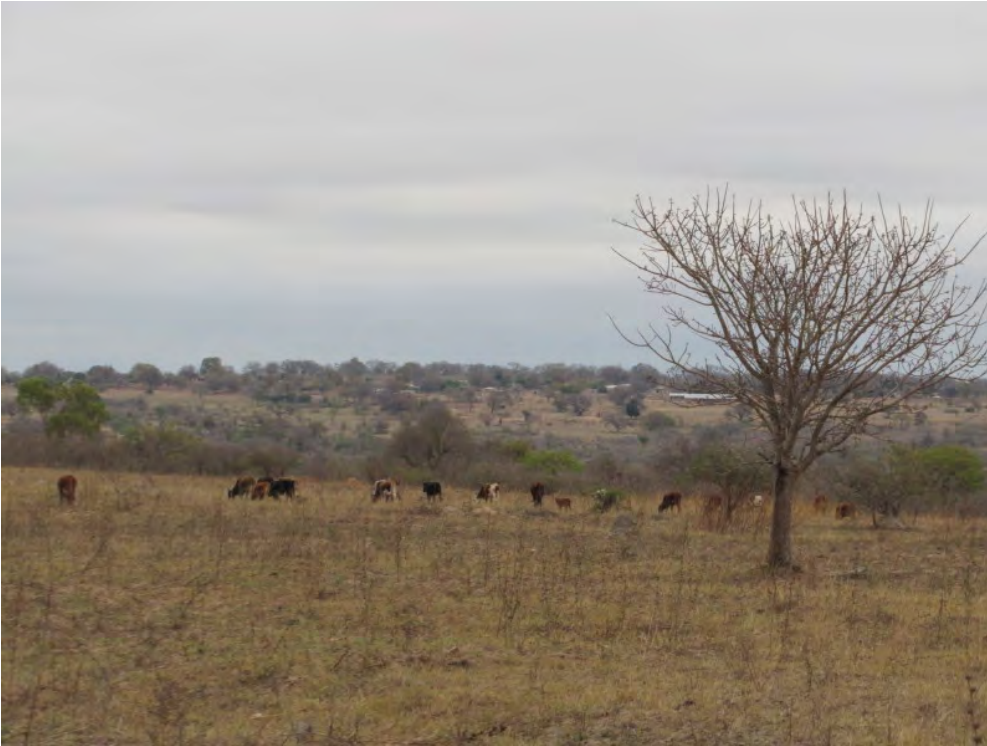
Figure 5: "Grassy" open area on the study site, being grazed by livestock.

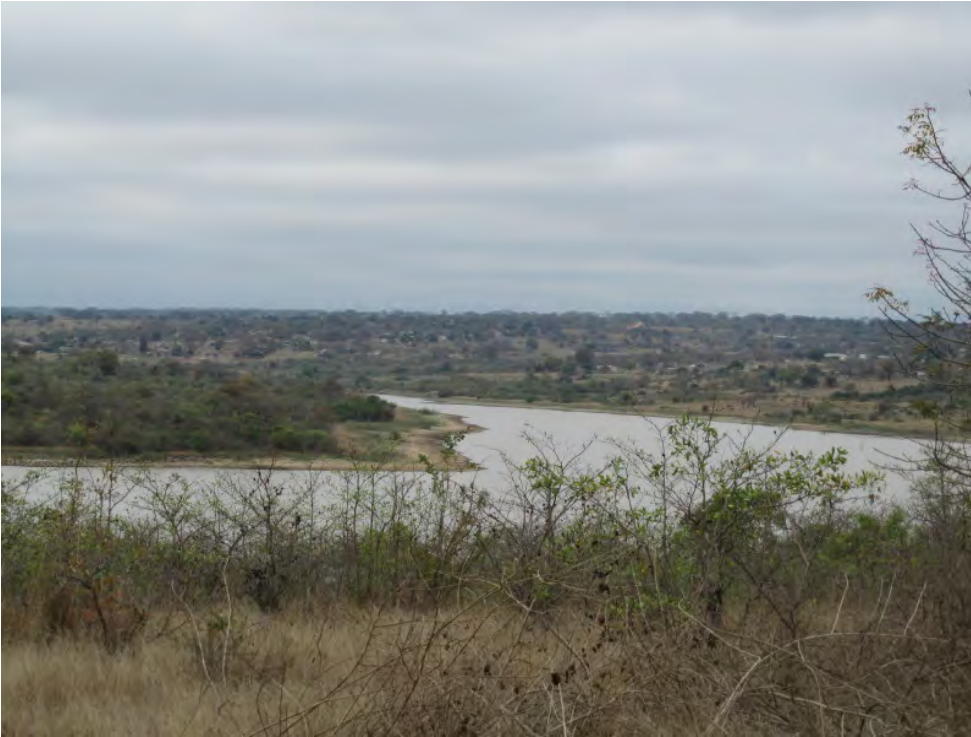
Figure 6: A large dam observed on site.

Dams have become important attractions for various bird species in the South African landscape. Various waterfowl, such as Spur-winged geese, Egyptian geese, and numerous duck species, may frequent these areas and are vulnerable to collision with power lines. Various Storks may also frequent these water bodies, as well as fish eating raptors such as the Osprey and African Fish Eagle. Very few dams were observed in the study area, however there is one large man-made dam (see figure 6) approximately 3.5km south east of Mbumbu switching station, which is the largest open water body on the site.

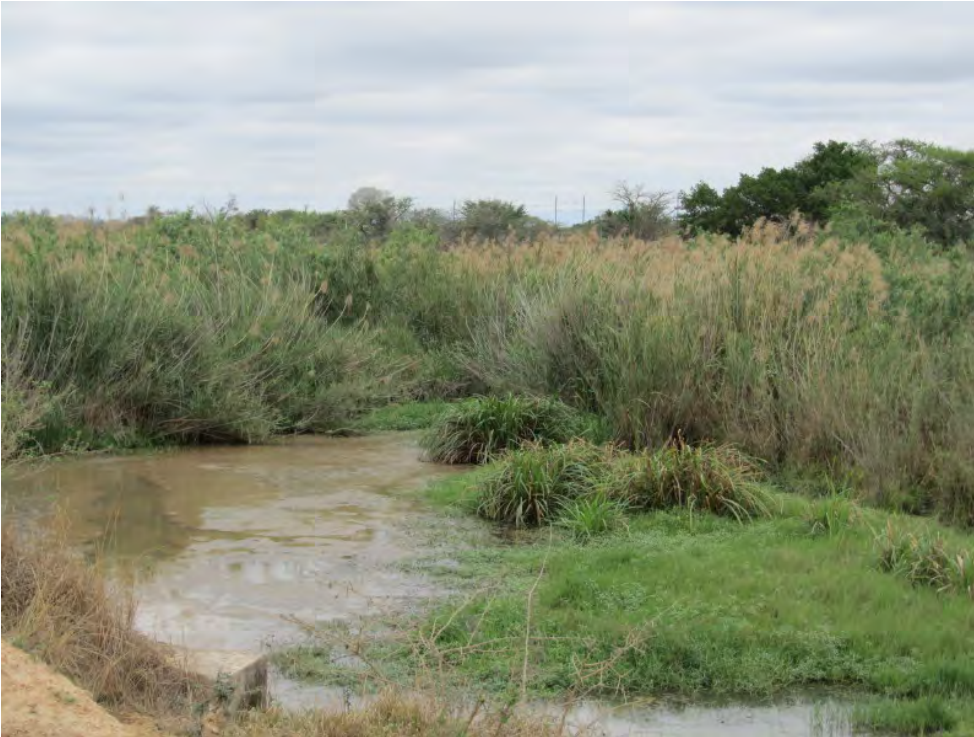
Figure 7: A stream on site showing reed bed habitat.

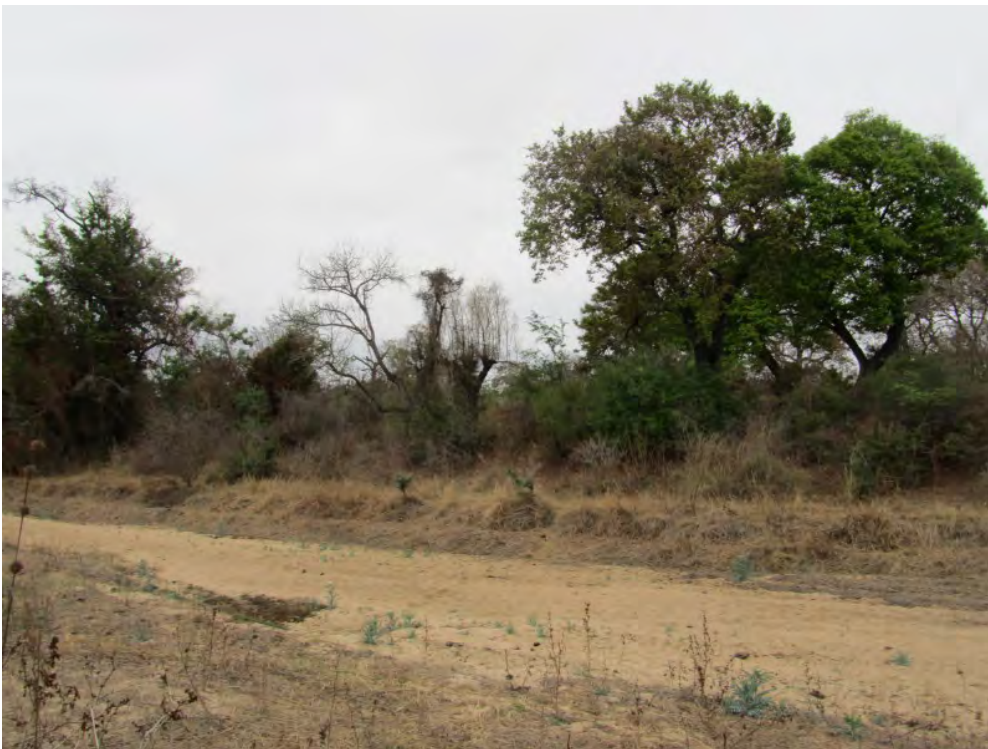
Figure 9: Relatively undisturbed woodland on site.

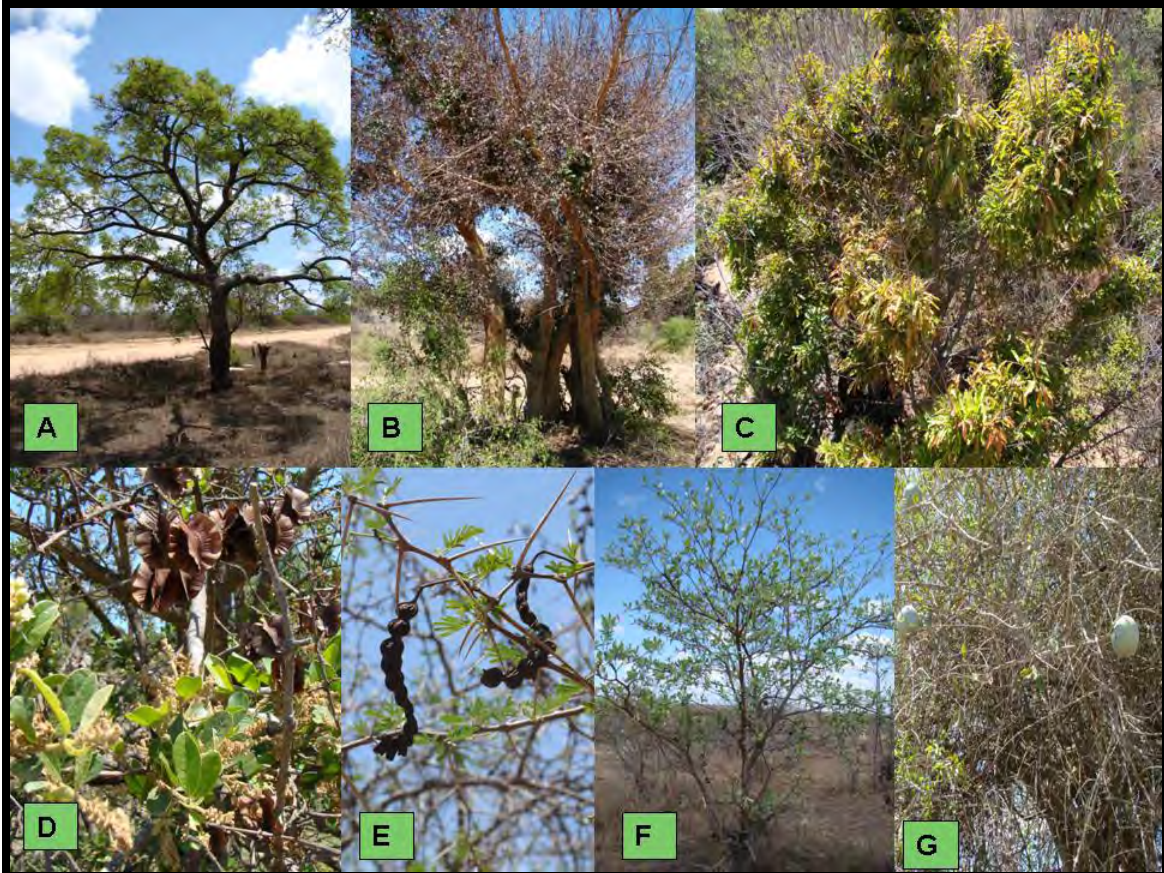
Figure2: A conglomerate of photographs displaying the dominant tree species observed along the proposed powerline alignments. A: Marula (*Sclerocarya birrea* subsp. *caffra*) was observed along the alignments as well as access roads and villages; **B:** Common Cluster Figs (*Ficus sycamorous*) was observed along the riparian zones along the streams and rivers; **C:** Red-leaved Fig (*Ficus ingens*) was observed on the rocky areas adjacent to the proposed Tsakani substation site as well as along the riparian zone of the perennial stream adjacent to the Red alignment middle point; **D:** Large-fruited Bushwillow (*Combretum zeyheri*) occurred within scattered localities along the alignments as well as **E:** Scented Thorns (*Acacia nilotica* subsp. *kraussiana*); **F:** Silver Cluster Leaf (*Terminalia sericea*) was observed in dense stands within the sandy soils adjacent to the alignments and **G:** Several fruiting Black Monkey-Orange (*Strychnos madagascariensis*) was observed adjacent to the alignments

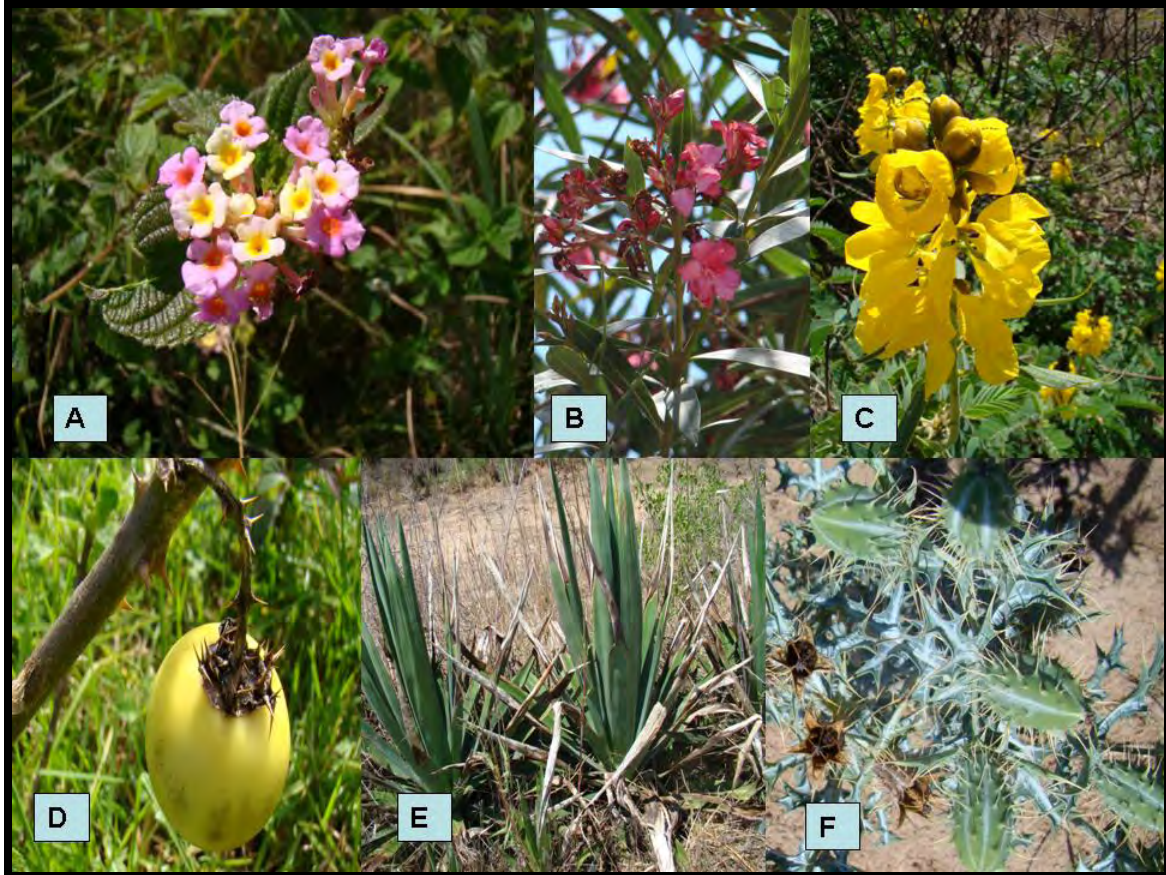
Figure4: Alien invasive vegetation observed along the proposed alignments included: A: Lantana (*Lantana camara*) Category 1 Weed; B: Oleander (*Nerium oleander*) Category 1 Weed, C: Peanut Butter Cassia (*Senna didymobotrya*) Category 3 (proposed Category 1b NEMBA); D: Dense-thorned Bitter Apple (*Solanum sisymbriifolium*)

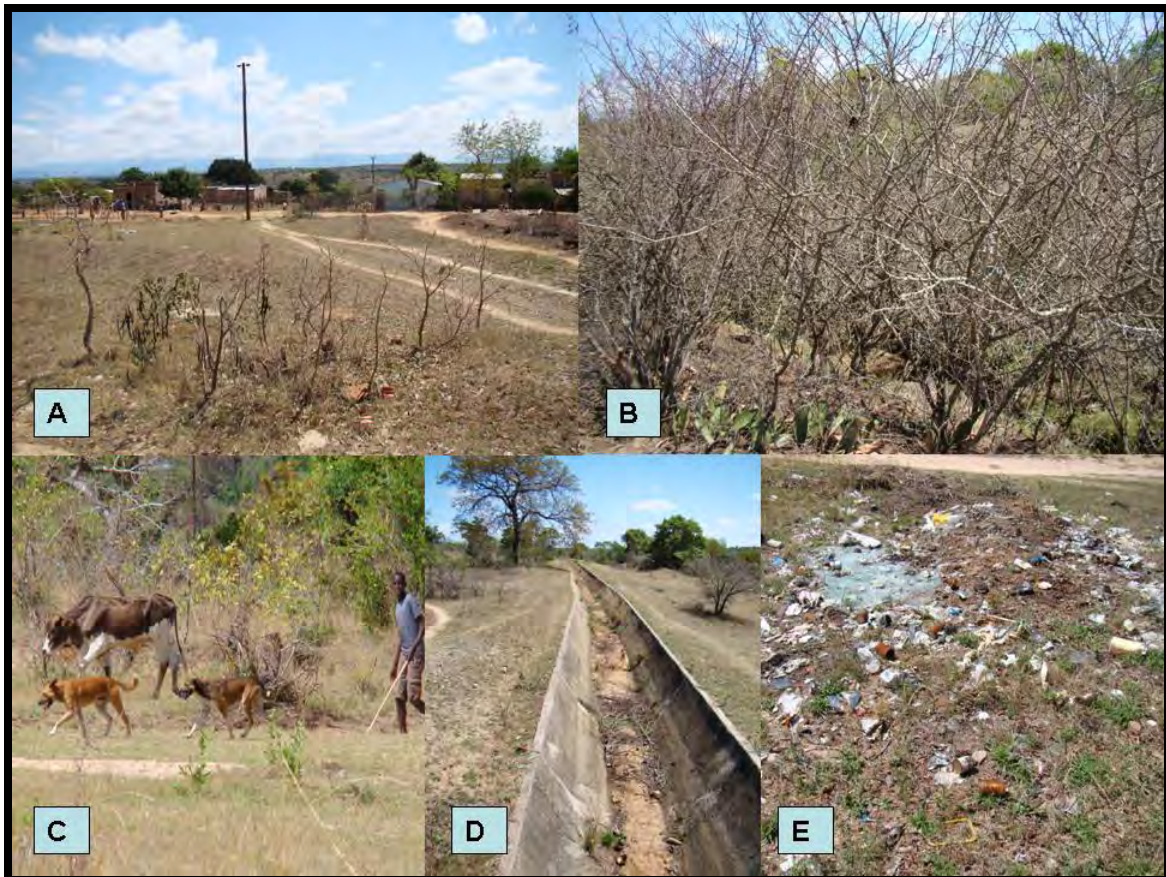
Figure6. A conglomerate of photographs displaying the current impacts on the vegetation as well as associated faunal species. A: The majority of vegetation adjacent to the proposed powerline alignments (especially green alignment) consists of completely transformed bushveld habitat with limited habitat diversity. The adjacent areas are utilised mainly for livestock grazing activities and suffers from extensive

overgrazing, mostly from goats and cattle. **(B:)** Their grazing and trampling can encourage thicket growth by *Dichrostachys cinerea* by reducing grass cover. **C:** Hunting with dogs as well as feral cats around the villages has a high impact on remaining faunal species. **D:** An existing irrigation/water furrow is situated adjacent to the dam along the green alignment and acts as a potential pit-fall trap for animal species migrating towards and away from the dam. **E:** Extensive dumping and littering occurs adjacent to the villages as well as several informal sand mining areas.

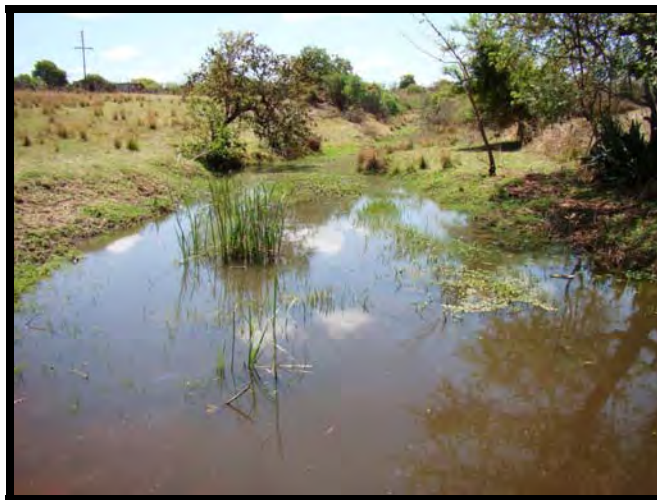
Figure7. Suitable breeding habitat for several frog species was observed within the seasonal pools situated within a perennial stream (red middle point). No surface water was present in the larger non-perennial rivers as well as several smaller drainage lines. No natural pans/depressions were observed during the site visit although several seasonally inundated depressions or old sand mining pits were observed adjacent to the alignments (especially the purple and red alignment)

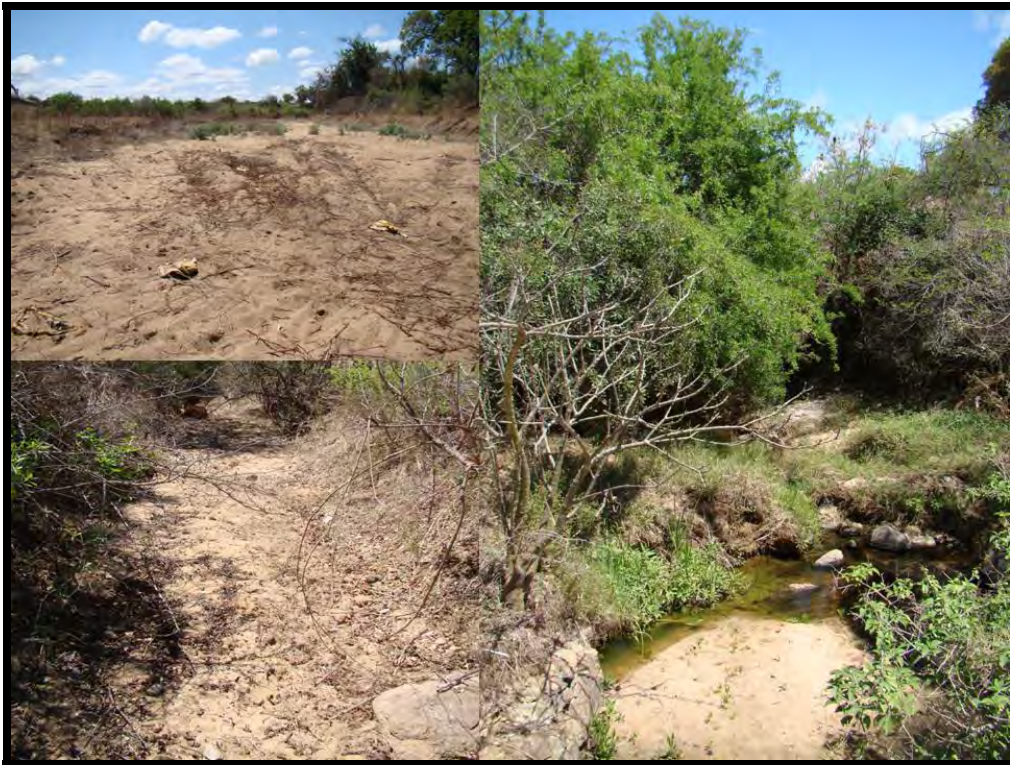
KHOKHOVELA RIVER; PERENNIAL AND NON-PERENNIAL DRAINAGE LINES

Certain sections along the Khokhovela River as well as surrounding perennial and non-perennial drainage lines are more typical of the natural riparian vegetation, whilst others especially around existing villages have been severely altered due to riparian zone degradation. Impacts include the change in species composition due to:

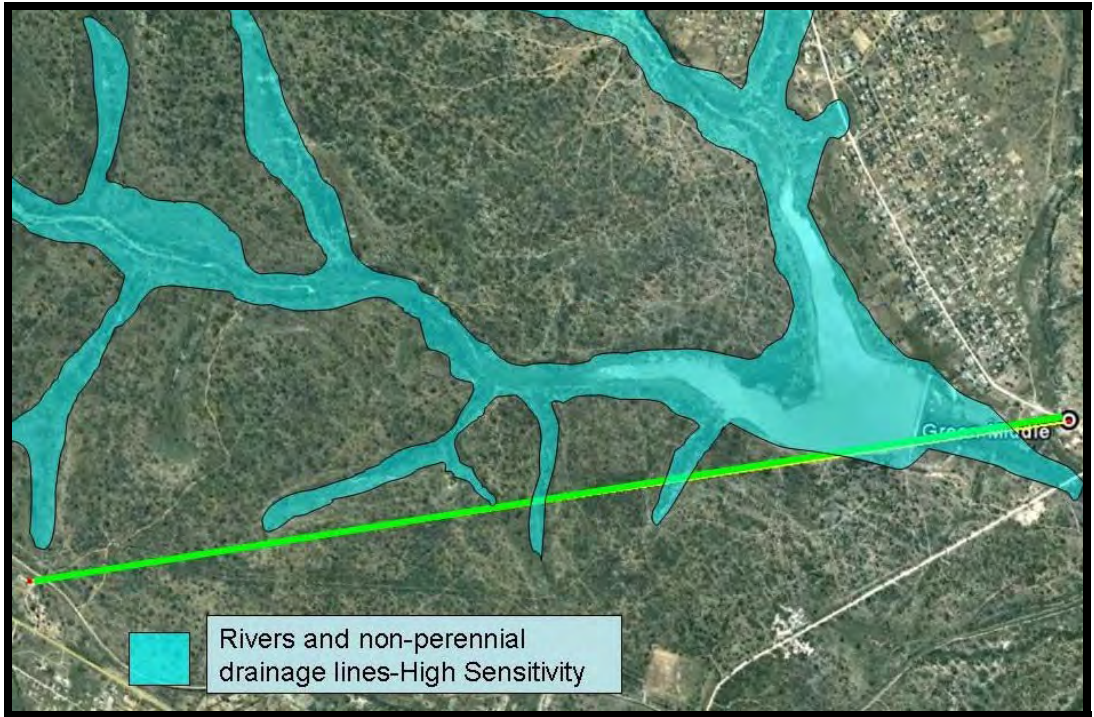
Green Middle joins with the red alignment from the west (5.18 km).

The green alignment bisects several non-perennial drainage lines. The majority of the riparian vegetation along the rivers has been removed for wood harvesting although certain sections display a more natural species composition. All riverine areas including their associated riparian or hygrophilous vegetation along the seasonal drainage lines must be considered as sensitive habitats and activities must be strictly managed (see management recommendations). As the majority of the alignment is situated within degraded or transformed vegetation as well as existing powerline servitudes, access roads and informal tracks and livestock pathways with limited habitat diversity this significantly reduces the level of disturbance and habitat destruction. In addition, fauna in the immediate vicinity of the existing lines as well as adjacent sand mining areas would already be relatively tolerant of disturbance as a result of maintenance activities as well as sand mining activities. The green alignment is the **preferred alignment** for the vegetation as well as remaining fauna within the areas.

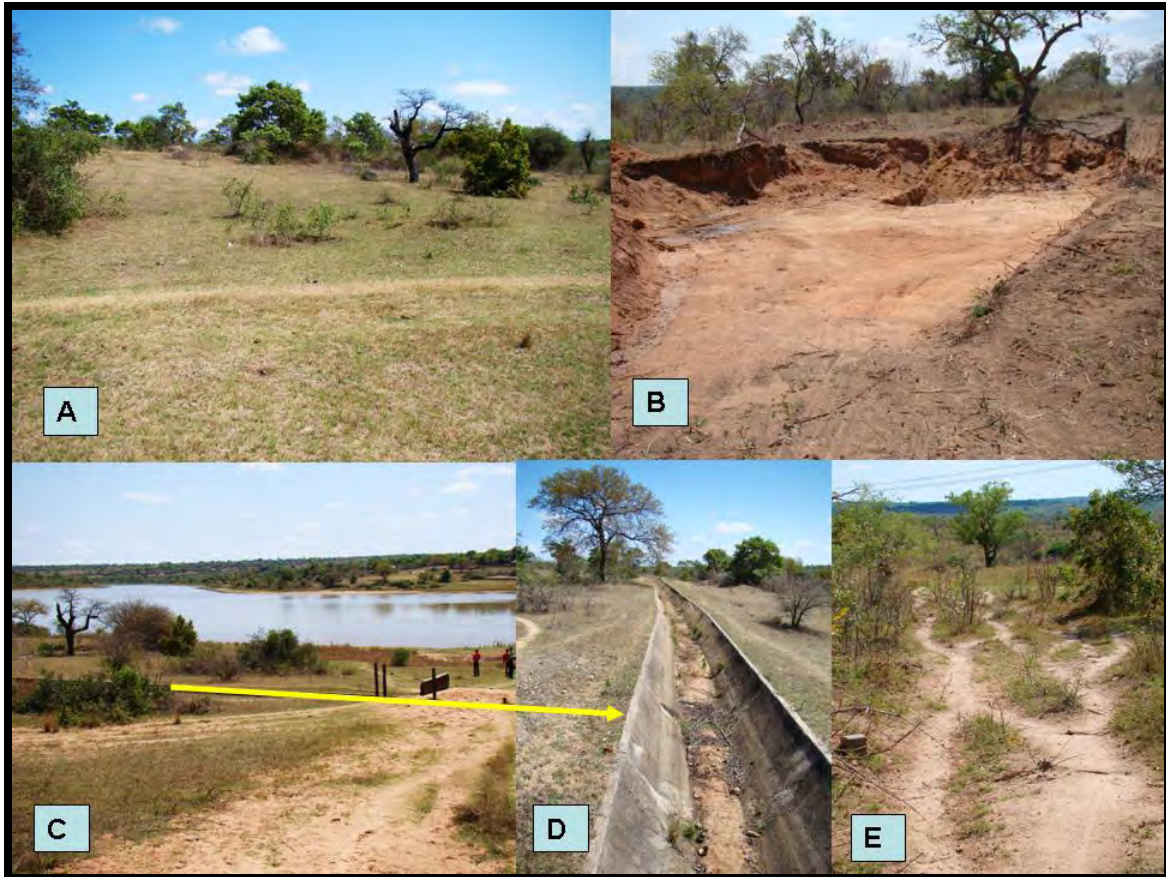
Figure13. A conglomerate of photographs displaying current impacts within and around the proposed green alignment. A: The green alignment exits the Mbumbu substation and heads in a south-easterly direction towards a large impoundment for approximately 5.35km. **B:** Several informal sand mining areas were observed to the east of the Mbumbu substation. Several large trucks were observed transporting sand from a large pit immediately to the east of the substation. **C:** The majority of riparian vegetation around the dam as well as non-perennial drainage lines has been removed and the vegetation has been degraded with only a few scattered large indigenous trees remaining. This will result in minimal vegetation clearance during construction activities as well as during the operational or maintenance phase. Ideally the final alignment of towers as well as powerline should be shifted around any large (>4m) indigenous tree species. **D:** A concrete irrigation trench/furrow restricts the migratory and dispersal movements of smaller animal species between the dam and the adjacent bushveld habitat. **E:** Existing Escom servitudes and lines as well as sand mining activities occur in the area. Several informal roads and tracks occur adjacent to the alignment especially for access to illegal sand mining operations in the area as well as wood harvesting. The vegetation has been impacted on by surrounding anthropogenic activities including extensive wood harvesting and overgrazing. Bush encroachment by *Dicrostachys cinerea*. Hunting with dogs was observed during site visitation.

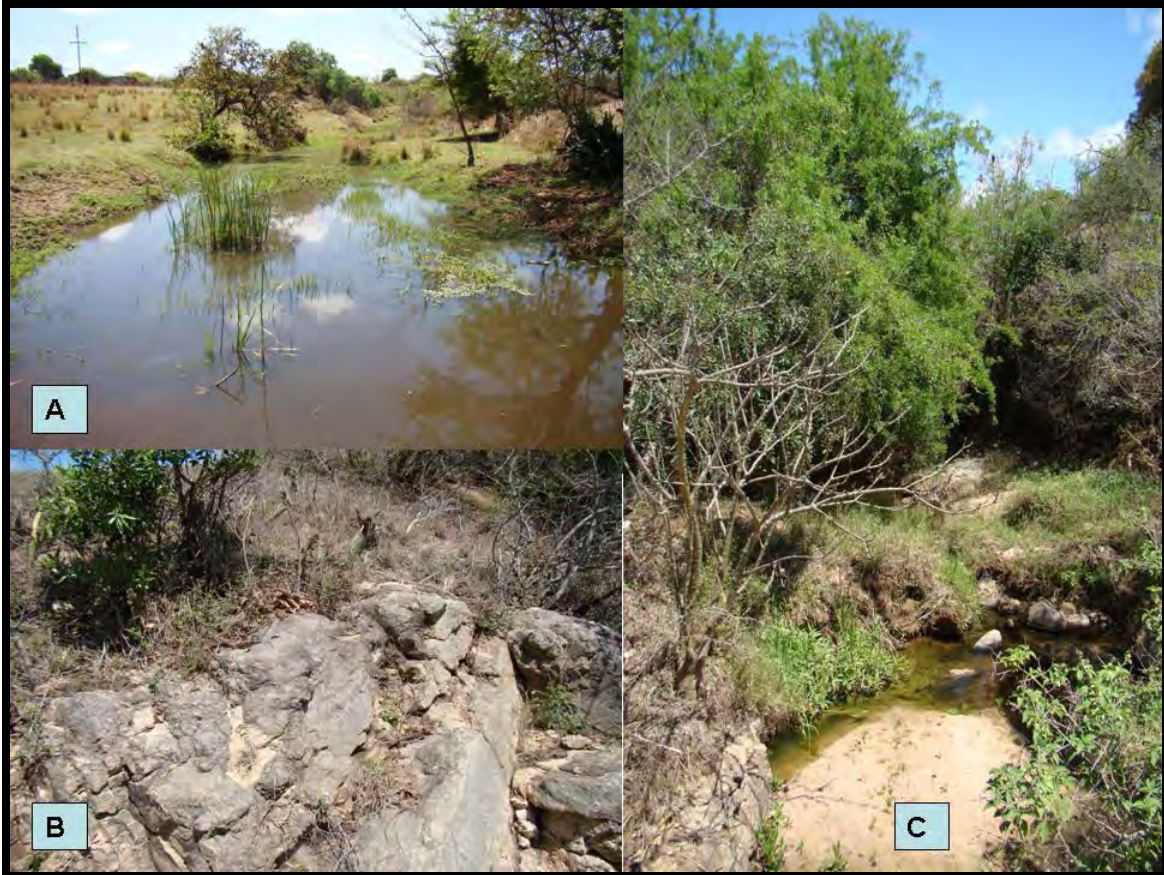
Figure14. **A:** The red middle point is situated adjacent to a perennial drainage line or stream which contains hygrophilous vegetation as well as pools. The stream provides a valuable water source for remaining animal species in the areas as well as the adjacent community; **B:** Rocky macro-channel banks downstream from the red middle point offer suitable habitat for rupicolous associated animal species as well as unique vegetation; **C:** The perennial stream has sections of indigenous riparian tree species and must be considered as a sensitive habitat due to ecological functioning as well as a potential biological or dispersal corridor.

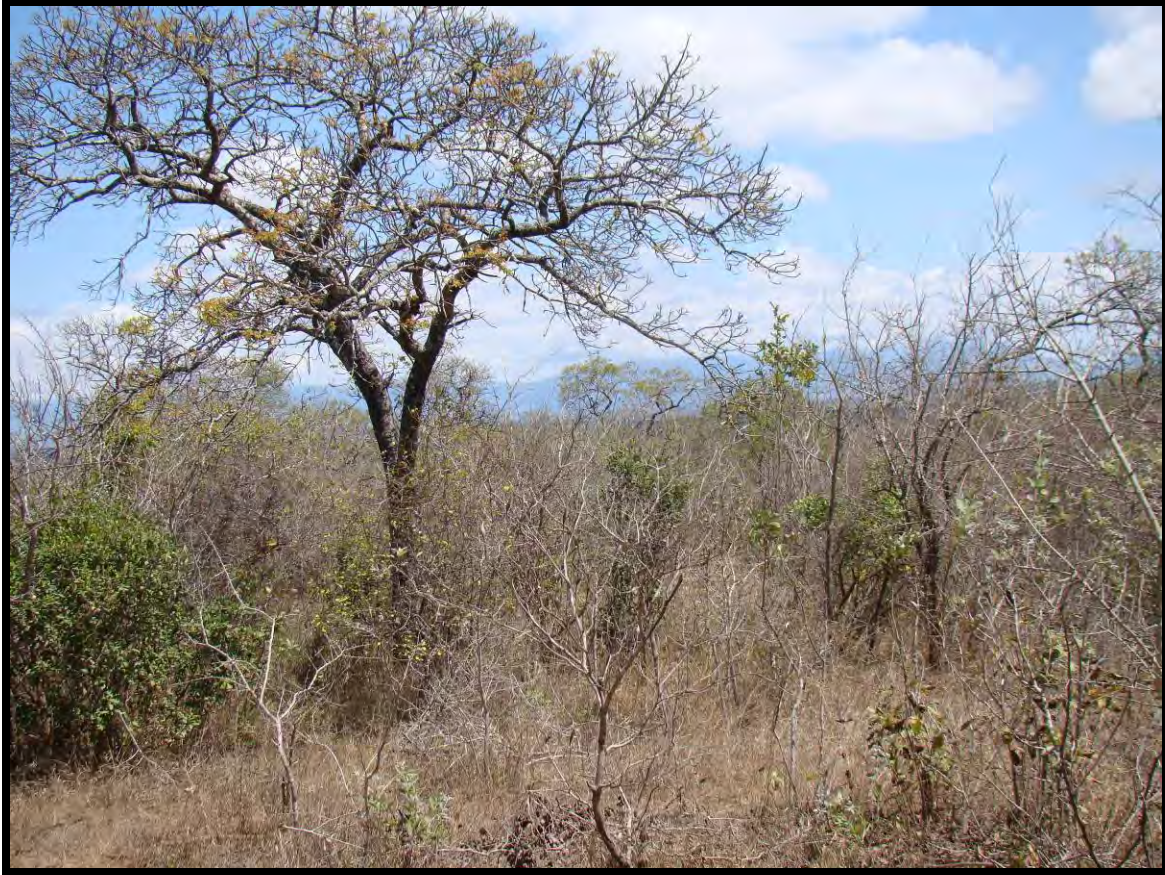
Figure15. The purple alignment bisects Granite Lowveld bushveld which displays a more natural species composition as well as containing several larger tree species. Areas to the east of the purple middle point are fenced. The area currently contains fewer access roads as well as informal tracks which restricts which restricts access as well as anthropogenic activities such as wood harvesting, poaching and hunting as well as sand mining. For this reason the purple alignment is the **least preferred alignment** from an ecological perspective.

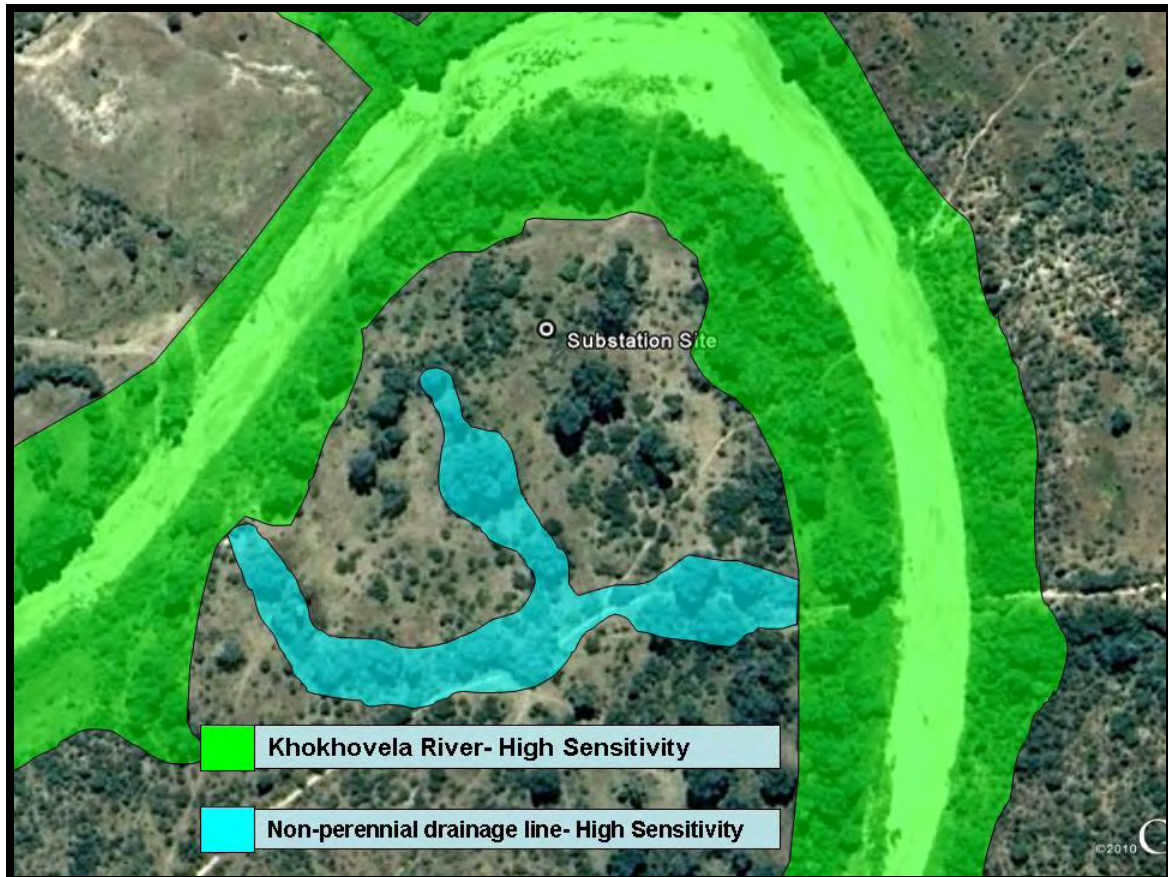
TSAKANI SUBSTATION SITE

The proposed 1ha Tsakani substation site is situated within transformed and degraded bushveld habitat adjacent to fallow agricultural lands and livestock enclosures. The Khokhovela River is immediately to the east of the proposed substation site. A non-perennial drainage line occurs to the south of the substation site. The substation must be sufficiently positioned outside the riparian areas of the Khokhovela River as well as non-perennial drainage line. DWA requires a 32m buffer zone from the outer edge of the riparian zones.

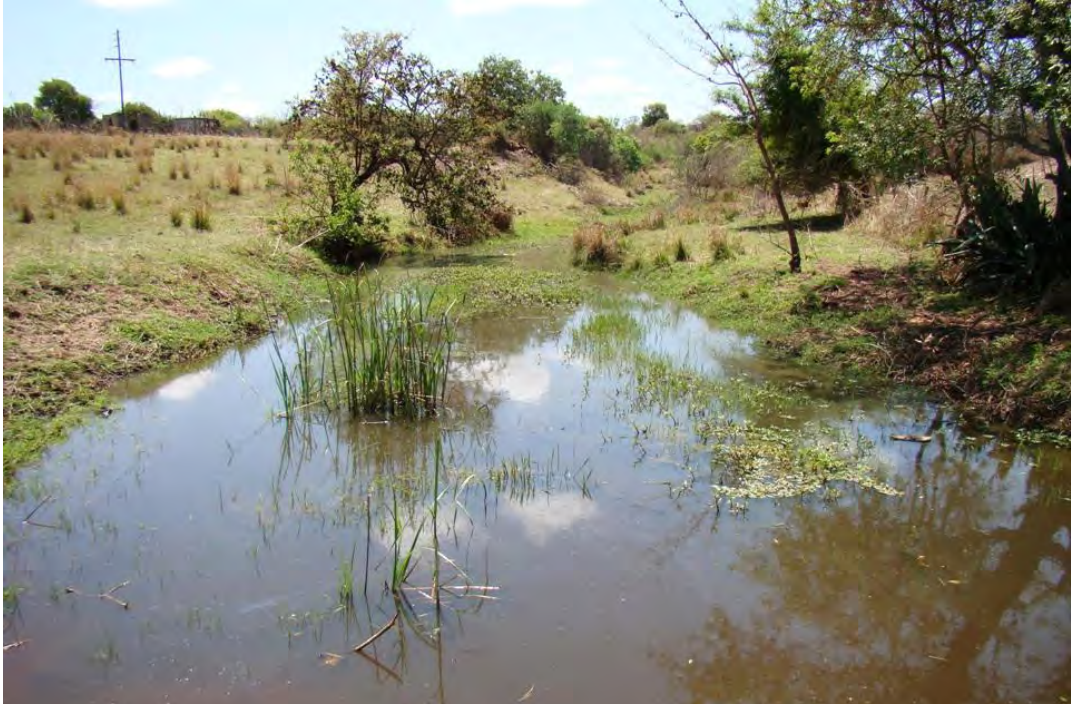
Figure 12: Picture of flat depression wetland on the southern route (Typha sp., marginal sedge and grass indicators)

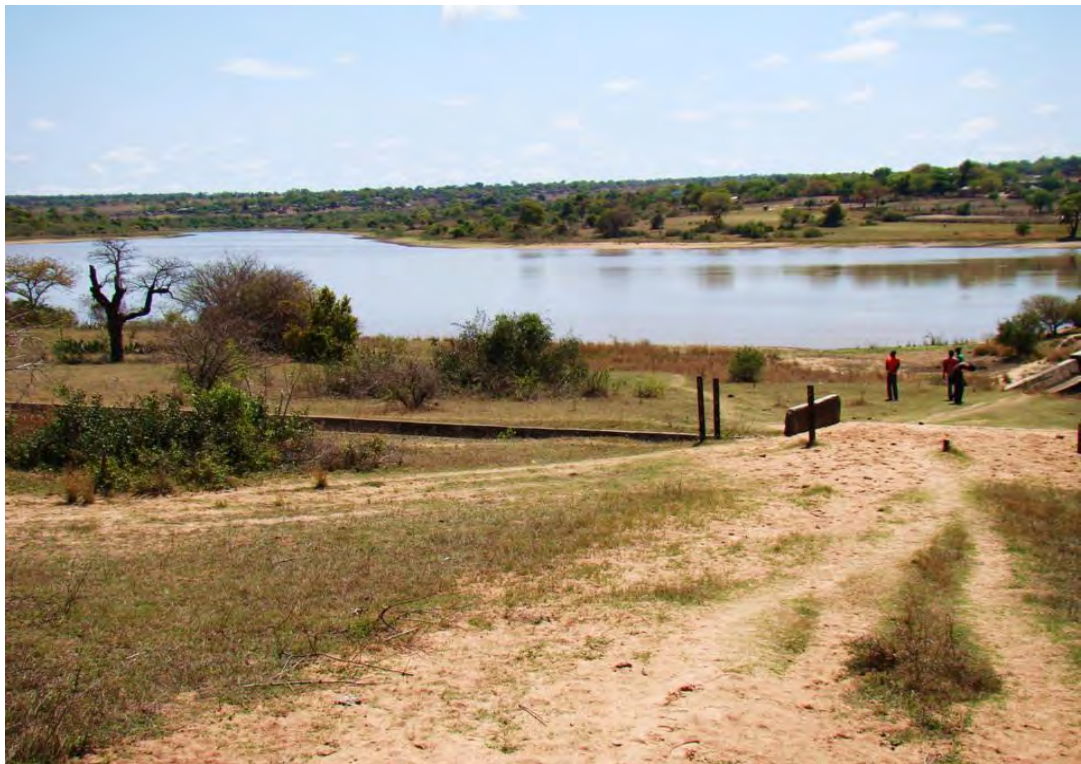
Figure 13: Picture of a modified river (dam)

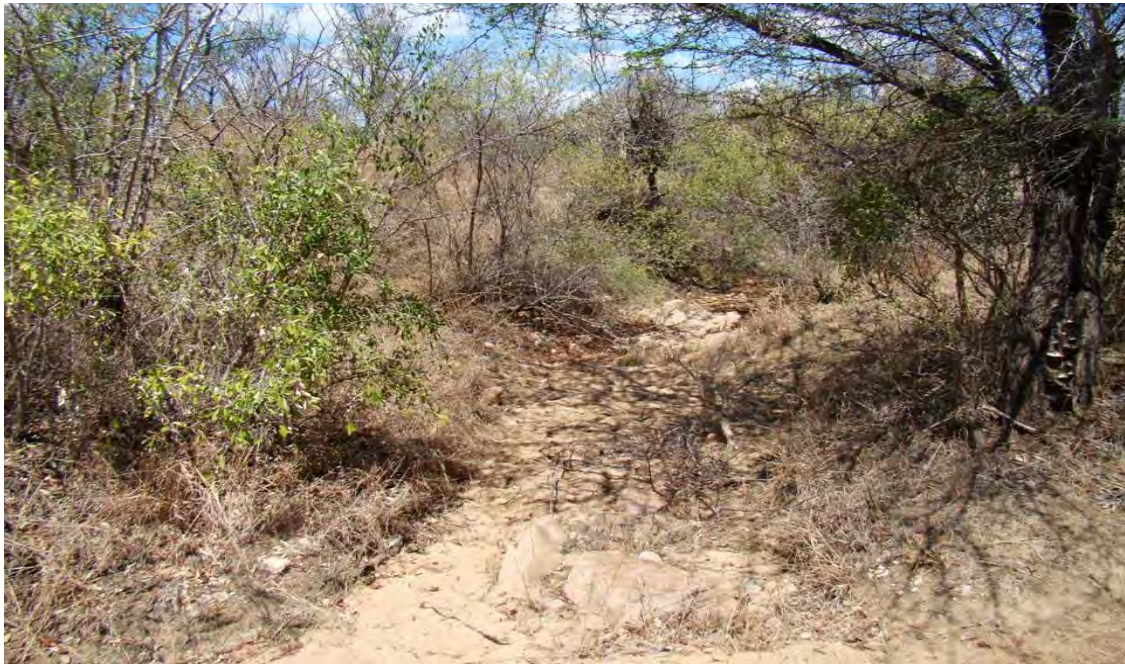
Figure 15: Picture of a seasonal stream in the study area

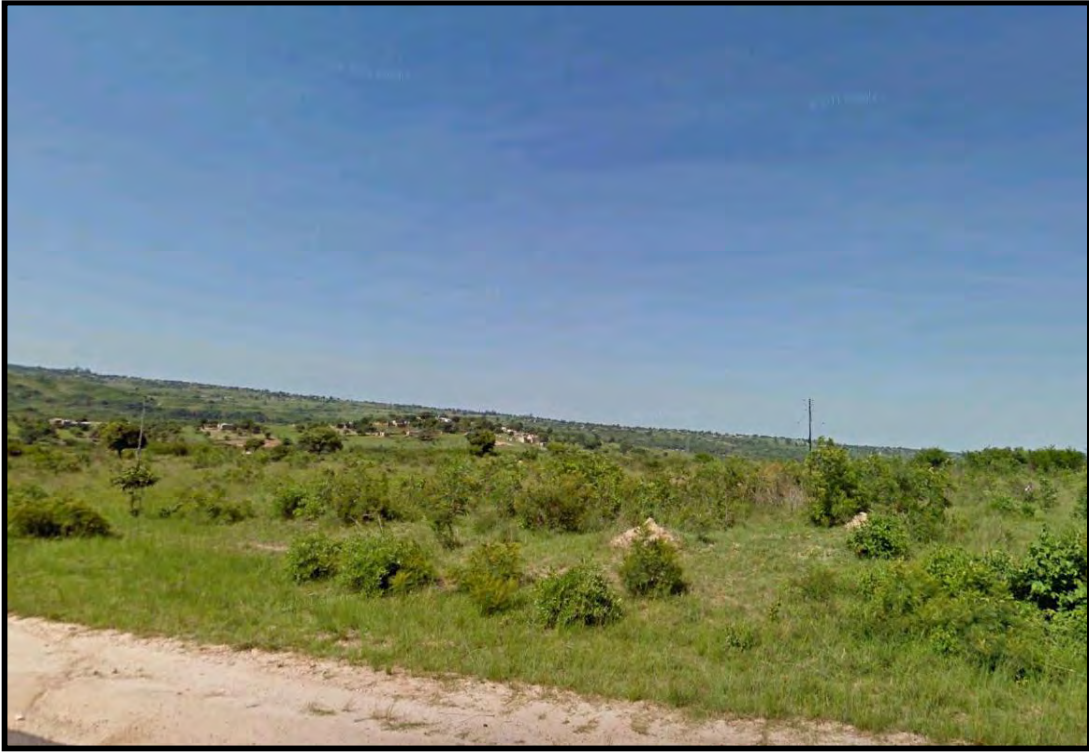
Figure 6: Disturbed area

The vegetation communities are not very pronounced within the project area and the vegetation is therefore structurally uniform throughout the area, comprising of Granite Lowveld Bushveld. This vegetation can be described variously as dense bush and trees on the uplands, open tree savanna in the bottomlands, and dense riverine woodland on the river banks. Most of the area surrounding the project area has been disturbed and severely impacted by human activity (over-grazing by livestock, collection of vegetation for various uses, settlements and cultivation) (Figure 2, 5, 6, 7).

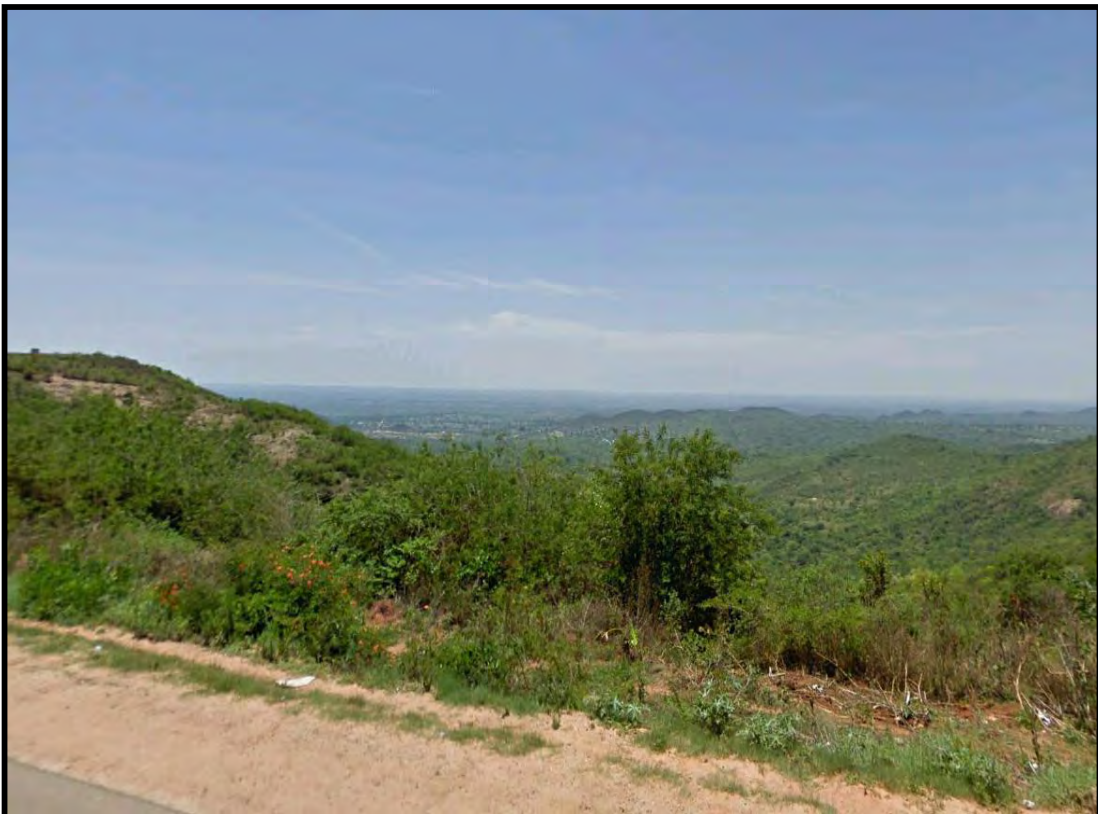
Figure 7: Topography & vegetation

The landscape setting can be defined in terms topography, vegetation, hydrology and land use features. These elements define the existing visual character of the landscape with which the planned infrastructure interacts. The planned infrastructure and surrounding areas are comprised of the following topographical features and landscape units with varying levels landscape quality (Figure 4, 7):

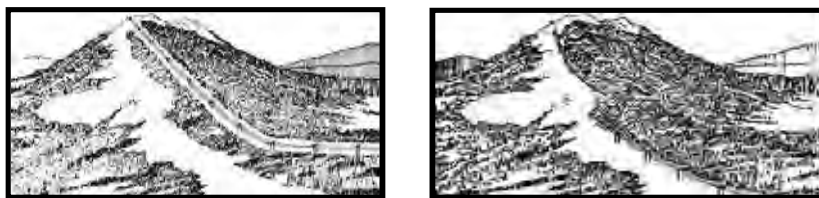
Figure 11: New disturbance should be avoided and the natural lines in the landscape should be followed where possible
