APPENDIX A
LOCALITY MAP

BA: Proposed Constructure of a 17km 132kV from existing Mbumbu Traction to new Tsakani Substation

**PRELIMINARY ECOLOGICAL ASSESSMENT SURVEY
FOR THE PROPOSED
MBUMBU-TSAKANI 17KM 132KV POWER LINE AND
NEW TSAKANI SUBSTATION;
NORTHERN REGION,
ESKOM DISTRIBUTION DIVISION
BASIC ASSESSMENT REPORT**

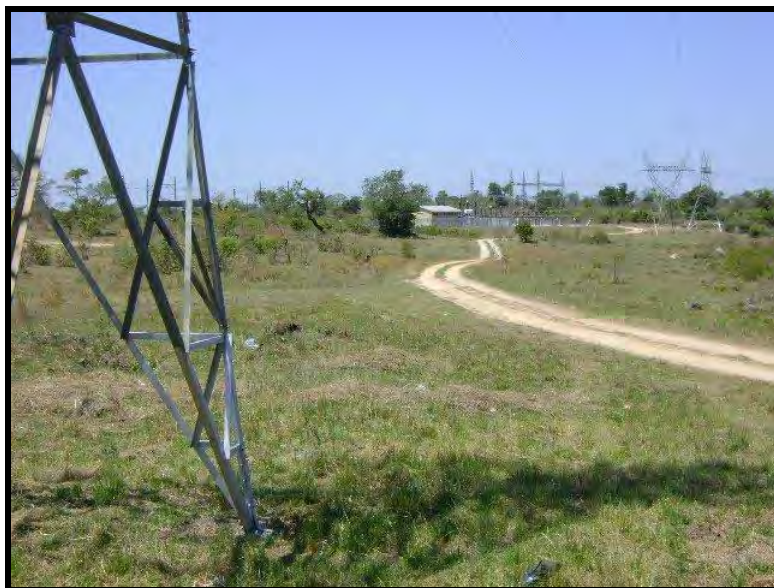
The purple line runs from the starting point in a north eastern direction through Lowveld bushveld vegetation – see photograph

Starting point of all three proposed routes

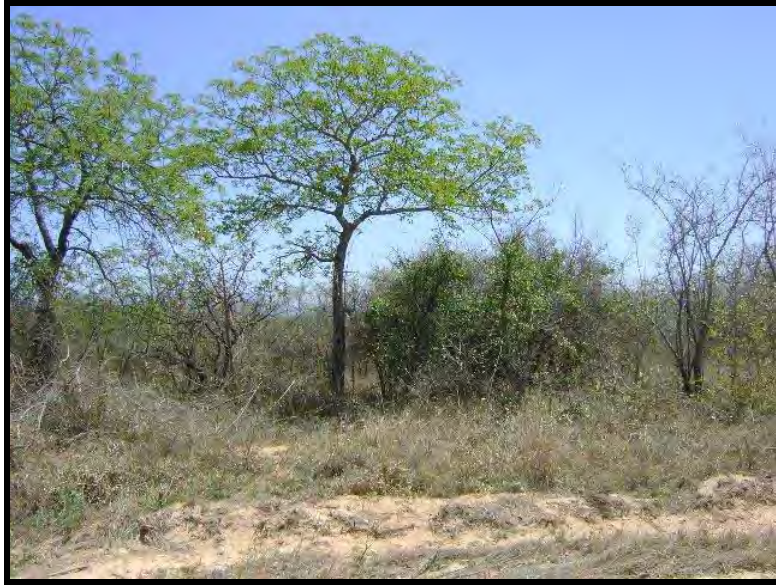
Then it crosses two streams and the dirt road at S24° 39' 14.4" & E31° 14' 20.1" – see photograph.

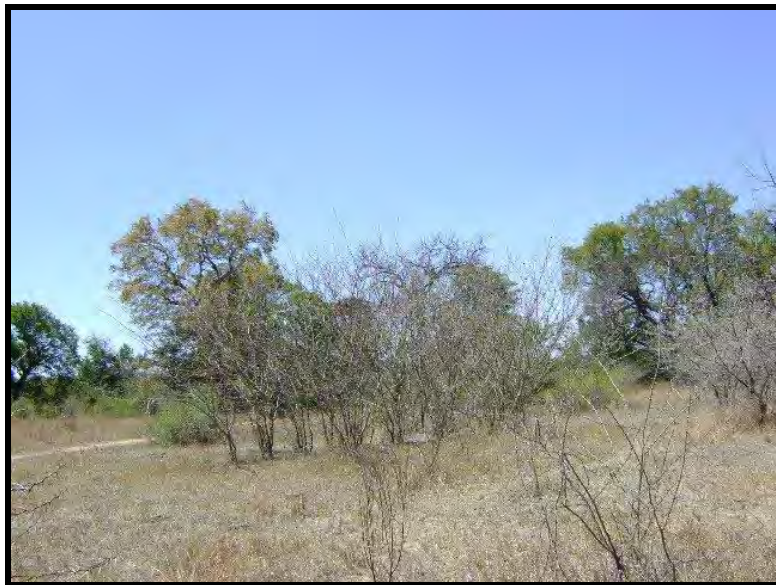
From here the line will run east to the end destination at S24° 39' 21.3" & E31° 19' 29.2". Along this section of the route it will also run through bushveld vegetation but will also cross some old fields where maize and sorghum was planted – see photograph.

End destination of all 3 proposed power lines

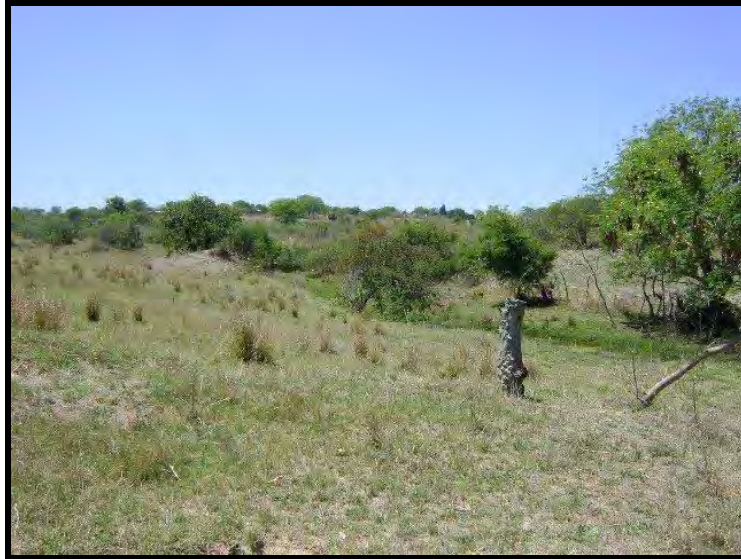
The red power line route starts at the same point as the other two lines and runs through thick Lowveld bushveld. At S24° 40' 52.2" & E31° 13' 38.7" it crosses the road near a stream and some nearby houses – see photograph

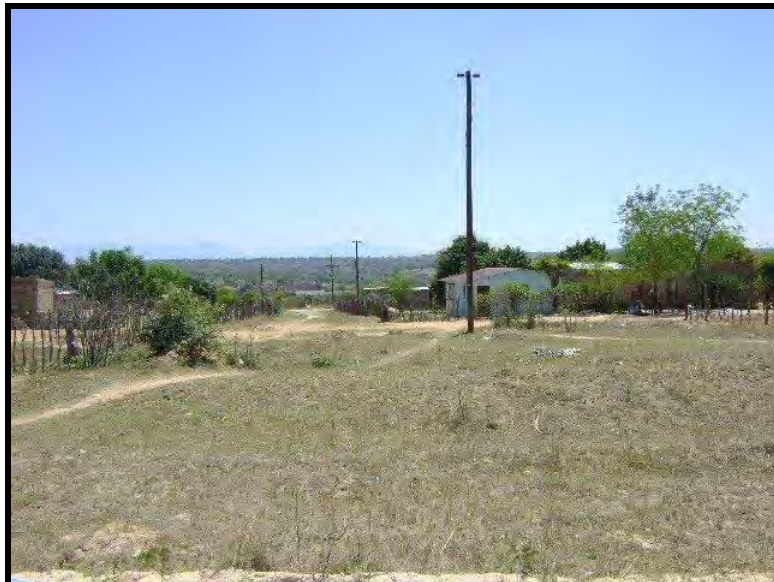
From here it runs in a south easterly direction mainly across old maize fields to S24° 41' 42.3" & E31° 16' 41.9" where it joint the green line – see photograph.

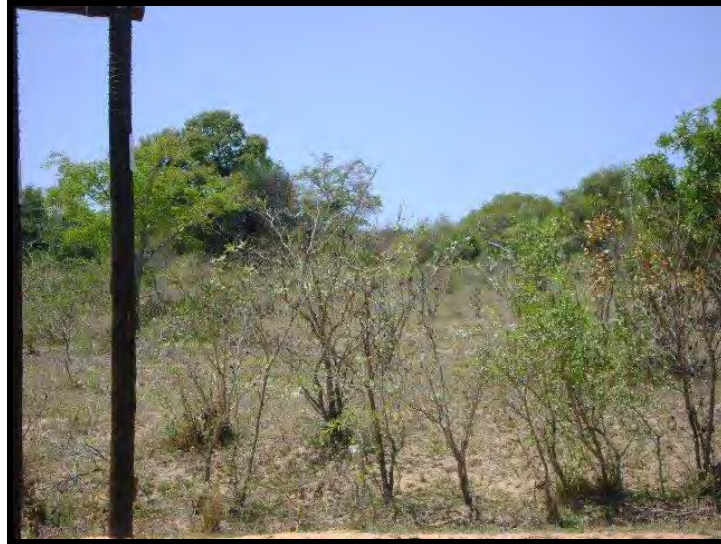
This route starts at the same point as the purple and red routes but follows a more southerly direction crossing a large dam to S24° 42' 9.9: & E31° 13' 37.2" – see photograph

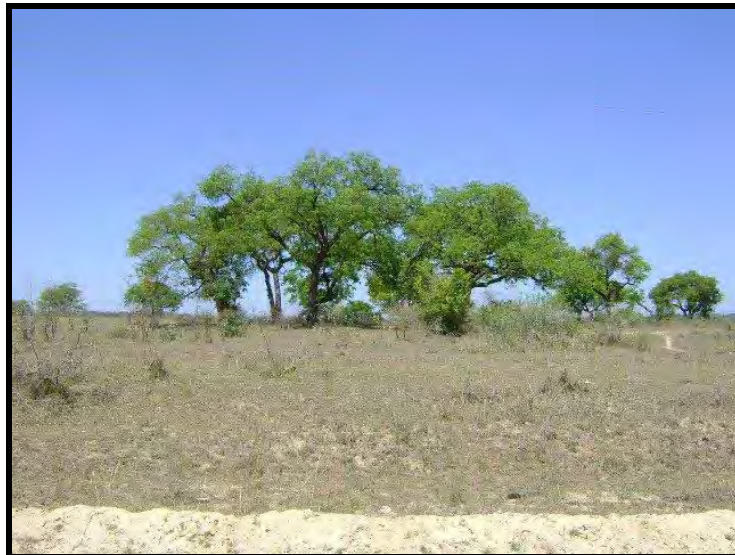
From here it follows an easterly direction till it joins the red line at S24° 41' 42.3" & E31° 16' 41.9". Along this section the route runs through an informal settlement area and across old fields see photograph

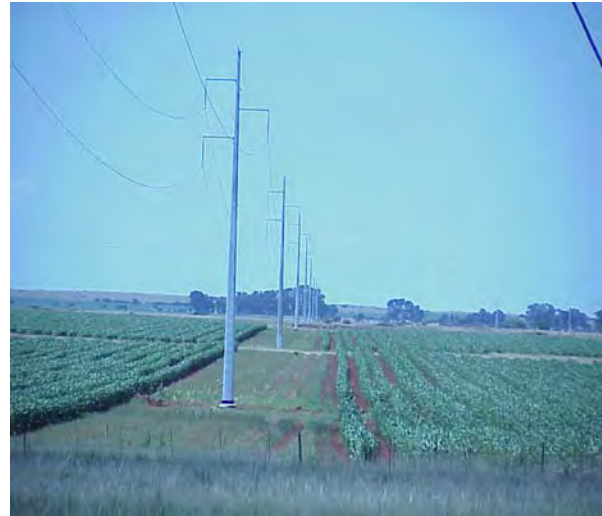
The self-supporting structure (suspension pole) is typically used along the straight sections of the power line, while the guyed intermediate or guyed suspension and angle strain structures are used where there is a bend in the power line alignment.

Figure 1: Monopole structures

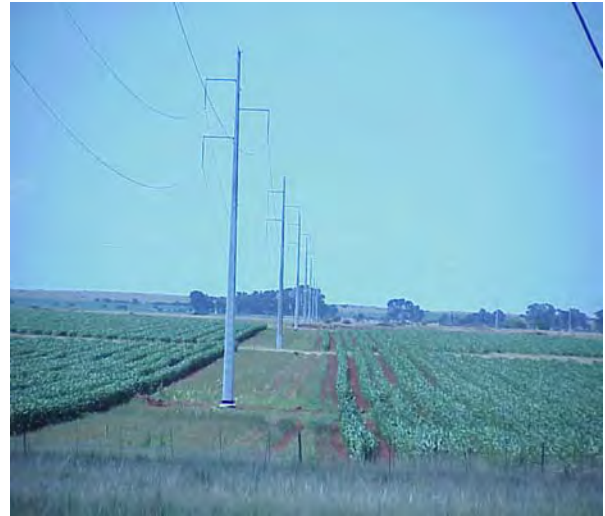
Figure 1: Monopole structures

The self-supporting structure (suspension pole) is typically used along the straight sections of the power line, while the guyed intermediate or guyed suspension and angle strain structures are used where there is a bend in the power line alignment.
