**AQUATIC SPECIALIST INPUT
TO THE
BASIC ENVIRONMENTAL IMPACT
ASSESSMENT:
PROPOSED PHOTOVOLTAIC ENERGY
PLANT ON KLIPGATS PAN FARM NEAR
COPPERTON, NORTHERN CAPE**

JANUARY 2012

PREPARED BY: James MacKenzie
MacKenzie Ecological & Development Services

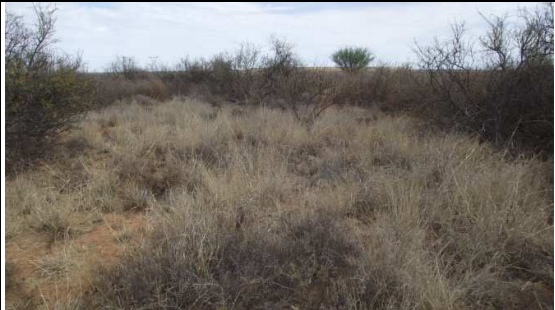
Kg1	Kg2

Feature code	Feature Description	No-go Area
Kg1	Small endorheic pan, extremely ephemeral, grass covered centre with shrub (mostly <i>Lycium cinereum</i>) boundary. Some <i>Prosopis glandulosa</i> present.	Yes
Kg2	This is a continuation of Hp1 on the farm Hoekplaas, essentially and rainfall drainage area that is not well defined or incised. Vegetation is slightly different with <i>Lycium cinereum</i> and <i>Rhigozum trichotomum</i> occurring along the drainage line and an elevated prevalence of <i>P. glandulosa</i> .	Yes
Kg3	This area was investigated due to its pattern on satellite imagery, but features are not endorheic pans and appear to be higher lying areas that are calcareous and support higher concentration of grasses, or are bare. Slight, localised inundation is likely following rain events but duration of inundation will be short.	No
Kg4	This is likely Klipgats Pan. It is a typical endorheic pan with an unvegetated centre characterised by open sediments and boulders. Inundation clearly takes place although it was dry at the time of the assessment. The unvegetated centre is surrounded by a zone of grass and small shrub, 100 – 150m wide and this is followed by an approximately 10m band of taller shrubs (typically <i>Lycium cinereum</i> and <i>Rhigozum trichotomum</i>).	Yes

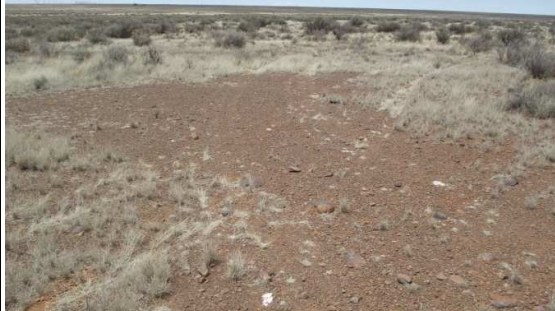
Kg5	Kg6

Kg5	This area is high ground with drainage evident down the slope, but	No

not a pan or surface water feature.	
Kg6 & 7	These are circular areas of grazing and trampling impact around watering points associated with wind pumps. They are most likely to be artificially wet features and not pans or depressions. The presence of sedges at these features indicates permanent inundation, but this is from underground water being regularly pumped and spilled.	No
Kg8	Drainage area that clearly channels flowing water during rain events. Vegetation composition and structure is different from upland area with a higher grass abundance and individual <i>P. glandulosa</i> along its route. Slight erosion and sediment movement is evident from past flows.	Yes
