Riparian Delineation and Assessment
**Various Portions of the Farm Rooikoppies 297-
JQ, Rustenburg, North West Province**

Reference 5163-2019

PROJECT: Riparian Delineation and Assessment: Various Portions of the Farm Rooikoppies 297-JQ, Rustenburg, North West Province

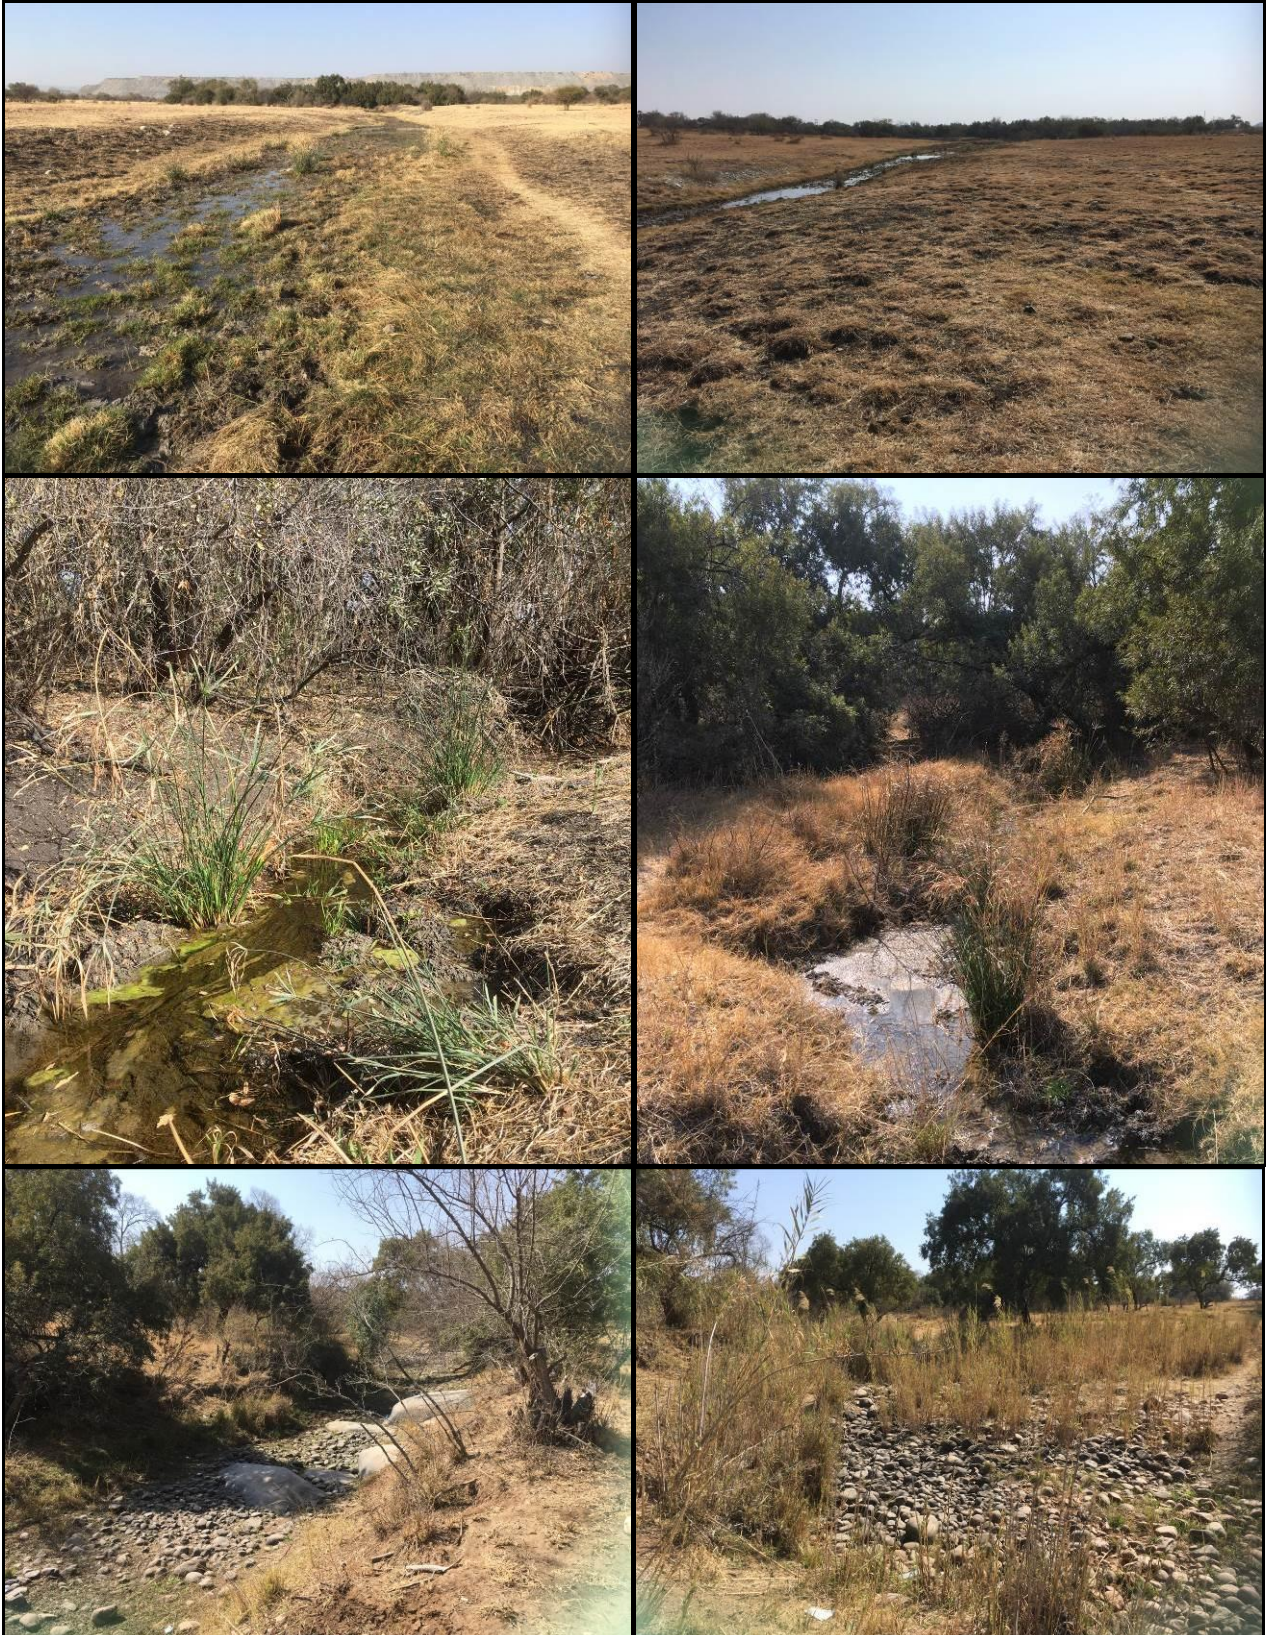
Figure 11: Riparian habitat observed on site: (top row) Recreated watercourse; (middle row) Eastern riparian zone; (bottom row) Sterkstroom riparian zone.

Photographs of the riparian habitats observed on site are provided in **Figure 11**.

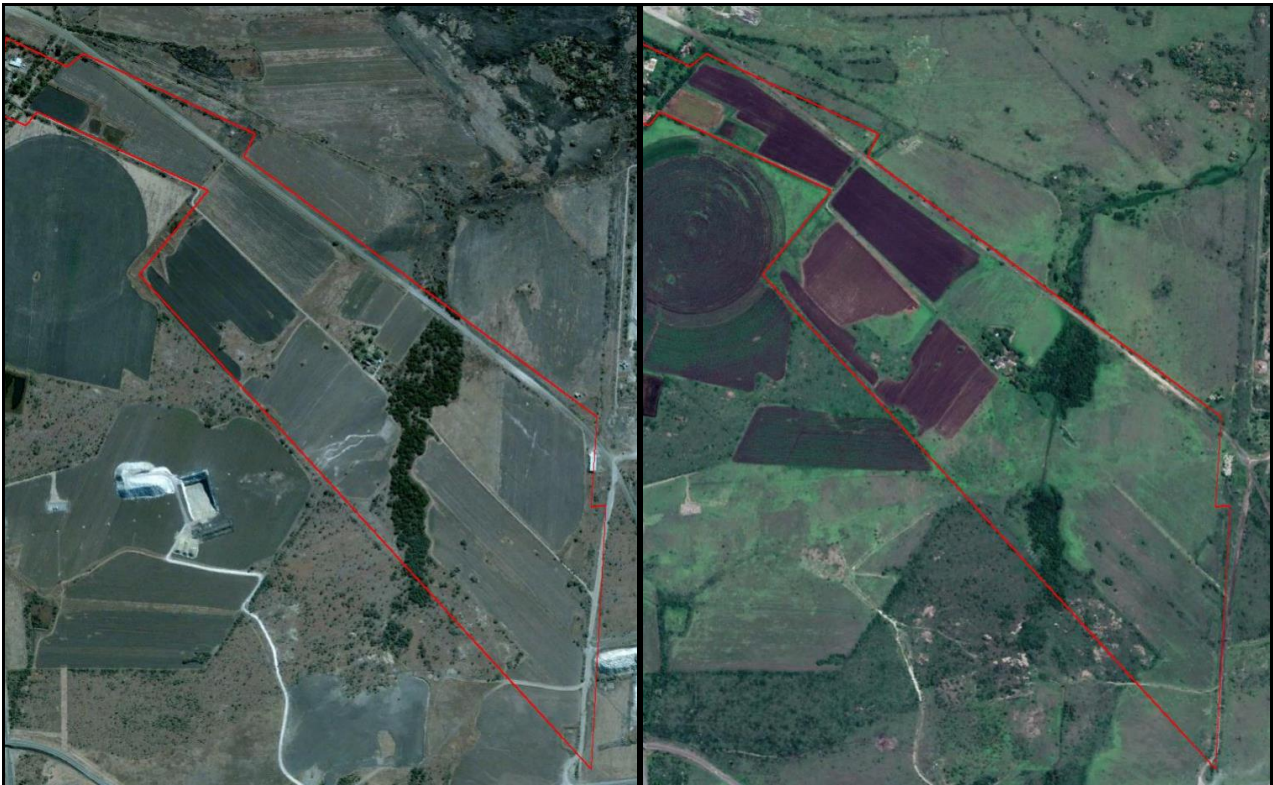
Figure 12: Comparison of the eastern riparian zone in 2004 (left) and 2019 (right), showing the change from intact riparian habitat to a recreated watercourse in the central section of the channel on site.

The eastern riparian zone lies further from the local communities and has therefore experienced less utilisation, though a degree of woody vegetation harvesting and livestock grazing was noted. A small degree of alien vegetation encroachment was also observed. Flows to this watercourse may have been affected by opencast mining in the catchment, resulting in reduced flows to the watercourse. The most significant impact affecting the eastern riparian zone is past mining which resulted in removal of the central section of the channel and riparian vegetation. Connectivity was reinstated post-mining in the form of a recreated watercourse, but the woody riparian vegetation was lost. As the reference state (pre-mining) of the recreated watercourse is riparian habitat, this system was assessed using VEGRAI Level 3, in the same way as were the other delineated riparian zones. **Figure 12** shows the state of the riparian habitat in the central section before mining and the current recreated watercourse after mining. The intact riparian vegetation and the recreated watercourse were assessed separately and found to be moderately modified (EC of “C”) and seriously modified (EC of “E”), respectively. The results of the VEGRAI Level 3 assessments are detailed in **Table 7** and **Figure 13** below.
