***FAUNAL, FLORAL, WETLAND AND AQUATIC
ASSESSMENT AS PART OF THE ENVIRONMENTAL
ASSESSMENT AND AUTHORISATION PROCESS FOR THE
PROPOSED RIETVLEI COLLIERY, MIDDELBURG***

April 2014

SECTION E - Aquatic Ecological Assessment

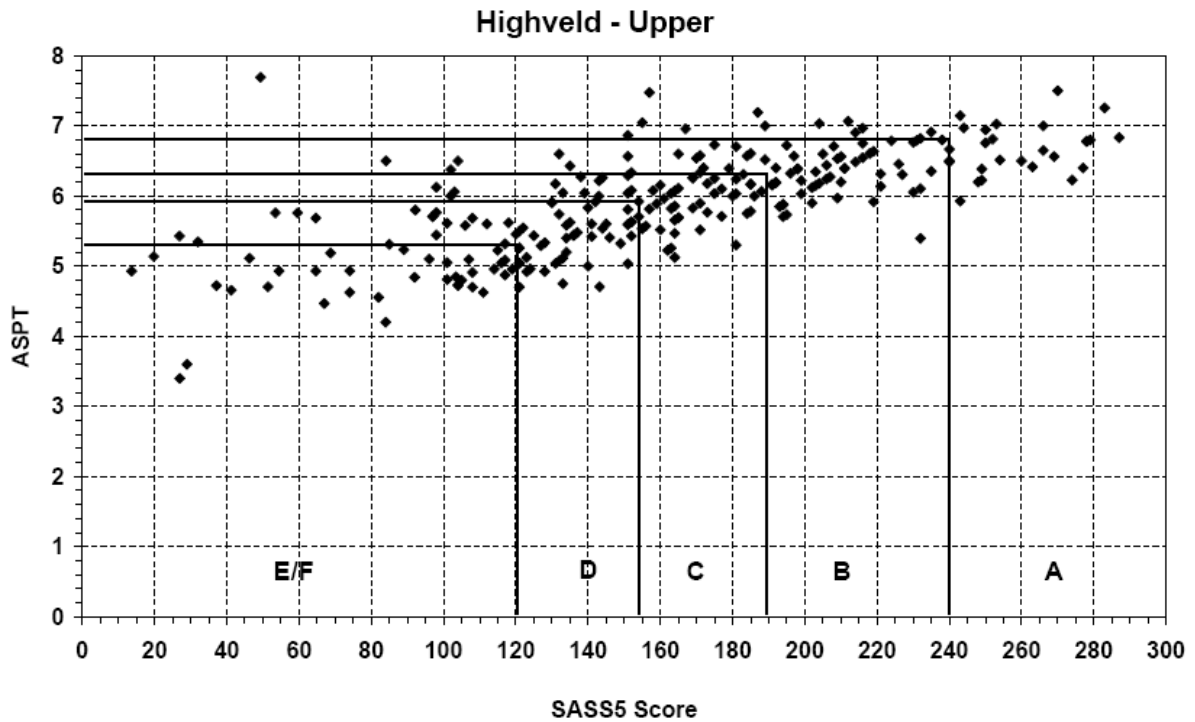
Figure 3: SASS5 Classification using biological bands calculated from percentiles for the Highveld Ecoregion, Dallas, 2007

Classification of the system took place by comparing the present community status to reference conditions which reflect the best conditions that can be expected in rivers and streams within a specific area and reflect natural variation over time. SASS and ASPT reference conditions were obtained from Dallas (2007), as presented in the figure below. Reference conditions are stated as a SASS score of 240 and an ASPT score of 6.8. Sites were classified according to the classification system for the Highveld Ecoregion according to Dallas (2007), as well as the classification system of Dickens and Graham 2001.

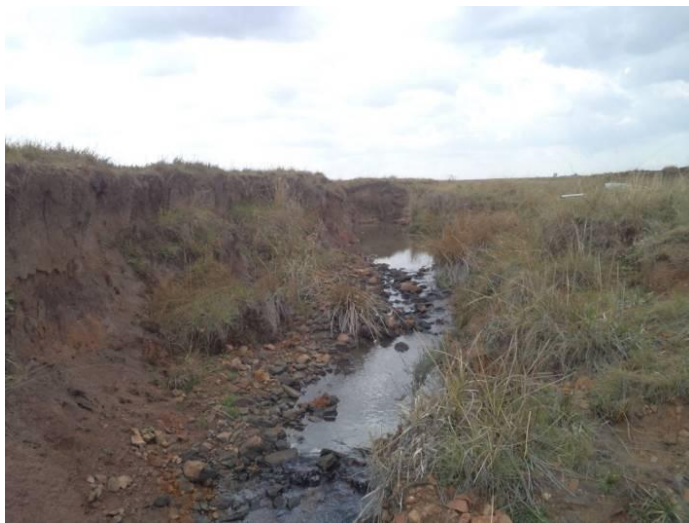
Figure 4: Upstream view of the Selons River site RV1 indicating the low flow at the time of assessment (2011).

Flow condition	Under the low flow conditions (2011), there is limited flow present and the flow can be regarded as slow to still throughout the system. The habitat conditions present provide limited habitats for aquatic macro-invertebrates and fish and some species requiring very fast flowing water are likely to be absent from the system. January 2014 site survey included high flow conditions. The habitat conditions during 2014 provided suitable habitat for aquatic macro-invertebrates and fish species.	Under the relatively low flow conditions (2011), there is limited flow present and the flow can be regarded as slow throughout the system. The habitat conditions present provide a fair range of habitats for aquatic macro-invertebrates and fish but some species requiring very fast flowing water are likely to be absent from the system. January 2014 site survey included high flow conditions. Habitat conditions during 2014 high flow season provided suitable habitat for aquatic macro-invertebrates and fish species.

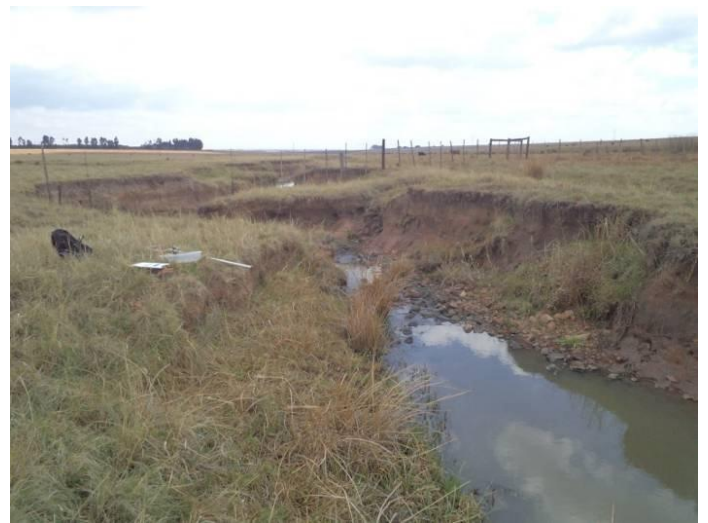
Figure 5: Downstream view of the Selons River site RV1 indicating bank side erosion (October 2011).

Water clarity	Water is slightly silted.	Water is slightly silted.
Water odour	No odours were evident.	No odours were evident.
Erosion potential	High potential for erosion is present, due to the poorly vegetated banks.	Some potential for erosion is present, especially under high flow conditions, however the banks are fairly well vegetated.

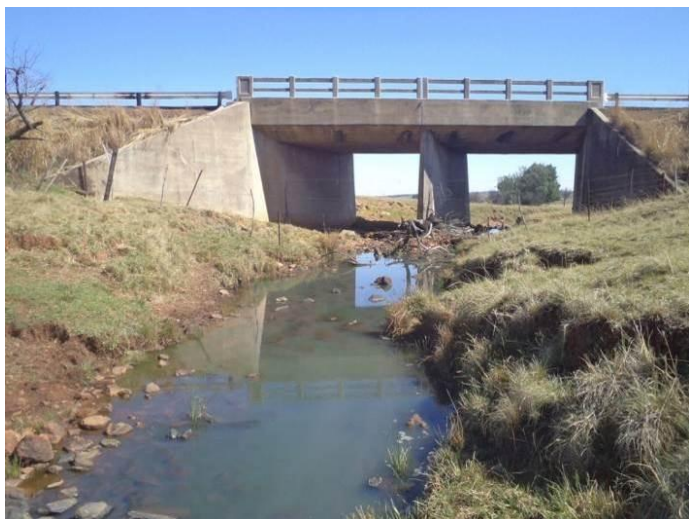
Figure 6: Downstream view of the Selons River site RV2 near the R555 bridge (October 2011).

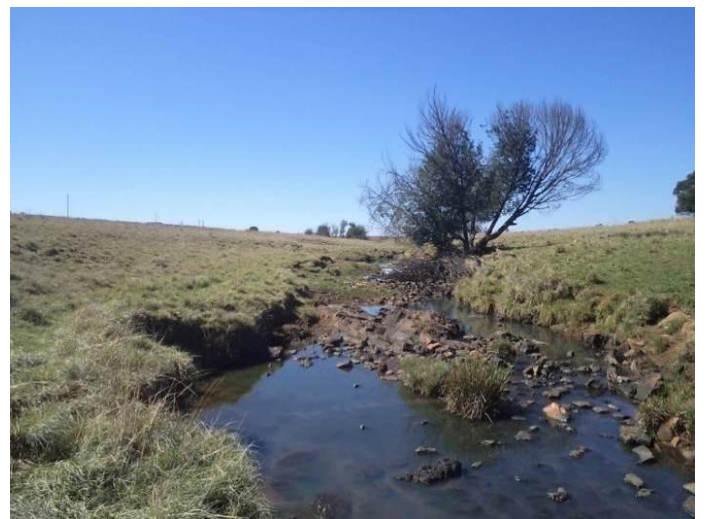
Figure 7: Upstream view of the Selons River site RV2 (October 2011).

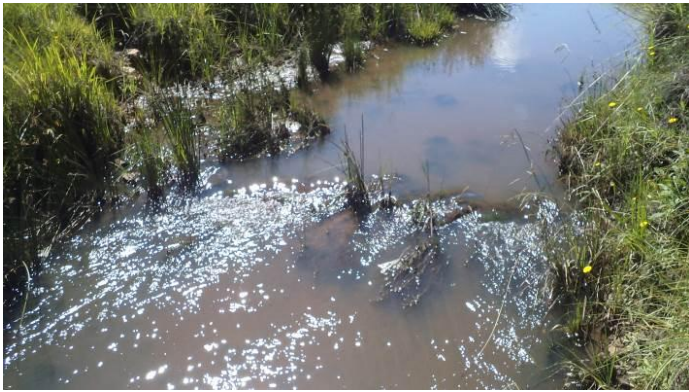
Figure 8: Upstream view of the Selons River site RV1 indicating the high flow at the time of assessment (2014).

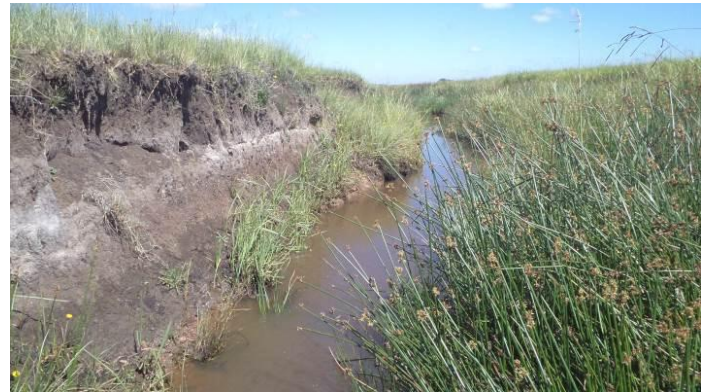
Figure 9: Downstream view of the Selons River site RV1 indicating good vegetation cover on the right and bank side erosion on the left (January 2014).

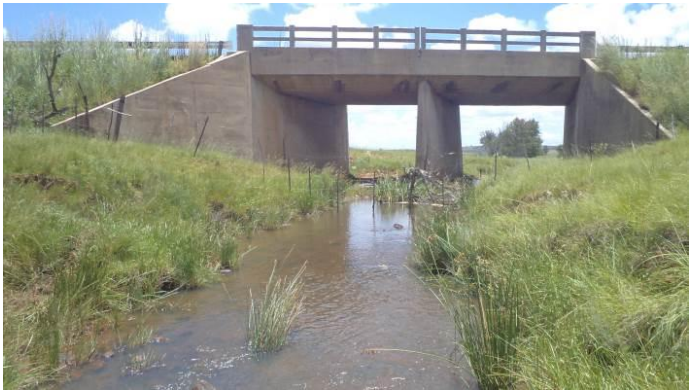
Figure 10: Downstream view of the Selons River site RV2 near the R555 bridge indicating good vegetation (October 2014).

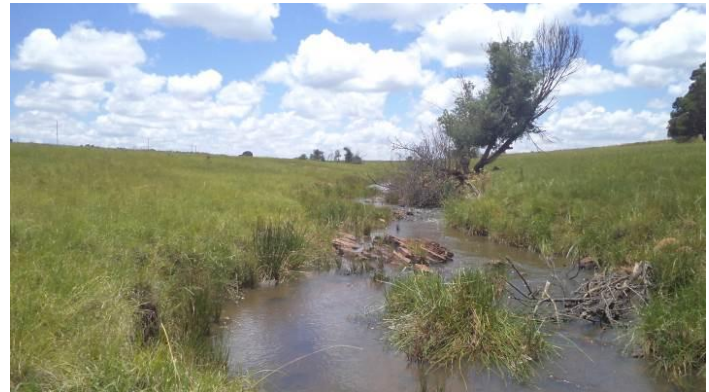
Figure 11: Upstream view of the Selons River site RV2 indicating high flow (January 2014).

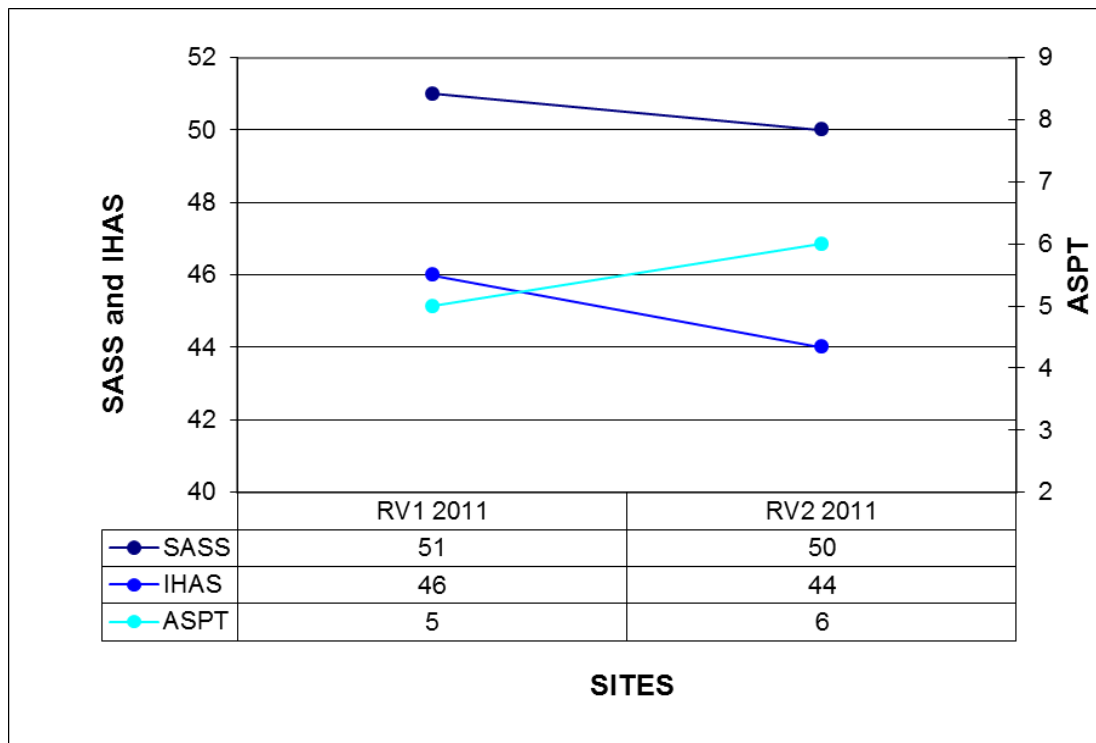
Figure 14: SASS5, IHAS and ASPT scores showing spatial trends for 2011

- During the early spring 2011 assessment, the two assessment sites can be considered as Class D (largely impaired) sites according to the Dickens and Graham (2001). With mostly tolerant taxa present.
- According to Dallas (2007) classification systems the upstream RV1 site and the downstream RV2 site are classed a Class E/F (severely/critically impaired). This is due to the naturally limited habitat that is available and the lack of flow in the river at the time of assessment (early spring 2011).
- Based on the available habitat conditions with special mention of the lack of flow and the lack of bankside vegetation cover, the poor aquatic macro-invertebrate community score in the system is most likely due to the limited availability of natural habitat at the RV1 and RV2 sites.

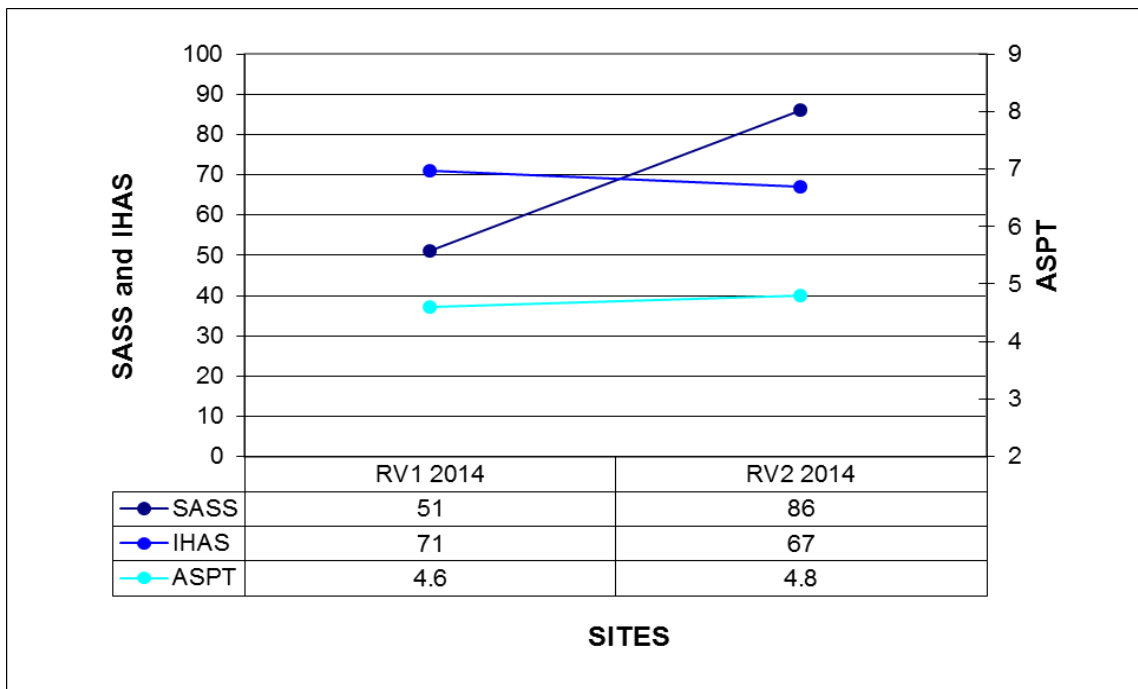
Figure 15: SASS5, IHAS and ASPT scores showing spatial trends for 2014

- At present, during the early 2014 assessment, the two assessment sites can be considered as Class D (largely impaired) sites according to the Dickens and Graham (2001).
- According to Dallas (2007) classification systems both upstream RV1 site and downstream RV2 sites are classed a Class E/F (severely/critically impaired). Even with an increase in flow these classifications have remained the same since the 2011 site survey at both sites.
- Based on the available habitat conditions the poor aquatic macro-invertebrate community score in the system is most likely due to the limited availability of natural habitat at the RV1 and RV2 sites.

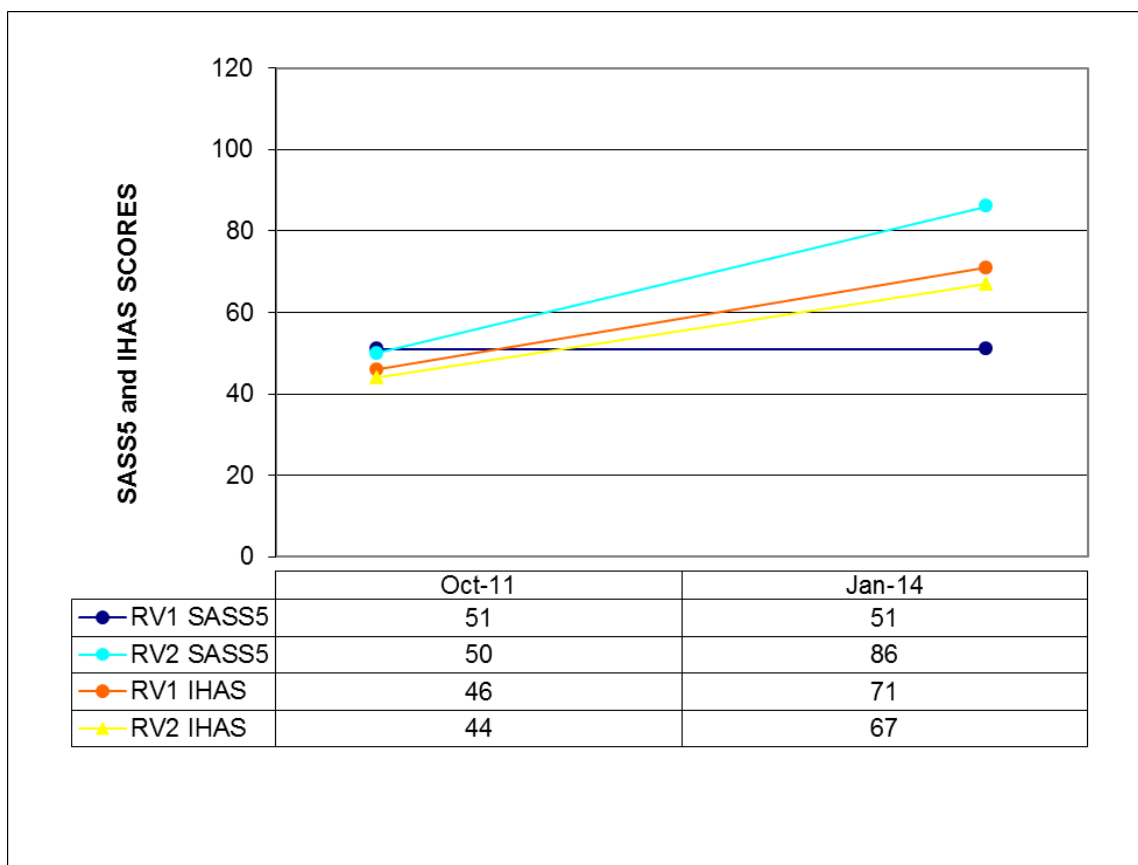
Figure 16: SASS5 and IHAS scores showing temporal trends for 2011 and 2014
