Underwater Heritage Impact Assessment, Prospecting Application for Sea Concession 14C, West Coast, South Africa

UNDERWATER HERITAGE IMPACT ASSESSMENT FOR A PROSPECTING APPLICATION FOR SEA CONCESSION 14C, WEST COAST

Report #: 2022/WC/004

Date: 07 April 2022

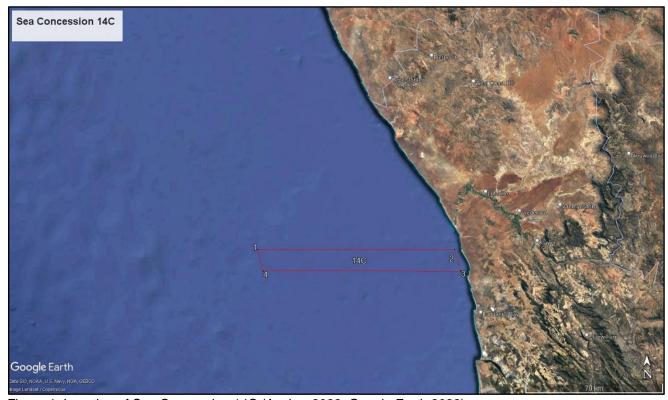
Figure 1: Location of Sea Concession 14C (Anchor 2022; Google Earth 2022)

The Sea Concession, 14C is considered in this report (**Error! Reference source not found.**). The area c. 1060 k m² and is between Doring Bay and Donkin Bay on the west coast of South Africa.

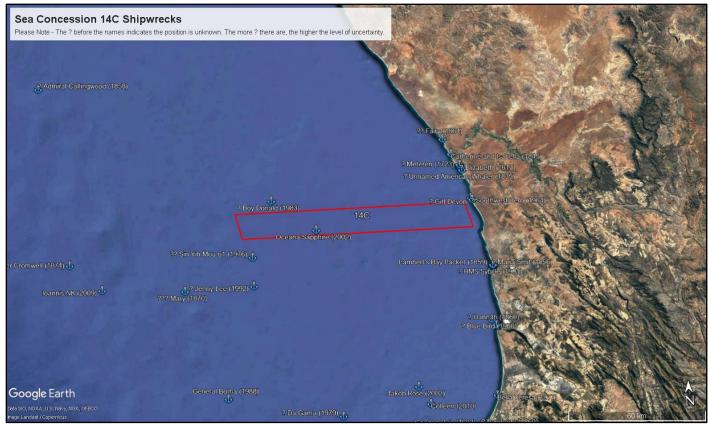
Figure 4: Shipwrecks in and around Sea Concession 14C (Google Earth 2022; SLR 2018; Turner 1988; Levine 1989; van den Bosch 2009; SAHRIS 2017; Reocities 2017; Maitland 2022; u-boat.net 2017)
