**REPORT ON THE GEOTECHNICAL CONDITIONS ON
PORTION 30 OF PORTION 29 OF THE FARM
BLAAUWS KOP 36, DISTRICT KENHARDT**

2020/J011/MCP

ON BEHALF OF : MACROPLAN

PREPARED BY : CEDARLAND GEOTECHNICAL
CONSULT (PTY) LTD

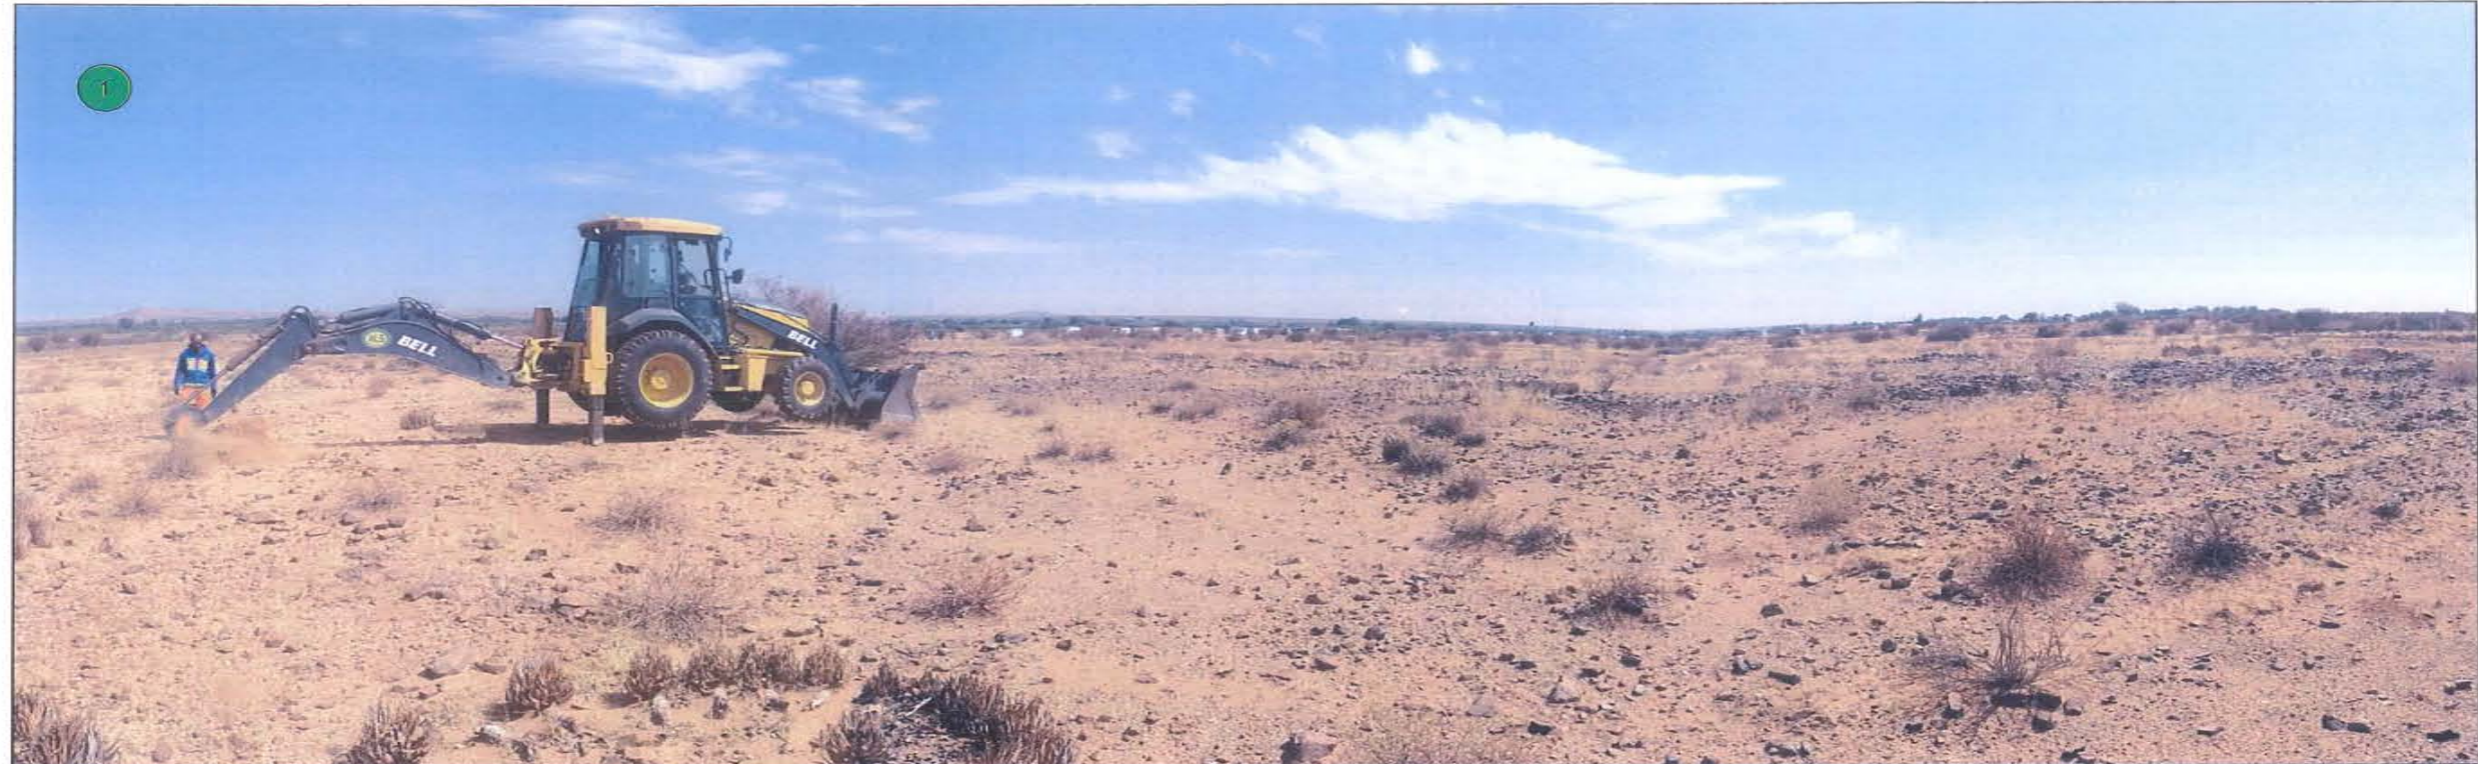
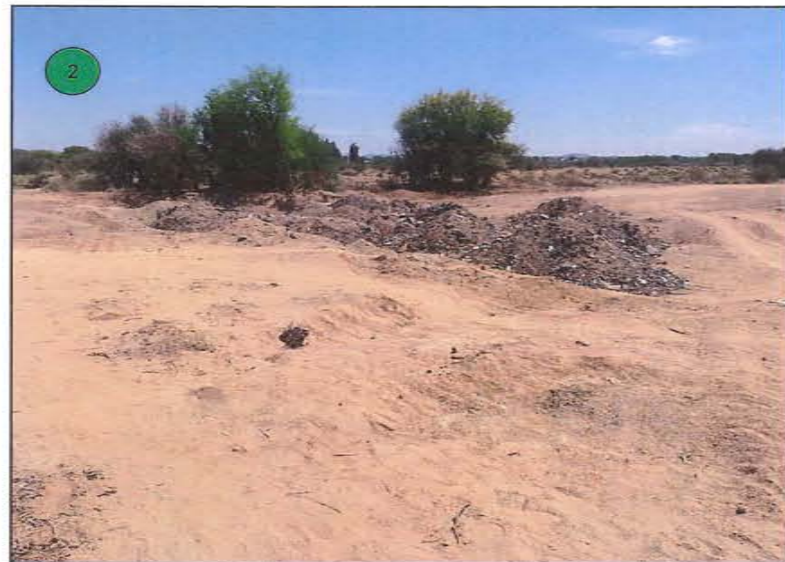
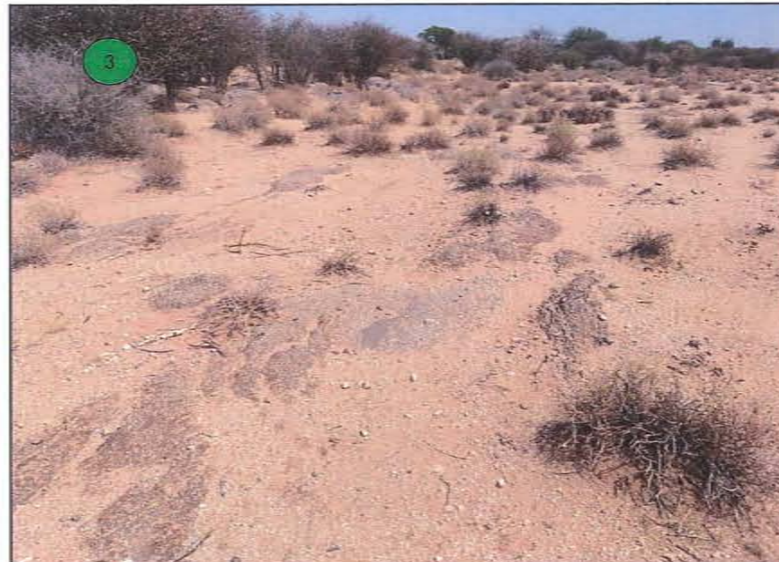
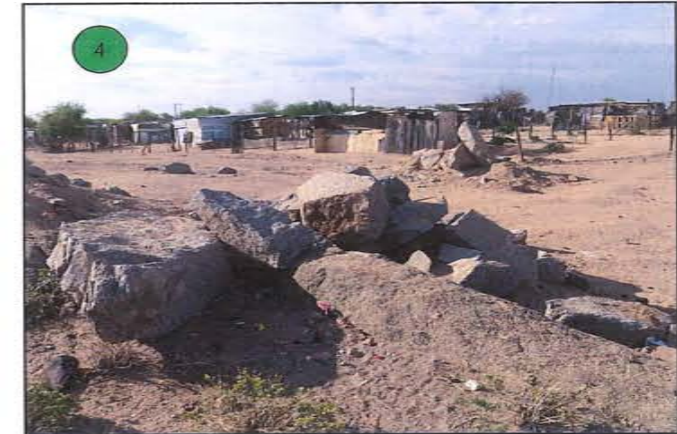
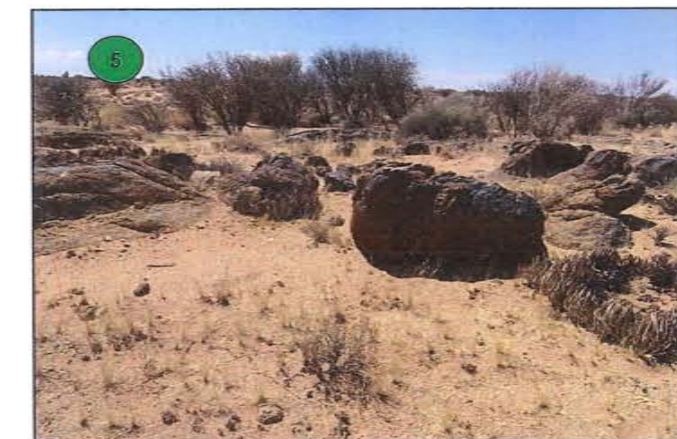
SITE CONDITIONS IN PLANGENI

- 1 Site conditions as seen from southeastern corner. Test pit 1 in excavation. Slight dip and darker rock line may represent a fault zone.
- 2 Informal waste site.
- 3 Granite exposed in non-perennial water course.
- 4 Blocks of excavated (blasted) solid granite.
- 5 Granite corestones.

Site conditions are illustrated on Photo 1 : Site Conditions. The area can be divided into two zones as follows :

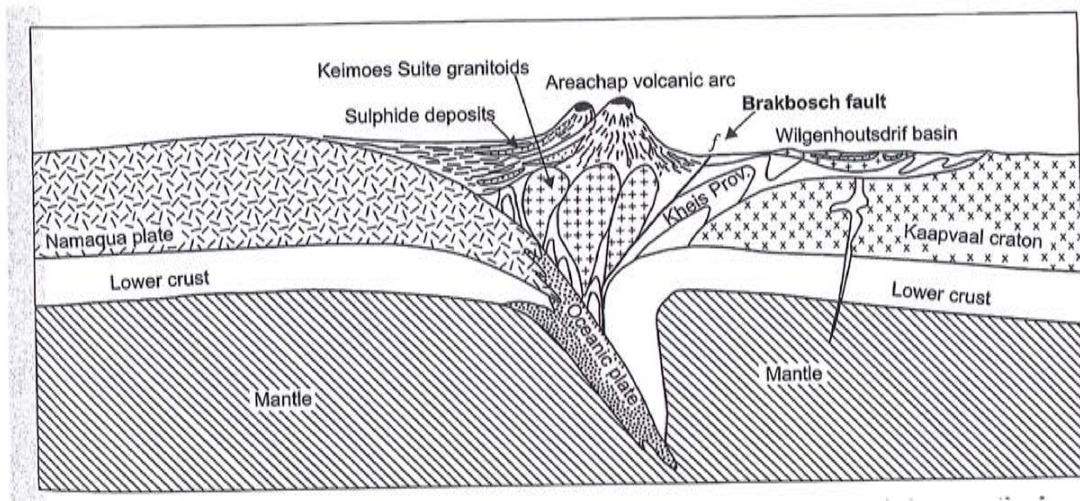
FIGURE 5 : SCHEMATIC PLATE TECTONIC MODEL SHOWING THE GRANITOIDS OF THE KEIMOES SUITE

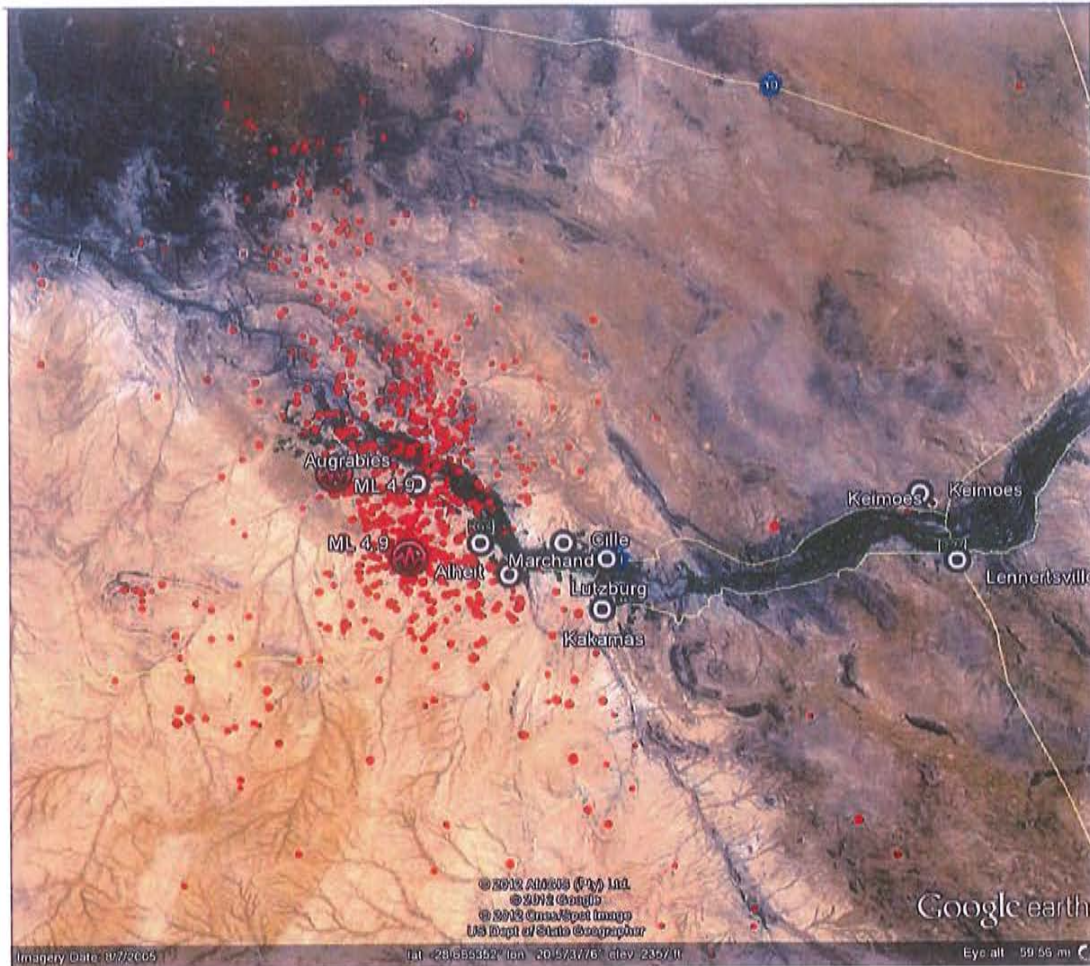
FIGURE 8 : HISTORIC OCCURRENCES OF EARTHQUAKES IN THE KAI IGARIB AREA

The closest source of seismic measurements to Plangeni under control of the Council for Geoscience is Tontelbos at $31^{\circ} 10' 12''S$ and $20' 30' 00''E$. Kijko^{Reference 14.10} indicates the following :

- The annual probability for an earthquake with intensity of 4,5 on the Modified Mercalli Scale to occur in the area is less than $10^{-0,7}$; and with an intensity of 8,5 to occur the probability is $10^{-3,8}$.
- The annual probability for an earthquake with an acceleration of $10^{-1,9}g$ to occur in the area is less than $10^{-0,7}$; and with an acceleration of $10^{-0,75}g$ to occur in the area is less than $10^{-3,8}$.
- A 10% probability exists that an earthquake with Peak Ground Acceleration exceeding of 0,07g may take place once in 50 years.

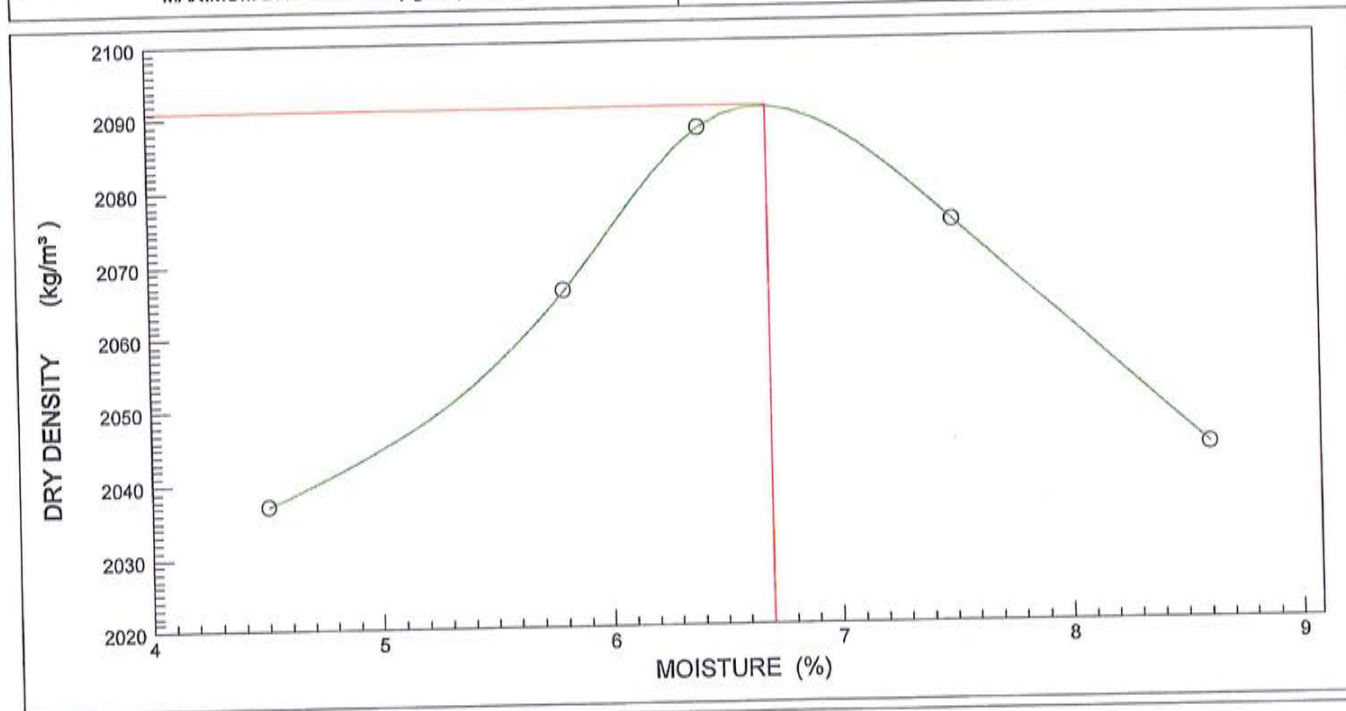
SAMPLE NO.	U9428
CONTAINER FOR SAMPLING	Black Nylon Bags
SIZE / APPROX. MASS OF SAMPLE	82kg
MOISTURE CONDITION OF SAMPLE	Moist
LAYER TESTED / SAMPLED FROM	400-800mm
MATERIAL DESCRIPTION	Mix W.Calcrete + W. Quartz
HOLE NO./ km / CHAINAGE	TP6
ROAD NO.	Not Specified
DATE RECEIVED	2020-10-06
DATE SAMPLED	2020-10-06
CLIENT MARKING	
COLOUR AND TYPE	Light Greyish Brown Gravel

POINT NO.	1	2	3	4	5			
DRY DENSITY (kg/m ³)	2037	2066	2088	2075	2044			
MOISTURE (%)	4,5	5,8	6,4	7,5	8,6			
MAXIMUM DRY DENSITY (kg/m ³) : 2091				OPTIMUM MOISTURE CONTENT (%) : 6.7

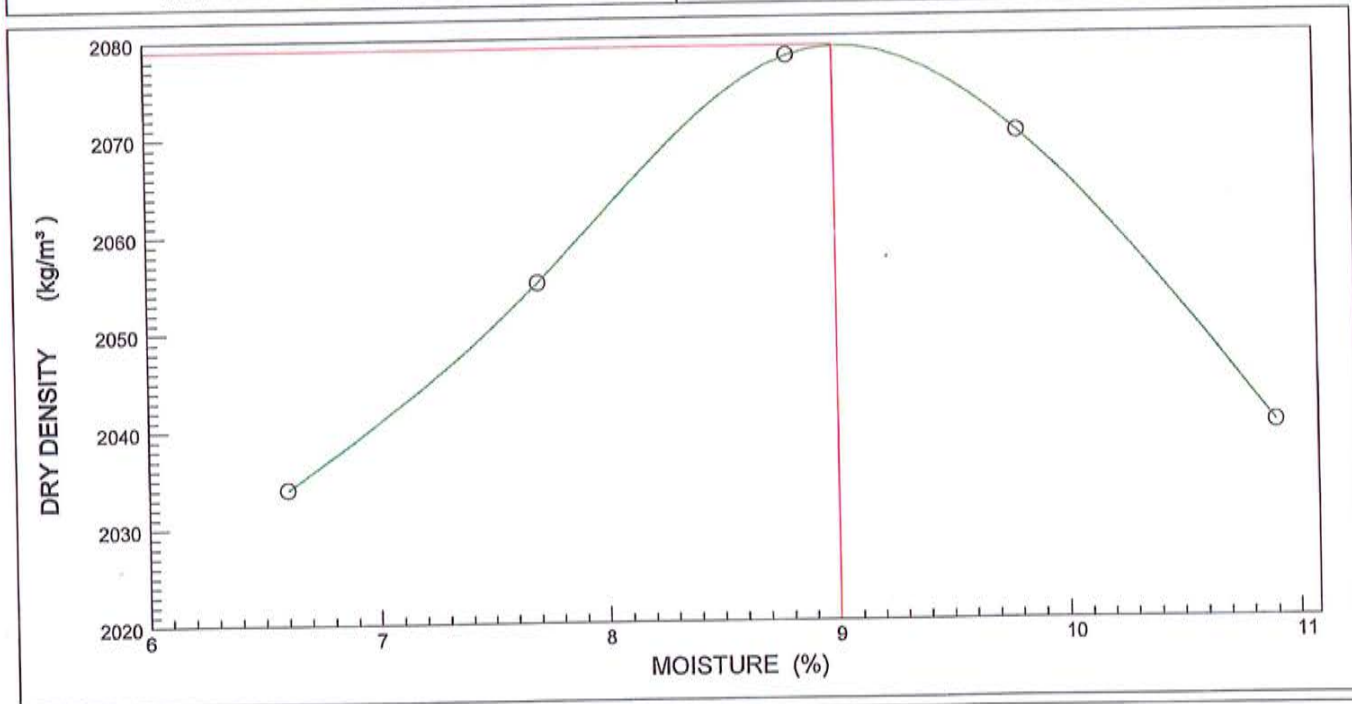
MAXIMUM DRY DENSITY (kg/m³) : 2079

OPTIMUM MOISTURE CONTENT (%) : 9,0

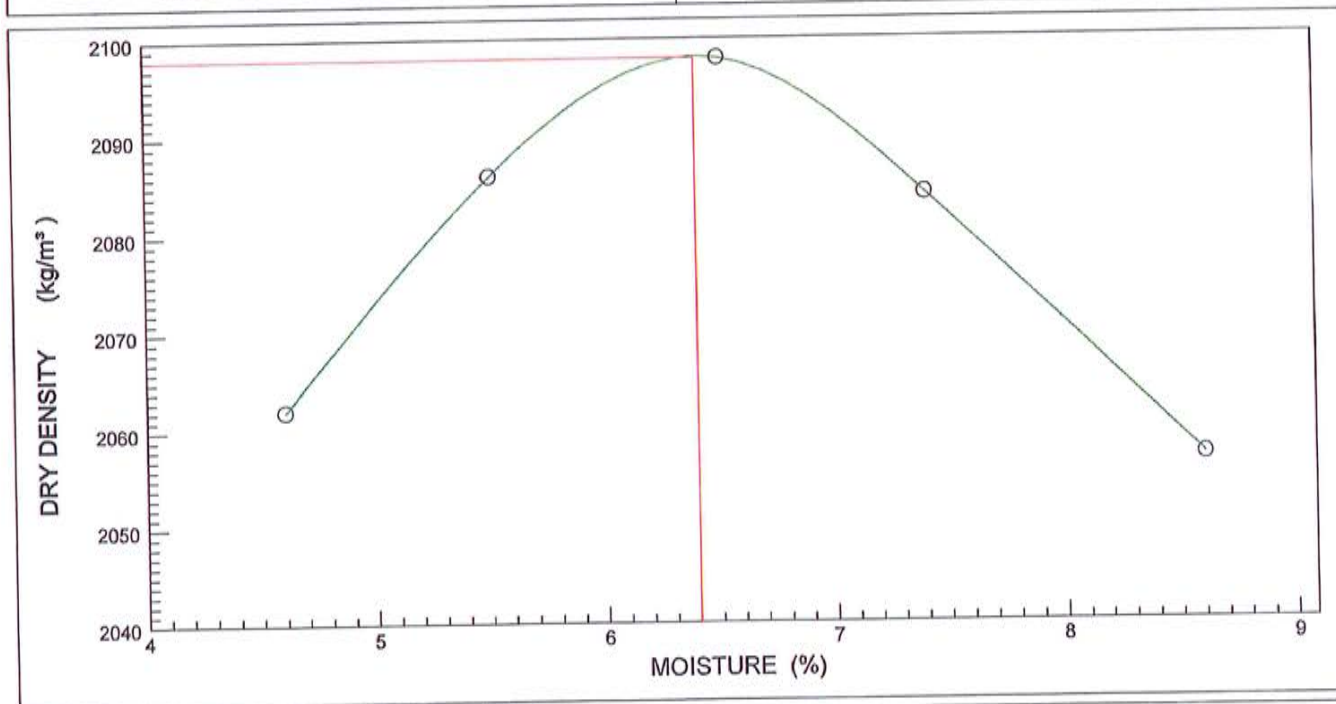
MAXIMUM DRY DENSITY (kg/m³) : 2098

OPTIMUM MOISTURE CONTENT (%) : 6,4
