SITE SENSITIVITY VERIFICATION and PLANT BIODIVERSITY COMPLIANCE STATEMENT

**PROPOSED CONSTRUCTION OF 132 KV
POWERLINES BETWEEN THE AUTHORISED
LOERIESFONTEIN 3 PV SOLAR ENERGY
FACILITY (12/12/20/2321/2/AM4) AND THE
AUTHORISED DWARSRUG WIND ENERGY
FACILITY (14/12/16/3/3/2/690/AM4), AND
FROM THE DWARSRUG WIND ENERGY
FACILITY TO THE AUTHORISED NAROSIES
SUBSTATION (12/12/20/2049/3), LOCATED
NEAR LOERIESFONTEIN IN THE HANTAM
LOCAL MUNICIPALITY, NAMAKWA DISTRICT
IN THE NORTHERN CAPE PROVINCE OF
SOUTH AFRICA**

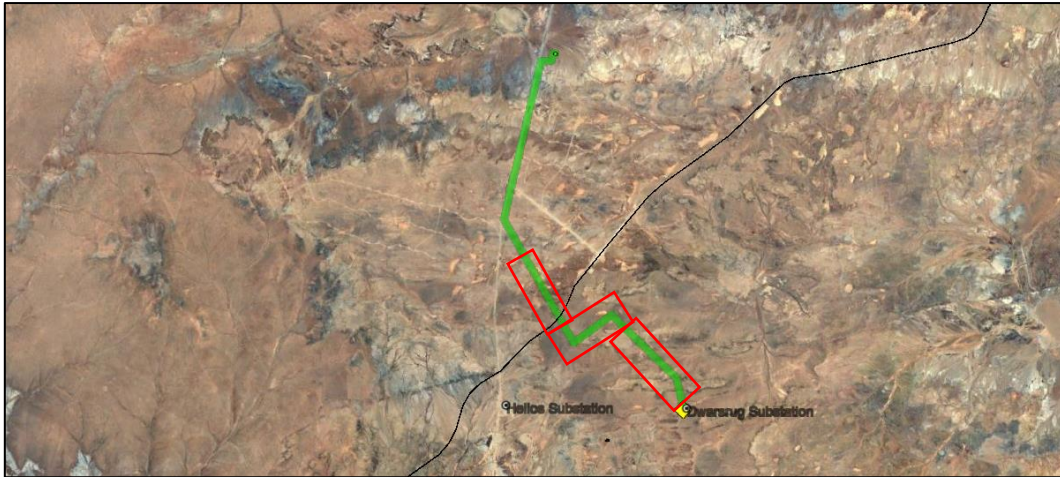
Figure 2: View of the proposed corridor for the new power line to link the Loeriesfontein Substation and the Dwarsrug Substation. The areas blocked in red indicate the low hills and drainage lines that are considered to be sensitive.

With this climatic conditions in mind, the walk down focused more on the habitat associated with the three options (Figure 1) that was proposed for the new power line. In general, the vegetation cover for the three proposed options were similar (sparse and very dry) with numerous patches devoid of any vegetation. The few exceptions was the more dense vegetation along the drainage lines. In addition, the low hills to the east of the site (Option 2) and the area south of the Sishen/Saldanha railway line are considered to be sensitive (Option 1 and 2 link Dwarsrug WEF to Loeriesfontein 3 PV – Option 3, to link Dwarsrug WEF to the Narosies power line) (Figure 2, 3 and 4).

- The area is associated with the current activities and disturbances of the project (newly constructed wind generator infrastructure):
 - It is near the Loeriesfontein/Granaatboskolk road and in an area where the vegetation shows the most signs of modification due to the construction of the wind generators
 - There are a few very small drainage lines noted, but the slope are not severe (some erosion was noted during the walk down – associated with the recent construction activities **and urgent rehabilitation must be carried out**)
 - There is better access from the wind farm property (access roads) to the proposed corridor (shorter distances)
 - The section south of the Sishen/Saldanha railway line is in a fair to good condition
 - It is recommended to limit traffic during construction
 - The low hills and associated drainage lines are sensitive (Figure 2)

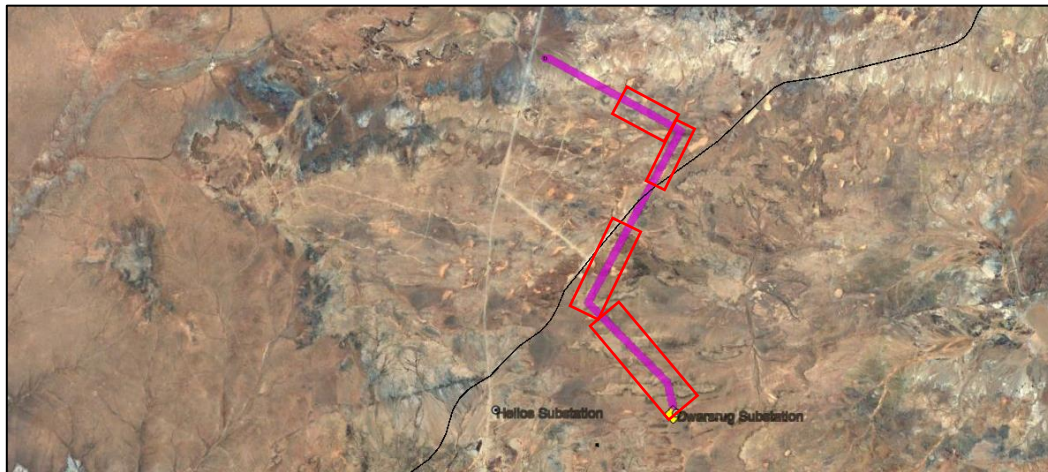
Figure 3: Option 2 – with sensitive low hills and drainage lines indicated in red.

- There are a number of small drainage lines along this corridor that will increase the erosion potential and added impacts on the vegetation – these systems drain to the Bitterputs Pan in the northeast. These pans form part of the important Bushmanland Vloere vegetation type (Mucina and Rutherford, 2006) (Figure 3).

- According to Todd (2014) the drainage lines associated with the study area are not well developed, which can be ascribed to the stony nature of the area and the low rainfall. “The drainage lines are typically dominated by species such as *Phaeoptilum spinosum*, *Rhigozum trichotomum* and *Osteospermum armatum* along their banks, with *Stipagrostis namaquensis* typically dominating any relatively stable sediments or bed material. Due the ecological role they play and their vulnerability to disturbance, drainage lines are considered sensitive and should be avoided as much as possible” (Figure 3).

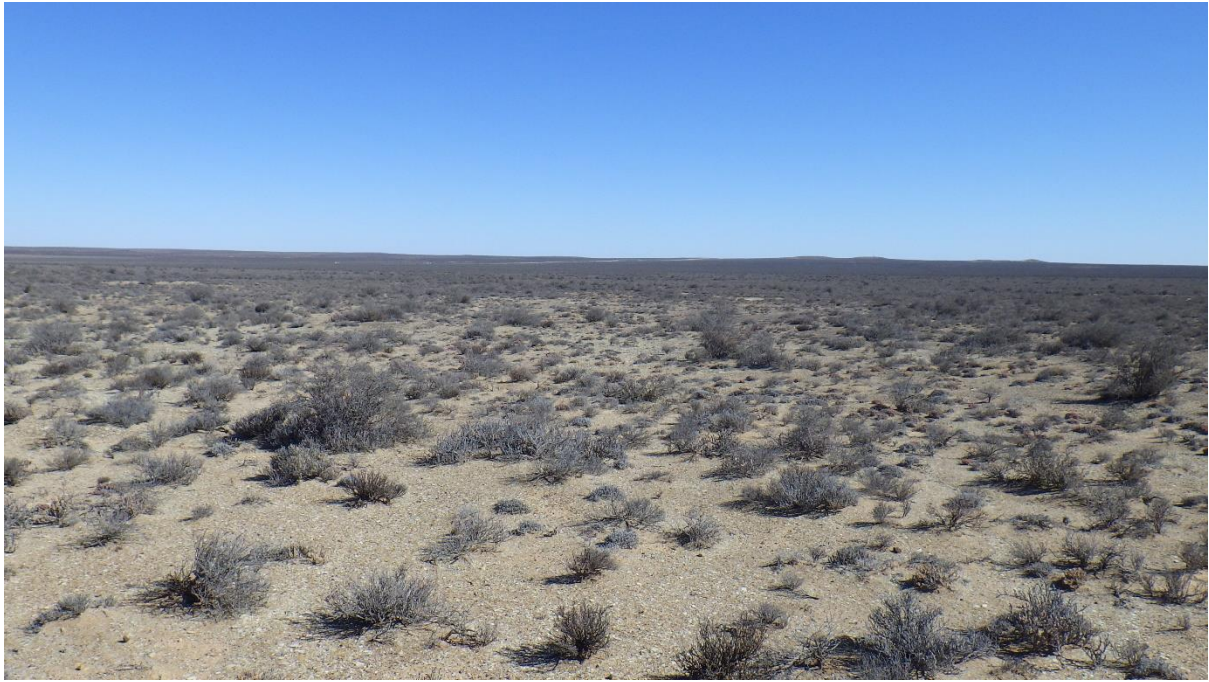
Figure 5: View of the vegetation (northern section) of Option 2.

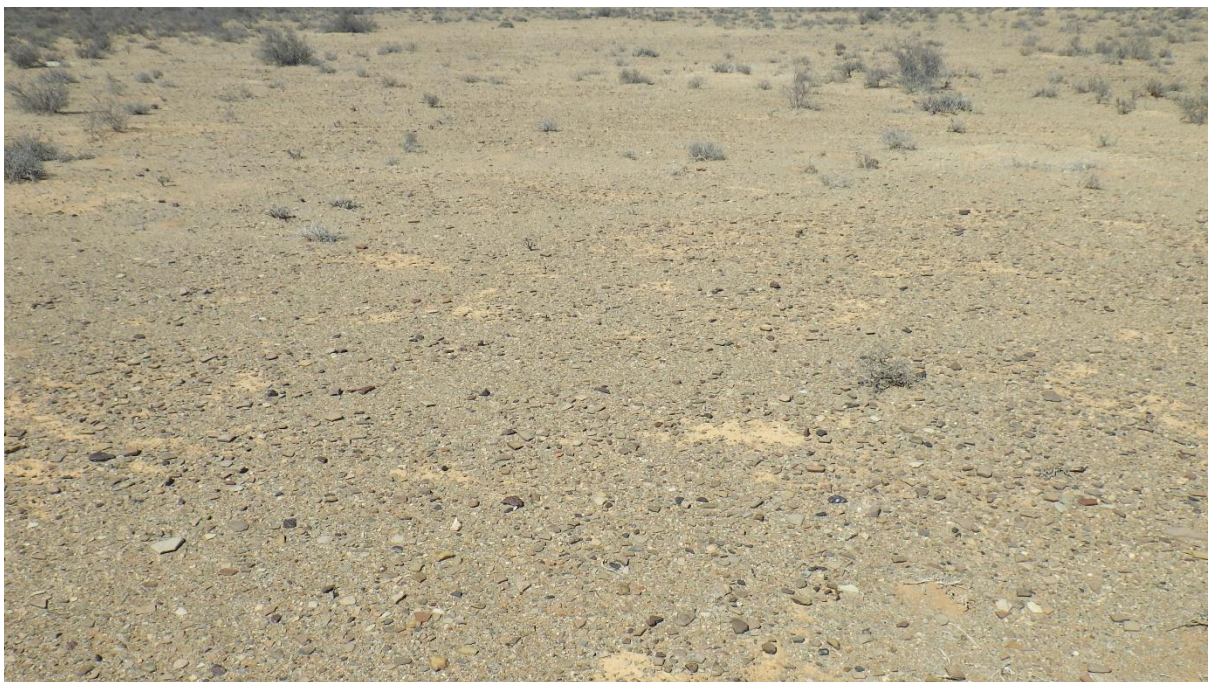
Figure 6: Some sections have very little vegetation (northern section – Option 2) and correspond with Todd (2014) observations.

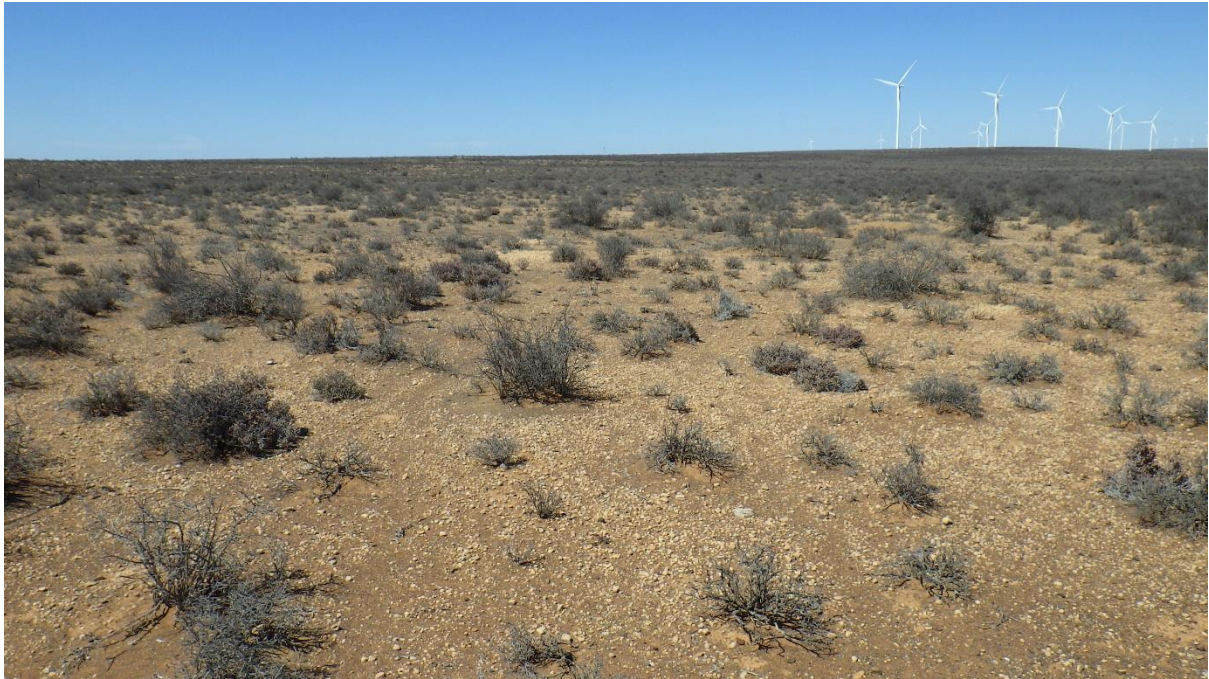
Figure 7: Vegetation on the eastern boundary (Option 2) in the section north of the railway line.

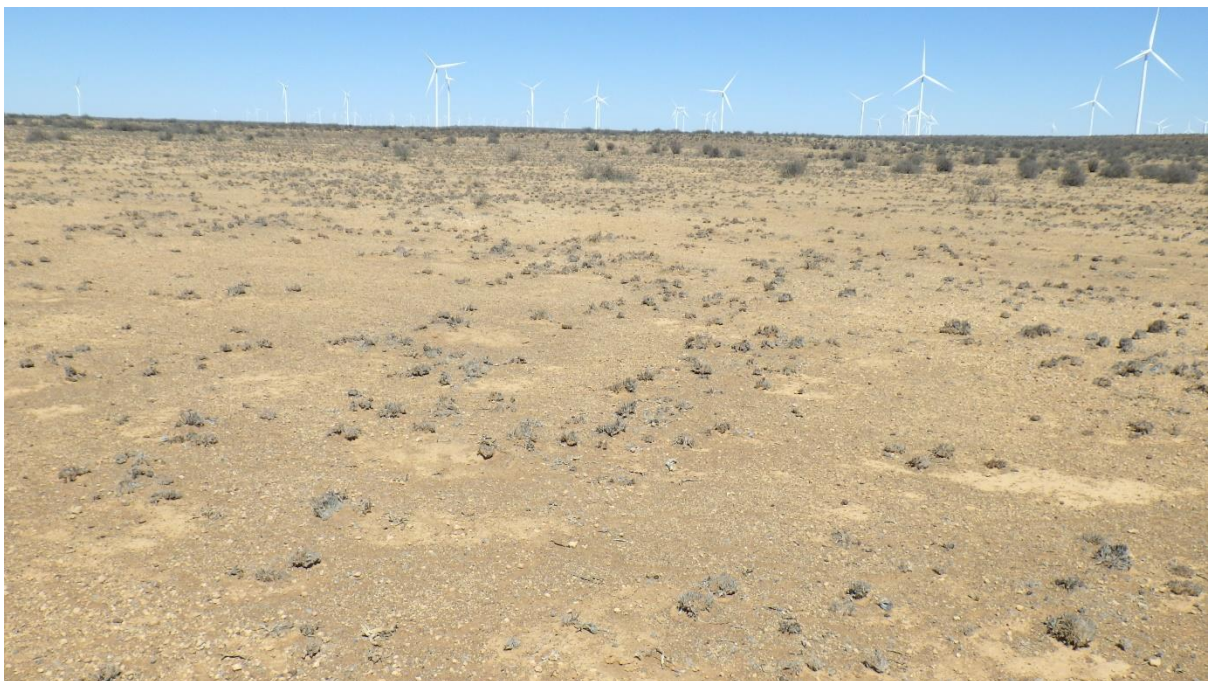
Figure 8: Some sections have very little vegetation (eastern section – Option 2) and correspond with Todd (2014) observations.

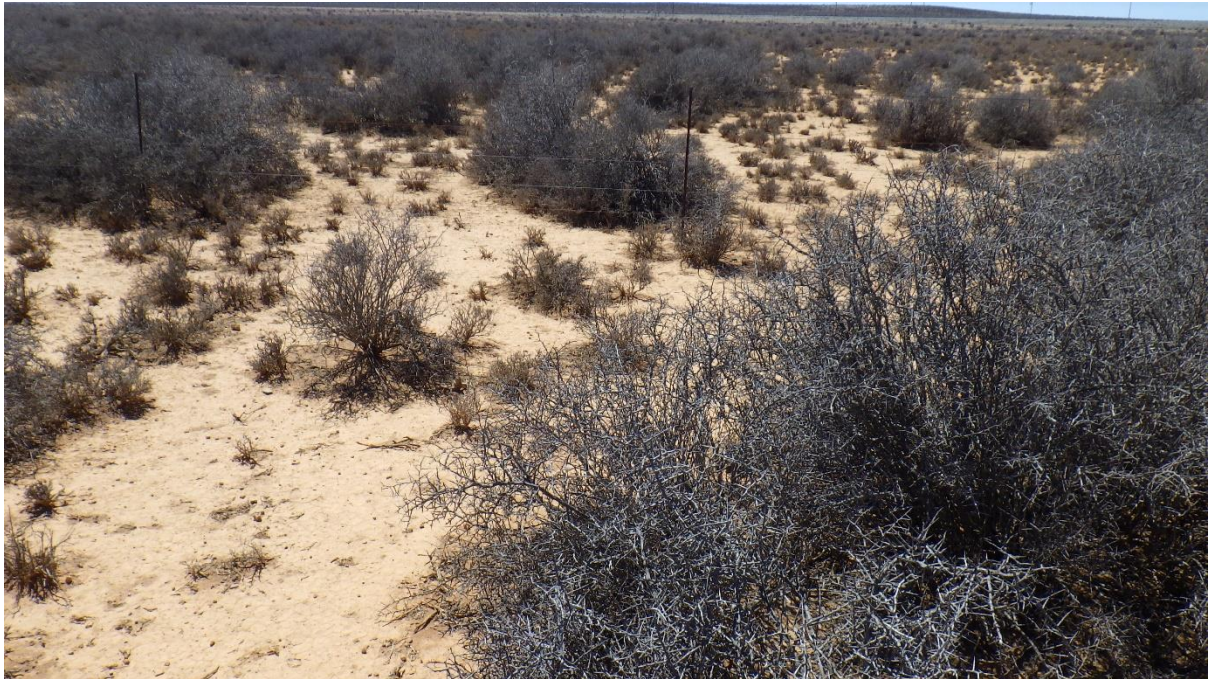
Figure 9: Example of a drainage line carrying water to Bitterputs Pan – not well-defined but denser vegetation is noted.

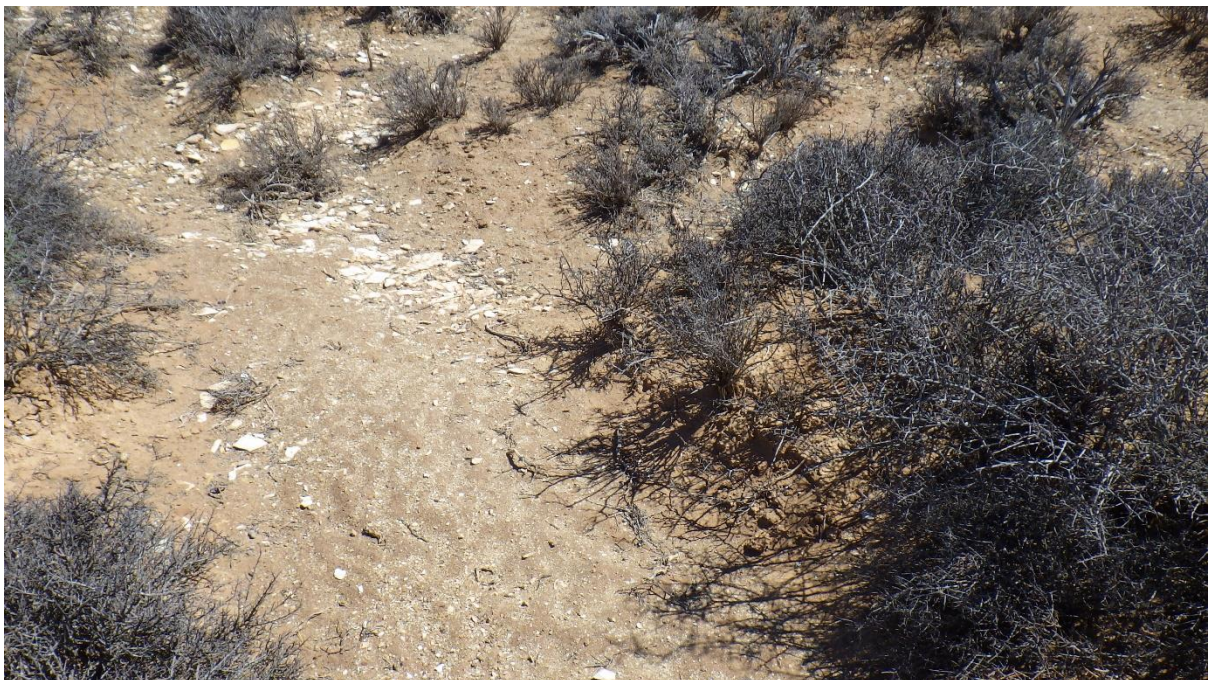
Figure 10: A more defined channel on the north-eastern/eastern sector of the corridor.

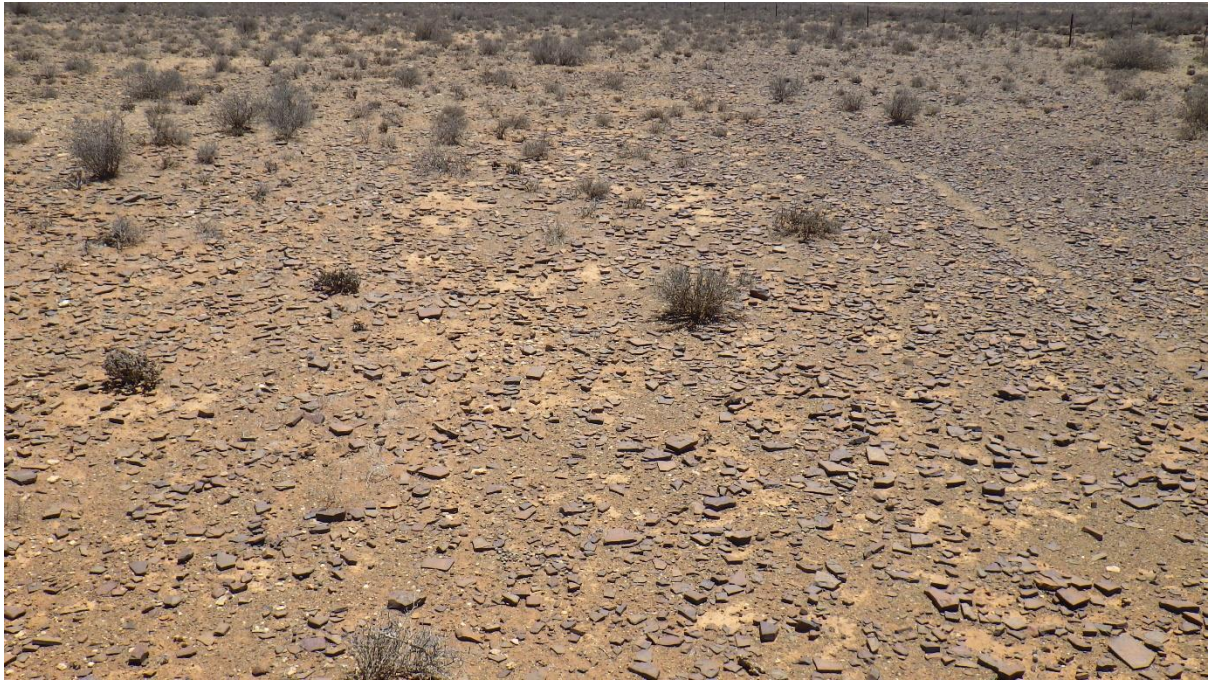
Figure 11: South of the railway line, some areas of Option 2 is dominated by hard, stony patches.

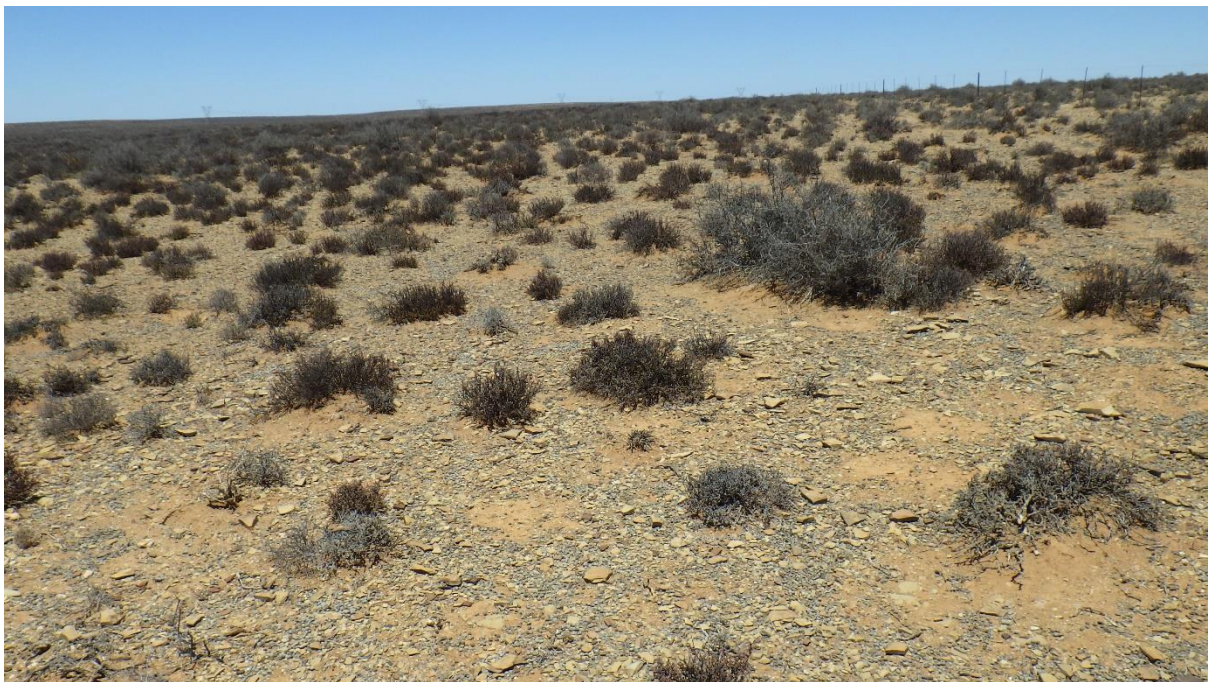
Figure 12: Option 2, south of the railway – little more vegetation, but still stony habitat.

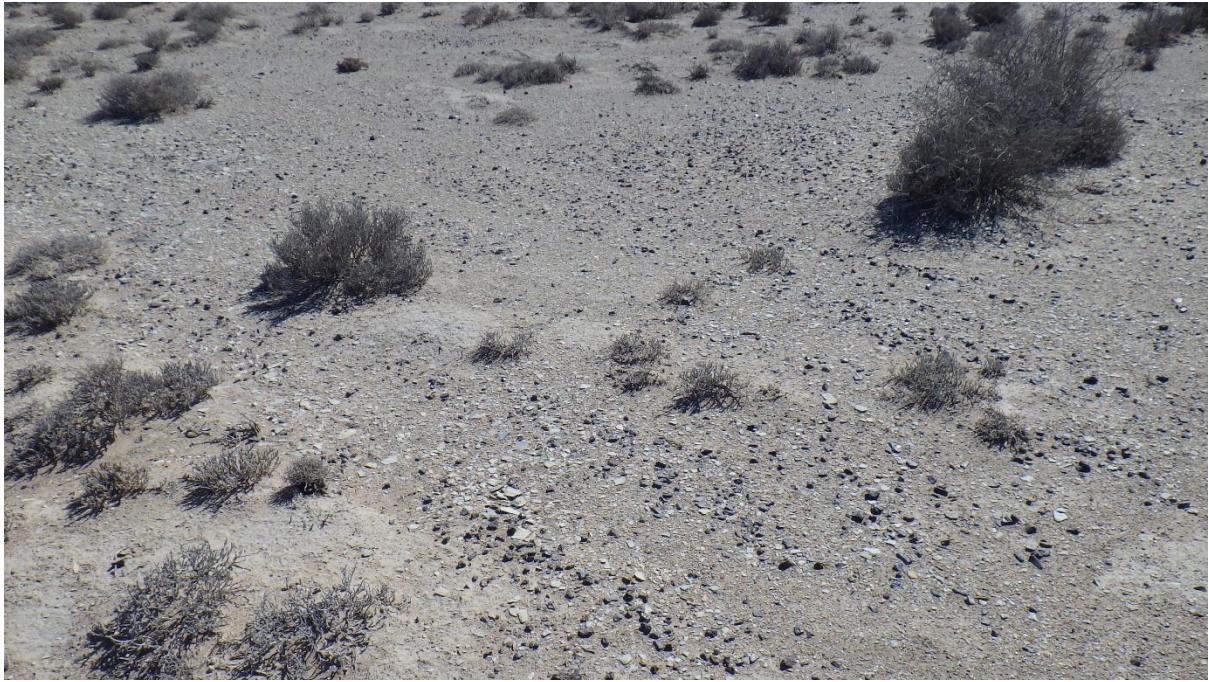
Figure 13: The western section (Option 1) with low vegetation cover in areas.

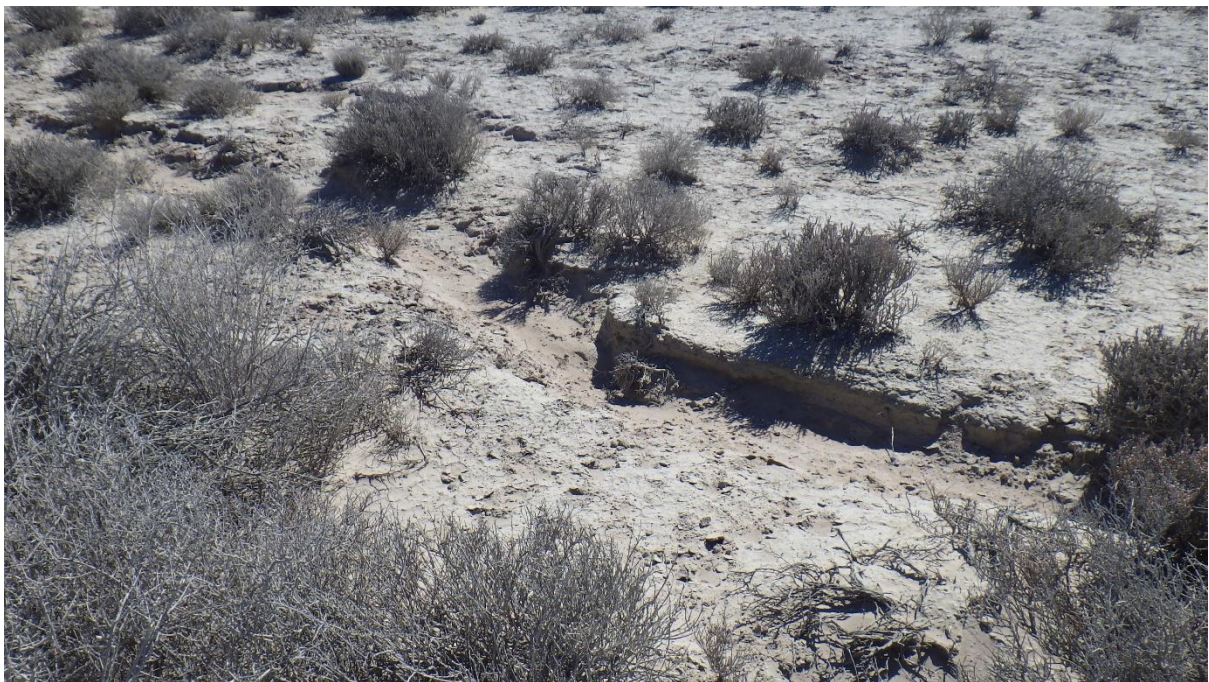
Figure 14: Example of erosion near the Loeriesfontein/Granaatboskolk road – reason for monitoring and rehabilitation.

6. A list of conditions and mitigating measurement has been provided that should be included in the EMPr.
7. It will be important to monitor all areas for erosion (both water and wind) as this will contribute the success of the project.

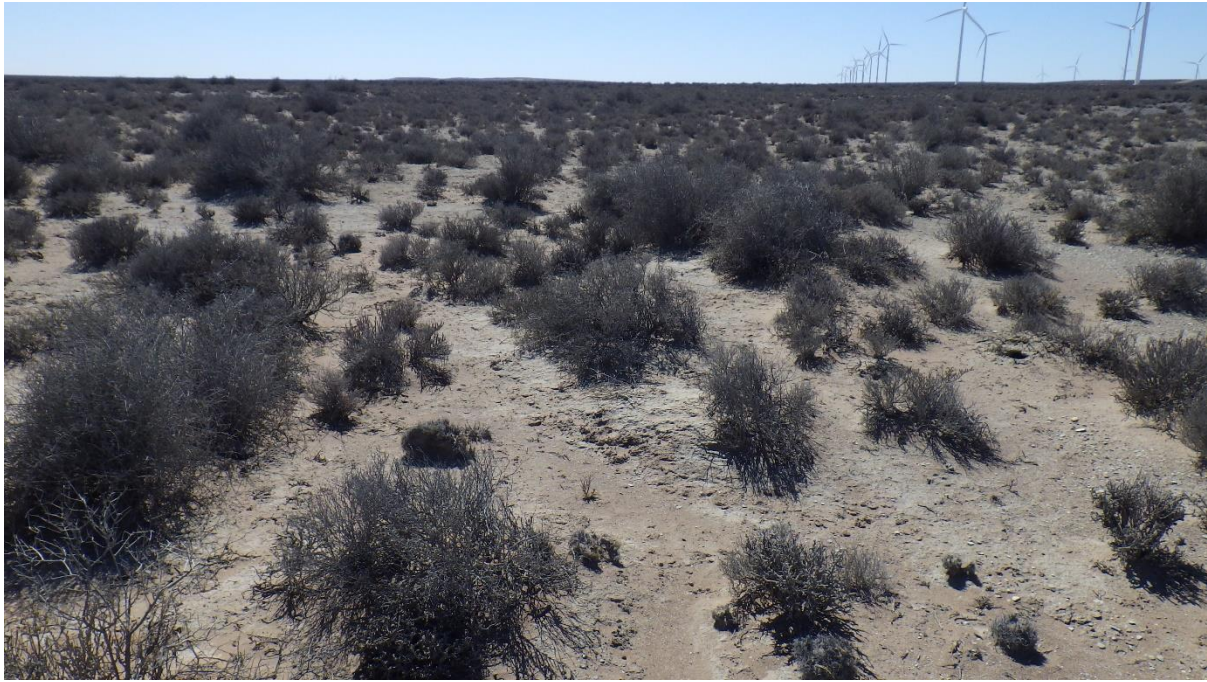
Figure 15: As was noted along Option 2, some areas along the proposed corridor for Option 1, denser vegetation patches are present.

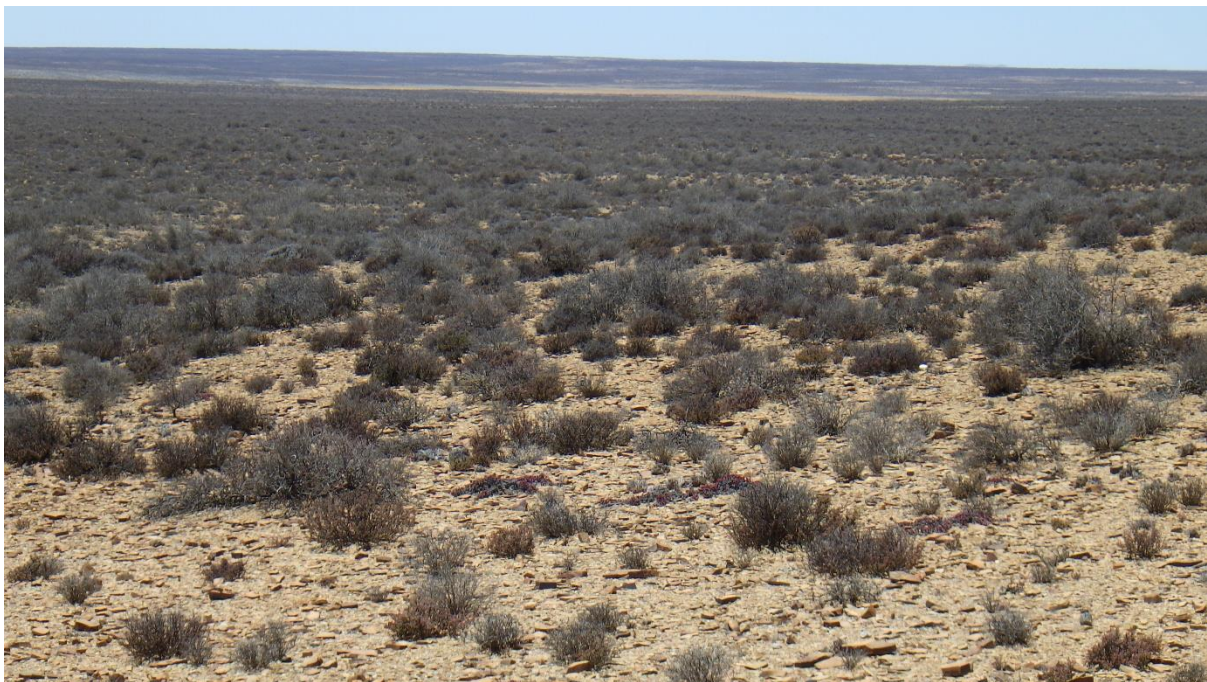
Figure 16: Along the southern sector of Option 1, some of the low hills are present.

With this in mind, once the final route is determined, a botanist must accompany the surveyors and construction team to ensure no species of concern on these low hills will be affected. The low incidence and abundance of the species will result in a very low impact from the structures. The main concern will be the clearing of the corridor and access road during construction.

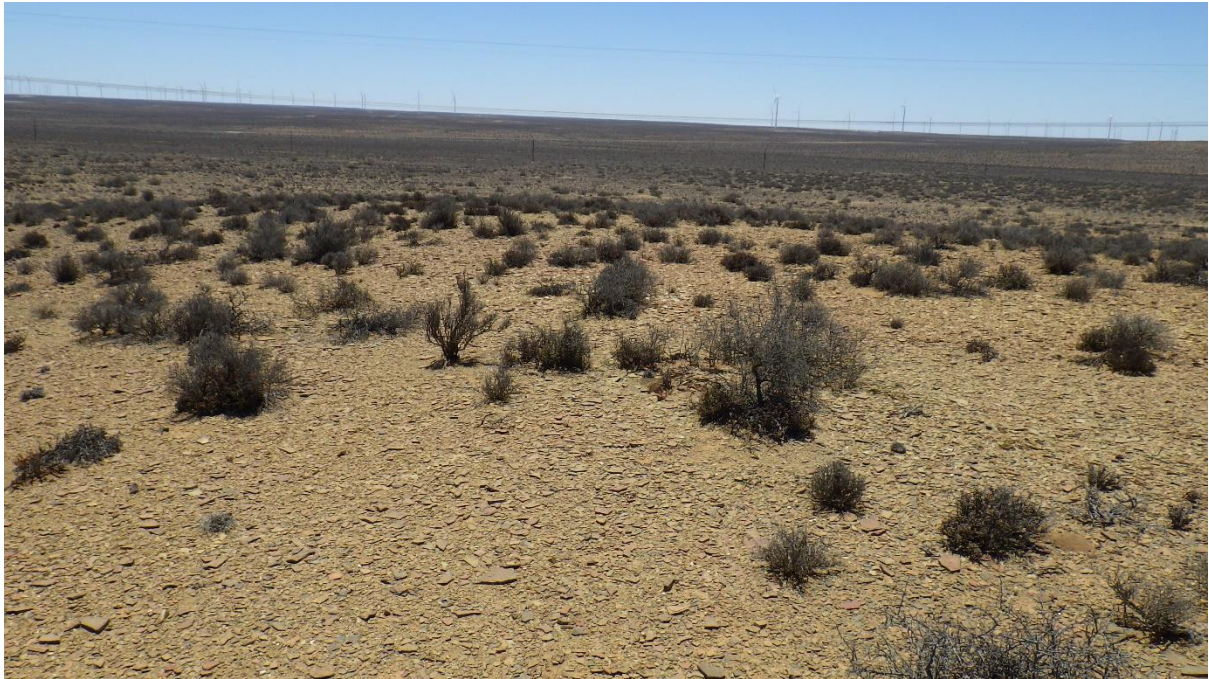
Figure 17: Some areas along this sector is very rocky with low plant cover.

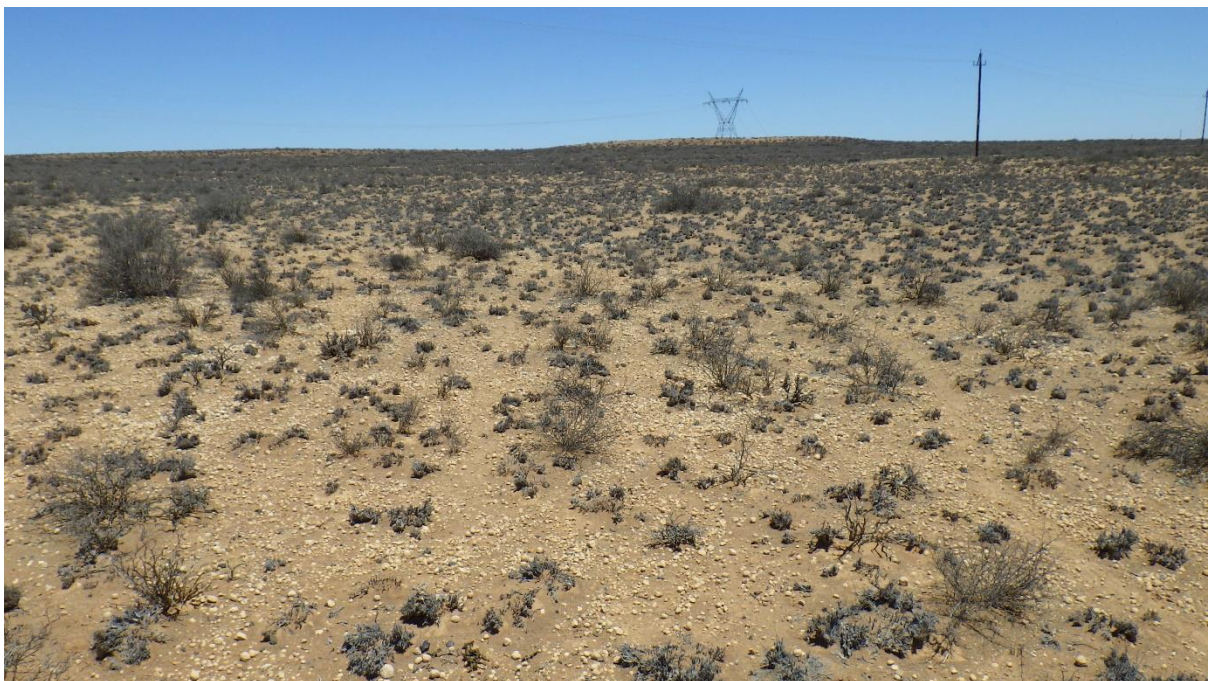
Figure 18: The low hills along the southern portion (Option 1 and 2) towards the BESS site.

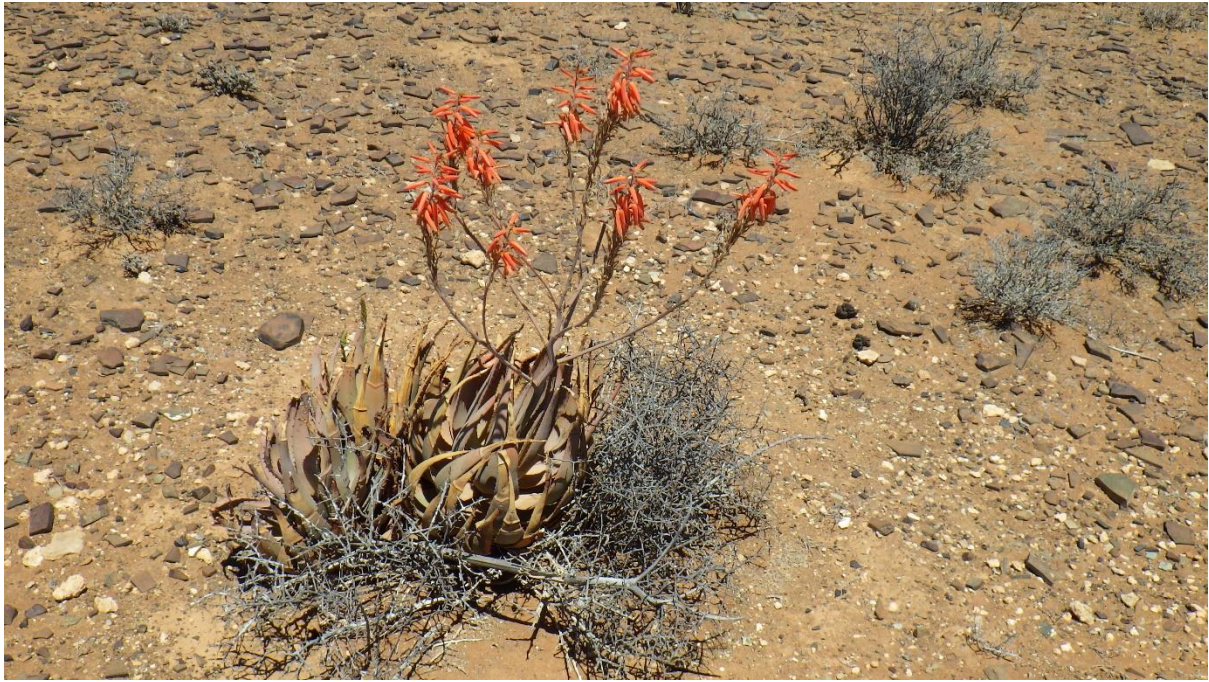
Figure 19: Example of *Aloe claviflora* along this sector – it must be left intact during construction.
