Phase 1 Heritage Impact Assessment for extension of existing Borrow Pit near Stella, Northwest Province.

Report prepared by Paleo Field Services PO Box 38806 Langenhovenpark 9330 December 2022

SITE SENSITIVITY AND TERRESTRIAL ECOLOGY VERIFICATION REPORT

Compiled for the Environmental authorisation for a mining permit registration of a Borrow Pit outside Stella, North West

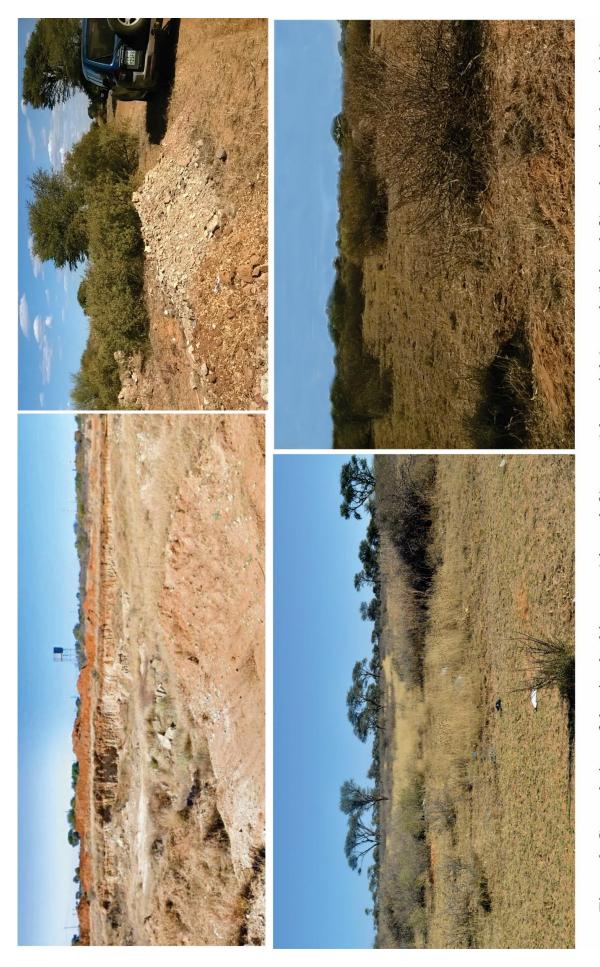
Figure 3. General view of the site, looking east (above left), west (above right), south (below left) and north (below right). ιJ

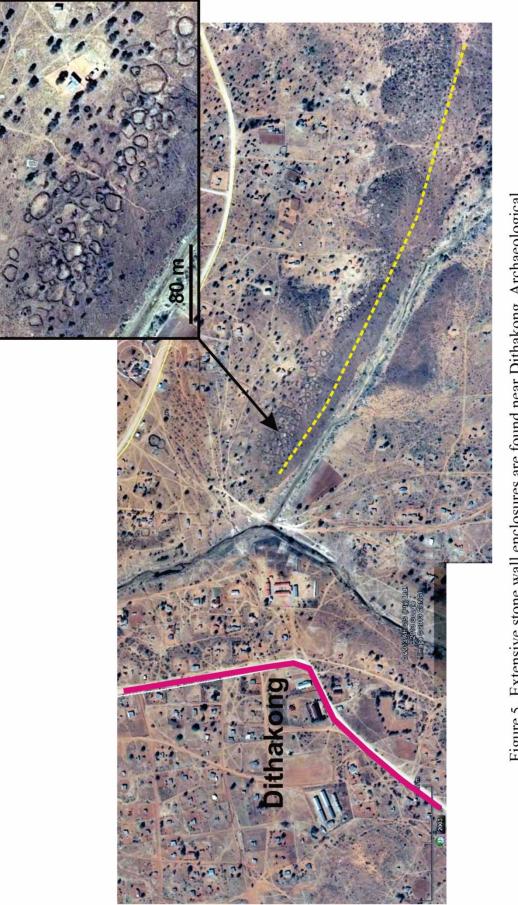
Figure 5. Extensive stone wall enclosures are found near Dithakong. Archaeological investigations conducted during the 1980's have revealed that the ruins were built during the 15th century A.D.

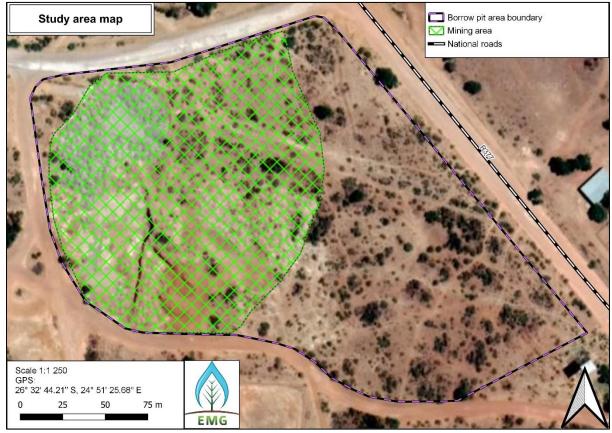
Figure 1: A study area map showing the borrow pit boundary and area which showed signs of excavation disturbances during the site visit.

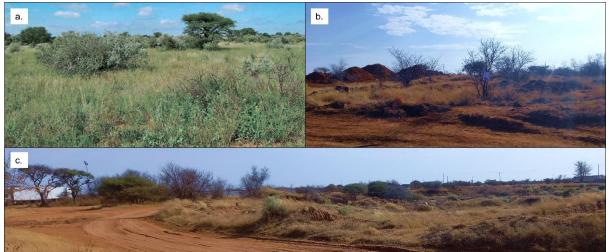
Figure 3: Ground view of the overall vegetation structure of a). SVk 2 Stella Bushveld (Mucina and Rutherford's,2006) in the optimal growing period. b). the remaining vegetation within the study area outside of the optimal growing period. c). vegetation influenced by vegetation fragmentation and historical excavation activities.

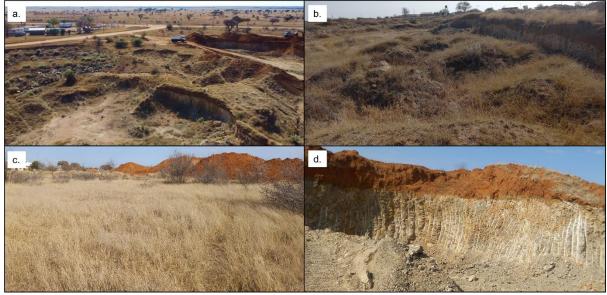
However, the site is currently experiencing major ongoing ecological impacts in the form of excavating and mining activities, which at the time of the site visit was responsible for at least 45% of the disturbance on site. Past and current excavation activities and their influences on the environment were observed within the study area.

Figure 5: Evidence of current major ecological impacts. a). Aerial view of the site's current activities. b). Ground view of an abandoned part of the study area, which was the first area to be excavated within the study area. c). Ground view of topsoil stockpiles surrounding the mining area. d). View of the mining face from within the borrow pit.

The proposed borrow pit registration will influence roughly 4.5 ha of a severely modified savanna environment. The borrow pit will influence only one individual of one nationally protected tree species. The registration of the borrow pit will, however, benefit the community and the environment. Total vegetation clearance and excavation area is expected to influence less than 5 ha due to restricted area placement of the borrow pit. Strict monitoring and the effective implementation of all
