FINAL

HUDDLE PARK WETLAND DELINEATION VERIFICATION

6 December 2012

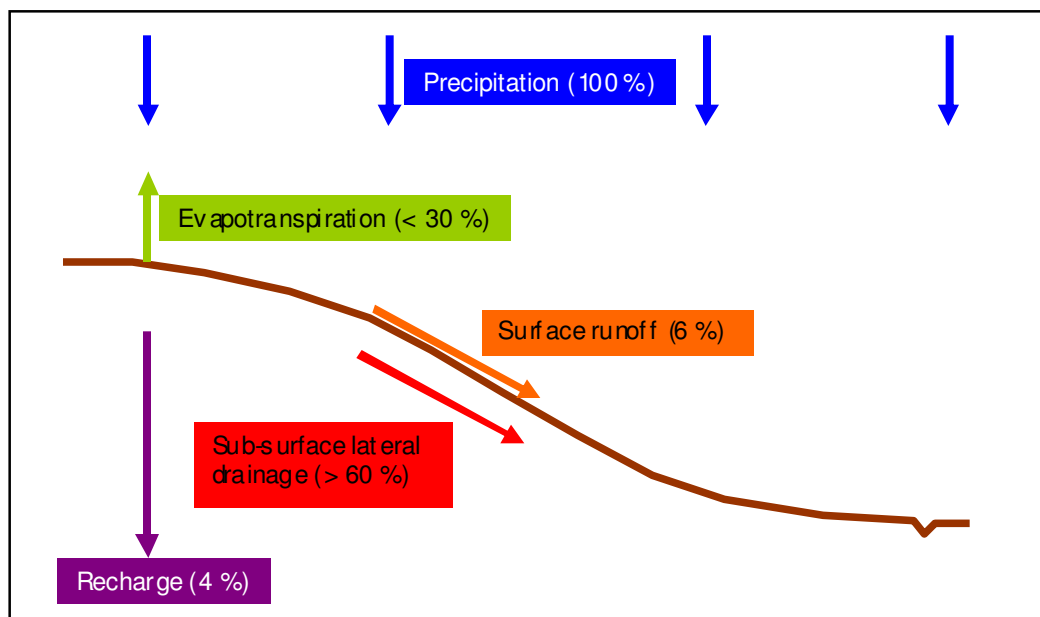
Figure 3. Idealised landscape with assumed quantities of water moving through the landscape expressed as a percentage of total precipitation (100%). Note the upland recharge area.

Water movement in a landscape is subject to gravity and as such it will follow the path of least resistance towards the lowest point. In the landscape there are a number of factors determining the paths along which this water moves. Figure 3 provides a simplified schematic representation of an idealised landscape. The total precipitation (rainfall) on the landscape from the crest to the lowest part or valley bottom is taken as 100%. Most geohydrologists agree that total recharge, the water that seeps into the underlying geological strata, is less than 4% of total precipitation for most geological settings. Surface runoff varies considerably according to rainfall intensity and distribution, plant cover and soil characteristics but is taken as a realistic 6% of total precipitation for our idealised landscape. The total for surface runoff and recharge is therefore calculated as 10% of total precipitation. If evapotranspiration (from plants as well as the soil surface) is taken as a very high 30% of total precipitation it leaves 60% of the total that has to move through the soil from higher lying to lower lying areas. In the event of an average rainfall of 750 mm per year it results in 450 mm per year having to move laterally through the soil. In a landscape there is a cumulative effect as water from higher lying areas flow to lower lying areas.

To illustrate: If the assumption is made that the area of interest is 100 m wide it follows that the first 100 m from the crest downwards has $4\,500\text{ m}^3$ (or 4 500 000 litres) of water moving laterally through the soil (100 m X 100 m X 0.45 m) per rain

season. The next section of 100 m down the slope has its own 4 500 m³ of water as well as the added 4 500 m³ from the upslope section to contend with, therefore 9 000 m³. The next section has 13 500 m³ to contend with and the following one 18 000 m³. It is therefore clear that, the longer the slope, the larger the volume of water that will move laterally through the soil profile.

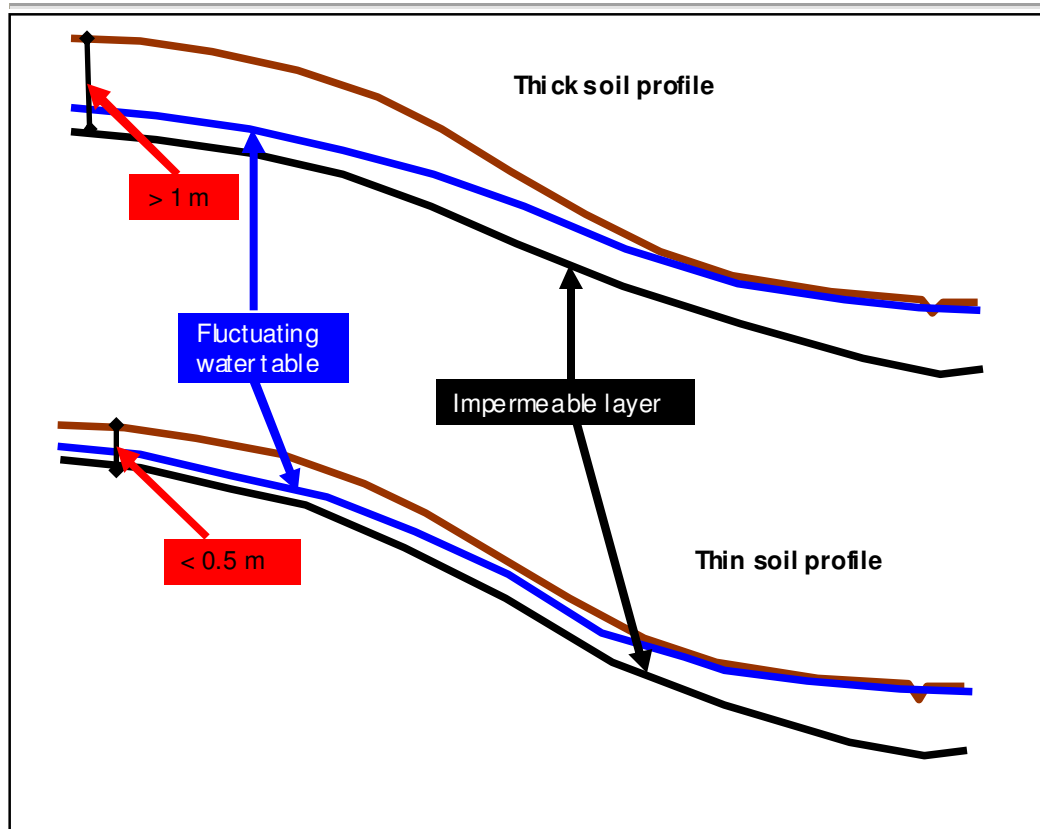
Figure 4. The difference in water flow between a dominantly thick and dominantly thin soil profile.

Amongst other factors, the thickness of the soil profile at a specific point will influence the intensity of the physical and chemical reactions taking place in that soil. Figure 4 illustrates the difference between a dominantly thick and a dominantly thin soil profile. If all factors are kept the same except for the soil profile thickness it can be assumed with confidence that the chemical and physical reactions associated with water in the landscape will be much more intense for the thin soil profile than for the thick soil profile. Stated differently: The volume of water moving through the soil per surface area of an imaginary plane perpendicular to the direction of water flow is much higher for the thin soil profile than for the thick soil profile.

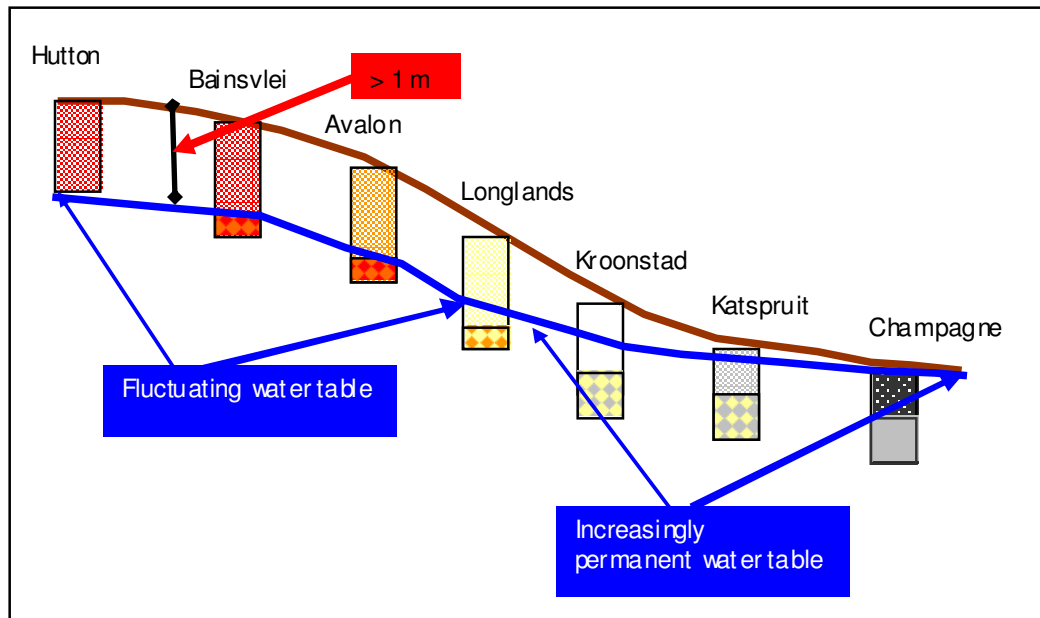
Figure 5. Idealised catena on a quartz rich parent material.

Here it is important to take note of the “catena” concept. This concept is one of a topographic sequence of soils in a homogenous geological setting where the water movement and presence in the soils determine the specific characteristics of the soils from the top to the bottom of the topography. Figure 5 illustrates an idealised topographical sequence of soils in a catena for a quartz rich parent material. Soils at the top of the topographical sequence are typically red in colour (Hutton and Bainsvlei soil forms) and systematically grade to yellow further down the slope (Avalon soil form). As the volume of water that moves through the soil increases, typically in midslope areas, periodic saturated conditions are experienced and consequently Fe is reduced and removed in the laterally flowing water. In the event that the soils in the midslope positions are relatively sandy the resultant soil colour will be bleached or white due to the colour dominance of the sand quartz particles. The soils in these positions are typically of the Longlands and Kroonstad forms. Further down the slope there is an accumulation of clays and leaching products from higher lying soils and this leads to typical illuvial and clay rich horizons. Due to the regular presence of water the dominant conditions are anaerobic and reducing and

the soils exhibit grey colours often with bright yellow and grey mottles (Katspruit soil form). In the event that there is a large depositional environment with prolonged saturation soils of the Champagne form may develop (typical peatland).

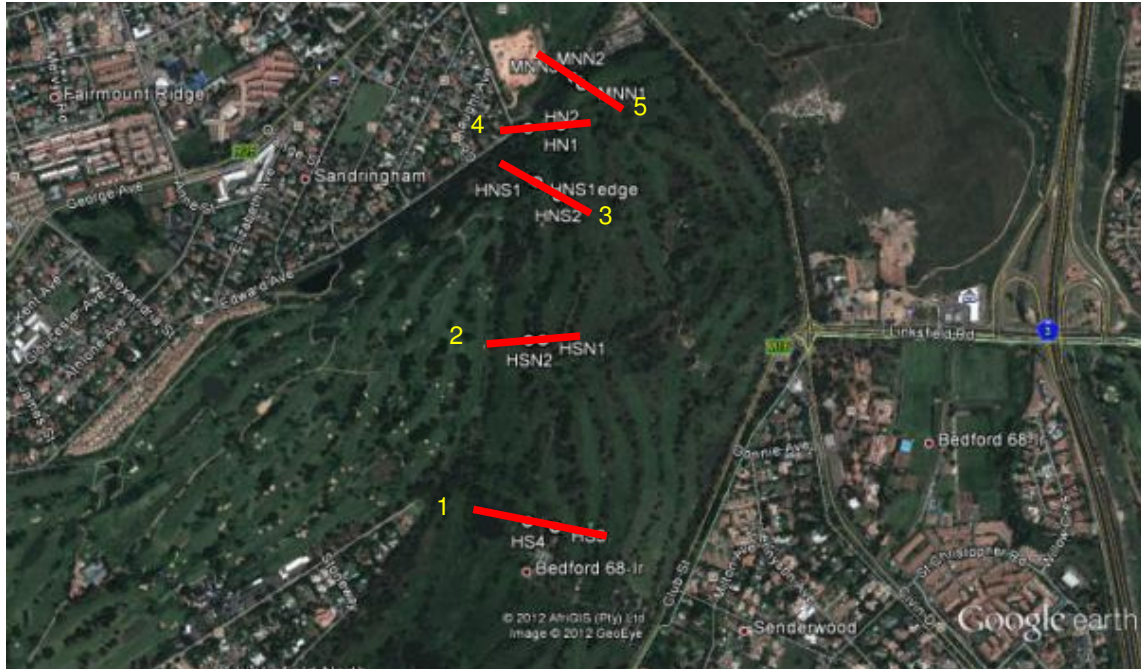
Figure 9. Position of the transects on Huddle Park Golf Course

Soils were classified along five (5) transects across the delineated wetland (Figure 9). The classification was conducted through auguring with a hand soil auger and the identification of soil morphological properties. These include texture, structure, soil

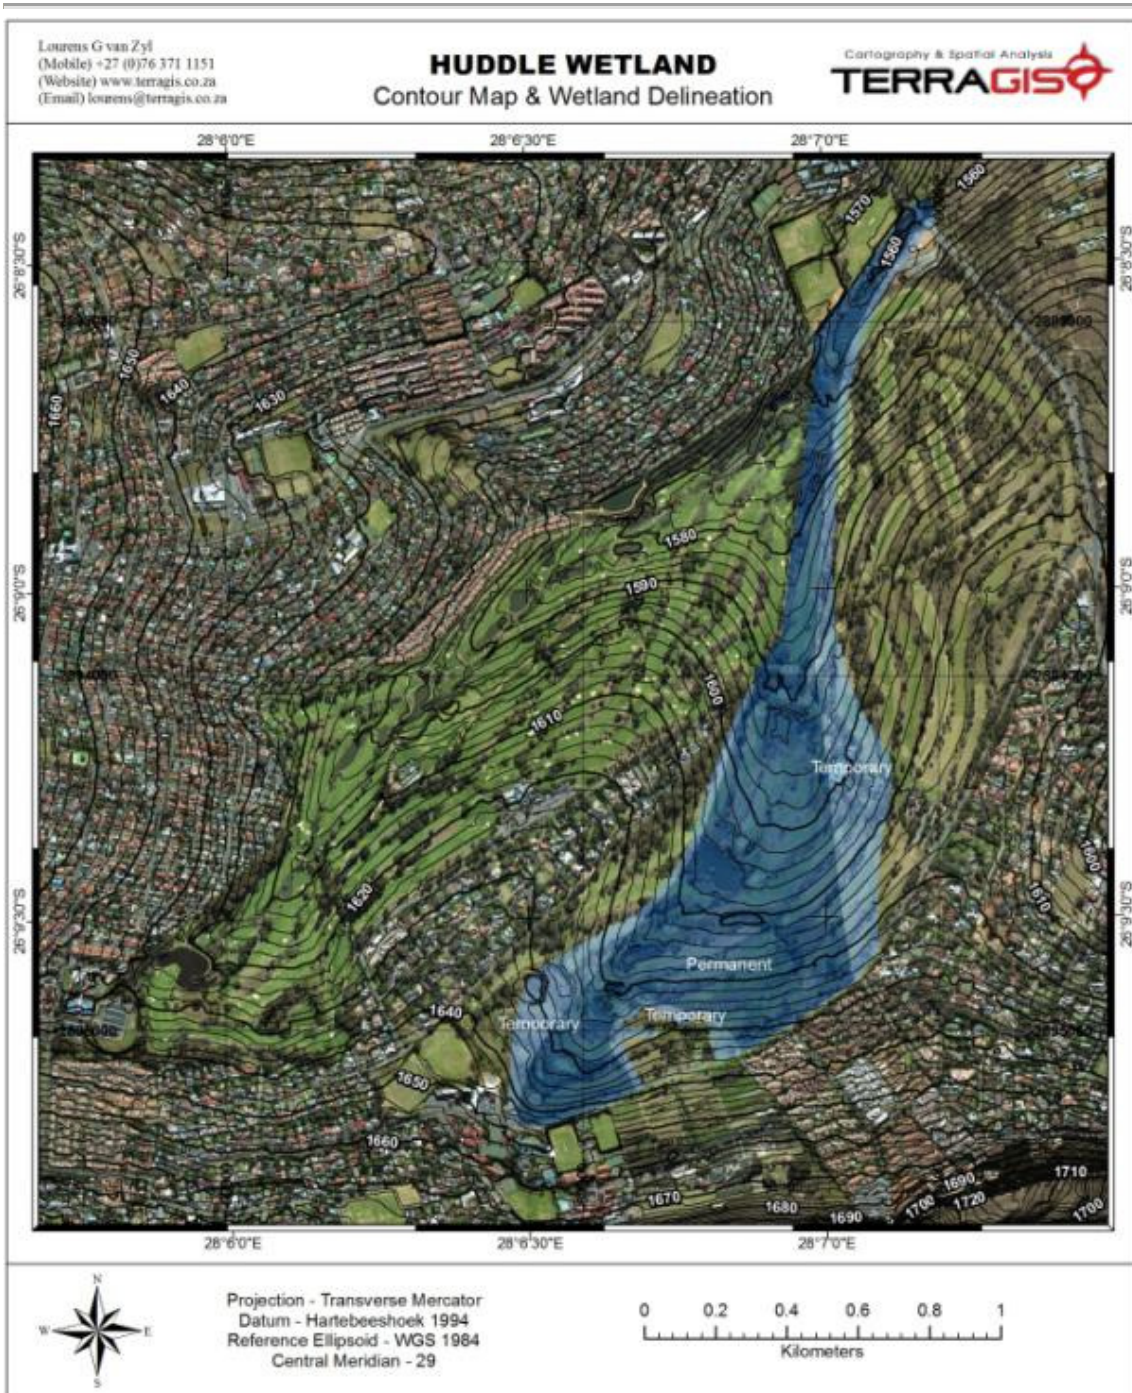
Figure 12. Satellite image with 2 m contours with a historic wetland delineation result superimposed on the image

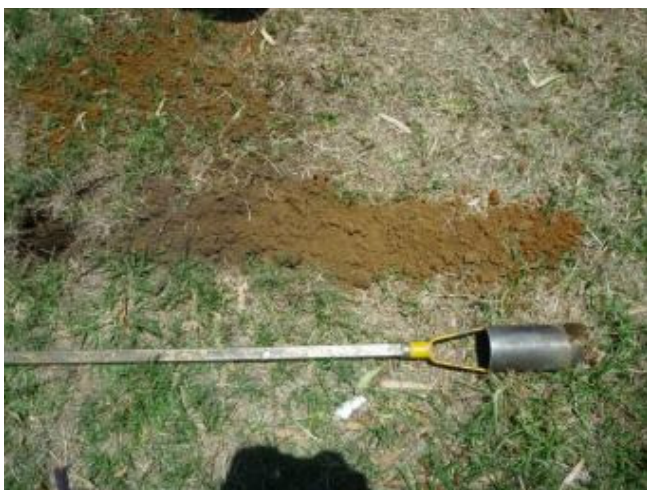
The delineation of the wetland along transect 1 was based on the presence of mottles within 50 cm of the soil surface in the soils. The sequence of soils encountered along Transect 1 was Longlands (Orthic A-horizon / E-horizon / Soft Plinthic B-horizon) at the highest point of investigation (Figure 14 and Figure 15); Glencoe (Orthic A-horizon / Yellow-brown Apedal B-horizon / Hard Plinthic B-horizon) on the midslope position (Figure 16 and Figure 17); Avalon (Orthic A-horizon / Yellow-brown Apedal B-horizon / Soft Plinthic B-horizon) in the midslope/footslope position (Figure 18 and Figure 19); deep Longlands in the footslope position (Figure 20 and Figure 21) and permanent zone wetland soils in the valley bottom position. These soils are typical of the HHGD. The soils further down the slope indicated varying degrees of mottling and bleaching – also an aspect that is typical of the HHGD.

Figure 14. Auger profile of a Longlands soil form

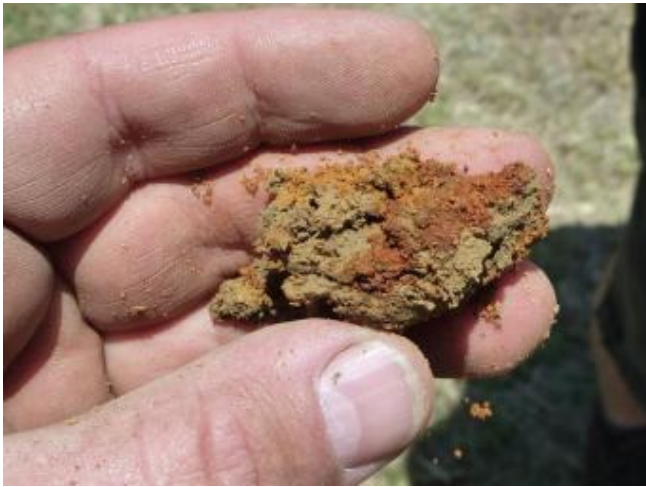
Figure 15. Mottling in the soft plinthic B-horizon of the Longlands soil form

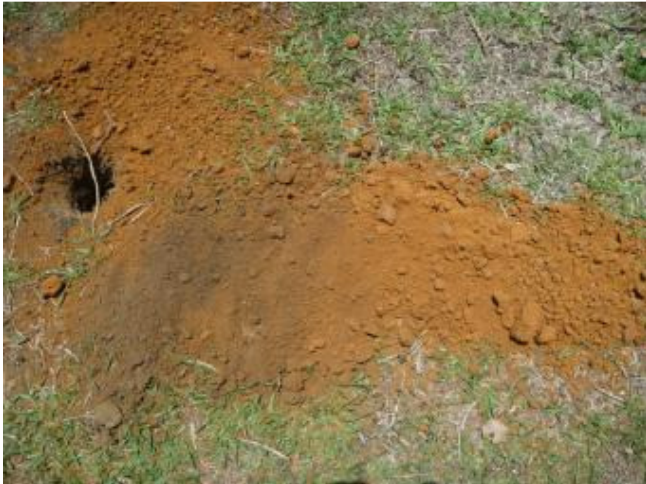
Figure 16. Yellow-brown apedal soil of the Glencoe form in the mislope position

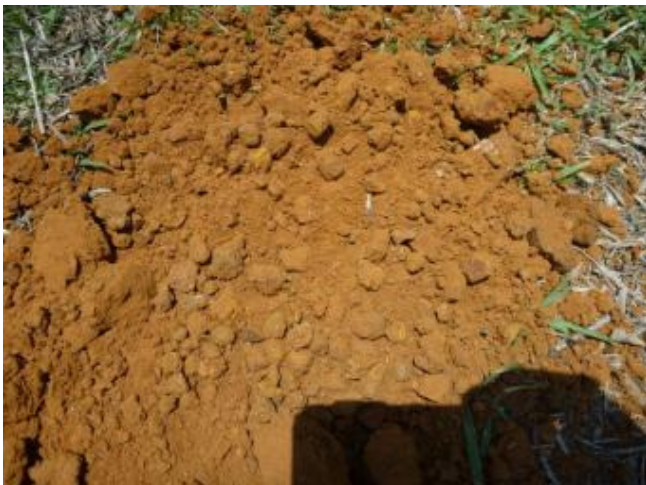
Figure 17. Concretions in the yellow-brown apedal soil of the Glencoe form in the mid slope position

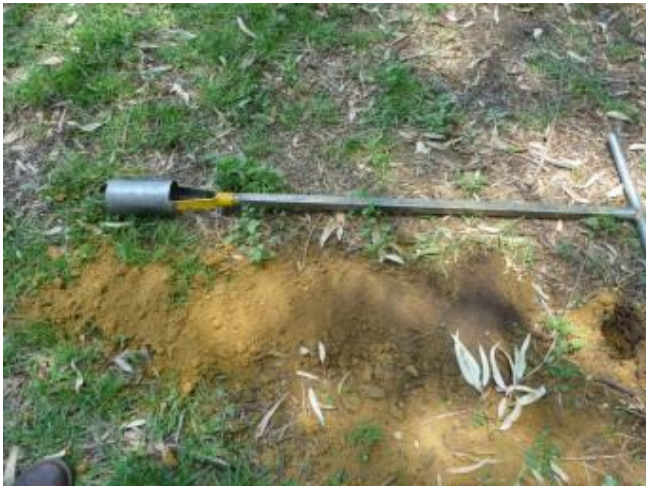
Figure 18. Yellow-brown apedal soil of the Glencoe form in the midslope position. Note the dark coloured orthic A-horizon.

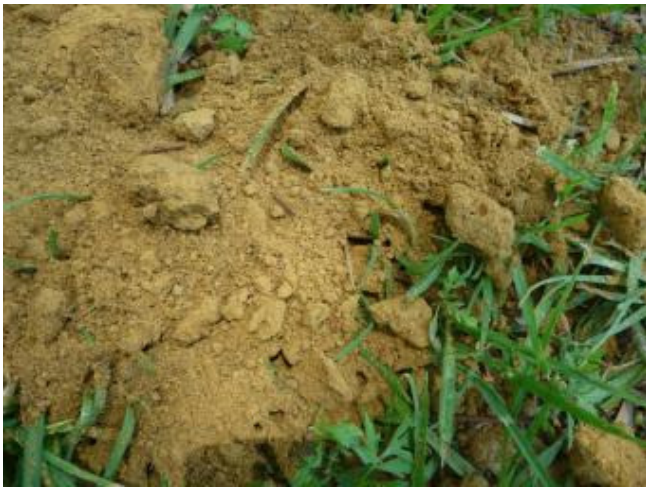
Figure 19. Mottles below the yellow-brown apedal horizon of the Avalon soil form

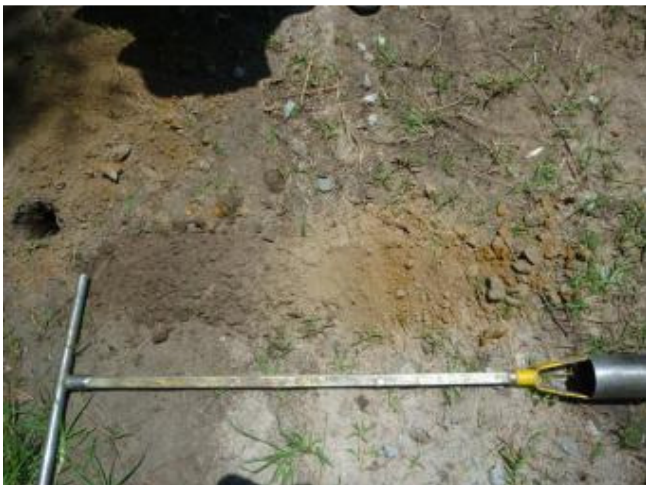
Figure 20. Soil of the Longlands form in the footslope position.

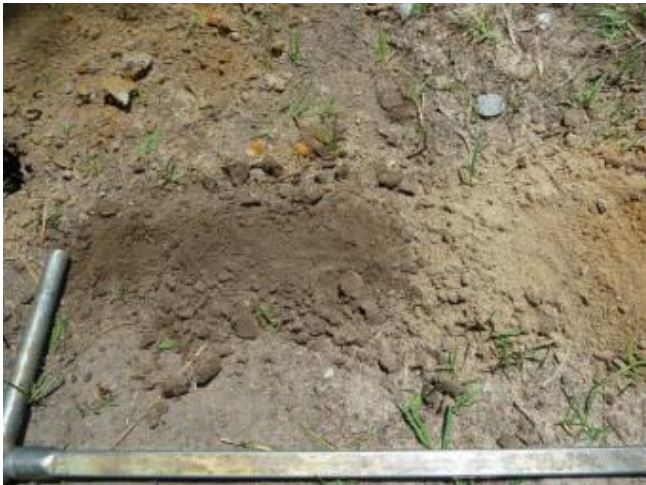
Figure 21. Dark coloured A-horizon in the Longlands soil form.

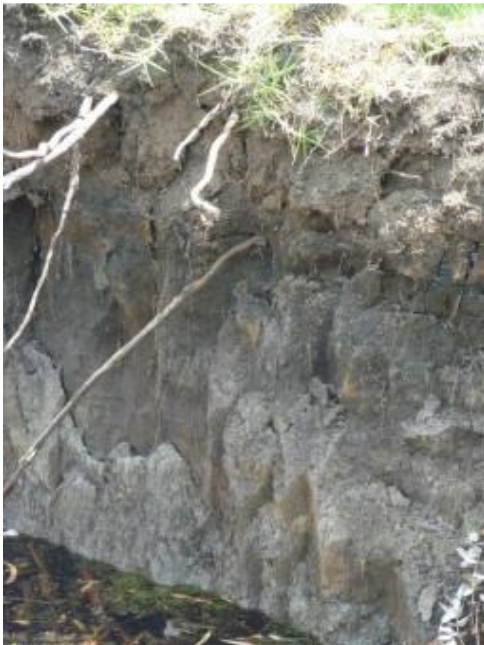
Along transect 2 it was evident that the upslope area was influenced by dolerite/diabase. The soils therefore did not follow the regular HHGD pattern but rather exhibited signs of good drainage as expressed in high chroma colours. The wetland zone was characterised by grey soils dominated by sandy materials (Figure 22). Within the drainage line soils with prismatic structure occur.

Figure 22. Sandy A-horizon overlying a prismatic B-horizon within the drainage depression

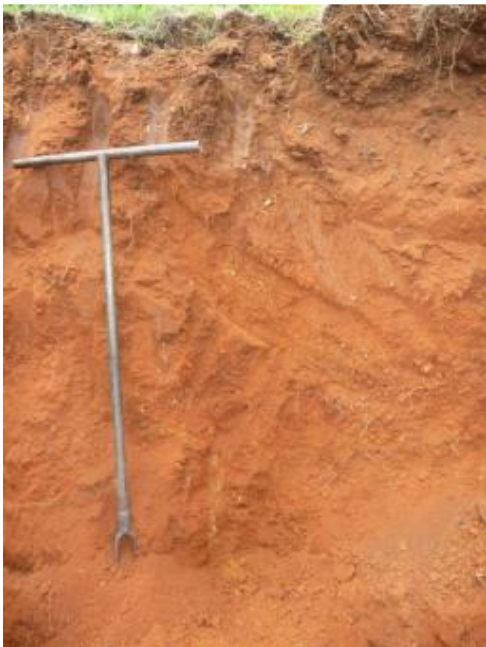
Along transects 3 to 5 the wetland area is very narrow as 1) the landscape becomes more V-shaped and 2) the soils are derived from mixed materials (granite and diabase). The transition between the terrestrial zone and the wetland zone therefore becomes very distinct as exhibited through textural and colour changes in the soils. The terrestrial soil exhibited high chroma colours and were of the Hutton and Clovelly forms (Figure 23). In this part of the landscape the typical sequence of soils from crest to valley bottom is Hutton (Orthic A-horizon / Red Apedal B-horizon / Unspecified); Clovelly (Orthic A-horizon / Yellow-brown Apedal B-horizon / Unspecified); Valsrivier (Orthic A-horizon / Pedocutanic B-horizon / Unconsolidated material without signs of wetness); Oakleaf (Orthic A-horizon / Neocutanic B-horizon / Unspecified) and Dundee (Orthic A-horizon / Stratified Alluvium). The Dundee soil form usually has grey colours indicative of prolonged saturation and could in some cases grade into eroded soils of the Kroonstad (Orthic A-horizon / E-horizon / G-horizon) or Katspruit (Orthic A-horizon / G-horizon) form. The only soils here that classify as wetland soils are Dundee, Kroonstad and Katspruit. The wetland channel has been altered through historical human activities and influences and exhibits soils with distinct stratification.

Figure 23. Profile of a Hutton soil in the terrestrial zone.
