**NORTHAM PLATINUM LTD**

**NORTHAM ZONDEREINDE, RAISEBORE SURFACE  
INFRASTRUCTURE  
GEOTECHNICAL INVESTIGATION  
FACTUAL REPORT**

Report No.: JW105/19/H806-00 – Rev 0

May 2019

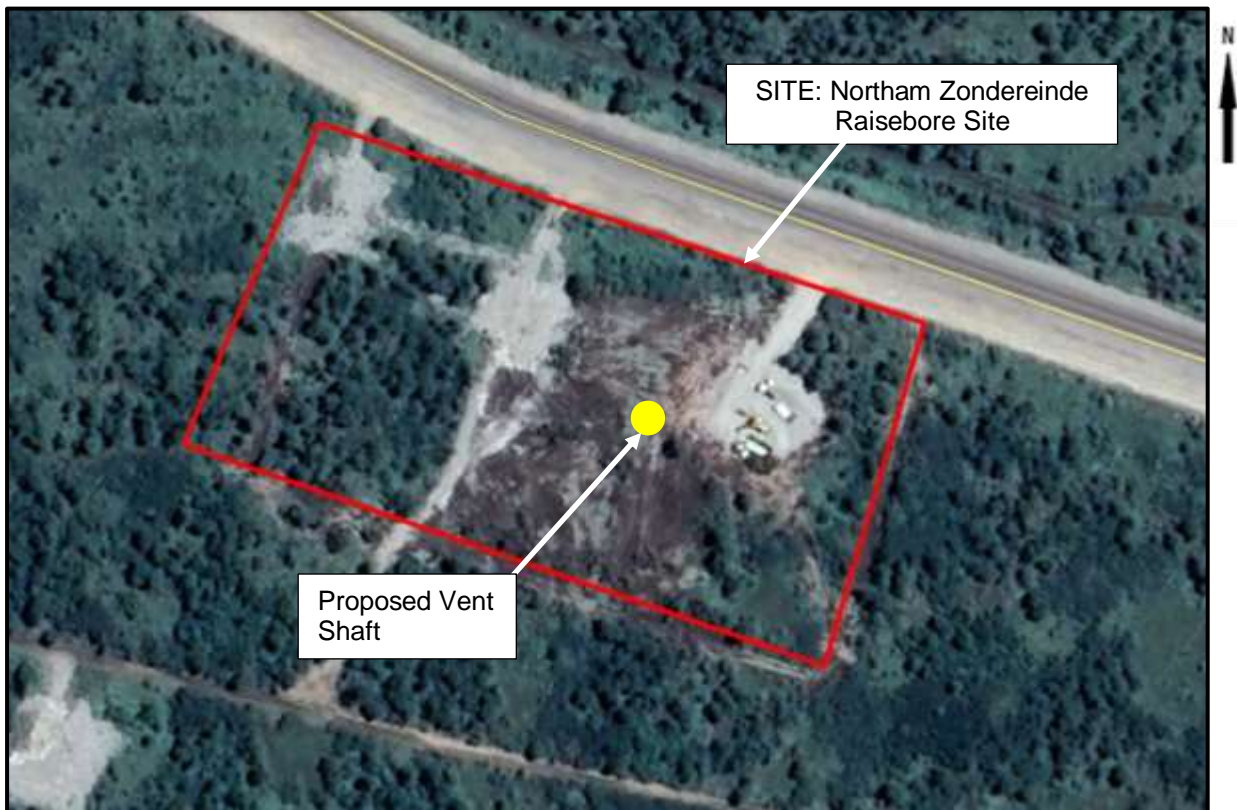
Figure 2: SITE LAYOUT

The site is currently undeveloped and has been cleared of all vegetation. Furthermore, it appears that the area under investigation has been levelled. This process has removed some of the blanketing material. At the time of the investigation a borehole was in the process of being drilled, to the east of the area investigated.

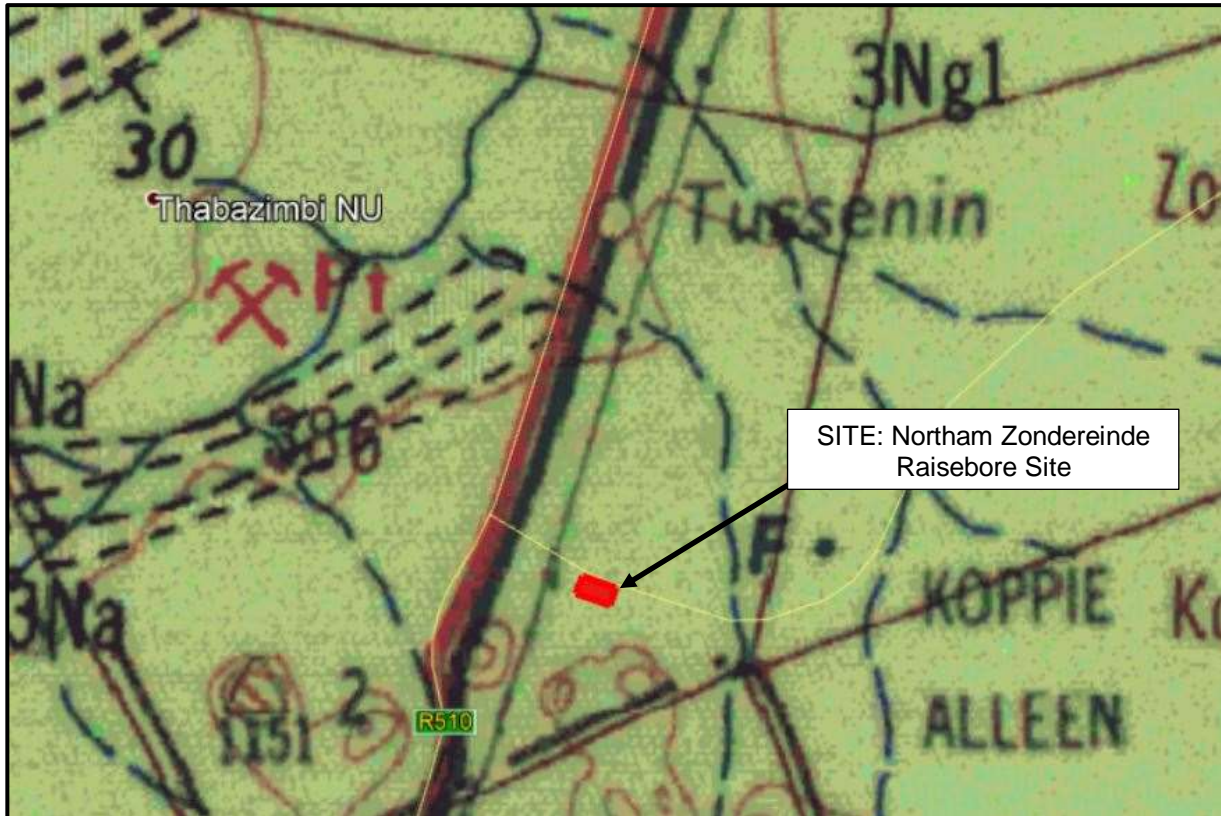
Figure 3: REGIONAL GEOLOGY

According to the published 1:250 000 geological map, sheet 2426 THABAZIMBI, the site is underlain by gabbro, noritic at base and locally anorthositic, belonging to the Bushveld Igneous Complex.

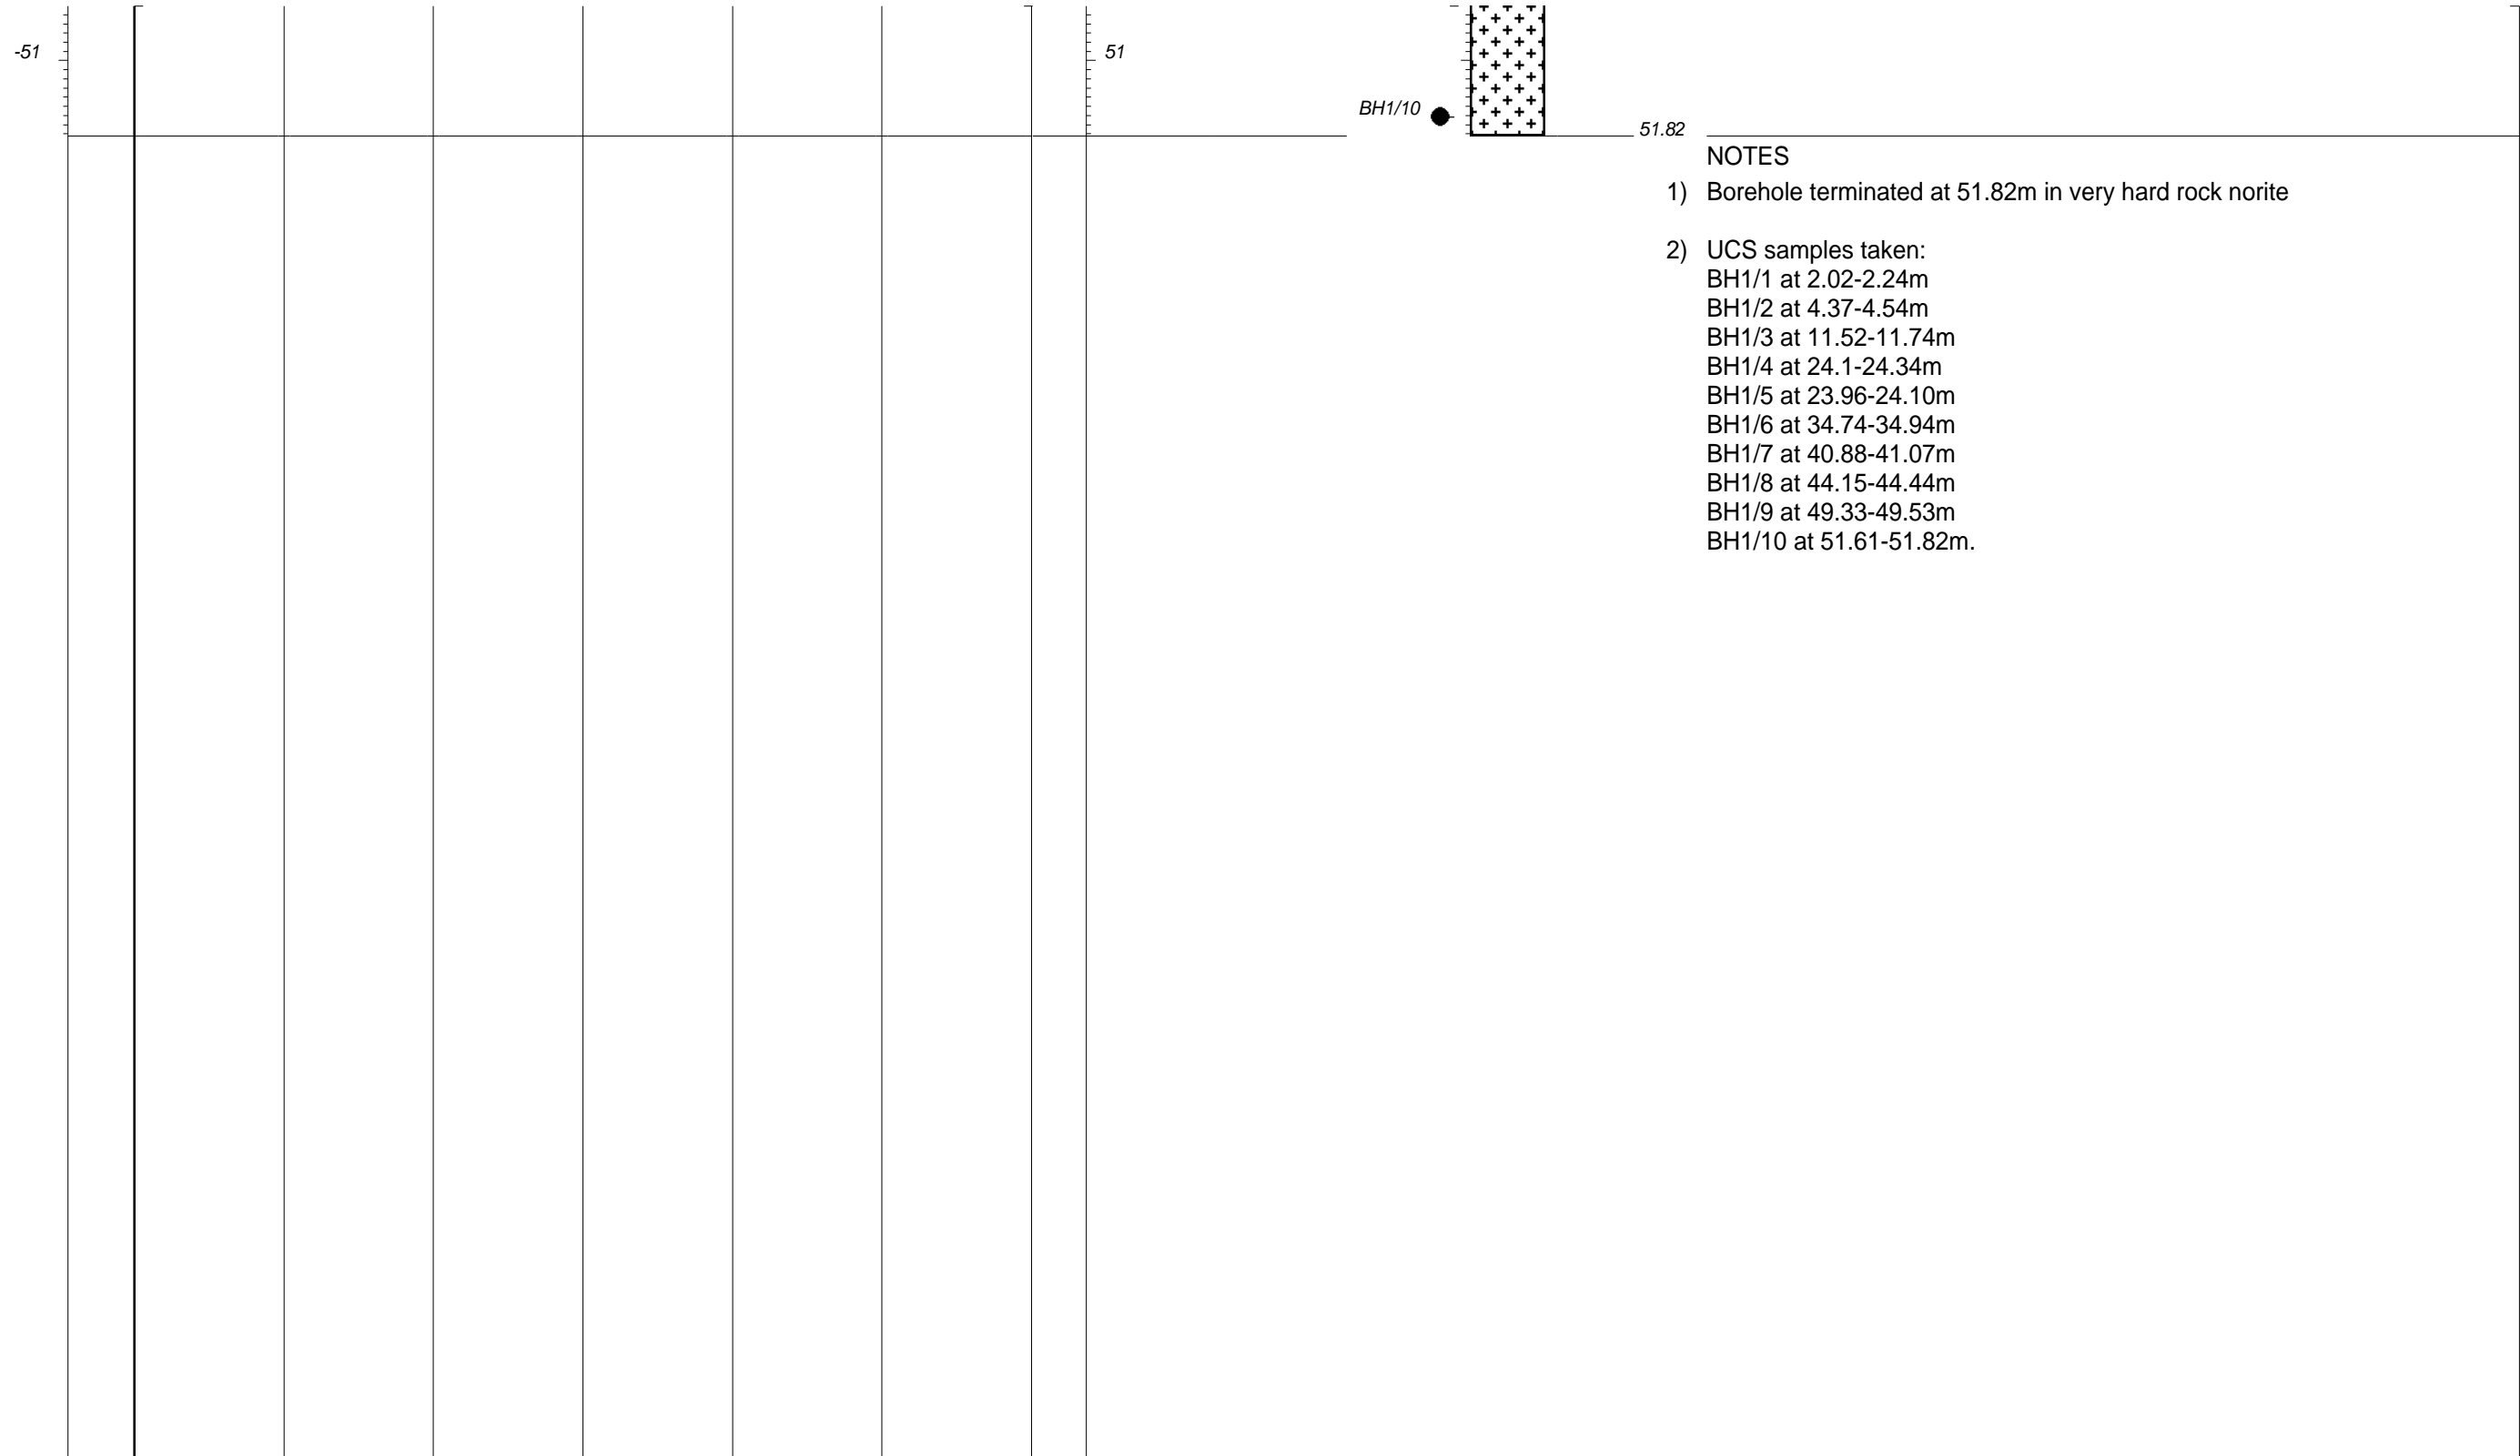
HOLE No: BH01  
Sheet 4 of 4

- NOTES**
- 1) Borehole terminated at 51.82m in very hard rock norite
  - 2) UCS samples taken:  
 BH1/1 at 2.02-2.24m  
 BH1/2 at 4.37-4.54m  
 BH1/3 at 11.52-11.74m  
 BH1/4 at 24.1-24.34m  
 BH1/5 at 23.96-24.10m  
 BH1/6 at 34.74-34.94m  
 BH1/7 at 40.88-41.07m  
 BH1/8 at 44.15-44.44m  
 BH1/9 at 49.33-49.53m  
 BH1/10 at 51.61-51.82m.

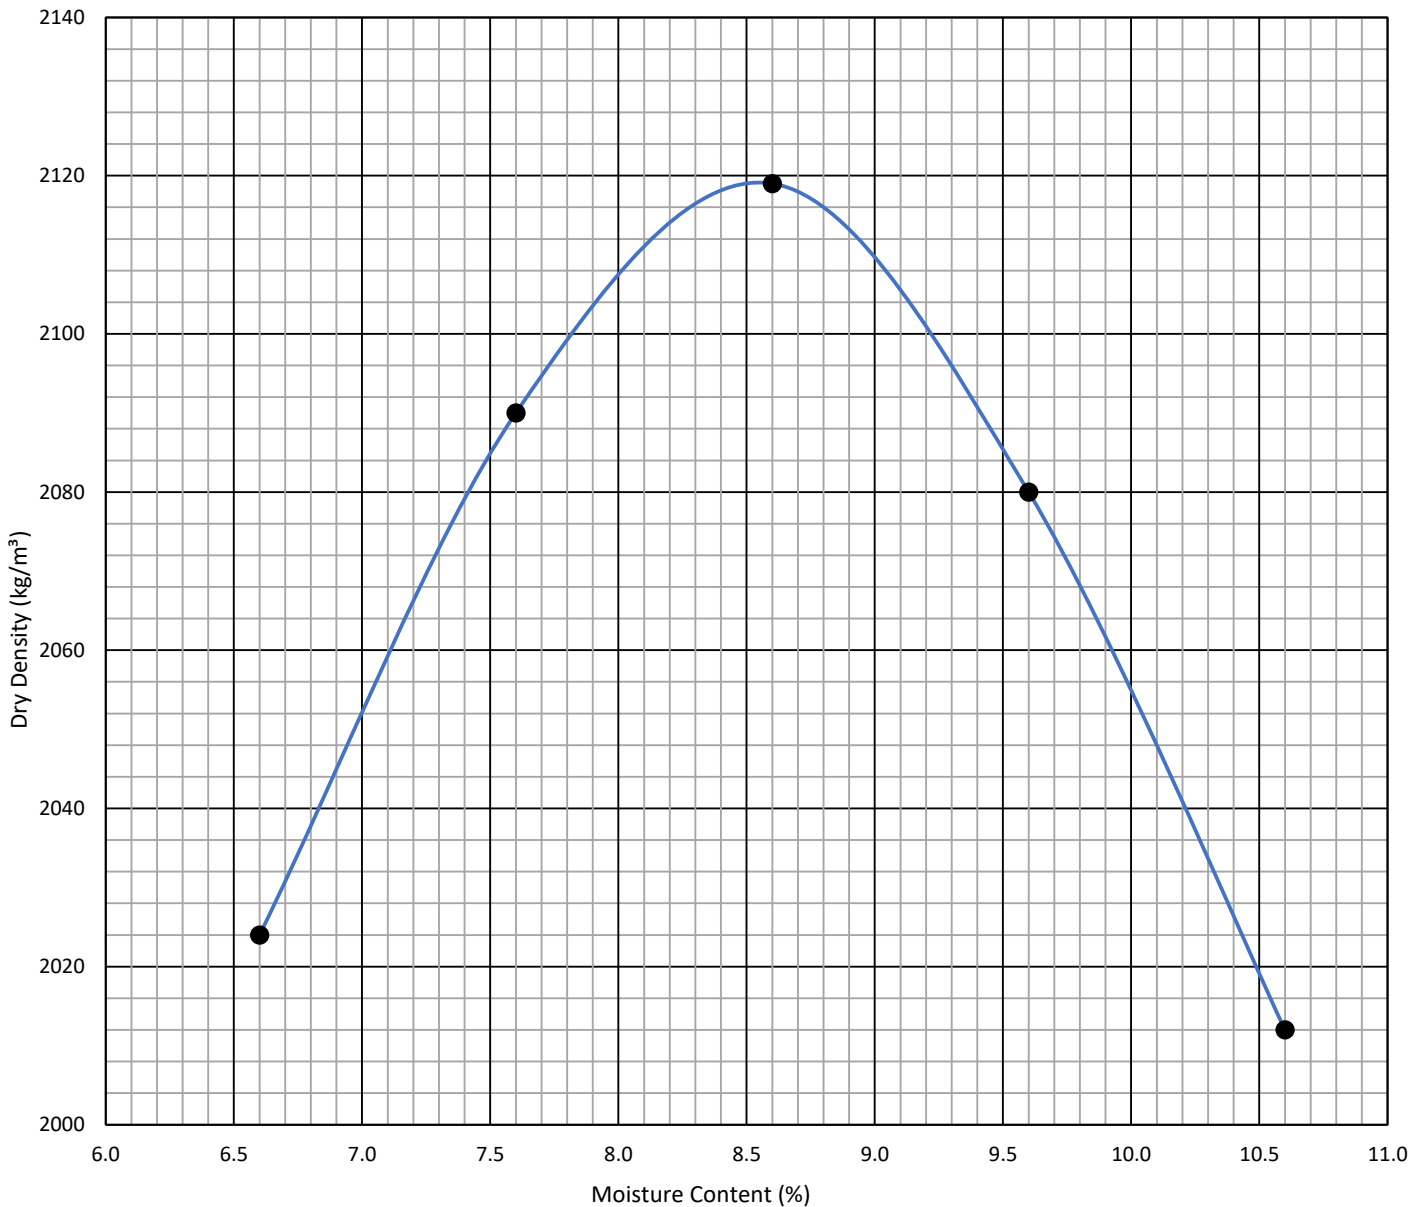
Optimum Moisture Content: **8.6** %

Moisture Content (%):	6.6	7.6	8.6	9.6	10.6		
Dry Density (kg/m <sup>3</sup> )	2024	2090	2119	2080	2012

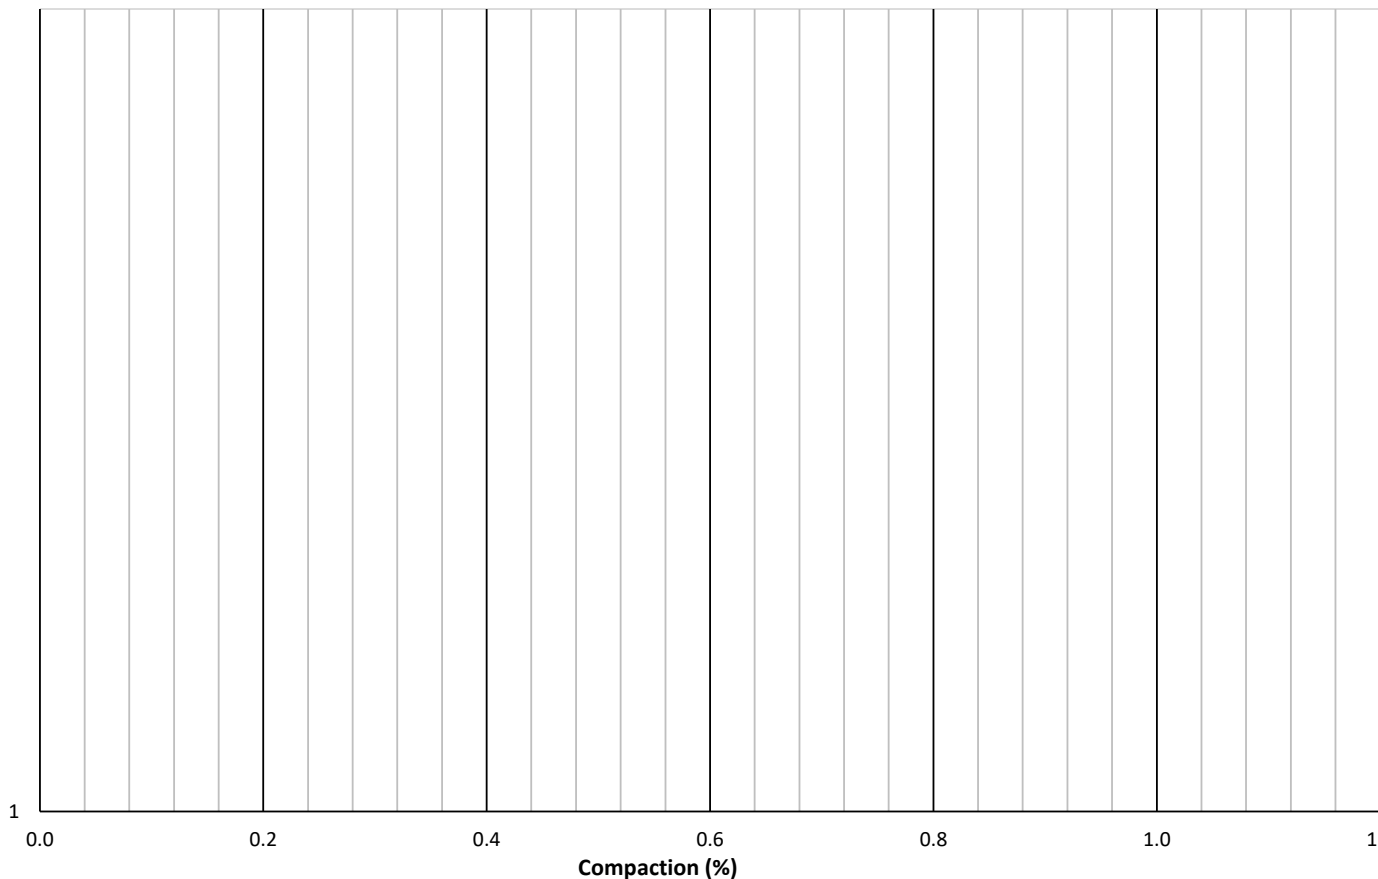
California Bearing Ratio (CBR)

Mod. AASHTO Values		Compaction Data: CBR			Swell	CBR at (mm)			CBR Values	
MDD	OMC	Dry Dens.	MC	Comp.		2.5	5.0	7.5	Compaction (%)	CBR
(kg/m <sup>3</sup> )	(%)	(kg/m <sup>3</sup> )	(%)	(%)	(%)					
1455	27.3	1447	27.2	100.0	11.6	1	1	1	100	No Readings
									98	
									97	
1455	27.3	1263	27.2	87.3	12.1	1	1	1	95	
									93	
1455	27.3	1165	27.2	80.5	7.9	1	1	1	90

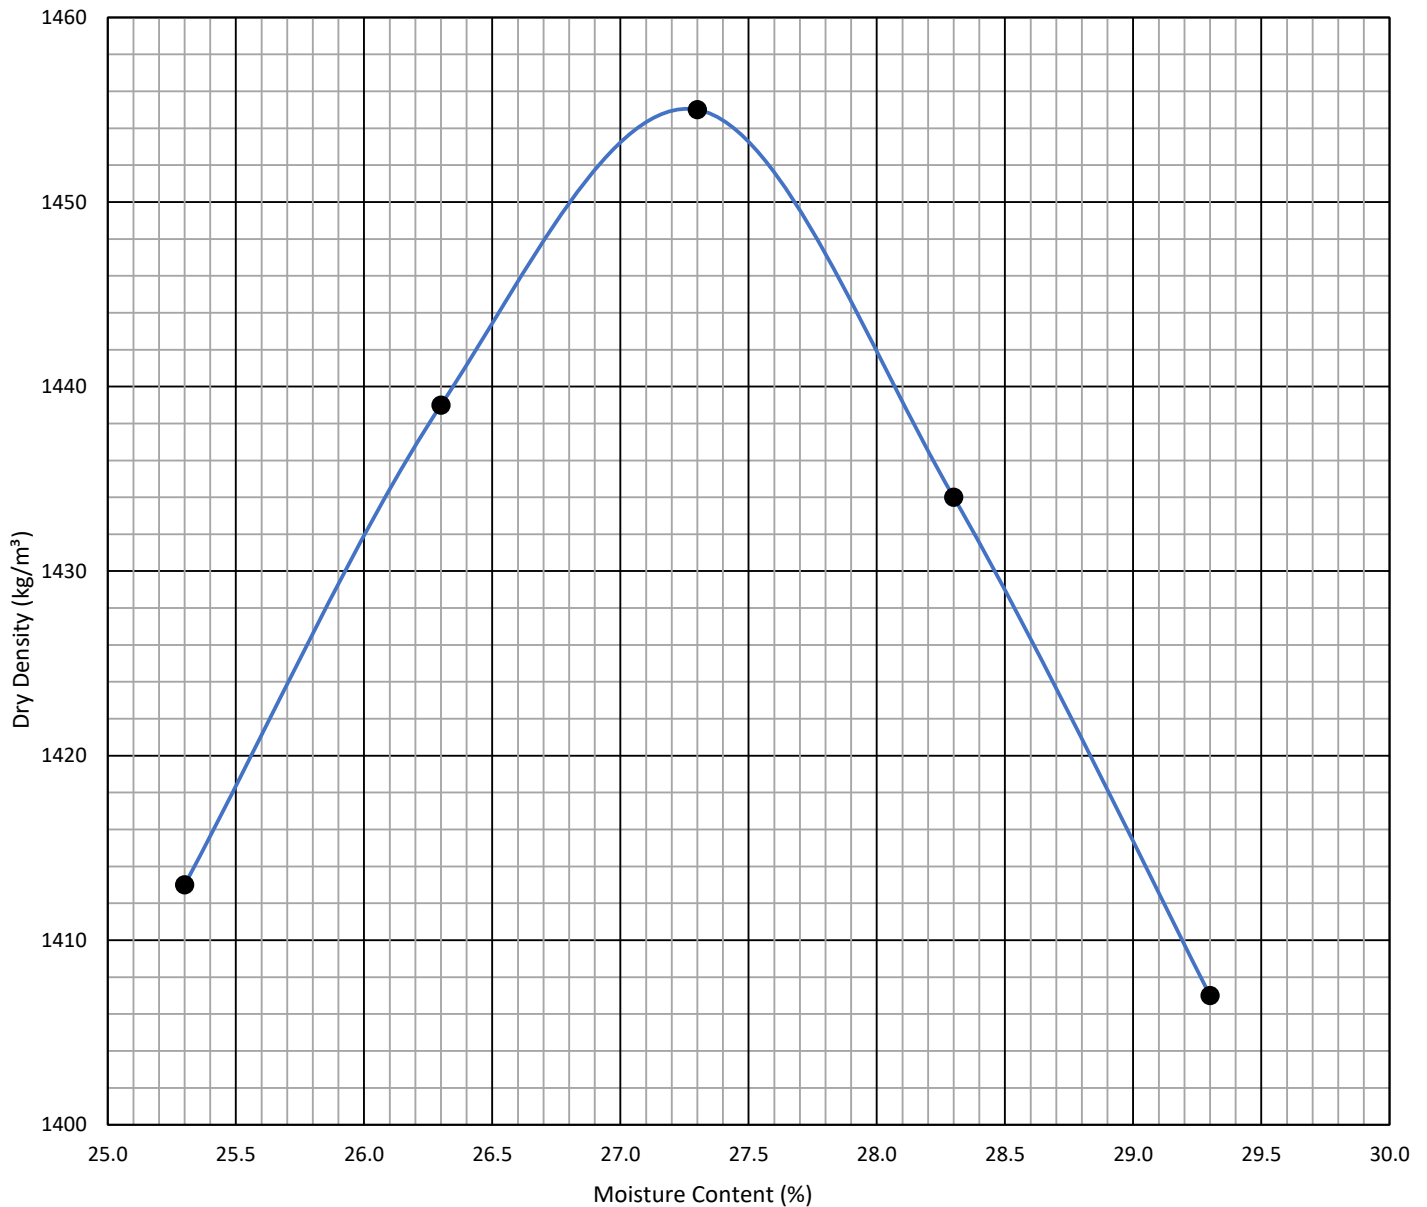
Optimum Moisture Content: **27.3** %

Moisture Content (%):	25.3	26.3	27.3	28.3	29.3		
Dry Density (kg/m <sup>3</sup> )	1413	1439	1455	1434	1407
