PLANT RESCUE PLAN

Longyuan Mulilo Maanhaarberg Wind Energy Facility, De Aar, Northern Cape

VEGETATION REHABILITATION PLAN

ALIEN INVASIVE PLANT MANAGEMENT PLAN

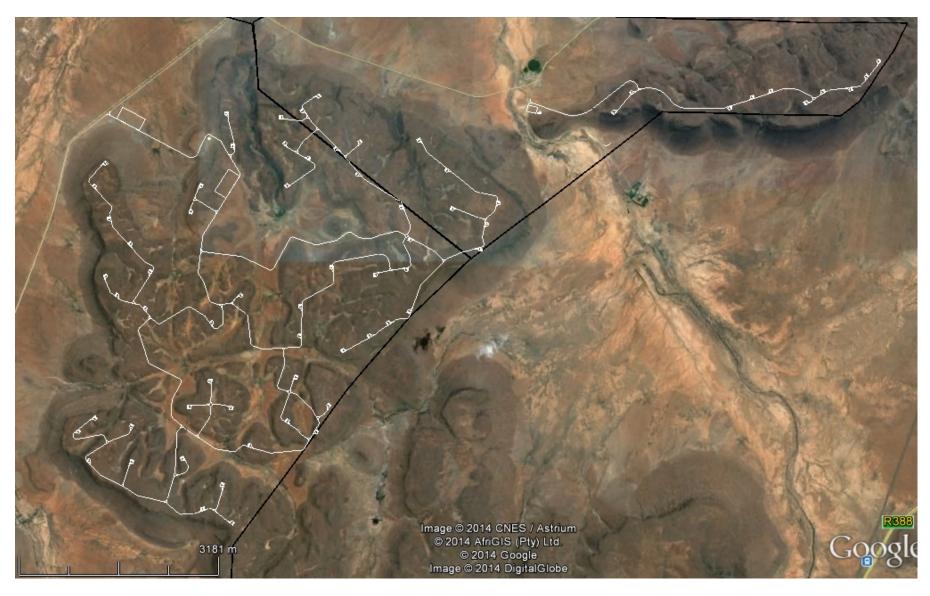
Figure 1: Map overview of the proposed developmental footprint (white) of the Maanhaarberg WEF. Development site boundaries in black.

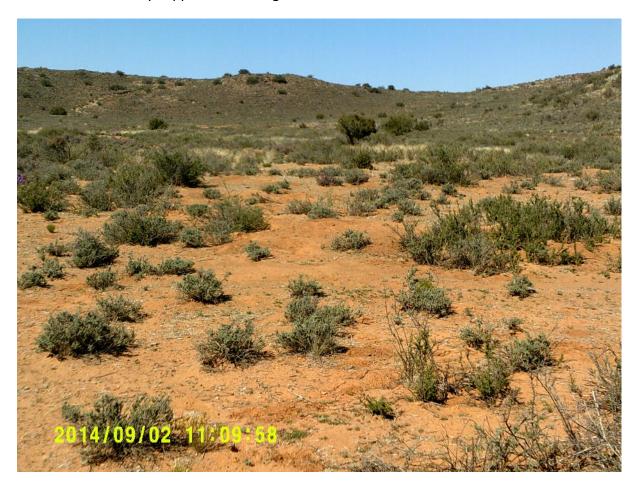
Figure 8: Low lying flats area with little vegetation cover and more sandy soils.

The valleys and low lying areas between ridges and below the plateau is mostly flat with low surface rock coverage, and vegetation cover varies from fields of grass and shrubs to patches of sparse vegetation in the sandy areas. Surface soil depth is deep and can therefore sufficiently support burrowing animals.

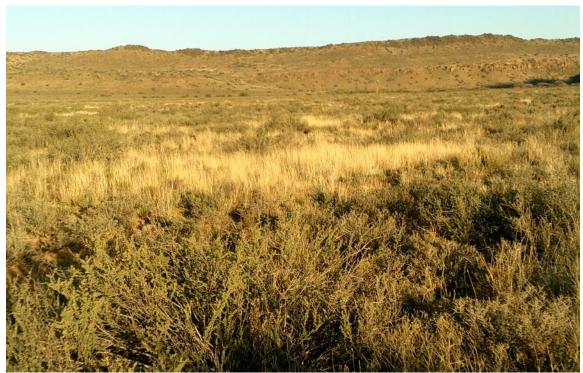
Figure 9: Low lying area with high vegetation cover.
