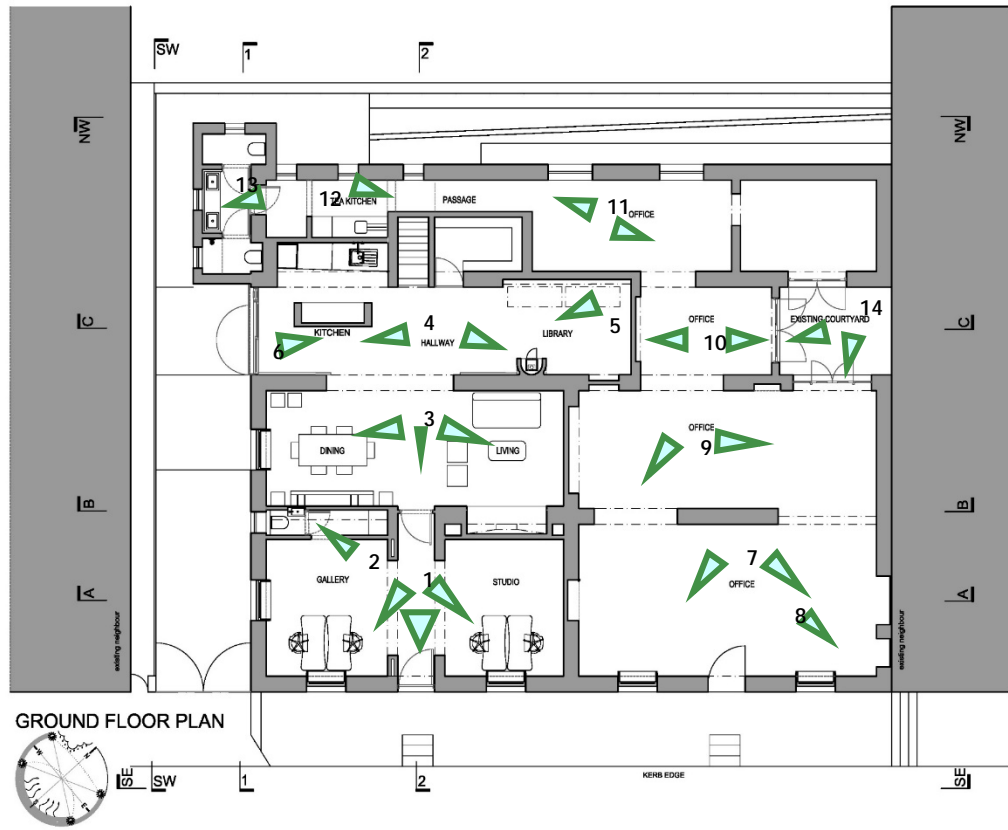
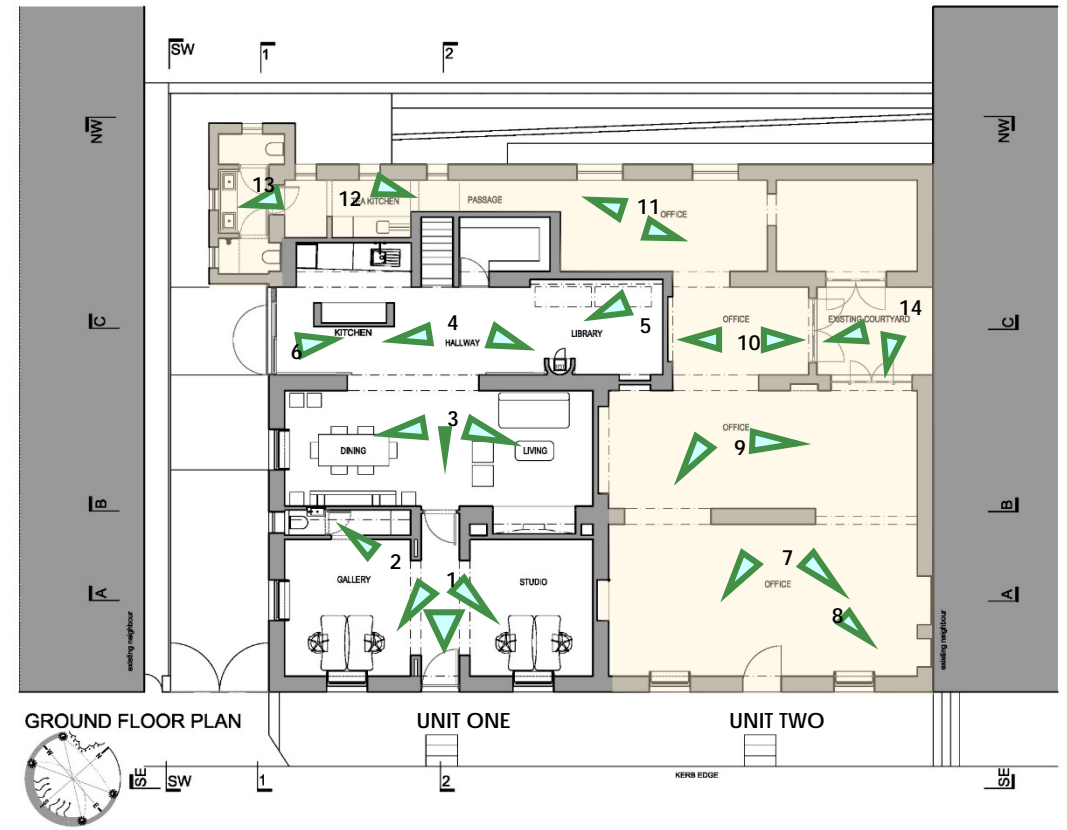
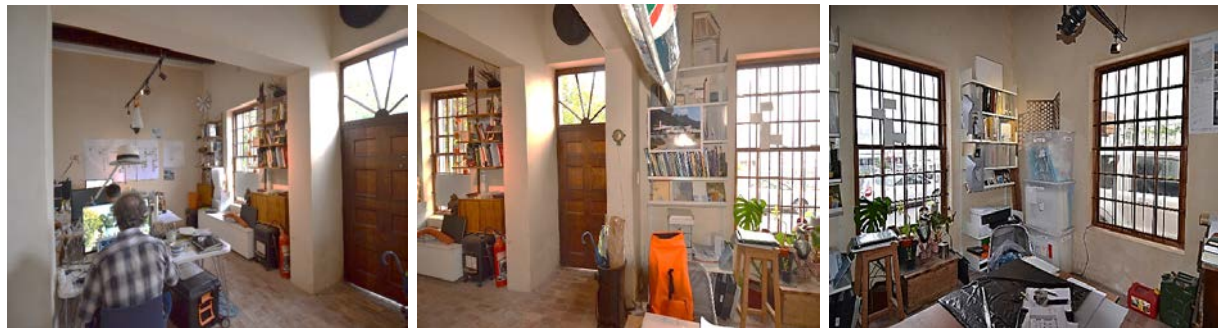
UNIT ONE – View 1

Gallery and studio spaces
Original spaces with 3,8m high ceilings (c 1850's).
Brick floor, bead mould ceiling beams and modern pine ceiling boards, modern sash windows and modern entrance door with fanlight (c1970/80).
(Ref: The Buildings of Cape Town Phase Two)

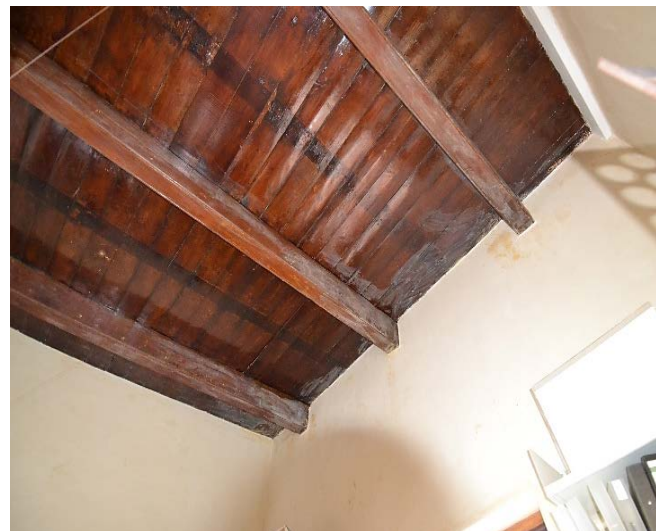
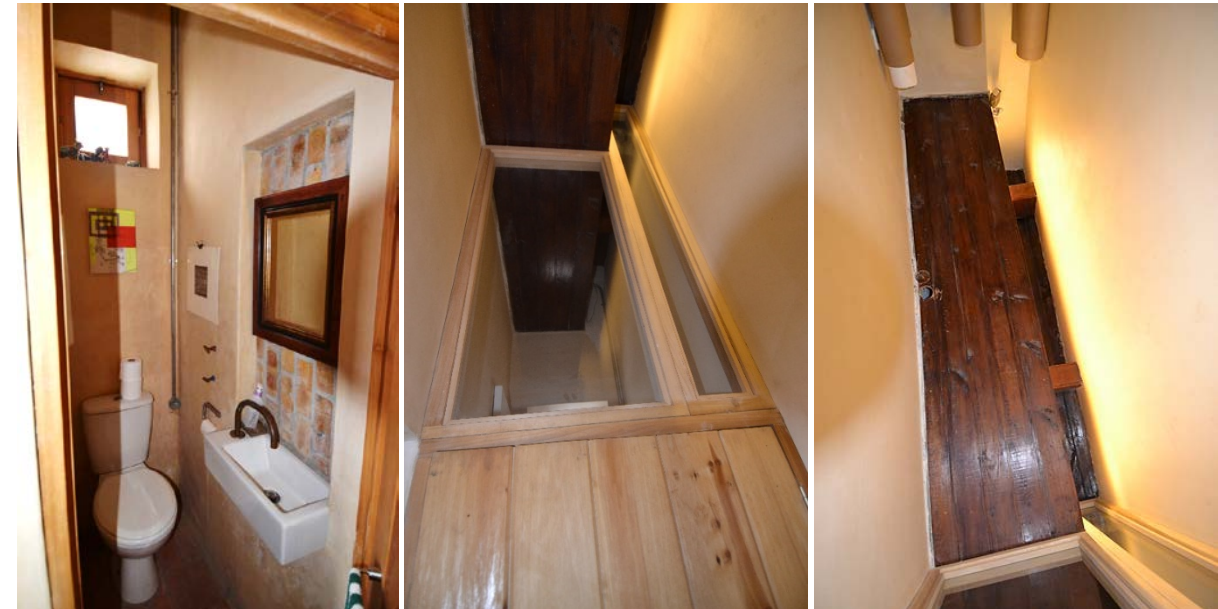
UNIT ONE – View 2

WC off gallery space, modern Poplar door with tall fanlight, high level dropped ceiling storage space, modern sanitary ware, recessed exposed brickwork splashback, square high level windows (c 2013/14).

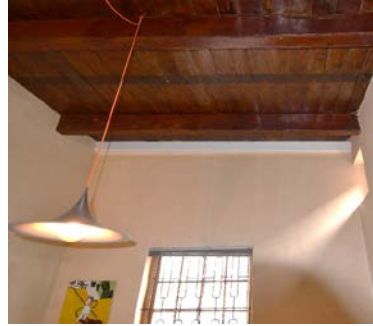
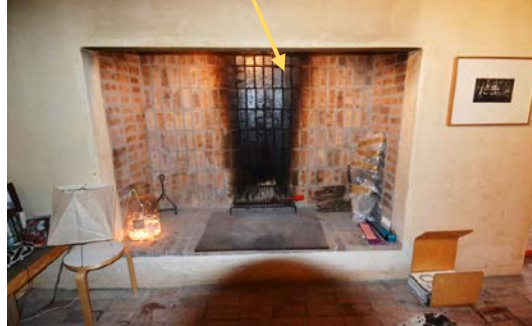
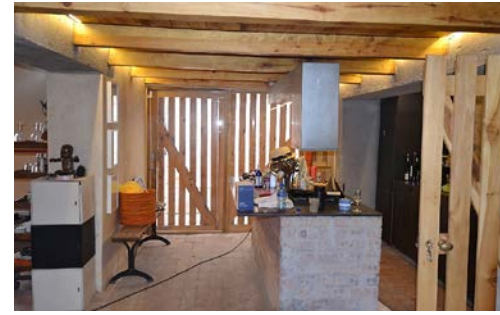
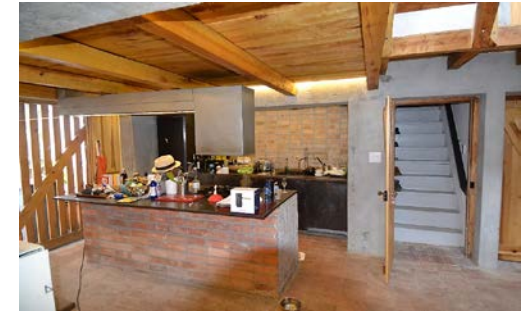
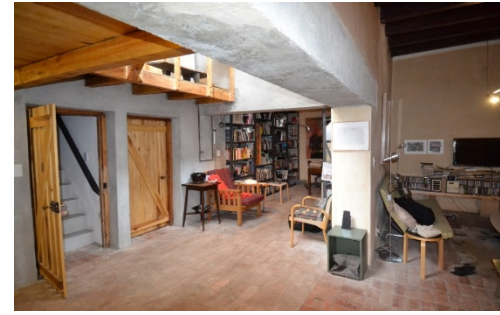
UNIT ONE – View 3

Dining room and Living room spaces. Original spaces with 3,8m high ceilings (c 1850's). Brick floor, bead mould ceiling beams, modern pine ceiling boards, modern sash windows, modern entrance door and fanlight (c 1970/80). Square high level windows, new fireplace, reinforced concrete beams over widened openings between rooms (c 2013/14).

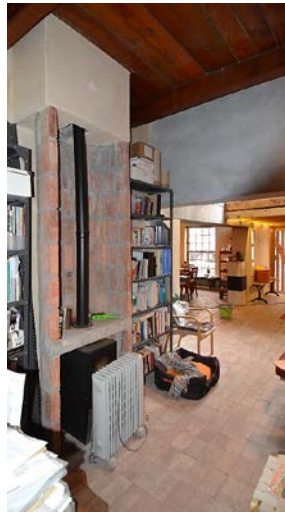
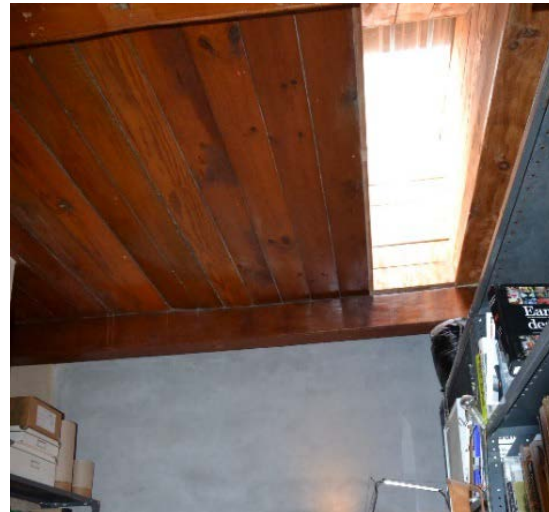
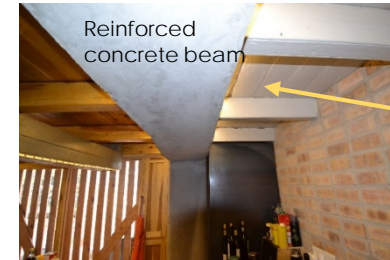
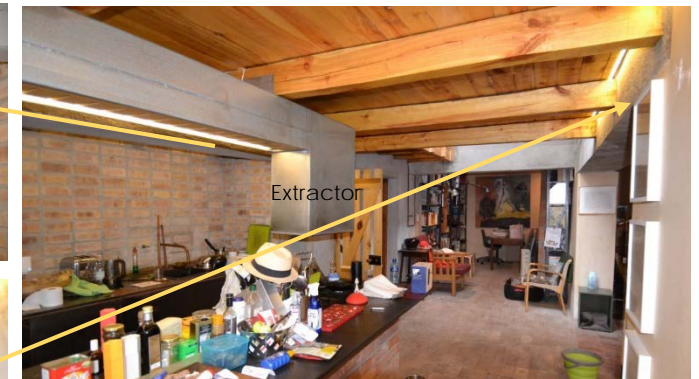
UNIT ONE – View 5

Library space. Brick floor, modern ceiling beams, modern pine ceiling boards, modern fireplace with exposed modern brickwork and modern roof-light detail (c 2013/14).

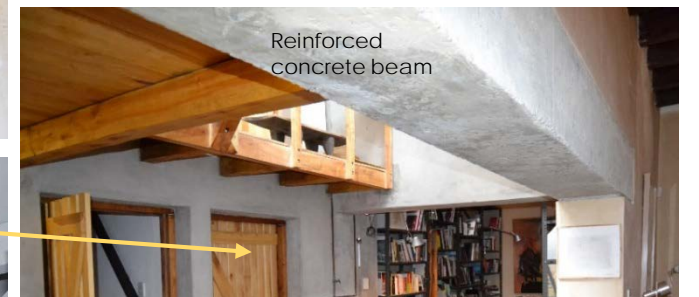
UNIT ONE – View 6

Kitchen and Store spaces. Brick floor, modern Poplar ceiling beams, modern poplar ceiling boards, reinforced concrete beams and modern kitchen with exposed modern brickwork rear splashback wall (c 2013/14). Some modern yet older pine beams and ceilings are painted, others have a natural finish.

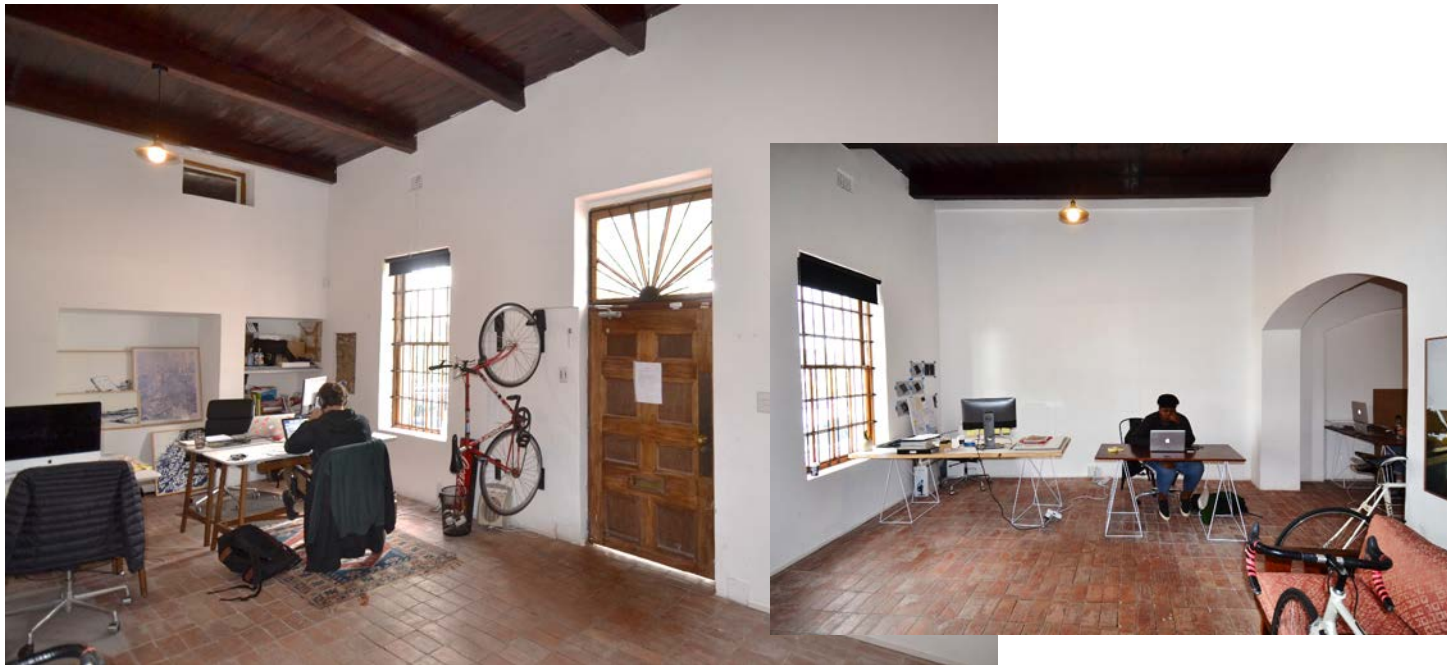
UNIT TWO – View 7

Office space.
Original spaces with 3,8m high ceilings (c 1850's).
Brick floor, bead mould ceiling beams, modern pine ceiling boards, modern sash windows, modern entrance door and fanlight, modern flat arched openings between rooms (c 1970/80).

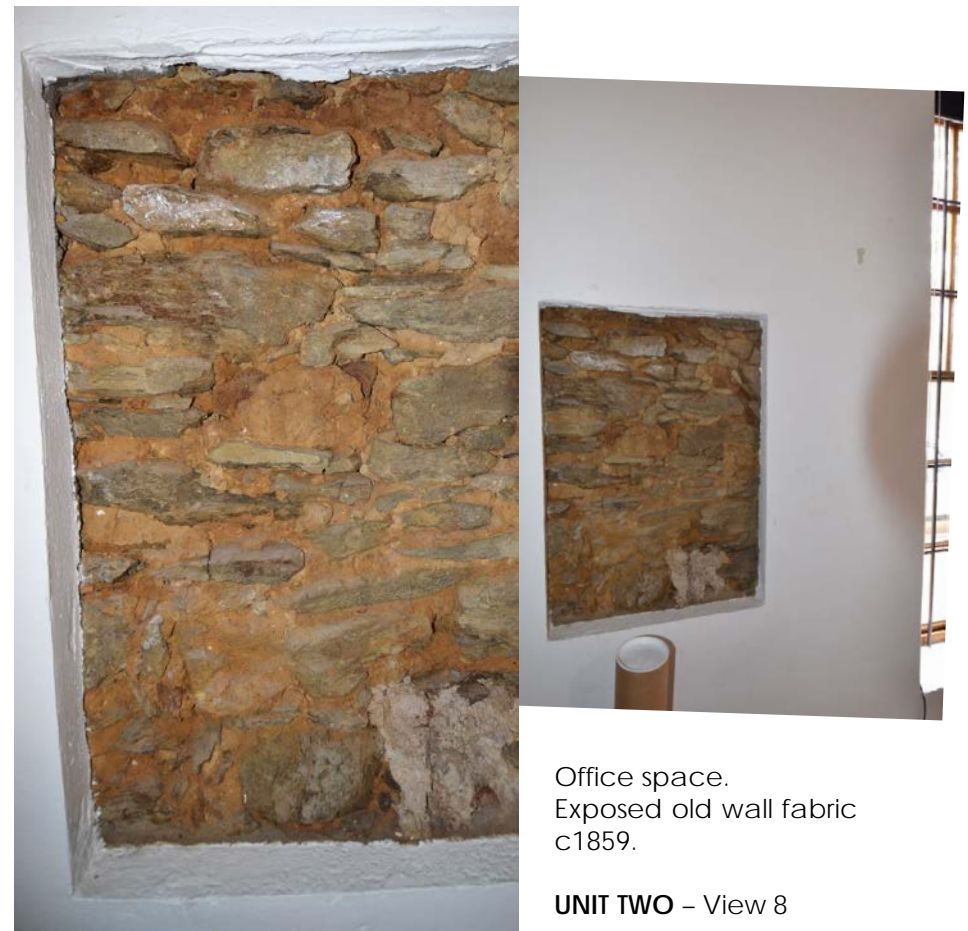
UNIT TWO – View 8

Office space.
Exposed old wall fabric
c1859.

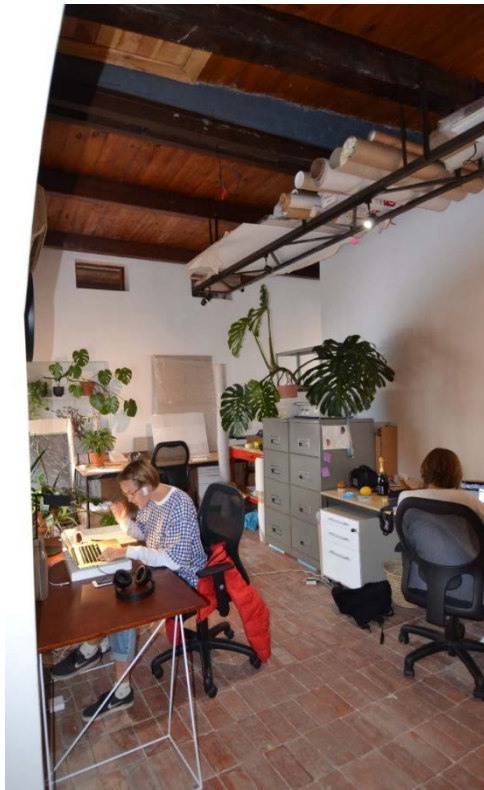
UNIT TWO – View 9

Office space.
Brick floor, bead mould ceiling beams, modern pine ceiling boards, modern sash windows, modern entrance door and fanlight, modern flat arched openings between rooms (c 1970/80).

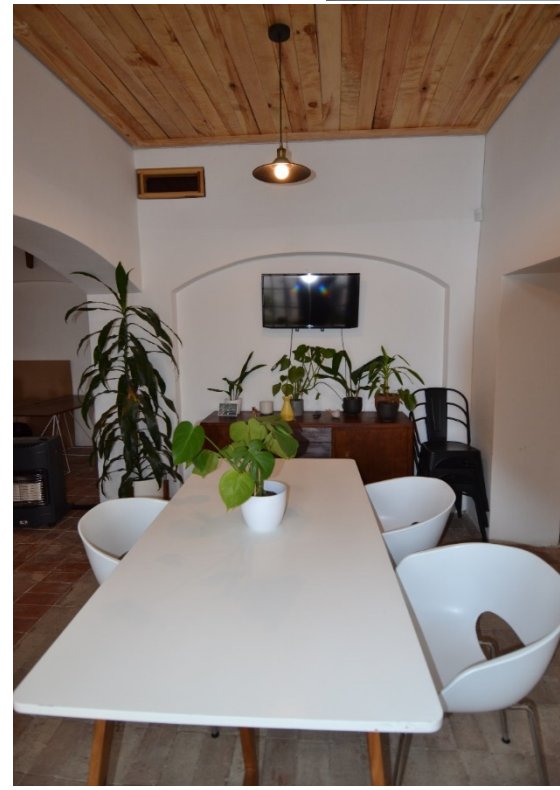
UNIT TWO – View 10

Office space.
Brick floor, modern pine ceiling boards, modern double doors, modern flat arched openings between rooms (c 1970/80).
Modern square high level square window (c 2013/14).

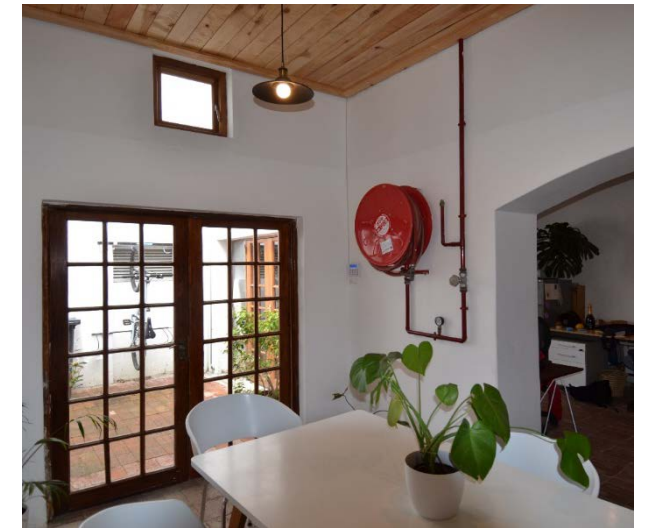
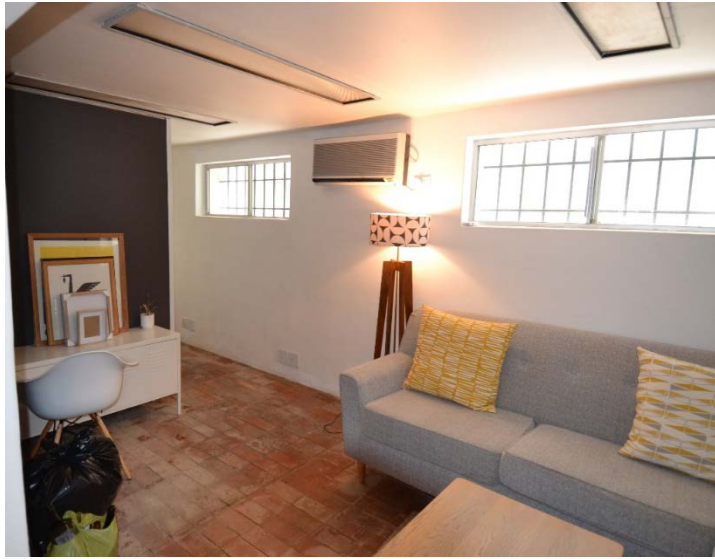
UNIT TWO – View 11

Office space.
Brick floor, flush plastered ceiling boards, recessed light panels, high level aluminium horizontally sliding windows (c 1970/80).

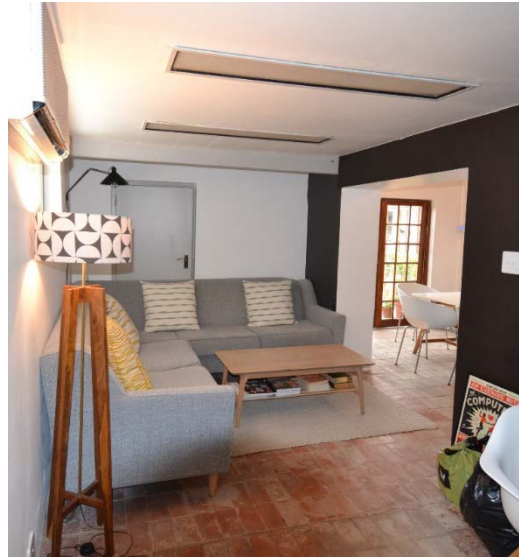
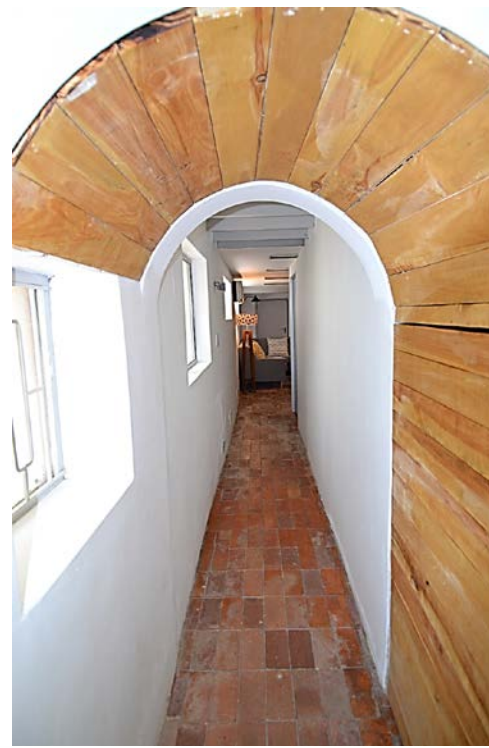
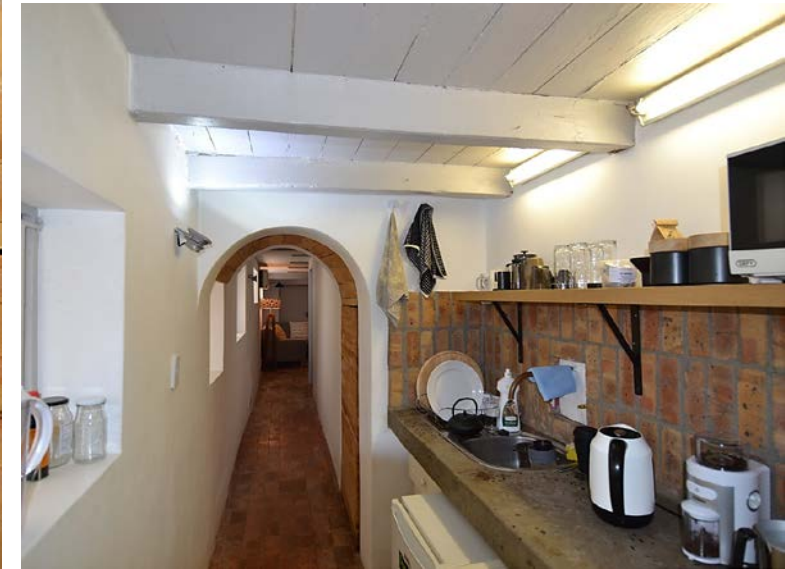
UNIT TWO – View 12

Kitchen and access space.
Brick floor, exposed modern painted pine ceiling beams and boards, high level aluminium sliding windows, arch openings(c 1970/80) lined with Poplar and modern kitchen with exposed brickwork splash back wall (2013/14).

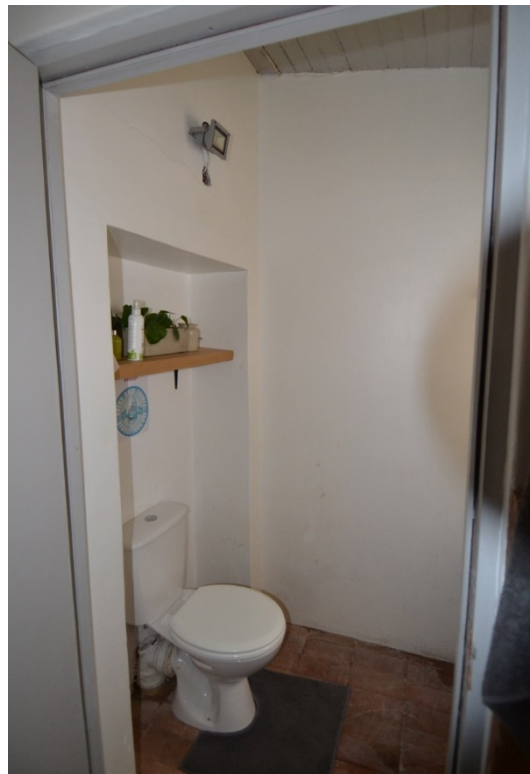
UNIT TWO – View 13

Bathroom spaces.
Brick floor, exposed modern painted pine ceiling beams and boards, high level aluminium windows (c 1970/80), modern sanitary ware, exposed modern brickwork splash back and flush new painted doors and frames (c 2013/14).

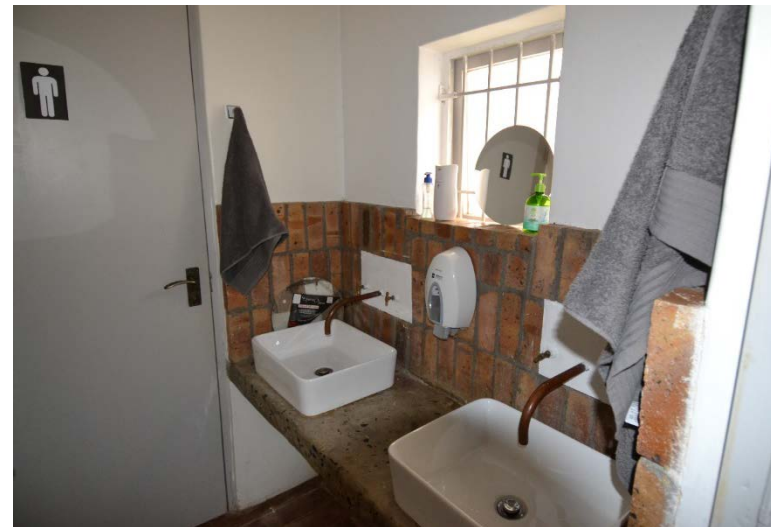
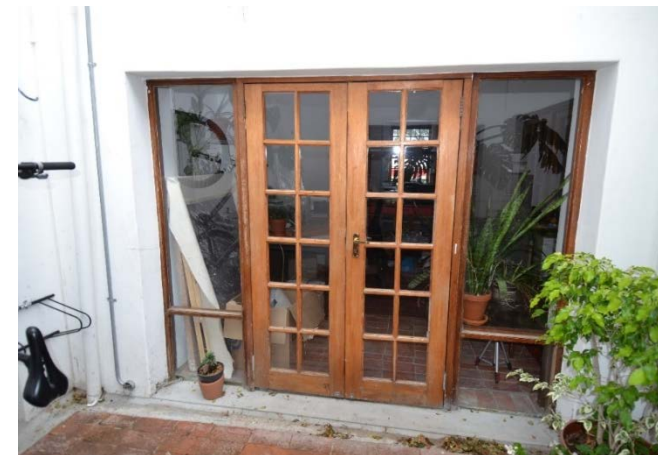
UNIT TWO – View 14

Court space.
Brick paving, modern double doors, modern sash, located in Unit One above(c 1970/80) and modern square high level square window (c 2013/14).

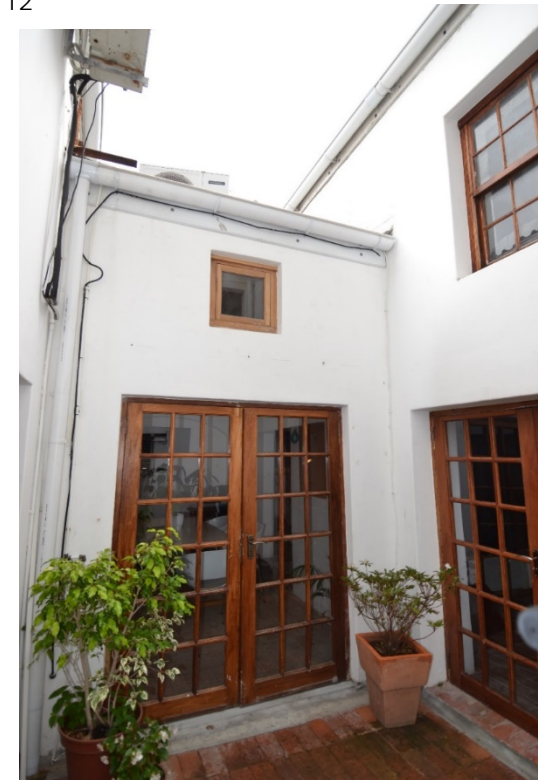
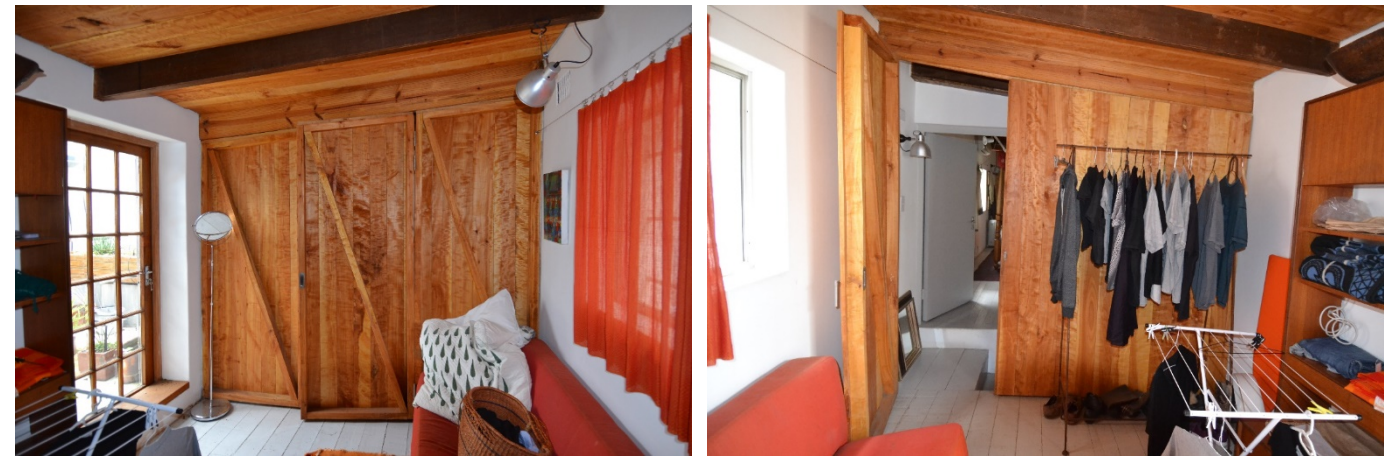
UNIT ONE – Upper level View 1

Guest bedroom space.
 Modern door to court, modern ceiling beams and ceilings (c 1970/80), modern Poplar vertical slatted and framed timber wall panels with diagonal bracing and integral doors between stair well/guest bedroom and guest bedroom/guest bathroom (c 2013/2014).

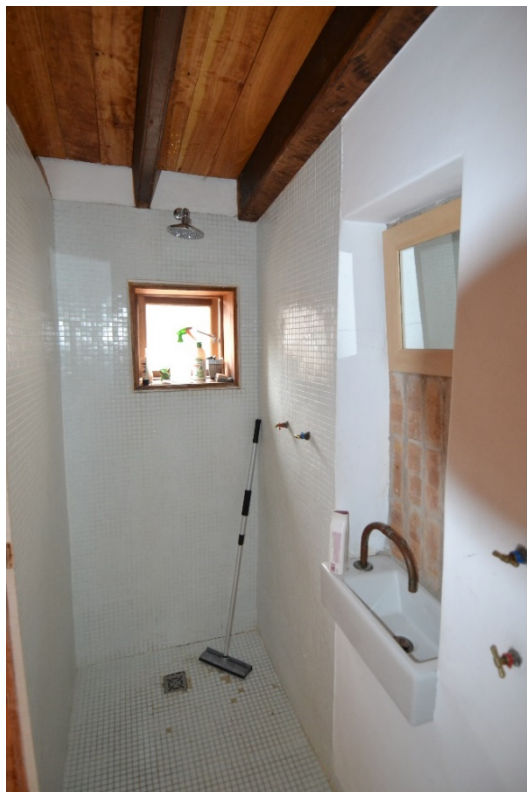
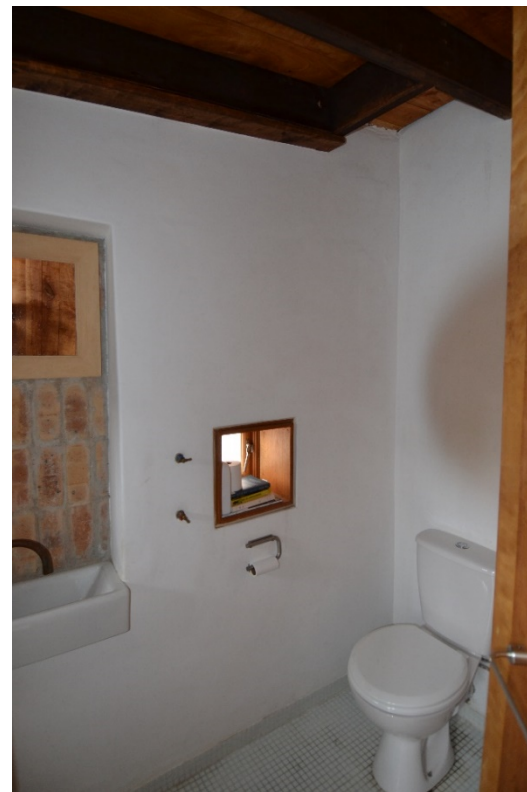
UNIT ONE – Upper level View 2

Guest bathroom space.
 Mosaic tiles to shower recess and back of framed timber wall panel.
 Modern sanitary ware, recessed exposed modern brickwork splash back, square high and low level windows (c 2013/14).

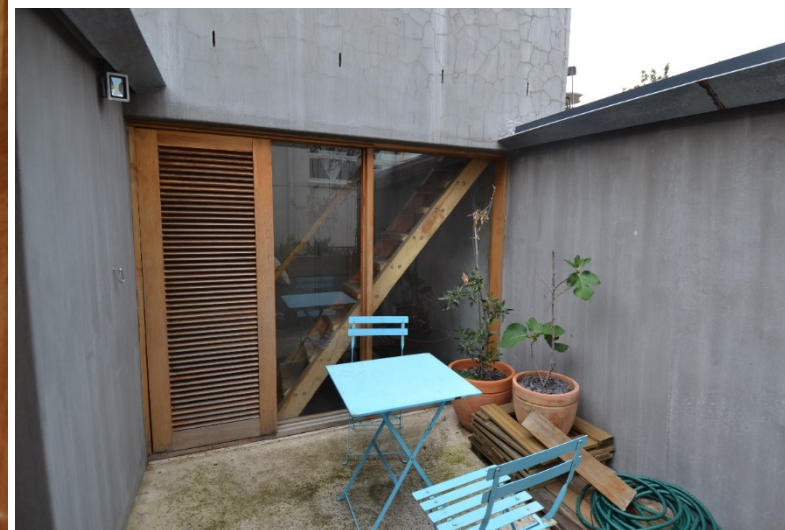
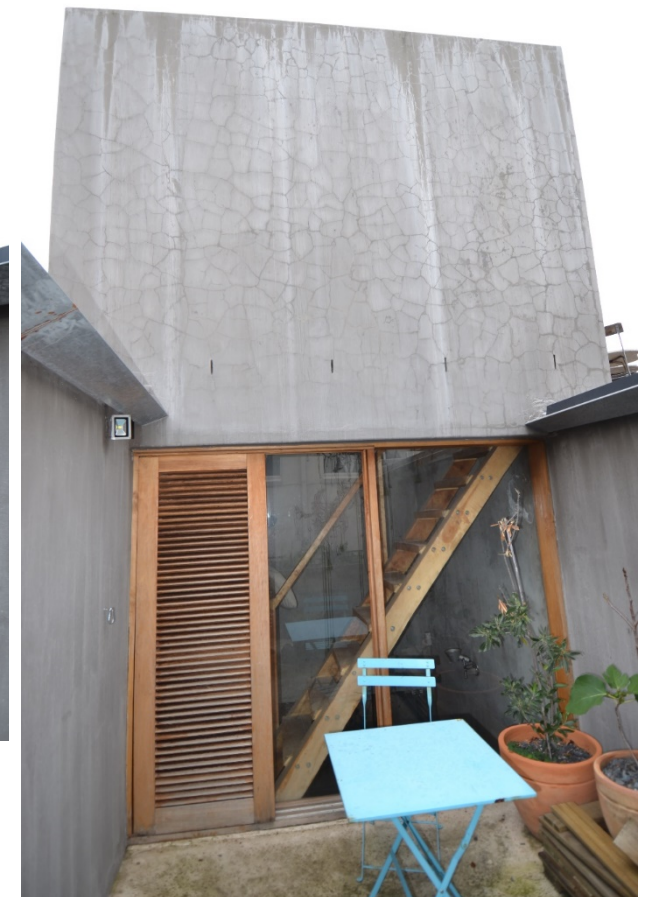
UNIT ONE – Upper level View 3

Mezzanine court space.
 Modern Poplar door with shutter and fixed full height side panels,
 modern Poplar open stair access to roof deck, modern special galvanised gutters (c 2013/14).

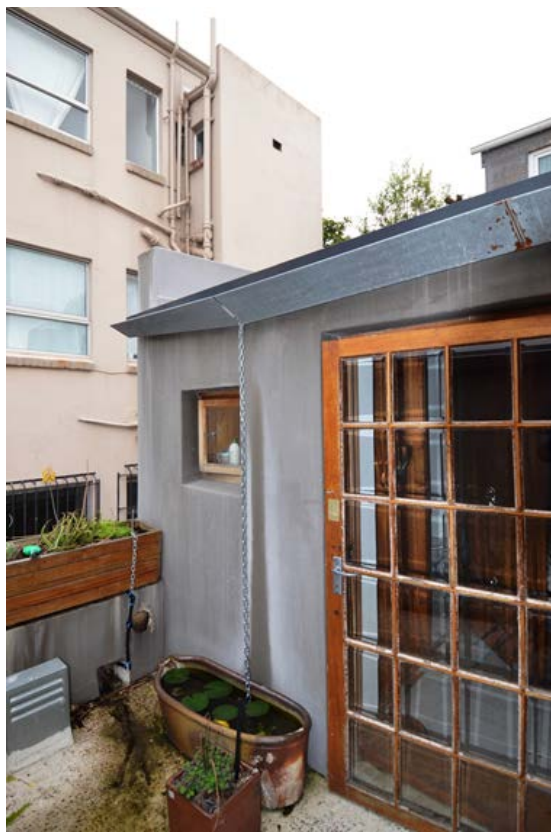
UNIT ONE – Upper level View 4

Mezzanine court space.
Modern door (c 1970/80), modern special galvanised gutters (c 2013/14).

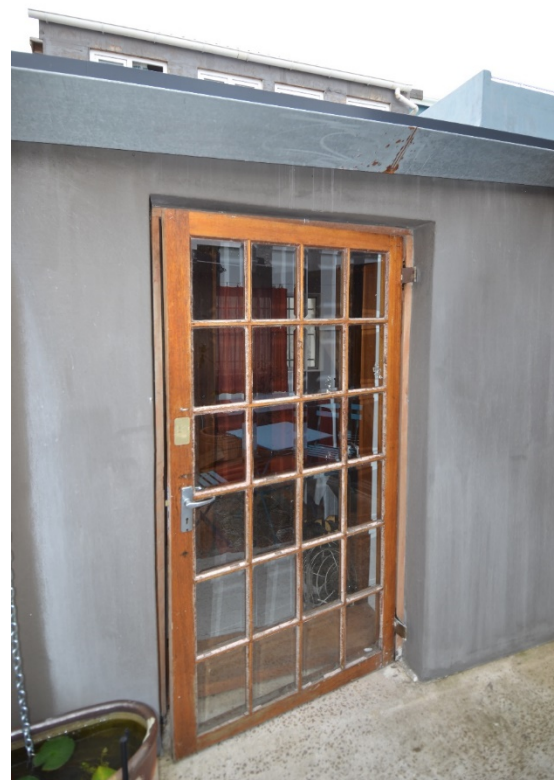
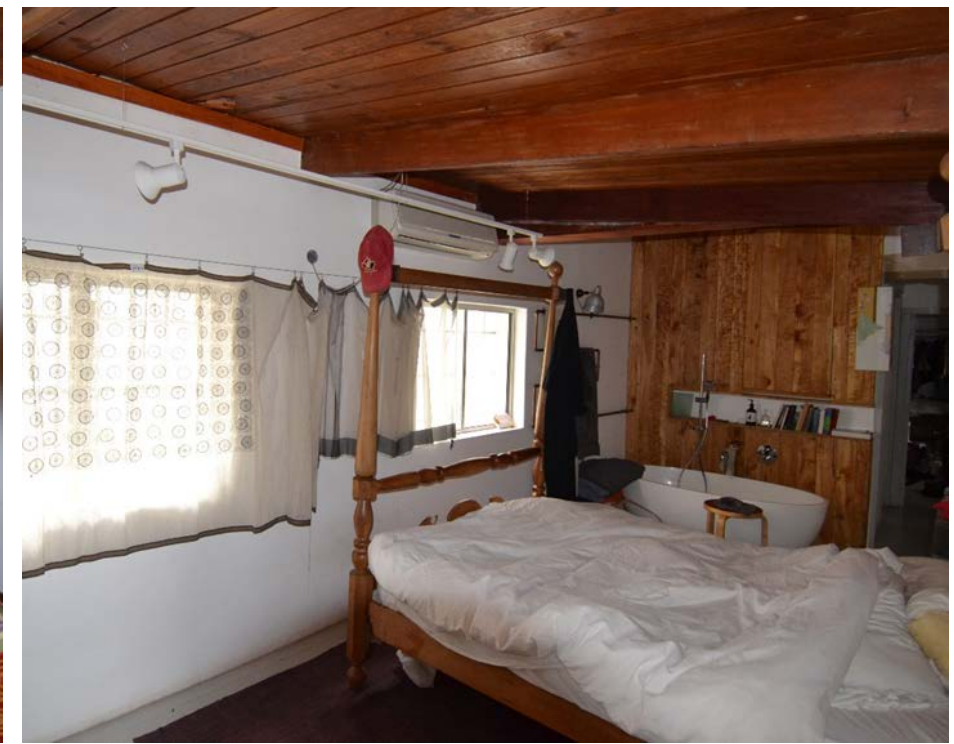
UNIT ONE – Upper level View 5

Main bedroom space.
Modern ceiling beams and ceilings, modern aluminium horizontally sliding windows (c 1970/80).
Modern Poplar slatted braced door, modern Poplar mezzanine gallery and open stair to roof deck, modern free standing bath situated against modern Poplar vertical slatted and framed timber dividing wall panel (c 2013/14).

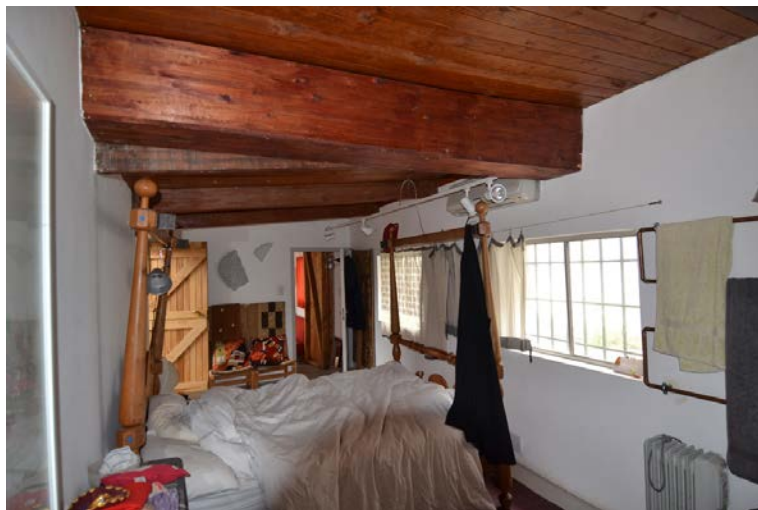
UNIT ONE – Upper level View 6

Main bedroom space.
Modern ceiling beams and ceilings, modern aluminium horizontally sliding windows (c 1970/80).
Modern Poplar slatted braced door and modern free standing bath adjacent to modern Poplar vertical slatted and framed timber dividing wall panel (c 2013/14).

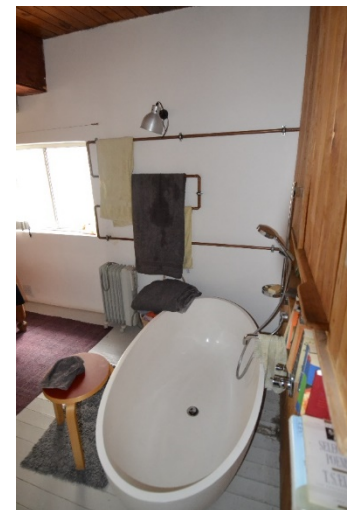
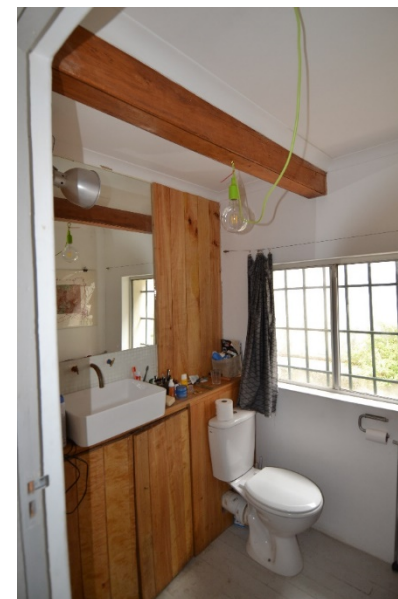
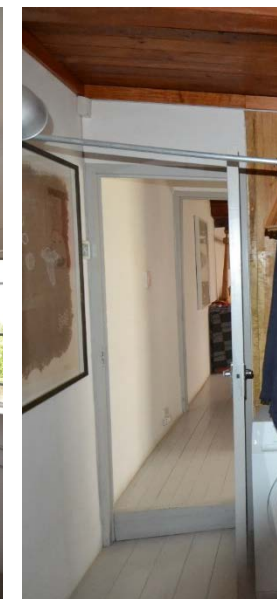
UNIT ONE – Upper level View 7

Main bathroom and dressing room space.
Modern ceiling beams and flush plastered ceilings in bathroom and modern pine ceilings in dressing room, modern aluminium horizontally sliding windows and flush panel doors (c 1970/80).
Modern sanitary ware and modern poplar cabinets (c 2013/14).

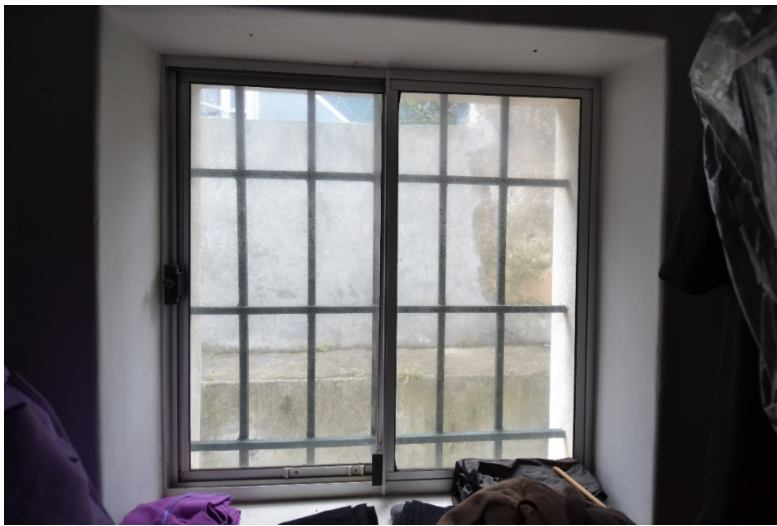
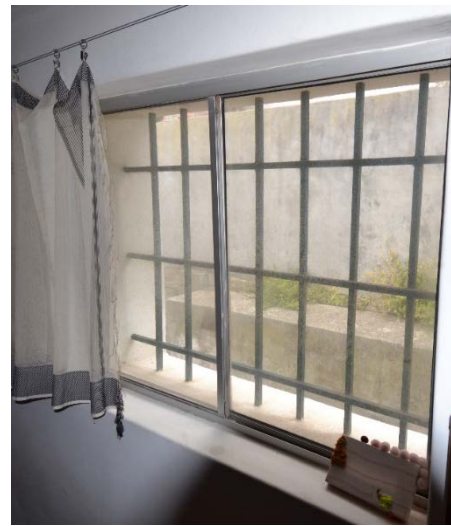
UNIT ONE – Upper level View 8

Main bedroom space.
 Modern aluminium horizontally sliding windows with plastered sills (c 1970/80).
 Modern exposed copper plumbing pipes (c 2013/14).

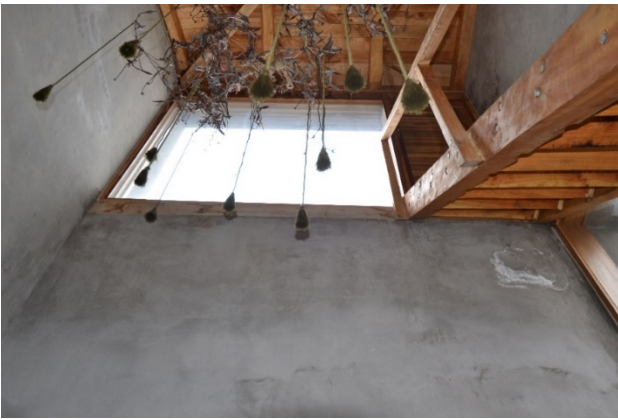
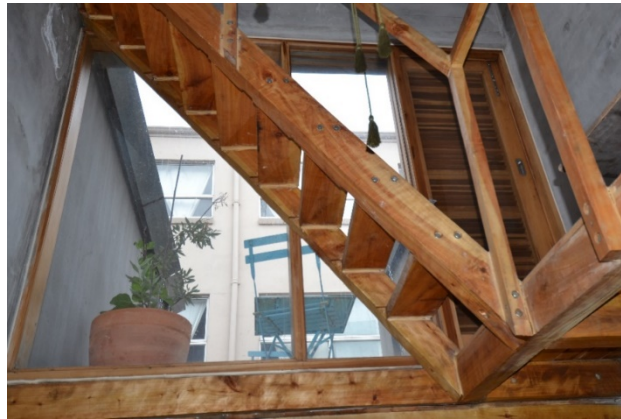
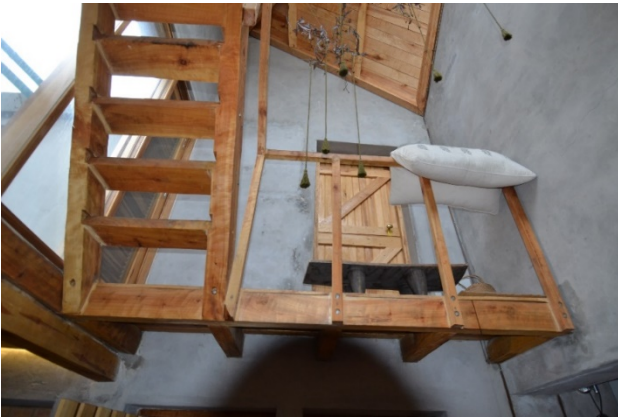
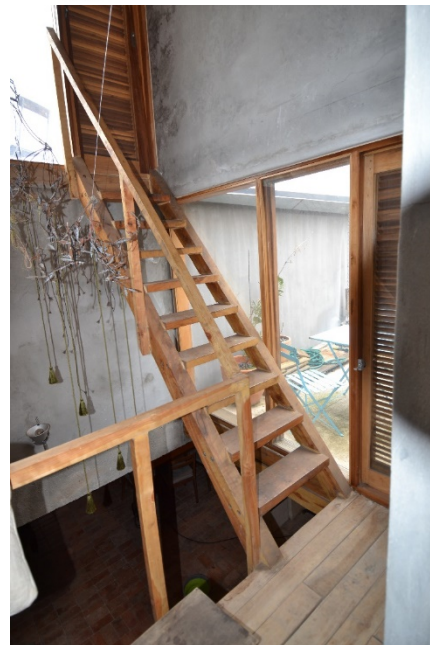
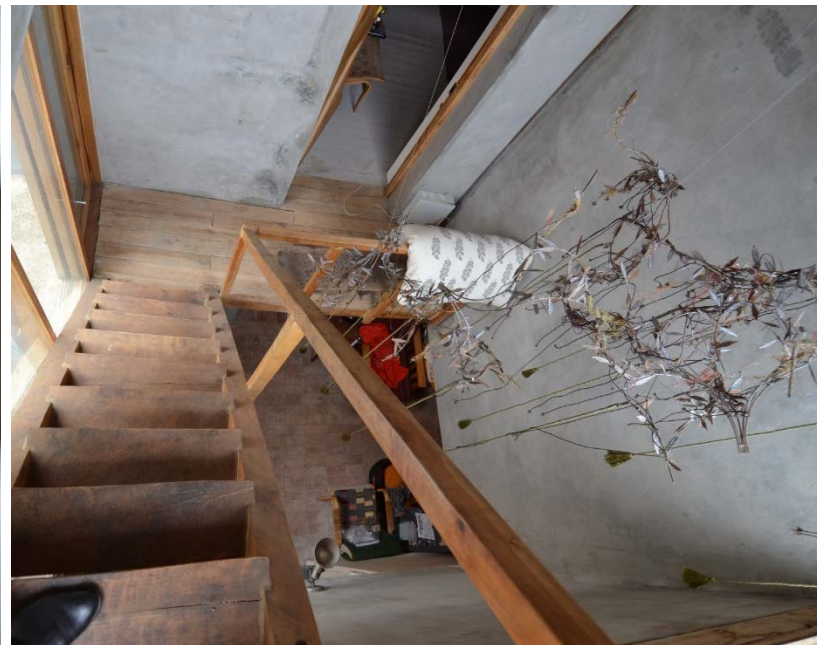
UNIT ONE – Upper level View 9

Tower space.
 Modern external Poplar doors with shutters and full height fixed side panels, modern open Poplar stair flights x2 with mezzanine landing as access to roof deck, modern timber roof with exposed Poplar timber beams, slatted Poplar ceiling and slatted braced Poplar door (c 2013/14).

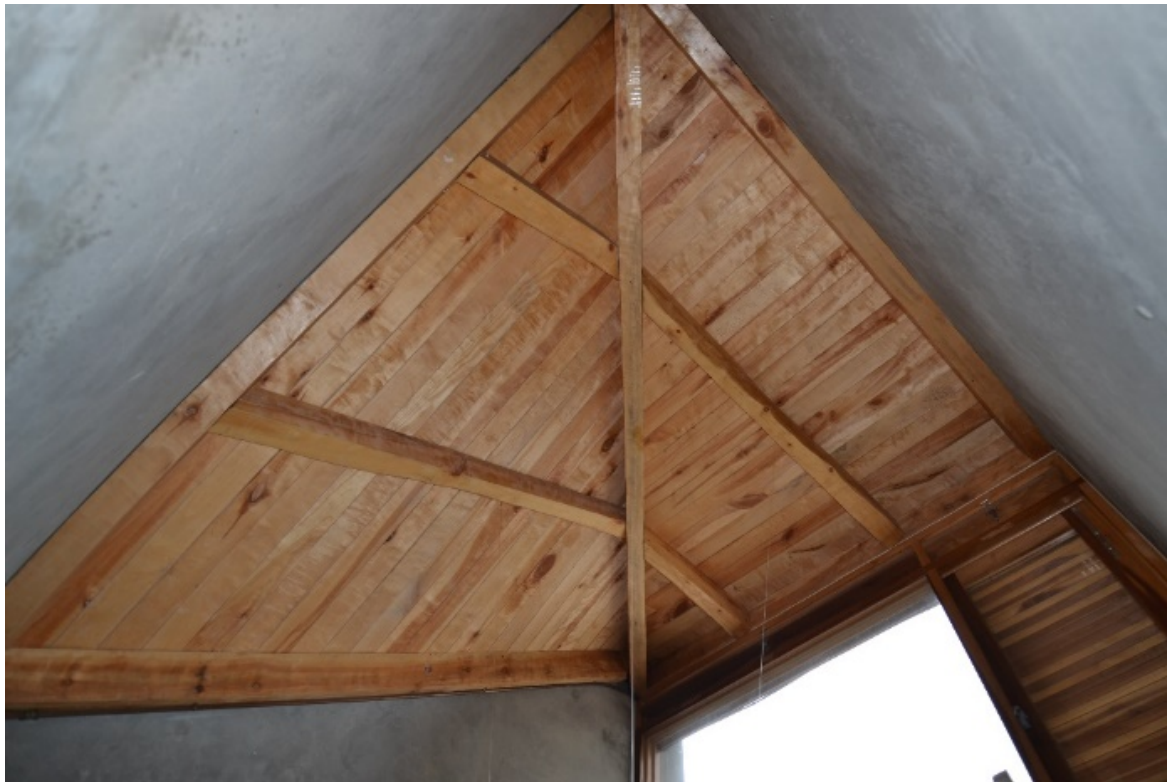
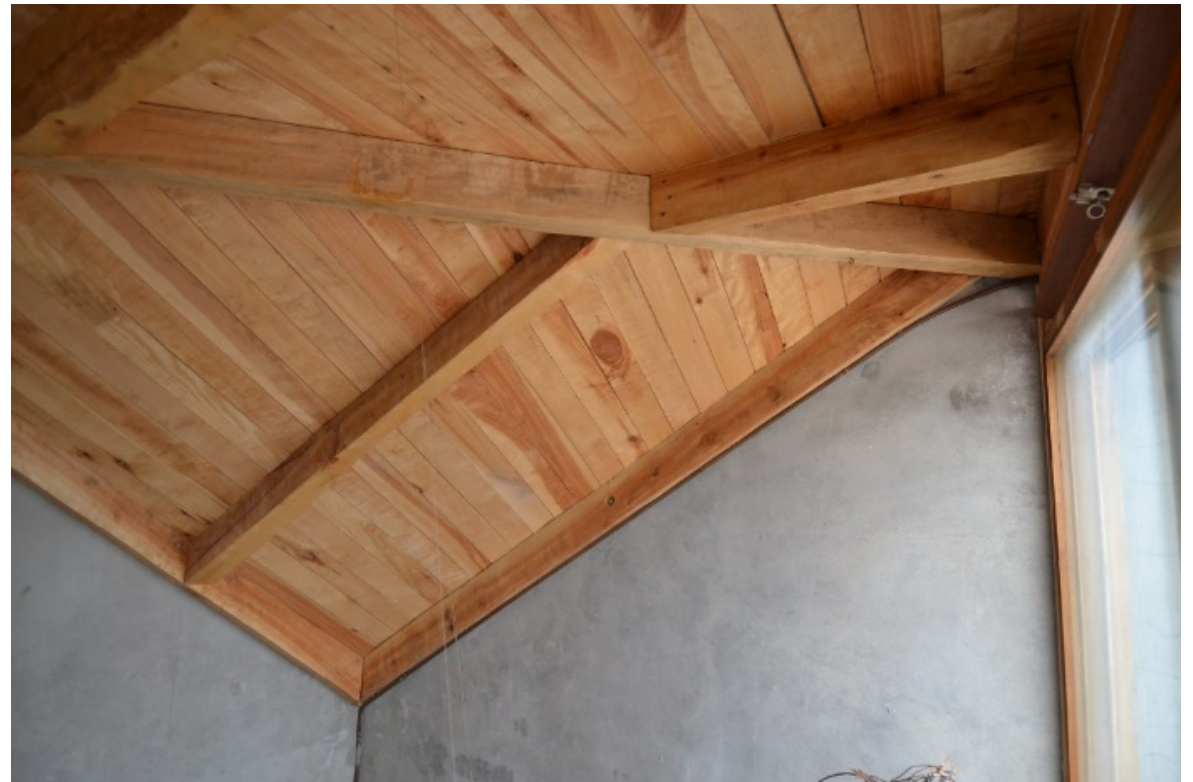
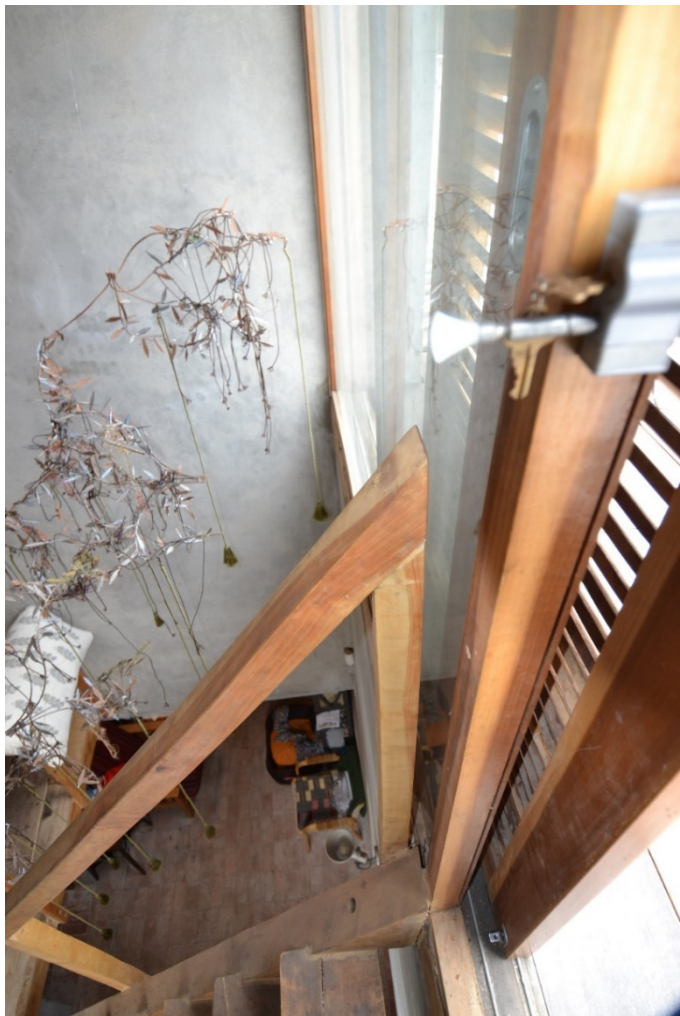
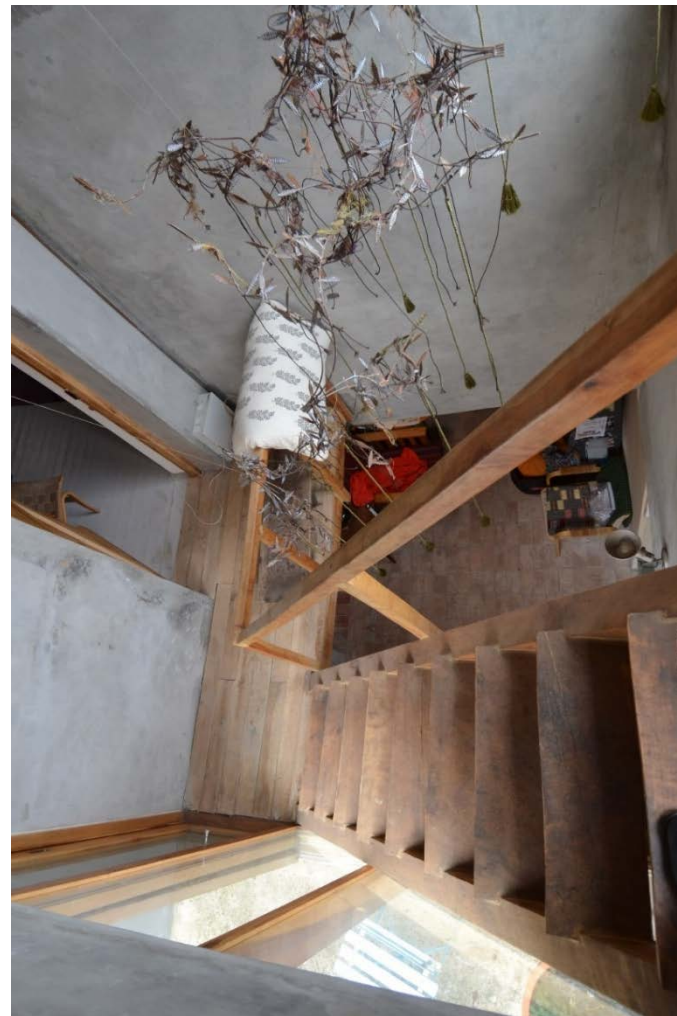
UNIT ONE – Upper level View 10

Tower space.
 Modern external Poplar doors with shutters and full height fixed side panels, modern open Poplar stair flights x2 with mezzanine landing as access to roof deck (c 2013/14).
