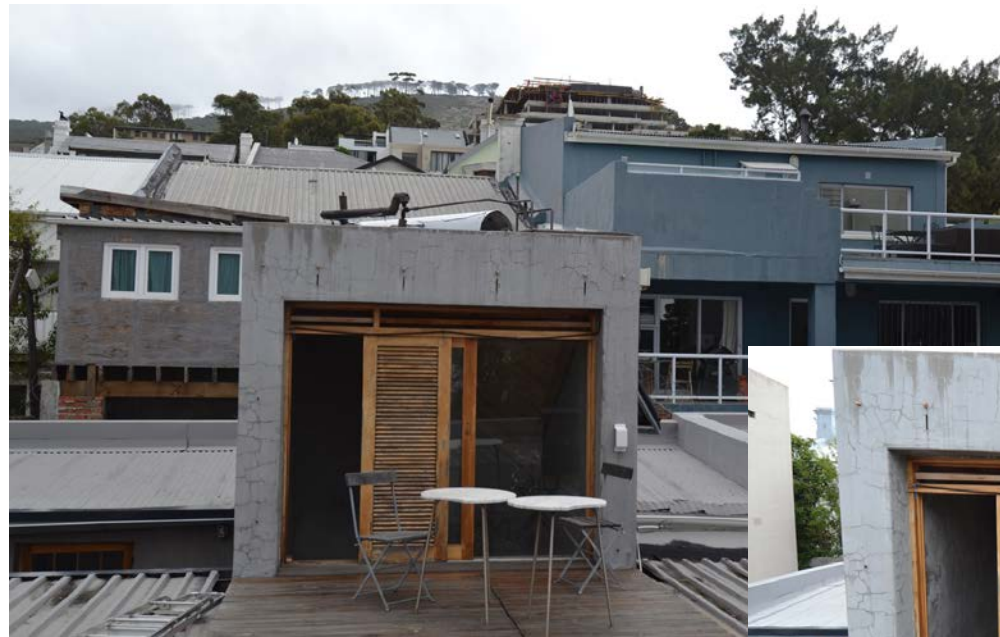
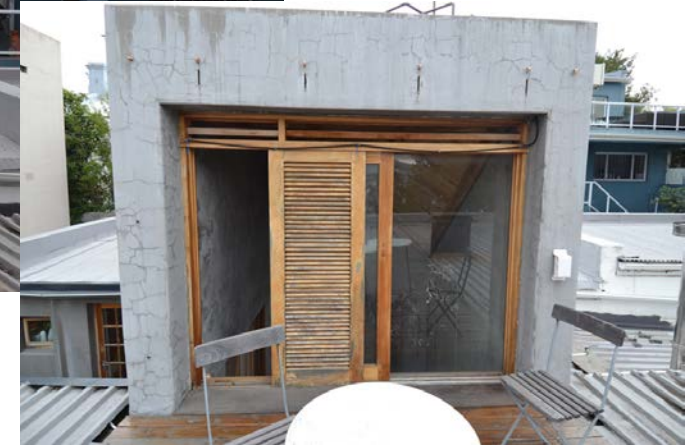
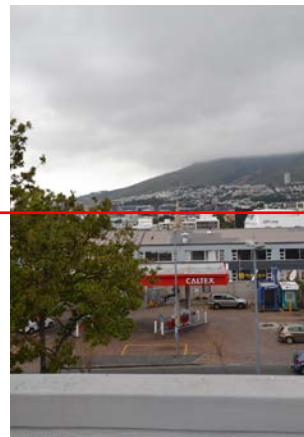
UNIT ONE – Roof deck View 13

Tower space.
Modern external Poplar doors with shutters and full height fixed side panels leading onto roof deck(c 2013/14).

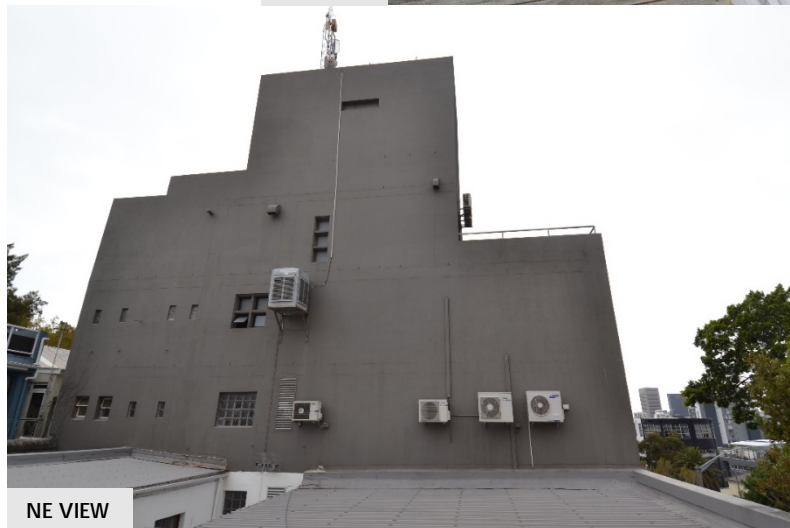
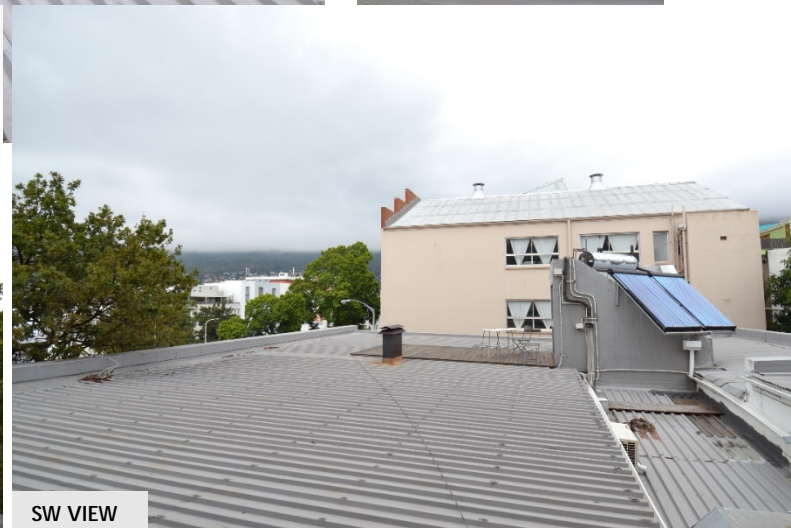
UNIT ONE – Roof deck View 14 SE, NE and SW

Note potential for views towards Heritage Resources - St Pauls Anglican Church, St Martin's Lutheran Church and possibly further afar to the Company Gardens and surrounds with added height.
