NATIONAL ROAD N1 SECTION 14 REHABILITATION

Locality - Municipal Borrow Pit A

ARCHAEOLOGICAL IMPACT ASSESSMENT OF TWO BORROW PITS ALONG THE NATIONAL ROUTE 1 NEAR TROPMSBURG, FREE STATE

**Palaeontological Desktop Evaluation of two borrow pits
near Trompsburg, Kapanong Local Municipality, FS
Province.**

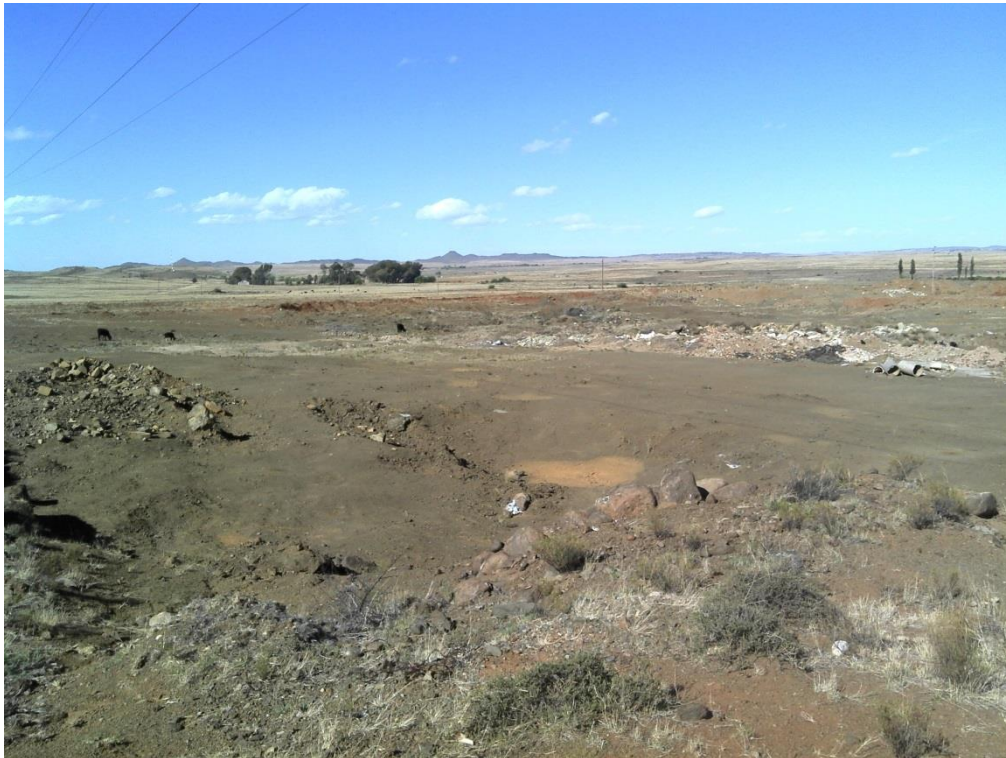
Figure 3: Visual character of landscape at Borrow Pit A

The landscape in the area is described as extensive, even or slightly undulating bottomland flats forming a matrix of large landscape patches interrupted by high dolerite sills/koppies (Figure 3). BP A is located adjacent to the R717 and so it will be visible to passers-by; however the site already consists of an active borrow pit where the Local Municipality are obtaining material for development projects in the area. The site is therefore already in a disturbed state, furthermore the site shows signs of poor housekeeping with the presence of illegally dumped materials as shown in Figure 4 below.

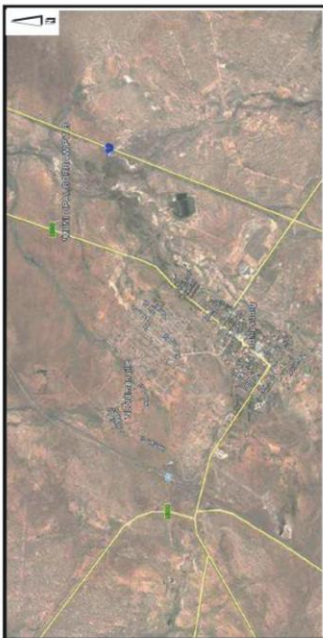
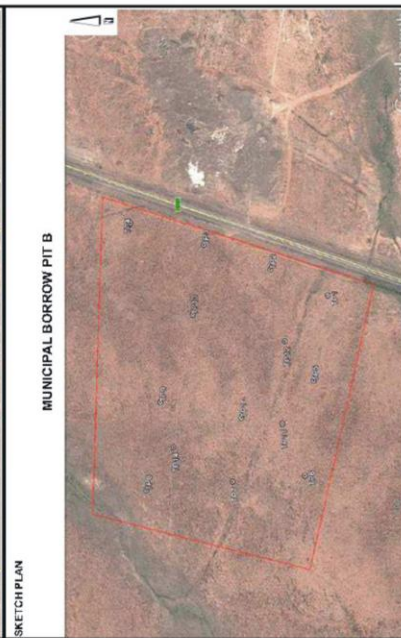
TEST PIT NO.	OVERBURDEN (m)	GRAVEL (m)	DESCRIPTION
1	0.300	1.400	Weathered dolerite
2	0.300	1.100	Weathered dolerite
3	0.270	1.100	Weathered dolerite
4	0.300	1.400	Weathered dolerite
5	0.200	2.500	Weathered dolerite
6	0.250	1.000	Weathered dolerite
7	0.200	2.000	Weathered dolerite
8	0.200	2.400	Weathered dolerite
9	0.200	2.000	Weathered dolerite
10	0.200	2.500	Weathered dolerite
11	0.100	2.100	Weathered dolerite
12	0.100	3.600	Weathered dolerite
13	0.100	2.700	Weathered dolerite
14	0.200	3.600	Weathered dolerite

WHOLE UNIT BORROW AREA	SELECTED BORROW AREA
m	0.210
m	2.120
m²	122000
m³	29620
m³	259000
