**TIGANE EXTENSIONS 7 AND 8, HARTBEESFONTEIN,
KLERKSDORP MATLOSANA**

**ENGINEERING GEOLOGICAL INVESTIGATION
to DETERMINE the POTENTIAL for TOWNSHIP DEVELOPMENT
for TIGANE EXTENSIONS 7 and 8, HARTBEESFONTEIN,
on PORTIONS of the FARMS URAAN 295IP & VOGELSTRUISFONTEIN 273IP,
KLERKSDORP MATLOSANA, NORTHWEST PROVINCE.**

Report number: GS201908T

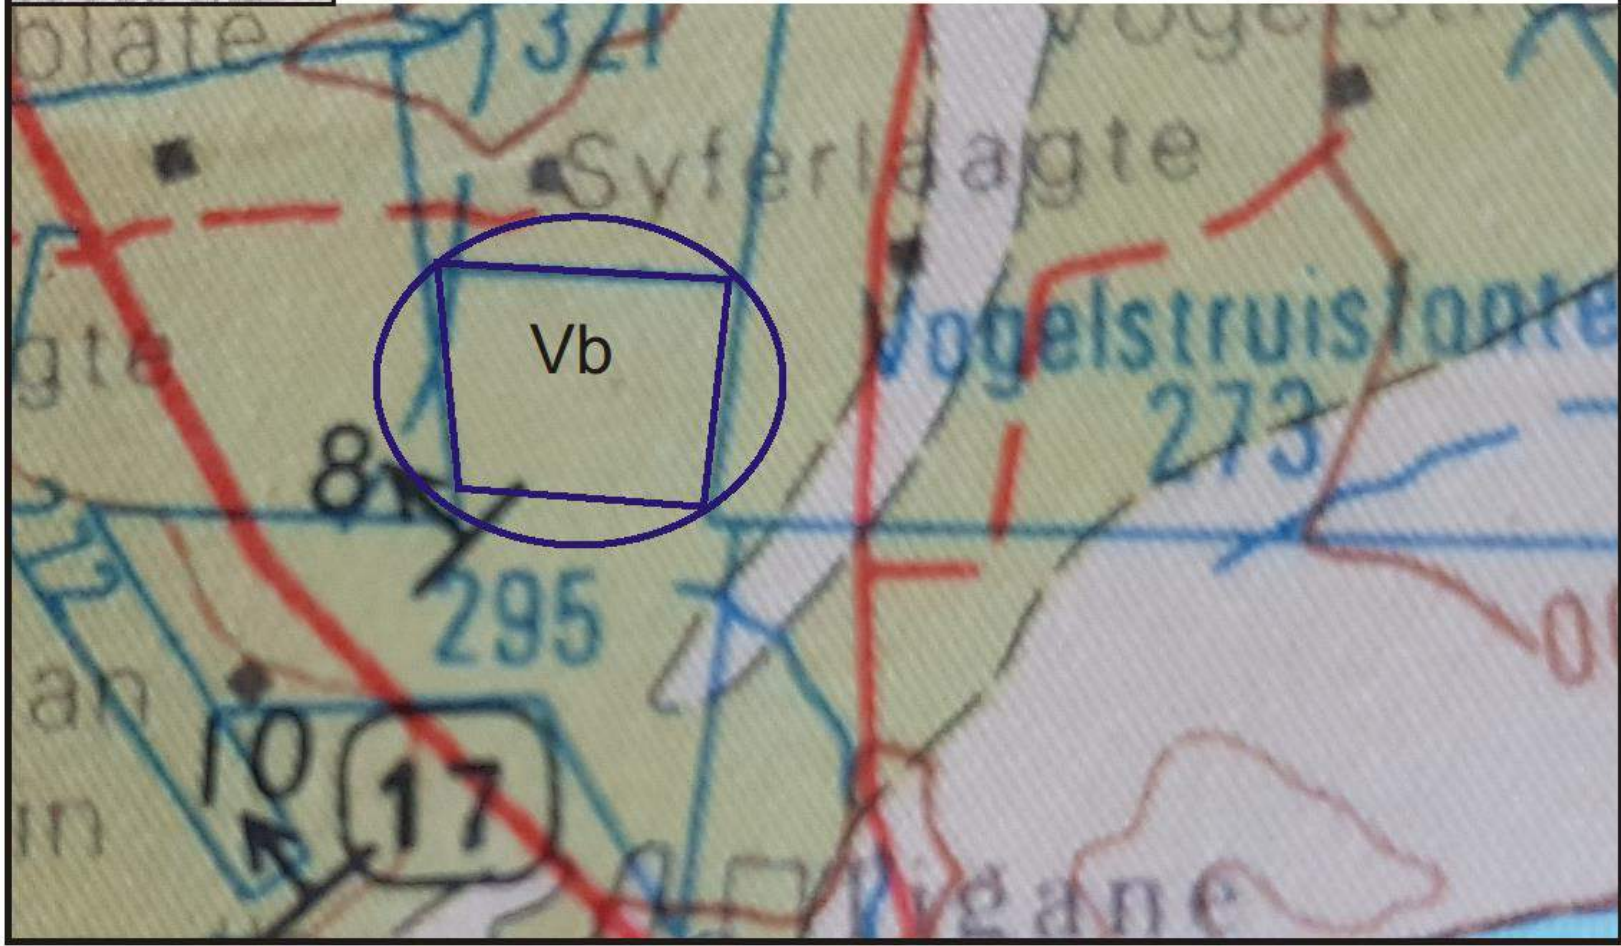
Figure 3: Geology Map
 Tigris X7 & 8, Hartbeesfontein, Northwest Province.

Geological Legend
 The site is underlain by quartzite, conglomerate & greywacke, of the Bothaville Formation, Platberg Group of the Ventersdorp Supergroup.

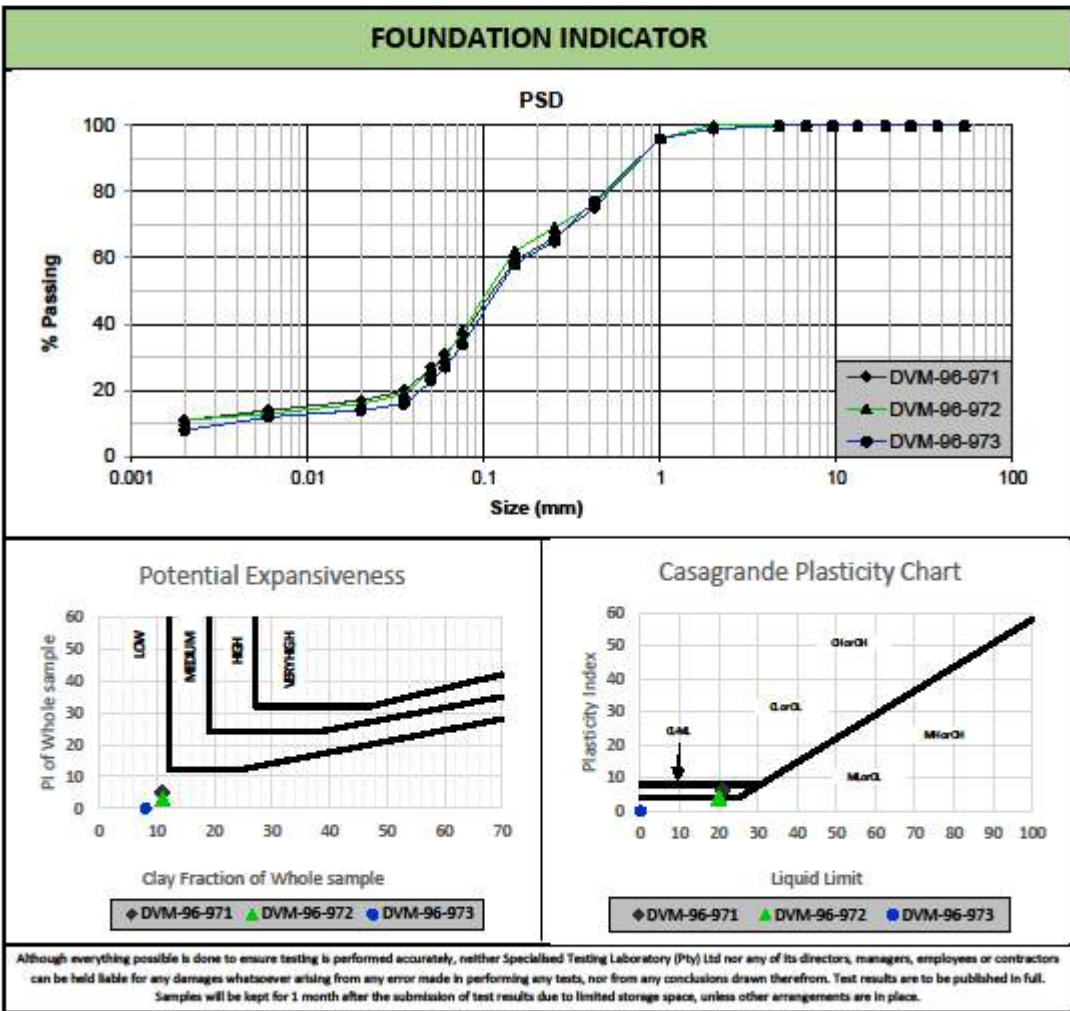
FOUNDATION INDICATOR							
Grading & Hydrometer Analysis (Particle Size (mm) & % Passing)				Atterberg Limits & Classification			
Sample	T4	T5	T7	Sample	T4	T5	T7
Depth (m)	0.6	0.8	0.4	Depth (m)	0.6	0.8	0.4
Lab No	DVM-96-971	DVM-96-972	DVM-96-973	Lab No	DVM-96-971	DVM-96-972	DVM-96-973

0.002	11	11	8	AASHTO (M145-91)	A - 4	A - 4	A - 2 - 4
Remarks: *: Assumed N / T: Not Tested							
<small>Although everything possible is done to ensure testing is performed accurately, neither Specialised Testing Laboratory (Pty) Ltd nor any of its directors, managers, employees or contractors can be held liable for any damages whatsoever arising from any error made in performing any tests, nor from any conclusions drawn therefrom. Test results are to be published in full. Samples will be kept for 1 month after the submission of test results due to limited storage space, unless other arrangements are in place.</small>
