Water Resource Assessment for the proposed Middledrift Water Supply Scheme - Update

Mthungeni, KwaZulu-Natal

March 2019

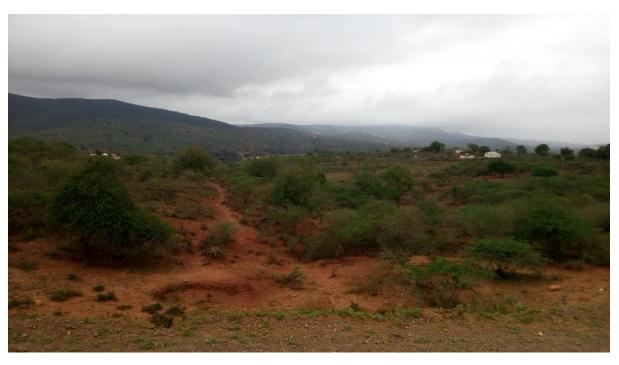
Figure 7: Photograph of a local drainage channel

The setting of the project area is characterised by all three channel networks. The project has attempted to identify and distinguish between these channels, delineating the wetland areas in the process.

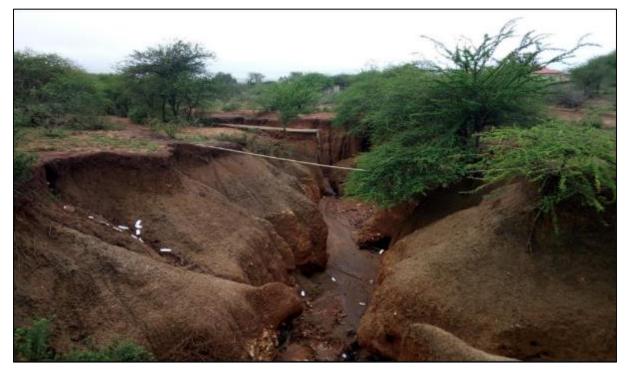
Figure 16: Photograph illustrating typical level of erosion of many drainage lines within the project area

The proposed water supply scheme may make use of water pipeline structures that cross drainage channels as presented in Figure 16. These drainage channels may be inundated during periods of high flow. It is recommended that the pipeline span the drainage channel and not use 'instream' support piers.
