NTUSI DAIRY FARM, PTN 4 KLIPSPRUIT 137 HT

WETLAND DELINEATION

17 May 2012

**MR. A. EMERY
EMROSS CONSULTING (PTY) LTD**

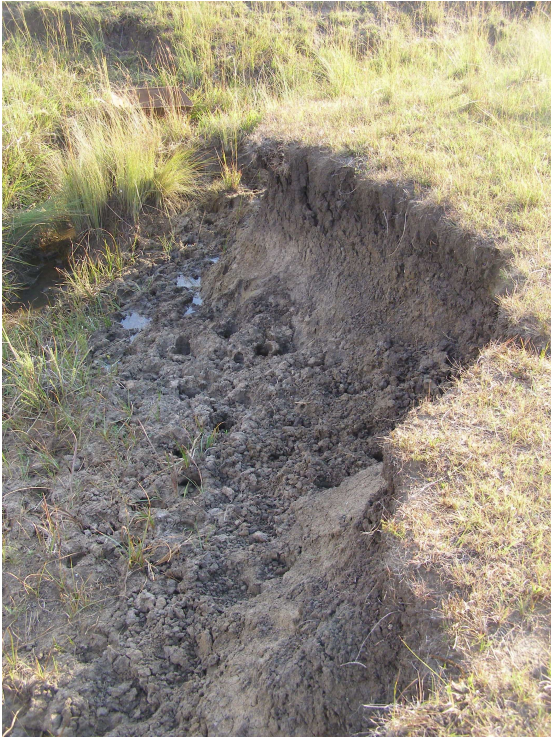
The river channel has been severely degraded by trampling of cattle as they cross the river channel and come down to the river to drink. This is causing the erosion of the river banks and desiccation of the surrounding seepage wetland areas.

Photo 1: Wetland A showing erosion of river bank as a result of cattle trampling.

- It is recommended that no development takes place within 30m of the demarcated wetland boundary.
- That Working for Wetlands is approached to assist in the building of gabions to prevent further wetland erosion and to protect and restore the wetland areas.
- That cattle watering points be established outside of the wetland areas.
- That the number of cattle be reduced to the lands carrying capacity.
- That suitable crossing points be created within the wetland for vehicles, people and cattle to prevent further erosion at the existing crossing points.

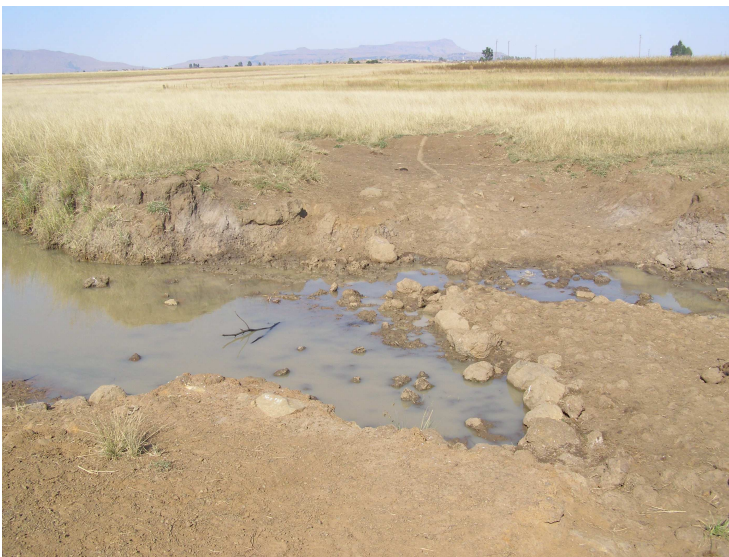
There is an old road crossing which is severely eroded (Appendix 1: Wetland Map).

Photo 2: Wetland A showing erosion at road crossing.

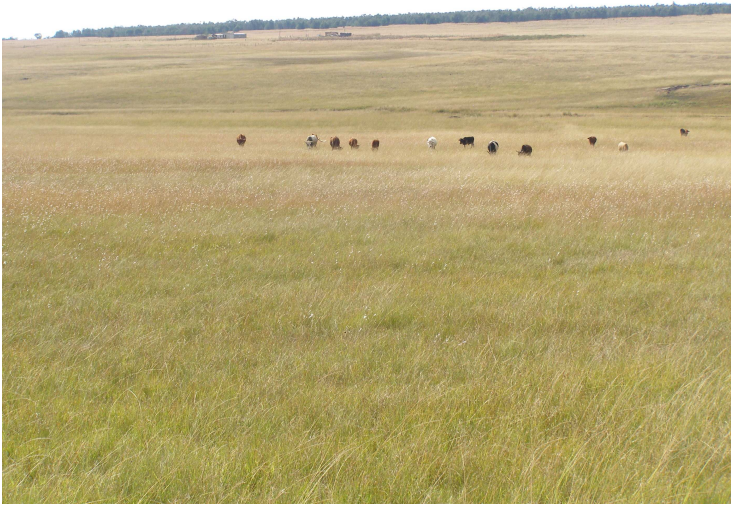
Photo 3: Wetland A showing broad seasonal to permanent seepage zone with cattle grazing within it.

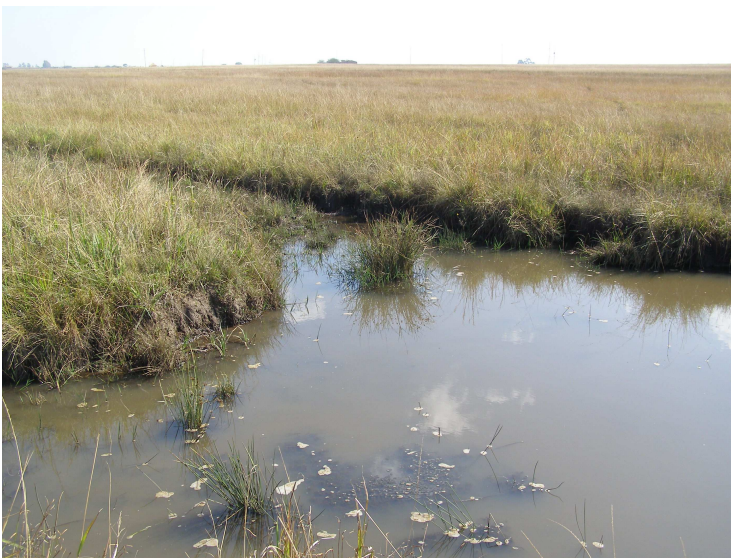
This is a large seepage wetland area to the west of Wetland A. The head of the wetland is predominately permanent wetland, with pools that are utilised for watering of cattle. The soils of the broad midsection indicate a seasonal wetland area, but it appears as though the area is becoming dried out by overgrazing which is reducing the vegetation cover.

Photo 4: Pool used for cattle watering at head of Wetland B.

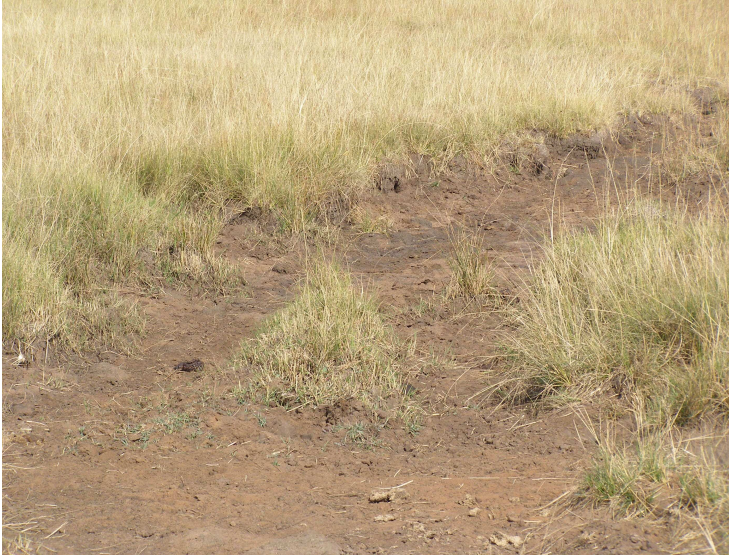
Photo 5: Dry pool within middle of Wetland B.

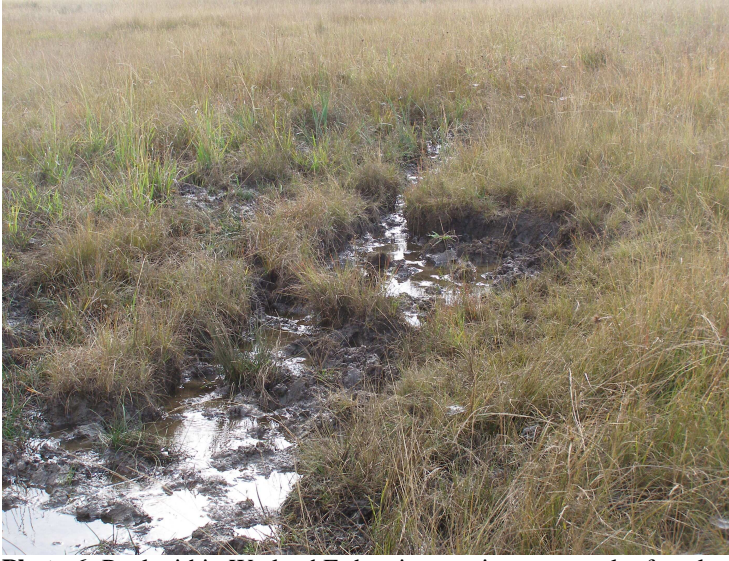
Wetland F is a seasonal to predominately permanent seepage wetland area. The wetland borders onto shallow rocky areas on its southern and eastern boundary. There are numerous pools that are utilised for the watering of cattle. These areas are becoming eroded.

Photo 6: Pool within Wetland F showing erosion as a result of cattle using pool for water.

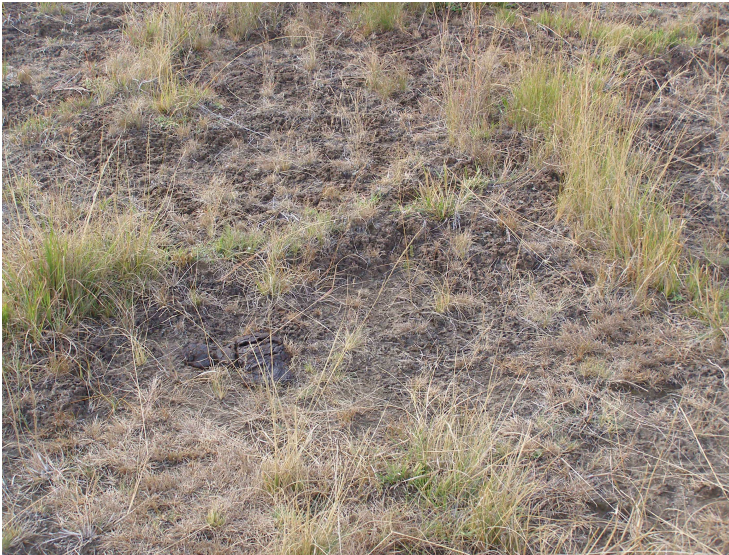
Photo 7: Rocky areas typically bordering many of the wetlands

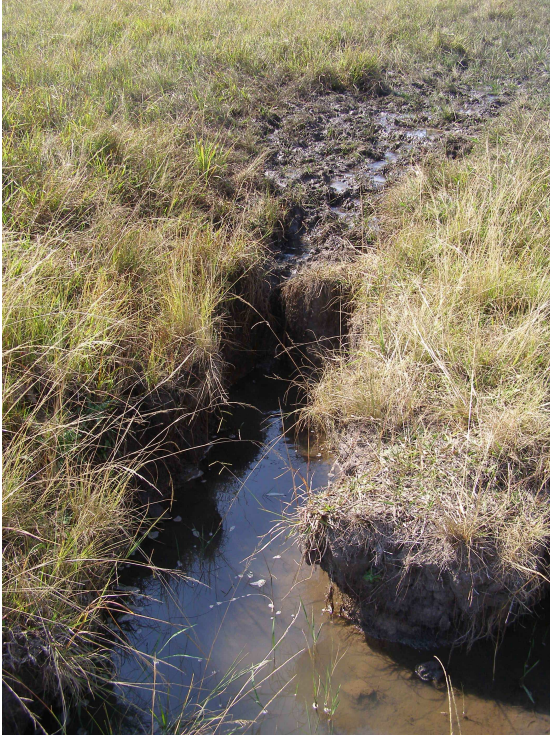
Wetland H is a seasonal to predominately permanent seepage wetland area. The wetland borders onto shallow rocky areas on its northern and southern boundary. There are two pools at the head of the wetland that are utilised for the watering of cattle. There is a headcut into the wetland and a pool (Appendix 1: Wetland Map). Below the headcut the wetland area has become desiccated and erosion is taking place alongside the stream.

Photo 8: Headcut within wetland H.

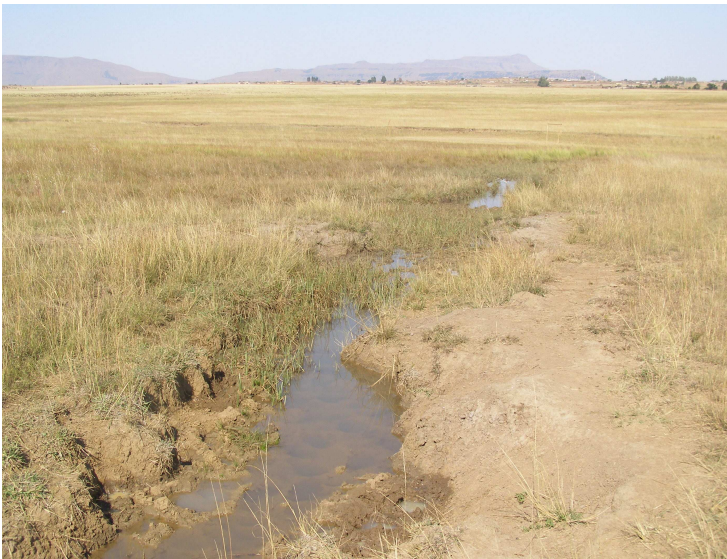
Photo 9: Desiccated wetland below headcut.

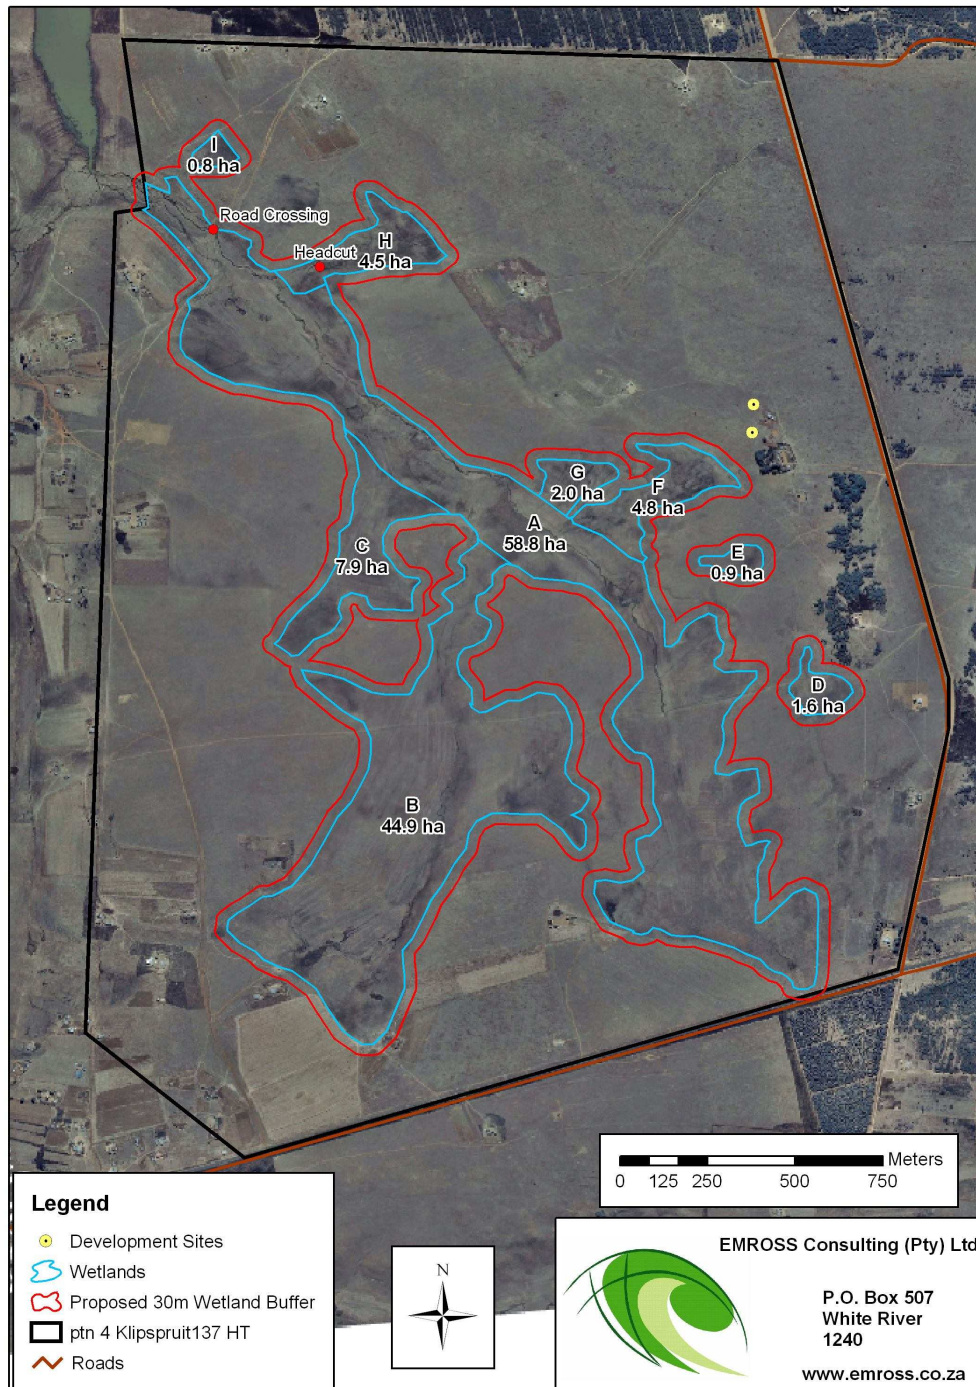
APPENDIX 1: MAP 1. WETLAND AREAS

A total of 126 ha (22%) of the 574 ha farm was delineated as wetland areas (Table 3.1) (Appendix 1: Wetland Map). The majority of the wetland area can be classified as either seasonal or permanent wetland areas. The wetlands often abutted onto rocky areas or areas with very shallow soils. The wetlands are showing signs of overgrazing and cattle are causing erosion in permanent zones where pools are used for the watering of the cattle.
