BOTHAS HILL SERVICE STATION & RETAIL CENTRE

Geotechnical Investigation Report

May 2021

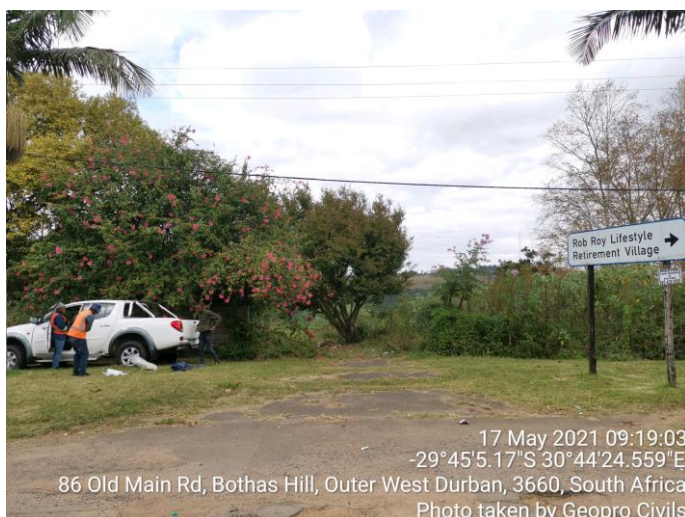
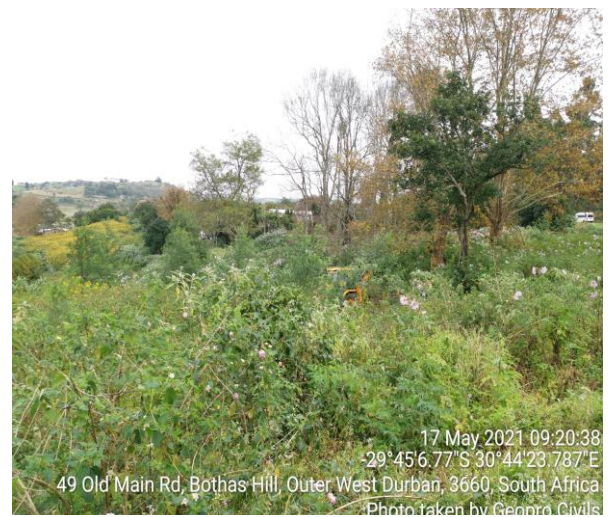
Figure 1: Image showing the proposed site for development, located on ERF363, Bothas Hill, Outer West Durban, Kwa-Zulu Natal.

Topographically, the trial pits are located on a tree and grass covered area. The proposed area for development is currently a zoned area with an existing old, demolished building. The site is surrounded by land uses including shops and a hotel opposite the proposed developmental site. Please see Annexure E for the site topography.

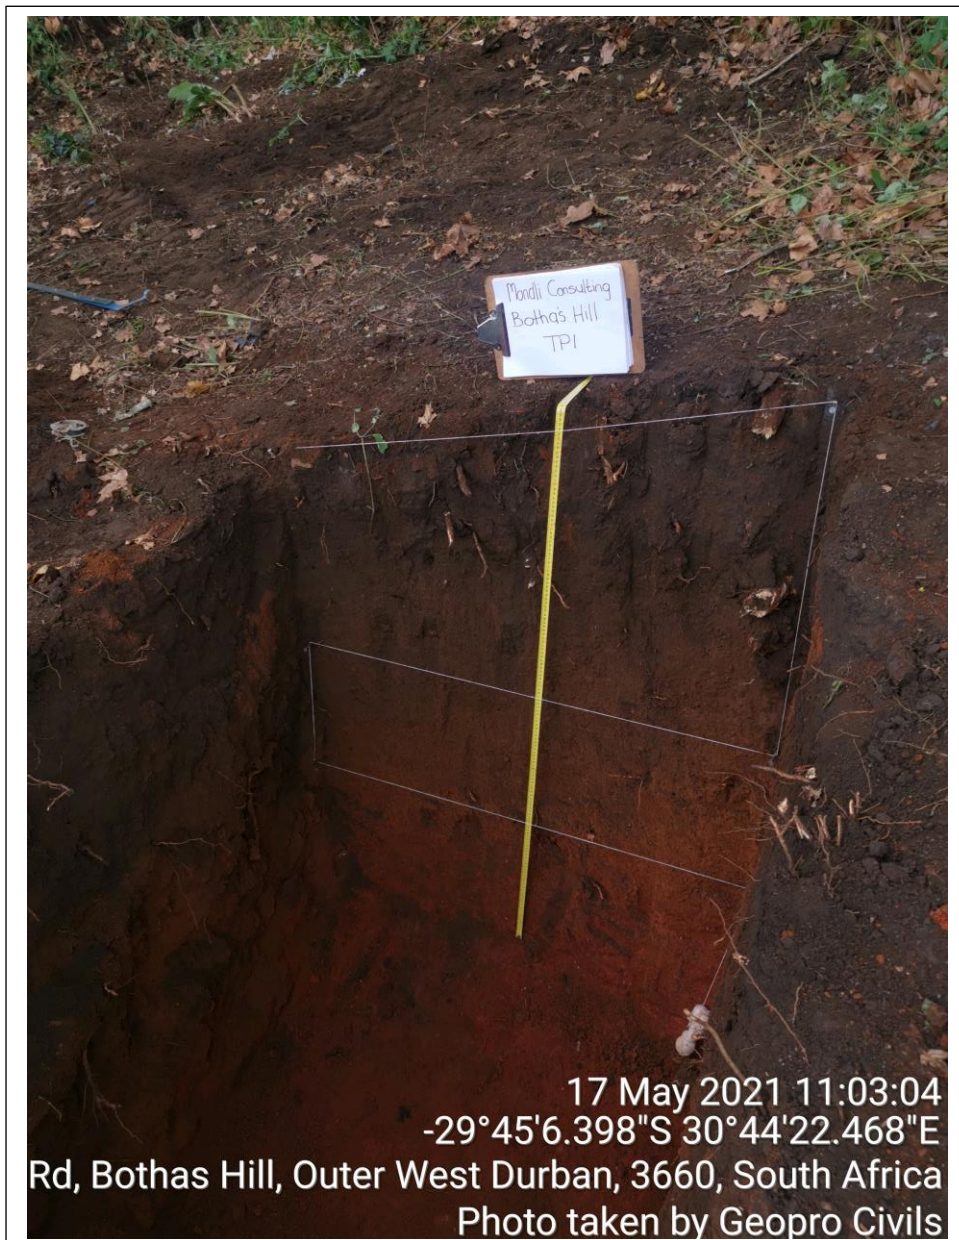
FIGURE 2: TEST PIT 1 PROFILING

<u>THICKNESS</u>	<u>PROFILE</u>	<u>DEPTH</u>	<u>DESCRIPTION</u>
680mm	¥¥¥¥ ¥¥¥¥ ¥¥¥¥ ¥¥¥¥ ¥¥¥¥ ¥¥¥¥ ¥¥¥¥ ¥¥¥¥ ¥¥¥¥ ¥¥¥¥ ¥¥¥¥ ¥¥¥¥ ¥¥¥¥ ¥¥¥¥ ¥¥¥¥	0mm	Moist, dark brown black, firm, intact, fine grained, topsoil
370mm	===== ===== ===== ===== ===== ===== ===== ===== ===== =====	680mm	Moist, light brown orange, firm, intact, medium - coarse grained, ferruginous sand, weathered granite
400mm	===== ===== ===== ===== ===== ===== ===== ===== ===== =====	1050mm	Moist, dark red, firm, intact, medium - coarse grained, ferruginous sand, weathered granite
		1450mm	No water Seepage

CLIENT NAME	Mondli Consulting Services
PROJECT NAME	Bothas Hill Service Station & Retail Centre
POSITION IN FIELD	Test Pit 1
CO-ORDINATES	-29° 45' 6.398" S 30° 44' 22.468" E
DATE ASSESSED	17.05.2021

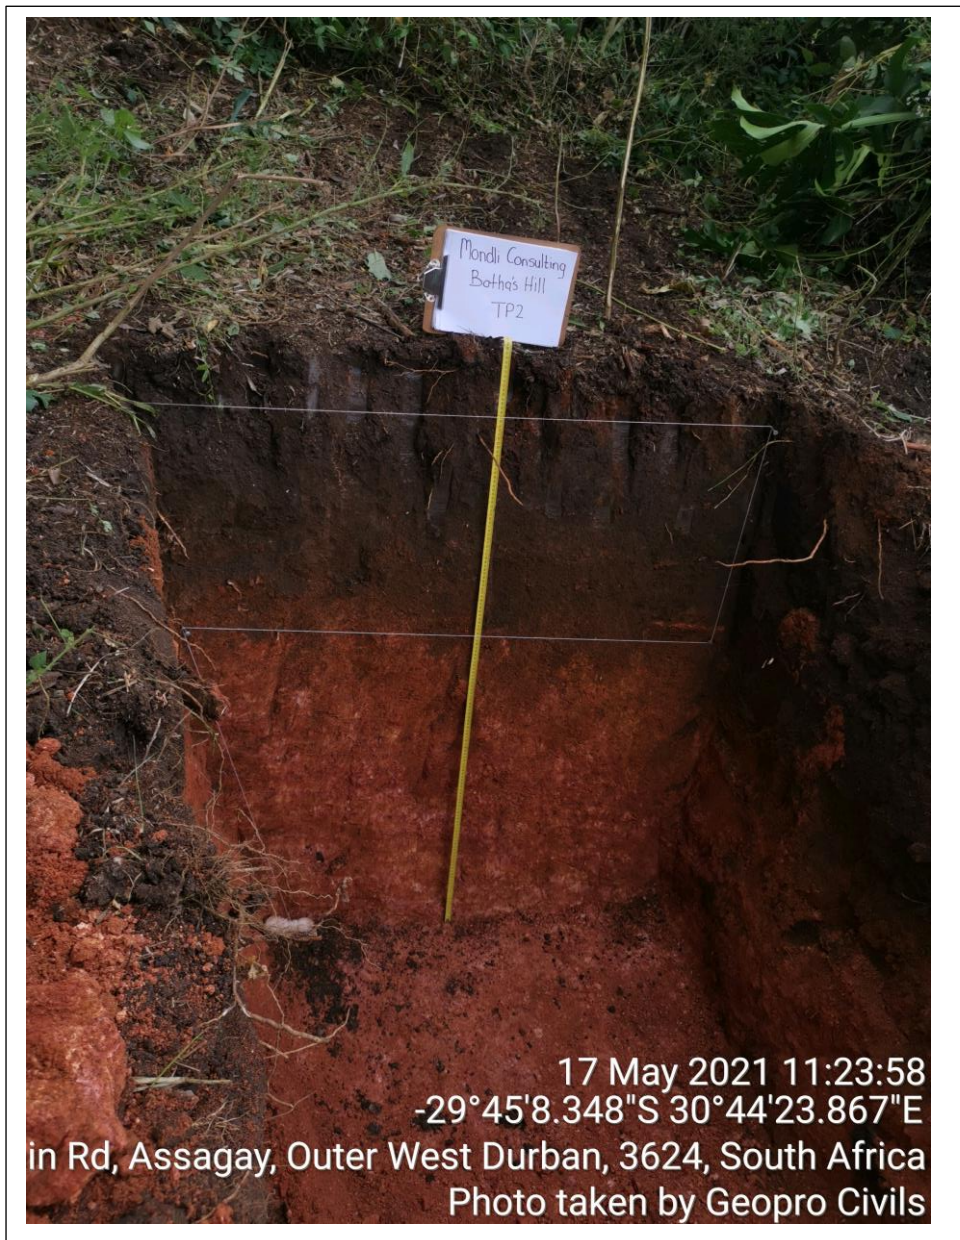
FIGURE 3: TEST PIT 2 PROFILING

CLIENT NAME	Mondli Consulting Services
PROJECT NAME	Bothas Hill Service Station & Retail Centre
POSITION IN FIELD	Test Pit 2
CO-ORDINATES	-29° 45' 8.348" S 30° 44' 23.867" E
DATE ASSESSED	17.05.2021

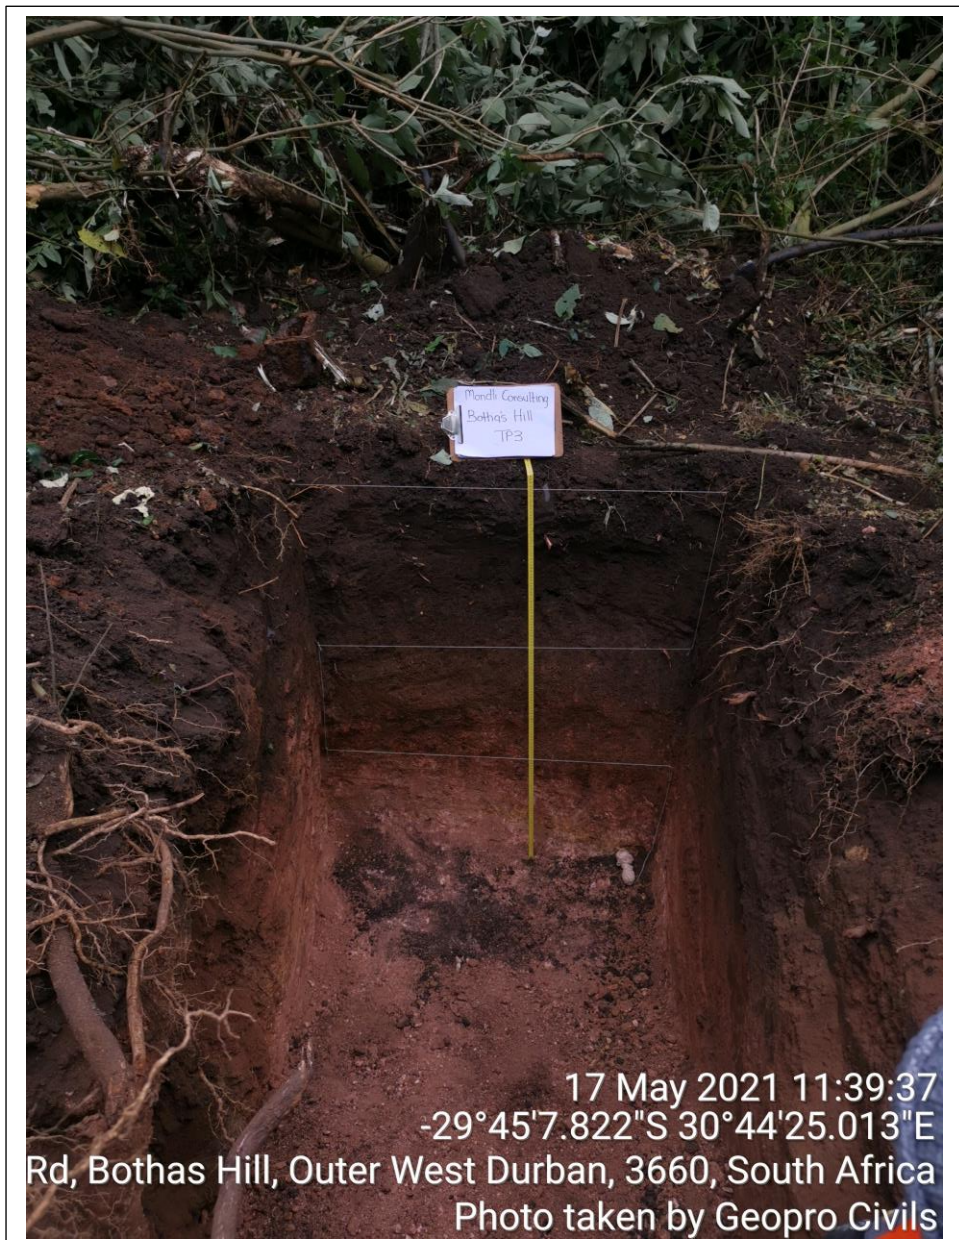
FIGURE 4: TEST PIT 3 PROFILING

<u>THICKNESS</u>	<u>PROFILE</u>	<u>DEPTH</u>	<u>DESCRIPTION</u>
670mm	¥¥¥¥ ¥¥¥¥ ¥¥¥¥ ¥¥¥¥ ¥¥¥¥ ¥¥¥¥ ¥¥¥¥ ¥¥¥¥ ¥¥¥¥ ¥¥¥¥ ¥¥¥¥ ¥¥¥¥ ¥¥¥¥ ¥¥¥¥	0mm	Moist, dark brown black, firm, intact, fine grained, topsoil
420mm	===== ===== ===== ===== ===== ===== ===== ===== ===== =====	670mm	Moist, light brown orange, firm, intact, medium - coarse grained, ferruginous sand, weathered granite
410mm	===== ===== ===== ===== ===== ===== ===== ===== ===== =====	1090mm	Moist, light pinkish, firm, intact, medium - coarse grained, ferruginous sand, weathered granite
		1500mm	No water Seepage

CLIENT NAME	Mondli Consulting Services
PROJECT NAME	Bothas Hill Service Station & Retail Centre
POSITION IN FIELD	Test Pit 3
CO-ORDINATES	-29° 45' 7.822" S 30° 44' 25.013" E
DATE ASSESSED	17.05.2021

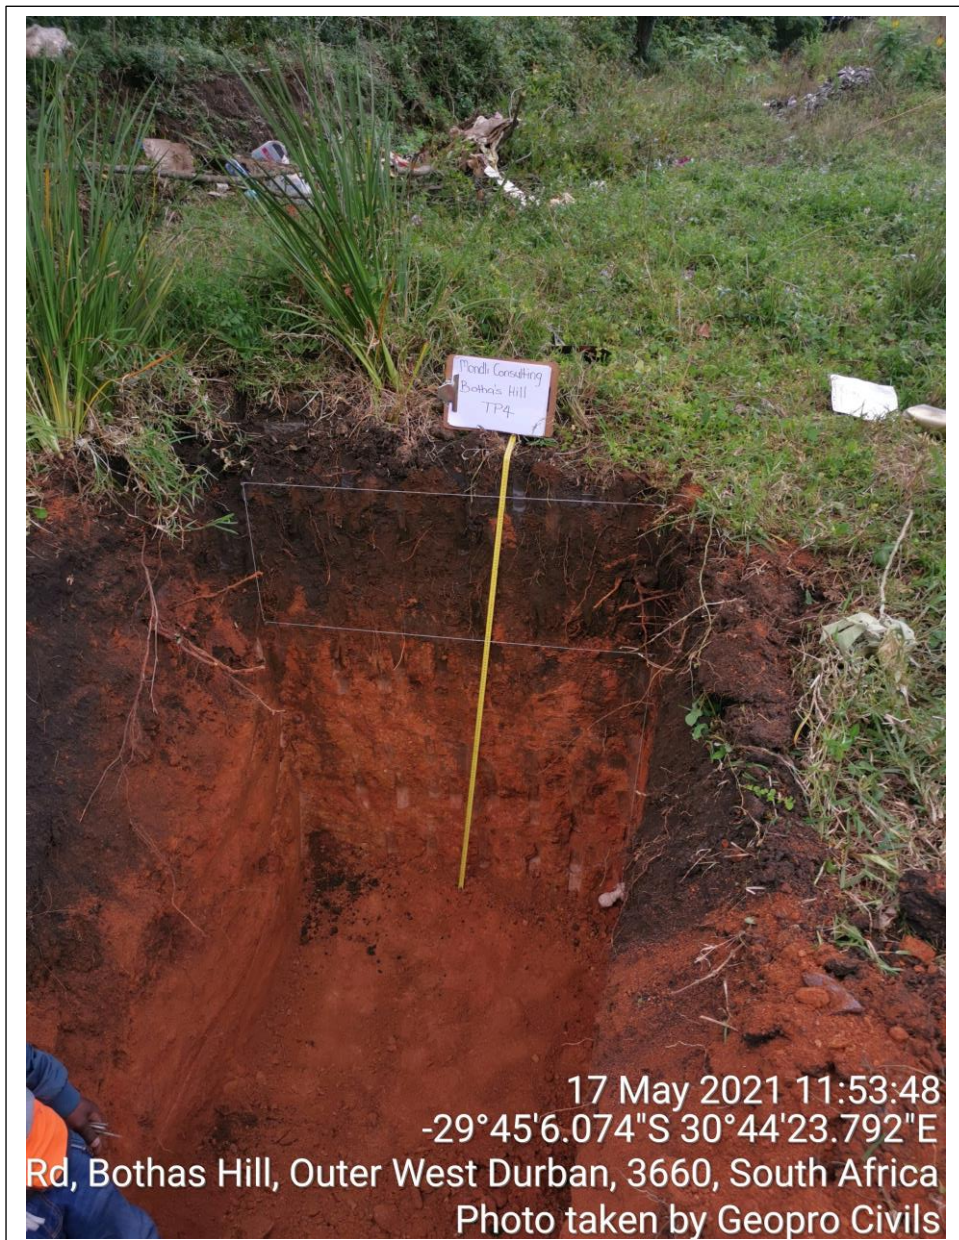
FIGURE 5: TEST PIT 4 PROFILING

THICKNESS	PROFILE	DEPTH	DESCRIPTION
530mm	¥¥¥¥	0mm	Moist, dark brown black, firm, intact, fine grained, topsoil
	¥¥¥¥		
	¥¥¥¥		
	¥¥¥¥		
	¥¥¥¥		
	¥¥¥¥		
	¥¥¥¥		
	¥¥¥¥		
	¥¥¥¥		
	¥¥¥¥		
	¥¥¥¥		
	¥¥¥¥		
	¥¥¥¥		
	¥¥¥¥		
970mm	=====	530mm	Moist, orange yellowish, firm, intact, medium - coarse grained, ferruginous sand, weathered granite
	=====		
	=====		
	=====		
	=====		
	=====		
	=====		
	=====		
	=====		
	=====		
	=====		
	=====		
	=====		
	=====		
		1500mm	No water Seepage

CLIENT NAME	Mondli Consulting Services
PROJECT NAME	Bothas Hill Service Station & Retail Centre
POSITION IN FIELD	Test Pit 4
CO-ORDINATES	-29° 45' 6.074" S 30° 44' 23.792" E
DATE ASSESSED	17.05.2021

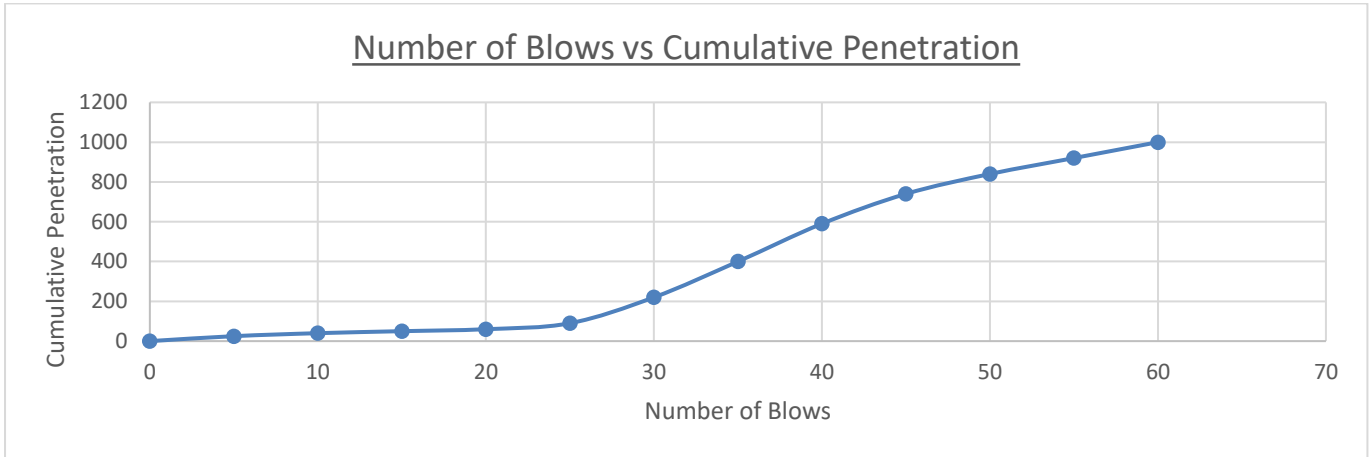
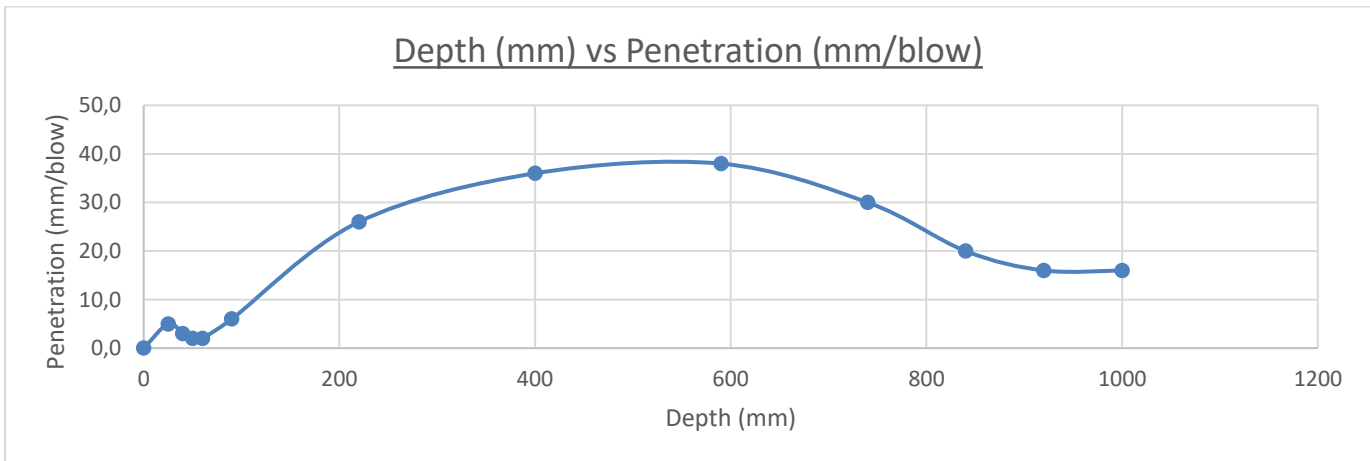
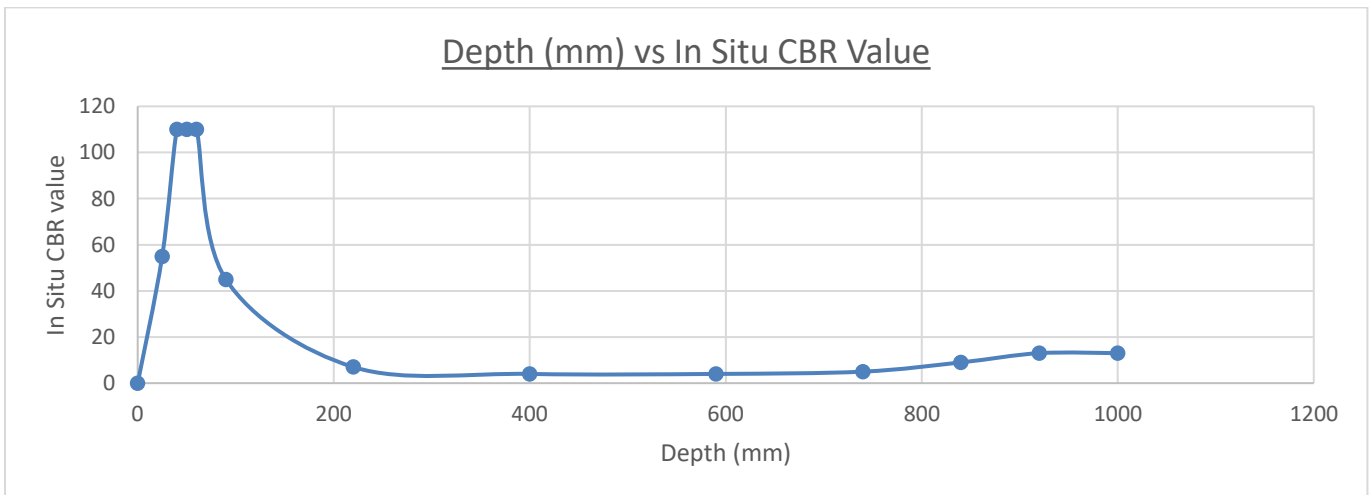
Client Name	Mondli Consulting Services	Date Tested	17.05.2021
Project Name	Bothas Hill Service Station	Date Reported	28.05.2021
Test Position	Test Spot 1	Job Card No.	0600

Test Method TMH 6 – Method ST6

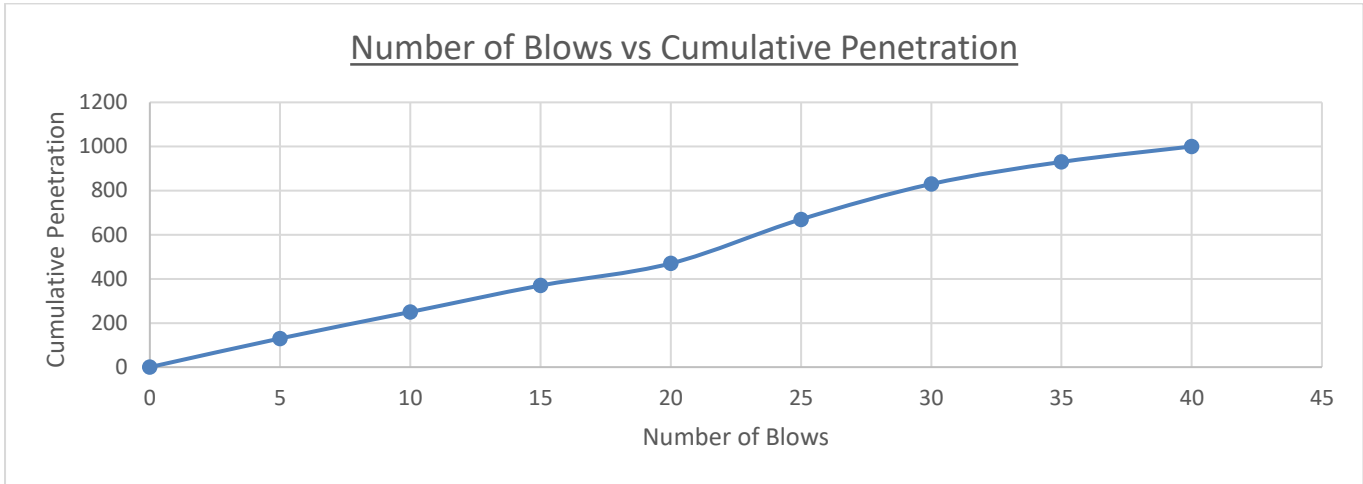
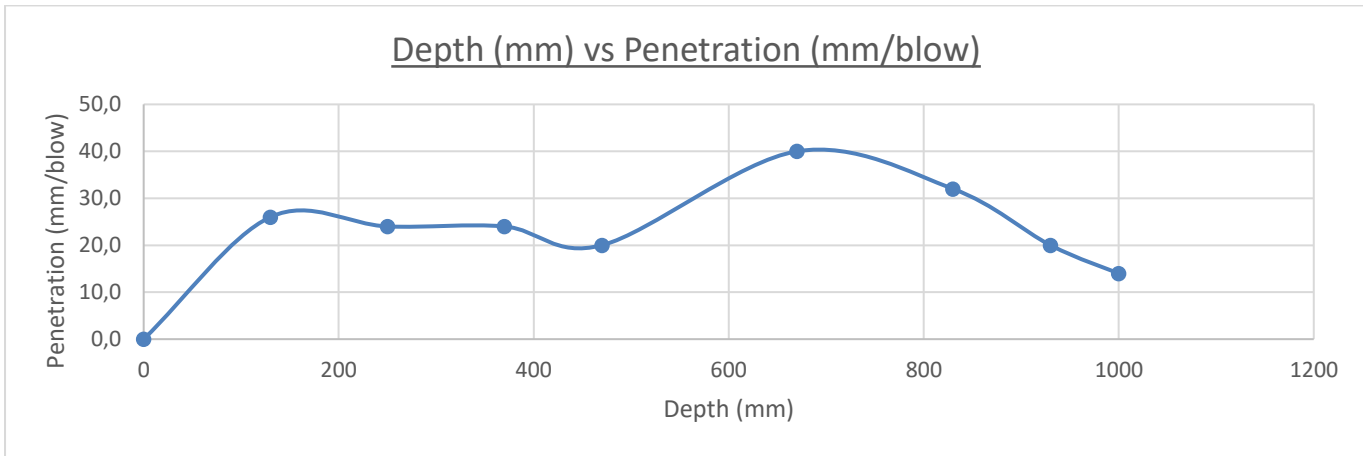
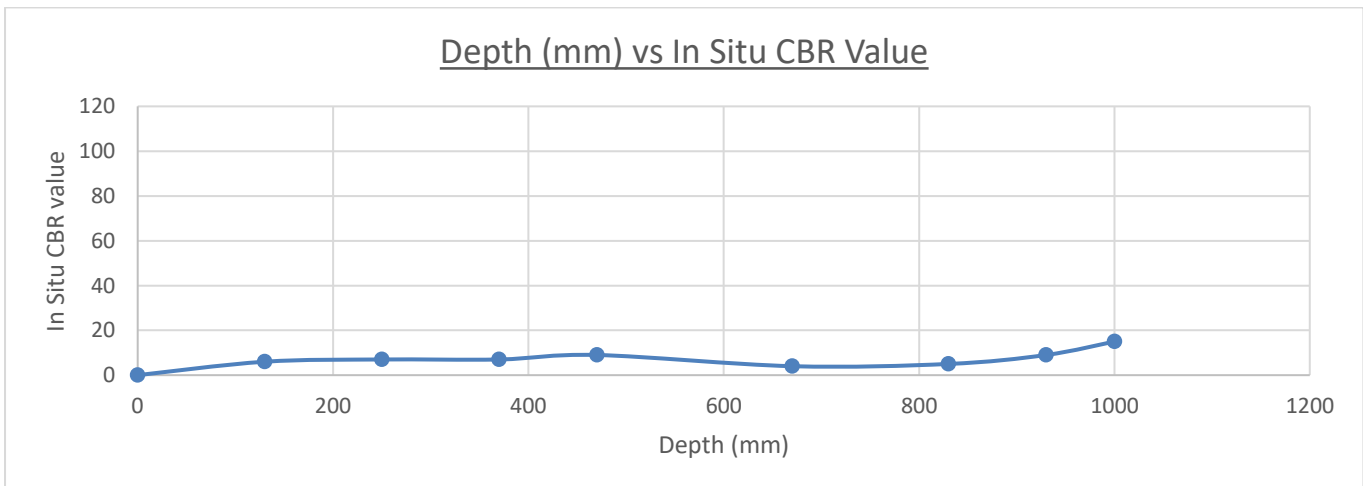
Client Name	Mondli Consulting Services	Date Tested	17.05.2021
Project Name	Bothas Hill Service Station	Date Reported	28.05.2021
Test Position	Test Spot 2	Job Card No.	0600

Test Method TMH 6 – Method ST6

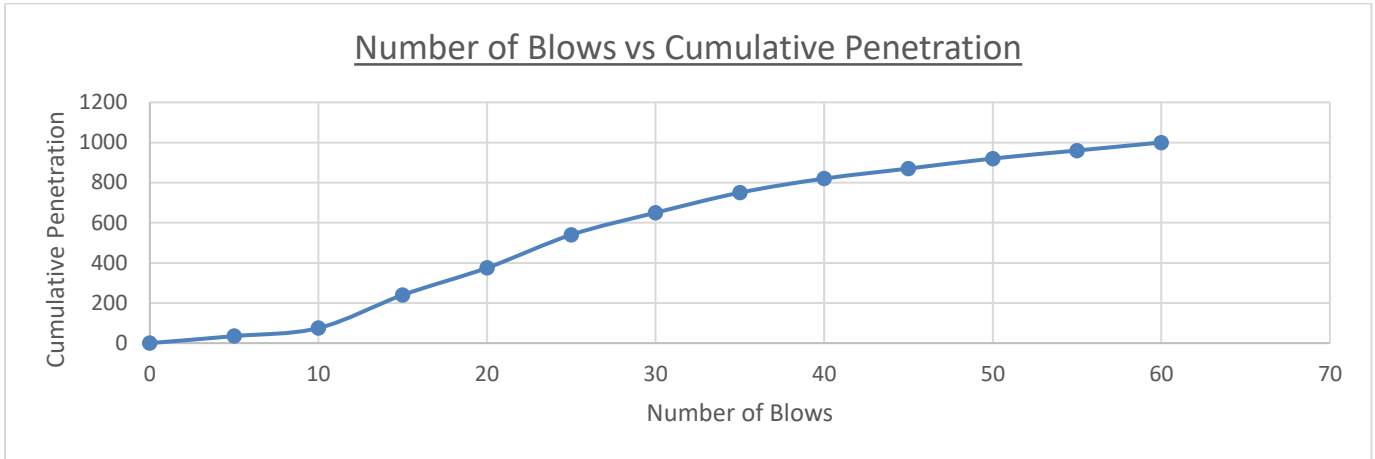
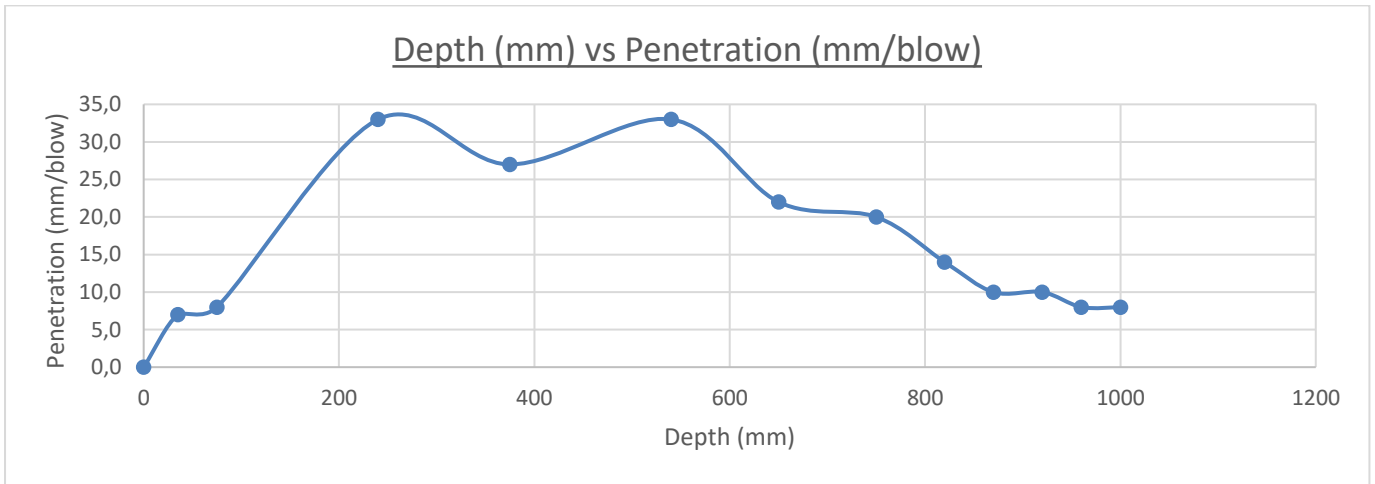
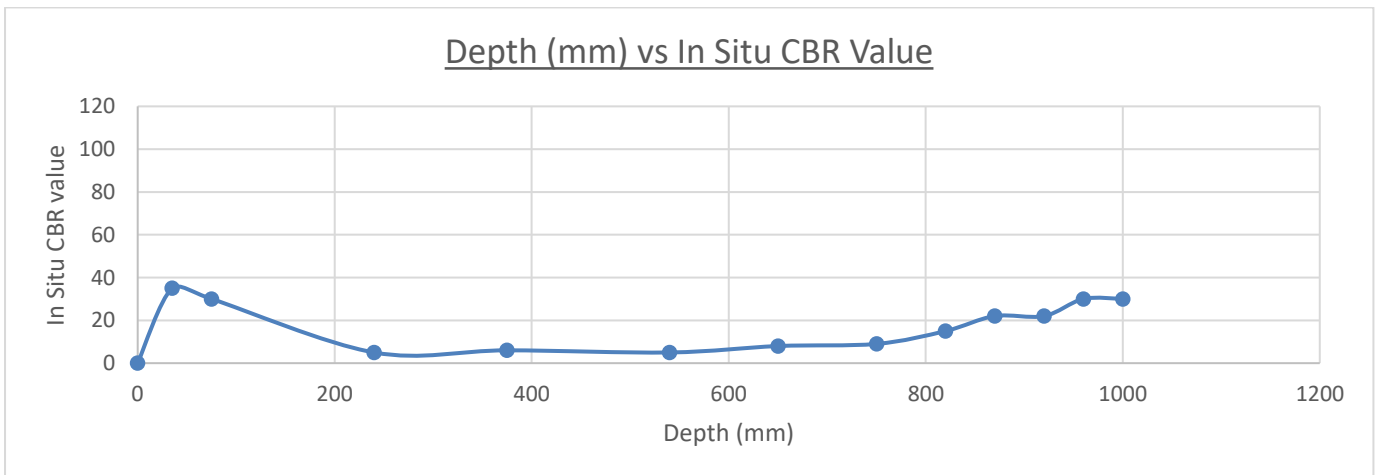
Client Name	Mondli Consulting Services	Date Tested	17.05.2021
Project Name	Bothas Hill Service Station	Date Reported	28.05.2021
Test Position	Test Spot 3	Job Card No.	0600

Test Method TMH 6 – Method ST6

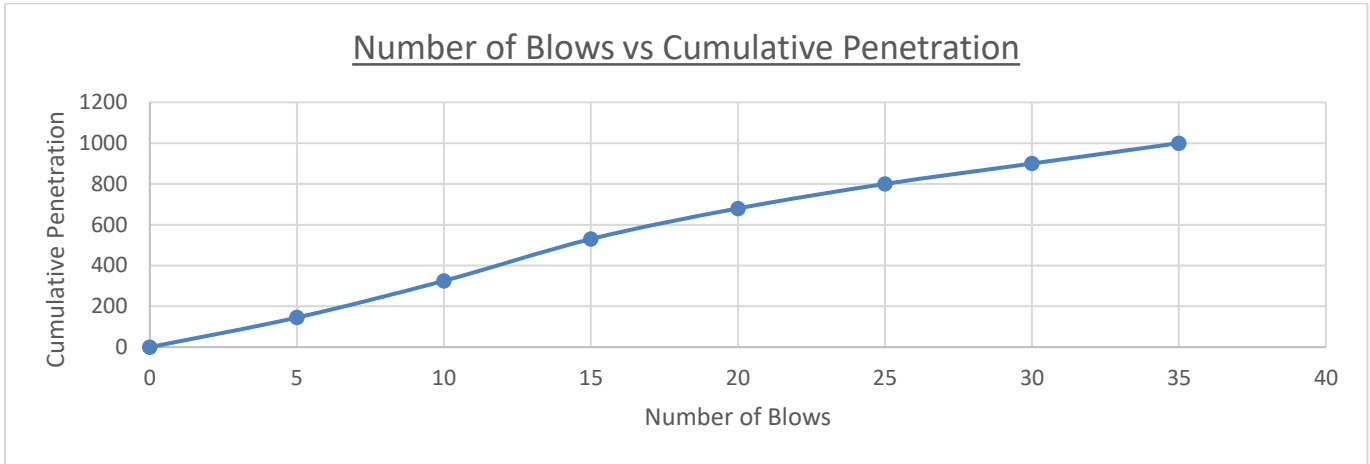
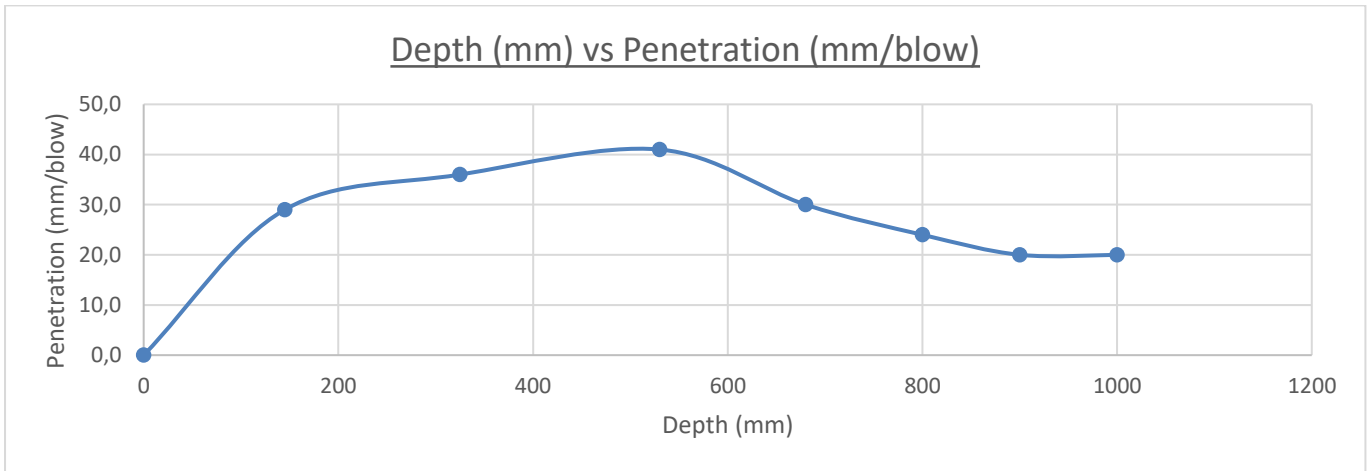
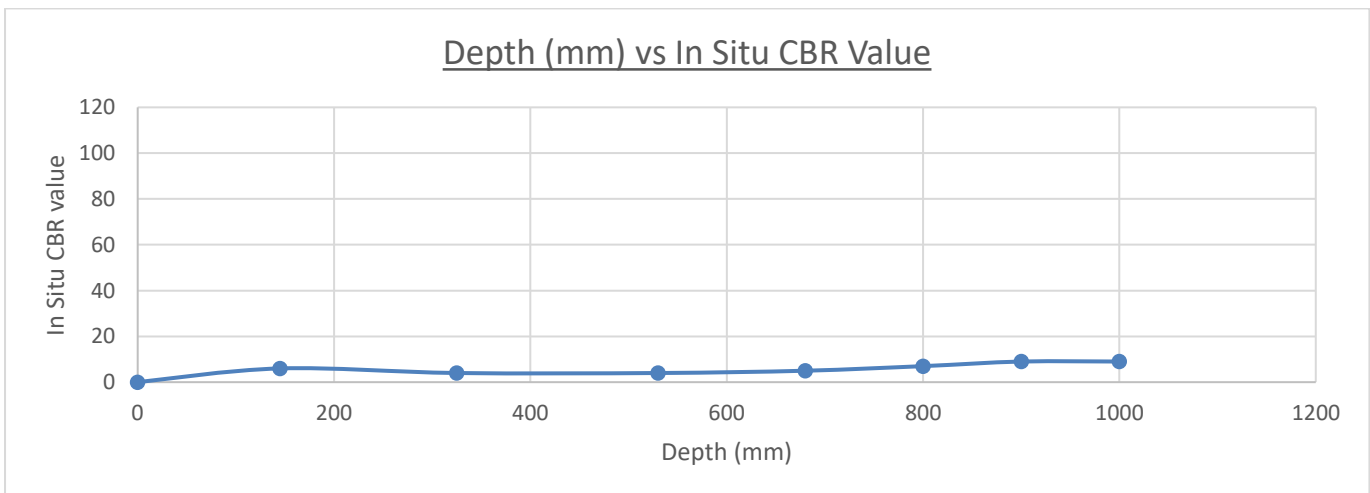
Client Name	Mondli Consulting Services	Date Tested	17.05.2021
Project Name	Bothas Hill Service Station	Date Reported	28.05.2021
Test Position	Test Spot 4	Job Card No.	0600

Test Method TMH 6 – Method ST6

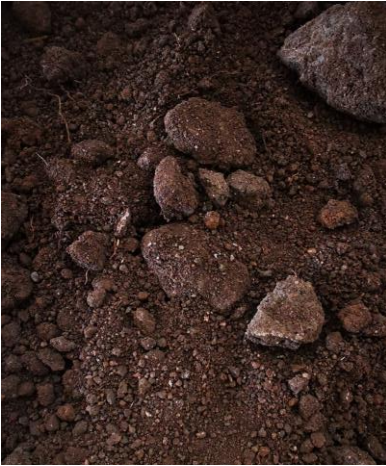
SIEVE ANALYSIS (% PASSING) – SANS 3001 – GR1

-
75.000 mm		-
63.000 mm		-
50.000 mm		-
37.500 mm		-
28.000 mm		-
20.000 mm		-
14.000 mm		100.0
5.0000 mm		99.5
2.0000 mm		95.4
0.4250 mm		63.5
<0.075 mm		21.0
Grading Modulus		SANS 3001 PR 5

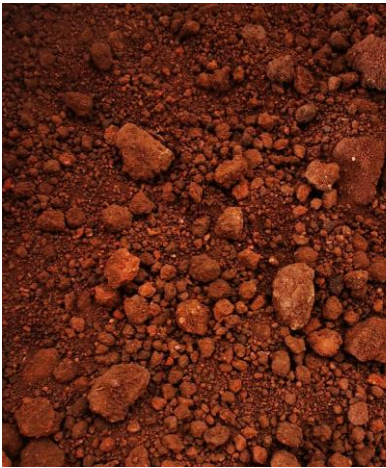
SIEVE ANALYSIS (% PASSING) – SANS 3001 – GR1

-
75.000 mm		-
63.000 mm		-
50.000 mm		-
37.500 mm		-
28.000 mm		-
20.000 mm		-
14.000 mm		100.1
5.0000 mm		99.7
2.0000 mm		92.3
0.4250 mm		56.5
<0.075 mm		15.3
Grading Modulus	SANS 3001 PR 5	1.36

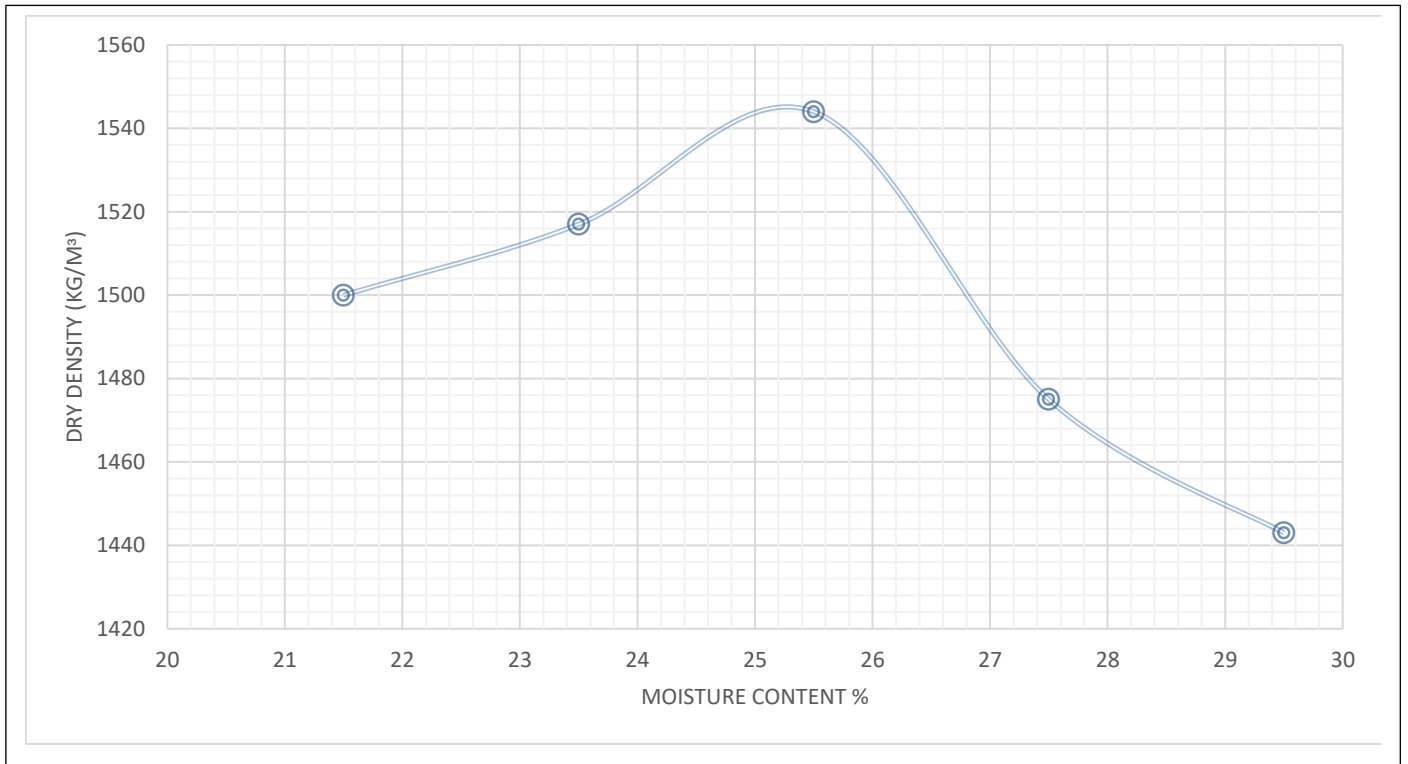
MAXIMUM DRY DENSITY AND OPTIMUM MOISTURE CONTENT – SANS 3001 – GR30

Moisture Content (%)	21.5	23.5	25.5	27.5	29.5		
Dry Density (kg/m³)	1500	1517	1544	1475	1443

Maximum Dry Density (kg/m³)	1544
Optimum Moisture Content (%)	25.2

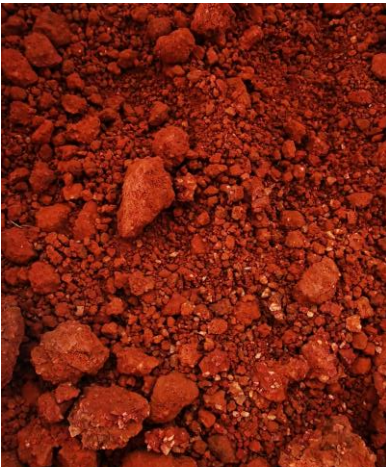
SIEVE ANALYSIS (% PASSING) – SANS 3001 – GR1

-	-
75.000 mm		-	-
63.000 mm		-	-
50.000 mm		-	-
37.500 mm		-	-
28.000 mm		-	-
20.000 mm		-	-
14.000 mm		100.0	
5.0000 mm		99.1	
2.0000 mm		84.5	
0.4250 mm		62.8	
<0.075 mm		21.4	
Grading Modulus	SANS 3001 PR 5	1.31

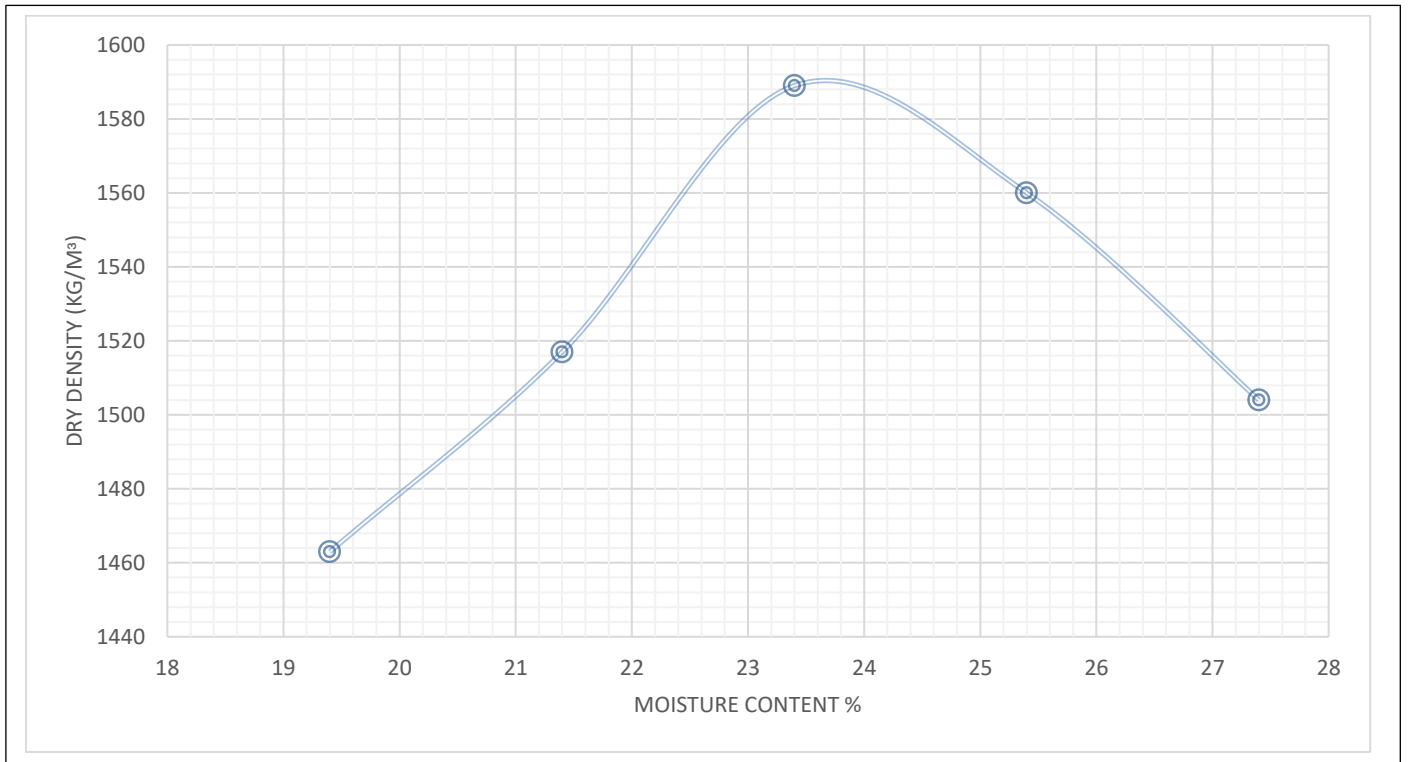
MAXIMUM DRY DENSITY AND OPTIMUM MOISTURE CONTENT – SANS 3001 – GR30

Moisture Content (%)	19.4	21.4	23.4	25.4	27.4		
Dry Density (kg/m³)	1463	1517	1589	1560	1504

Maximum Dry Density (kg/m³)	1590
Optimum Moisture Content (%)	23.7

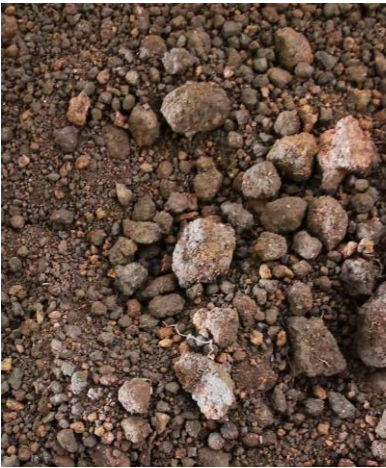
SIEVE ANALYSIS (% PASSING) – SANS 3001 – GR1

-
75.000 mm		-
63.000 mm		-
50.000 mm		-
37.500 mm		-
28.000 mm		-
20.000 mm		100.0
14.000 mm		98.9
5.0000 mm		95.5
2.0000 mm		81.8
0.4250 mm		48.9
<0.075 mm		14.7
Grading Modulus	SANS 3001 PR 5	1.55

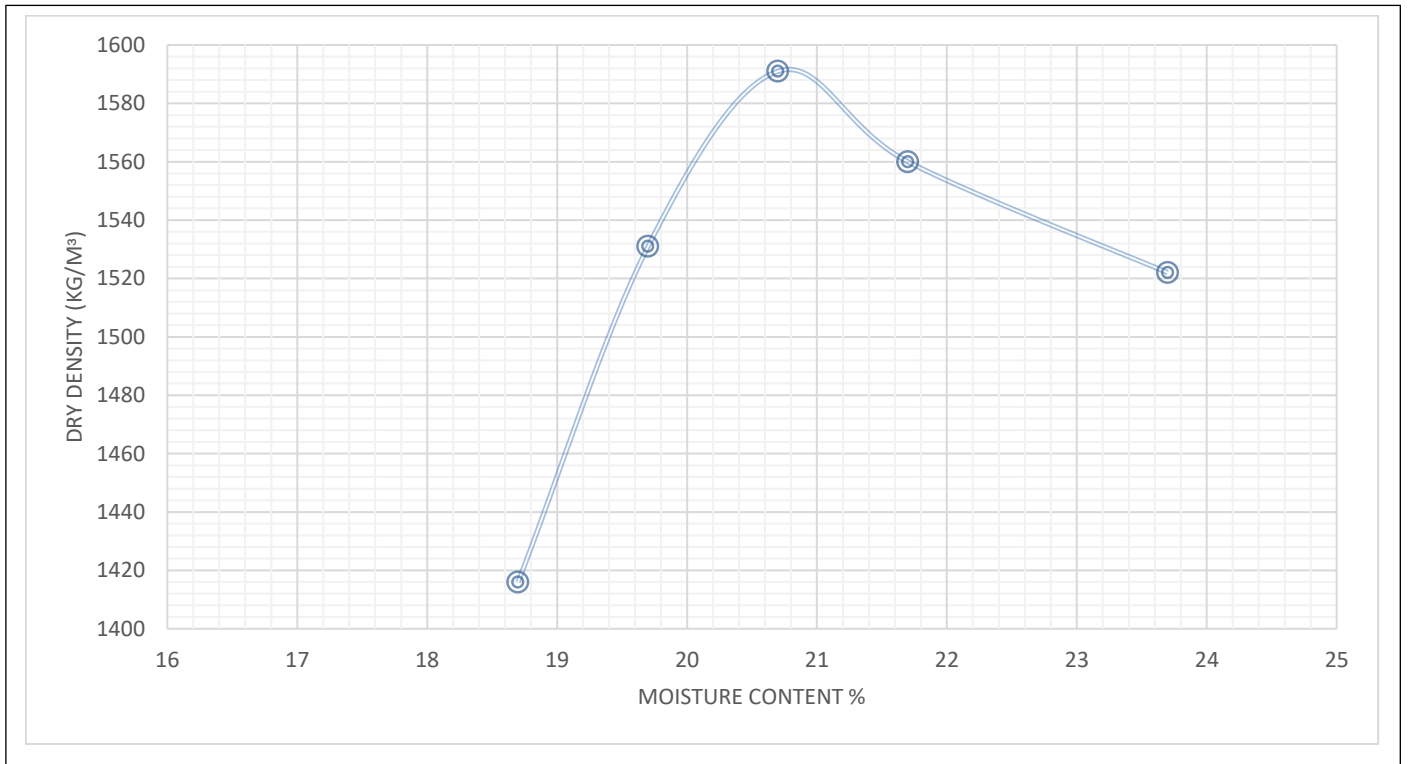
MAXIMUM DRY DENSITY AND OPTIMUM MOISTURE CONTENT – SANS 3001 – GR30

Moisture Content (%)	18.7	19.7	20.7	21.7	22.7		
Dry Density (kg/m³)	1416	1531	1591	1560	1522

Maximum Dry Density (kg/m³)	1591
Optimum Moisture Content (%)	20.7

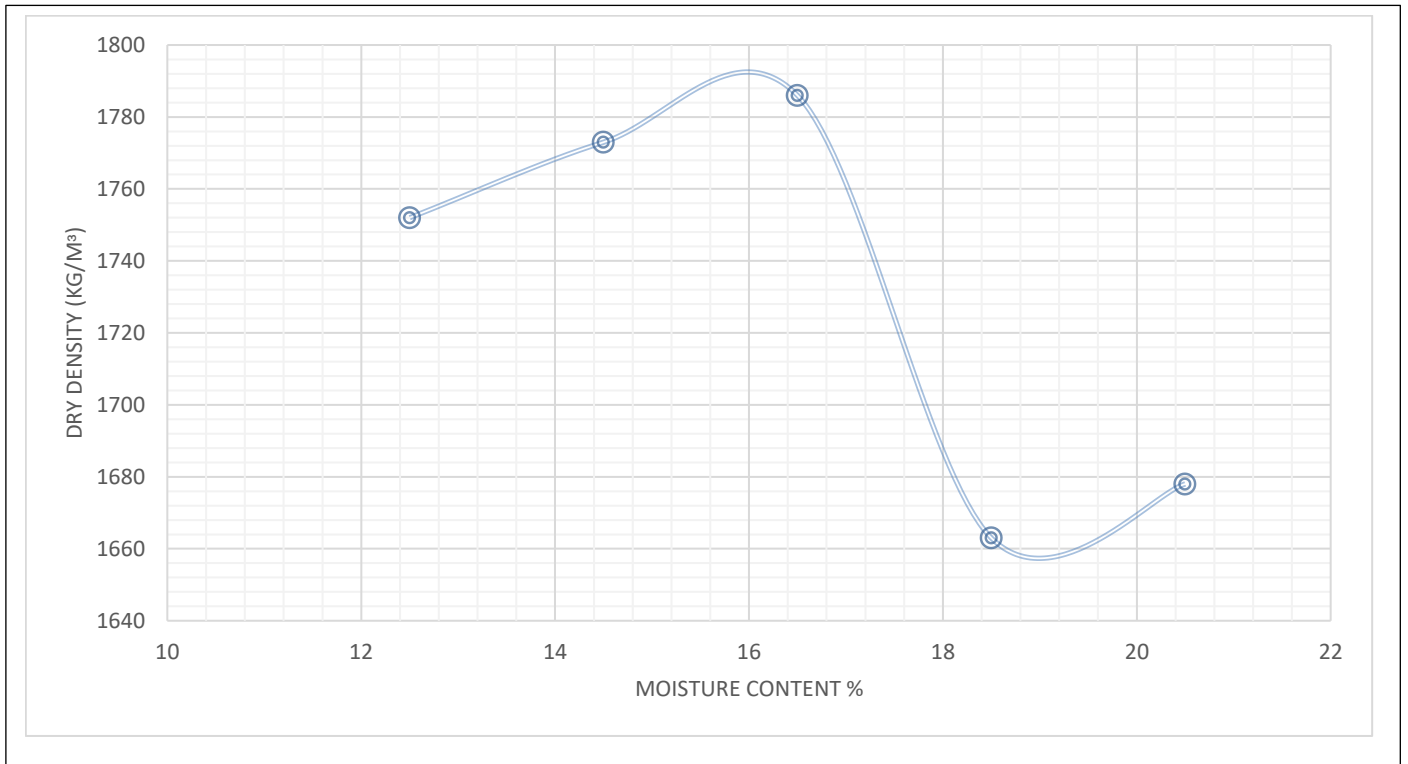
MAXIMUM DRY DENSITY AND OPTIMUM MOISTURE CONTENT – SANS 3001 – GR30

Moisture Content (%)	12.5	14.5	16.5	18.5	20.5		
Dry Density (kg/m³)	1752	1773	1786	1663	1678

Maximum Dry Density (kg/m³)	1792
Optimum Moisture Content (%)	16.0

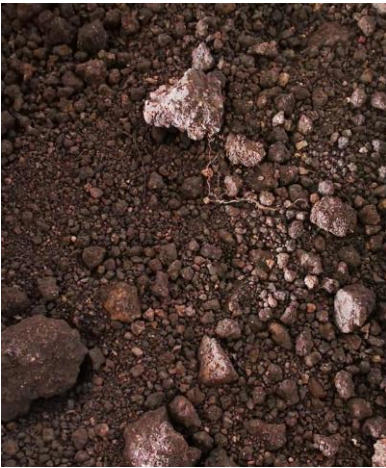
SIEVE ANALYSIS (% PASSING) – SANS 3001 – GR1

-
75.000 mm		-
63.000 mm		-
50.000 mm		-
37.500 mm		-
28.000 mm		-
20.000 mm		100.0
14.000 mm		99.3
5.0000 mm		96.4
2.0000 mm		81.1
0.4250 mm		45.3
<0.075 mm		24.0
Grading Modulus		SANS 3001 PR 5

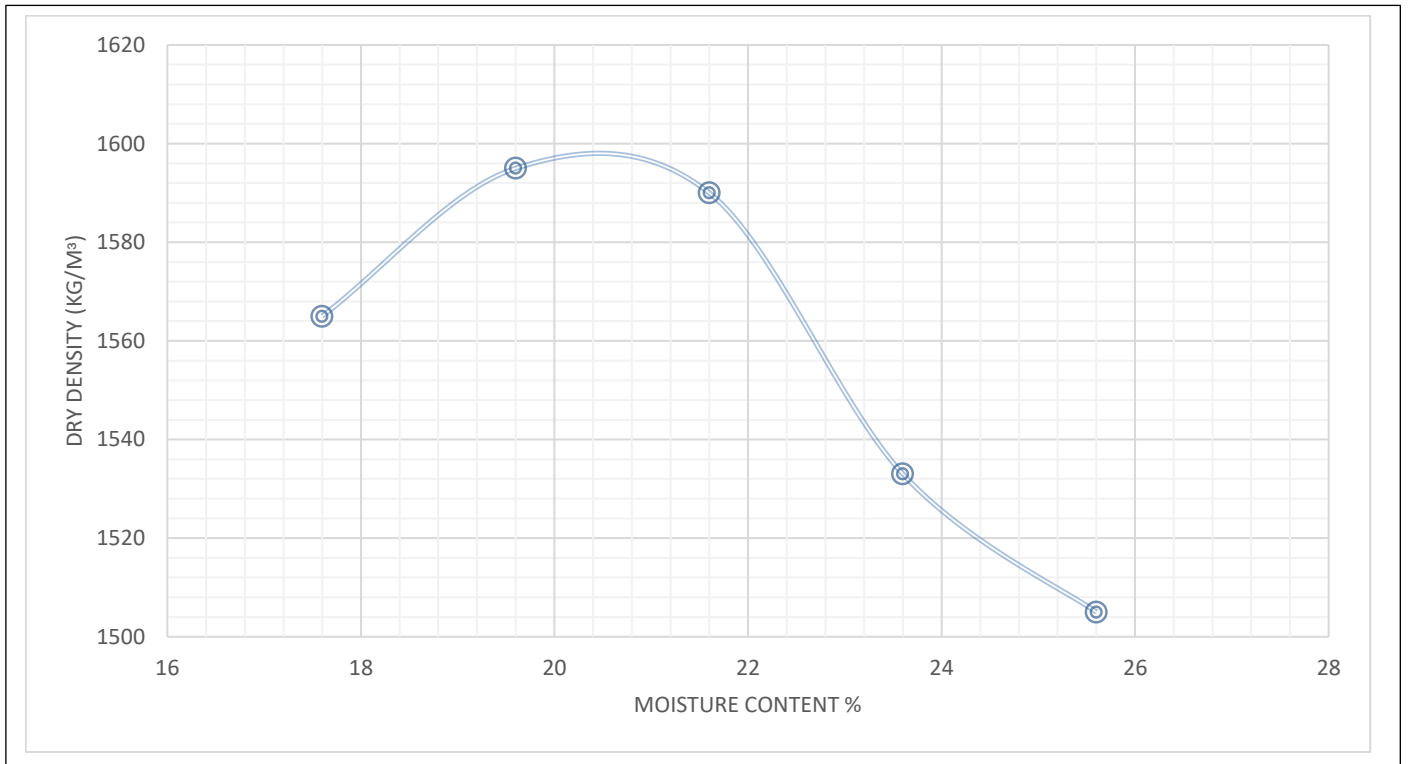
MAXIMUM DRY DENSITY AND OPTIMUM MOISTURE CONTENT – SANS 3001 – GR30

Moisture Content (%)	17.6	19.6	21.6	23.6	25.6		
Dry Density (kg/m³)	1565	1595	1590	1533	1505

Maximum Dry Density (kg/m³)	1598
Optimum Moisture Content (%)	20.3

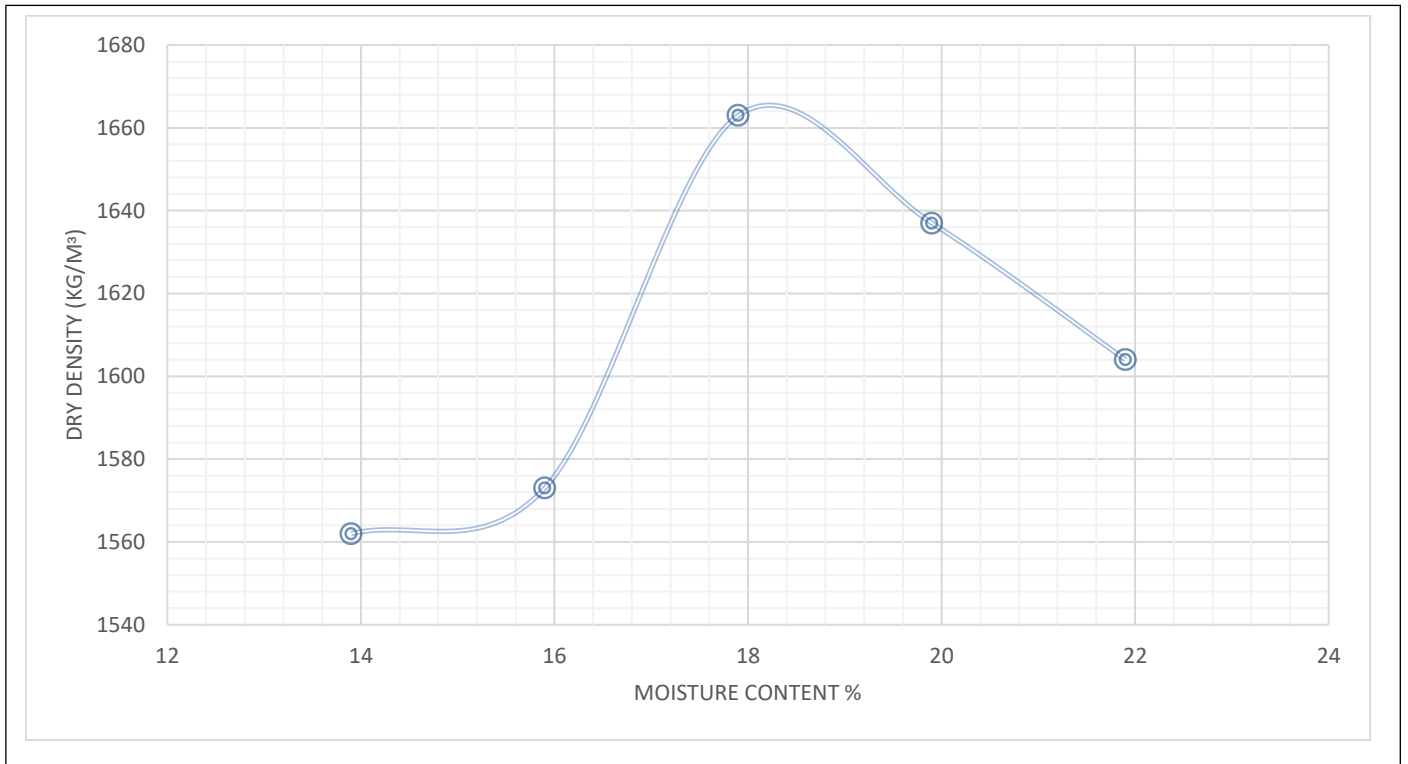
MAXIMUM DRY DENSITY AND OPTIMUM MOISTURE CONTENT – SANS 3001 – GR30

Moisture Content (%)	13.9	15.9	17.9	19.9	21.9		
Dry Density (kg/m³)	1562	1573	1663	1637	1604

Maximum Dry Density (kg/m³)	1664
Optimum Moisture Content (%)	18.1

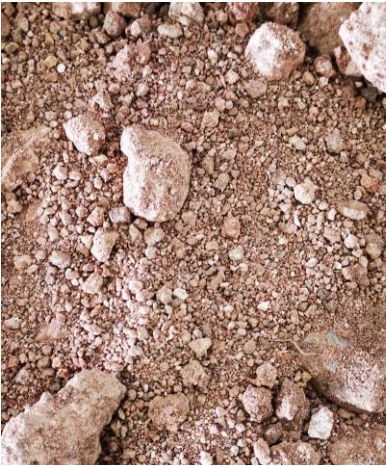
SIEVE ANALYSIS (% PASSING) – SANS 3001 – GR1

-
75.000 mm		-
63.000 mm		-
50.000 mm		-
37.500 mm		100.0
28.000 mm		96.9
20.000 mm		96.9
14.000 mm		96.9
5.0000 mm		94.4
2.0000 mm		78.3
0.4250 mm		52.6
<0.075 mm		37.3
Grading Modulus		SANS 3001 PR 5

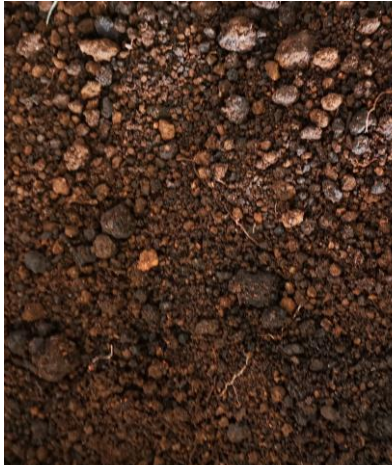
SIEVE ANALYSIS (% PASSING) – SANS 3001 – GR1

-
75.000 mm		-
63.000 mm		-
50.000 mm		-
37.500 mm		-
28.000 mm		-
20.000 mm		-
14.000 mm		100.1
5.0000 mm		99.7
2.0000 mm		88.5
0.4250 mm		49.9
<0.075 mm		20.5
Grading Modulus	SANS 3001 PR 5	1.41
