BOTHAS HILL SERVICE STATION & RETAIL CENTRE

Geotechnical Investigation Report

May 2021

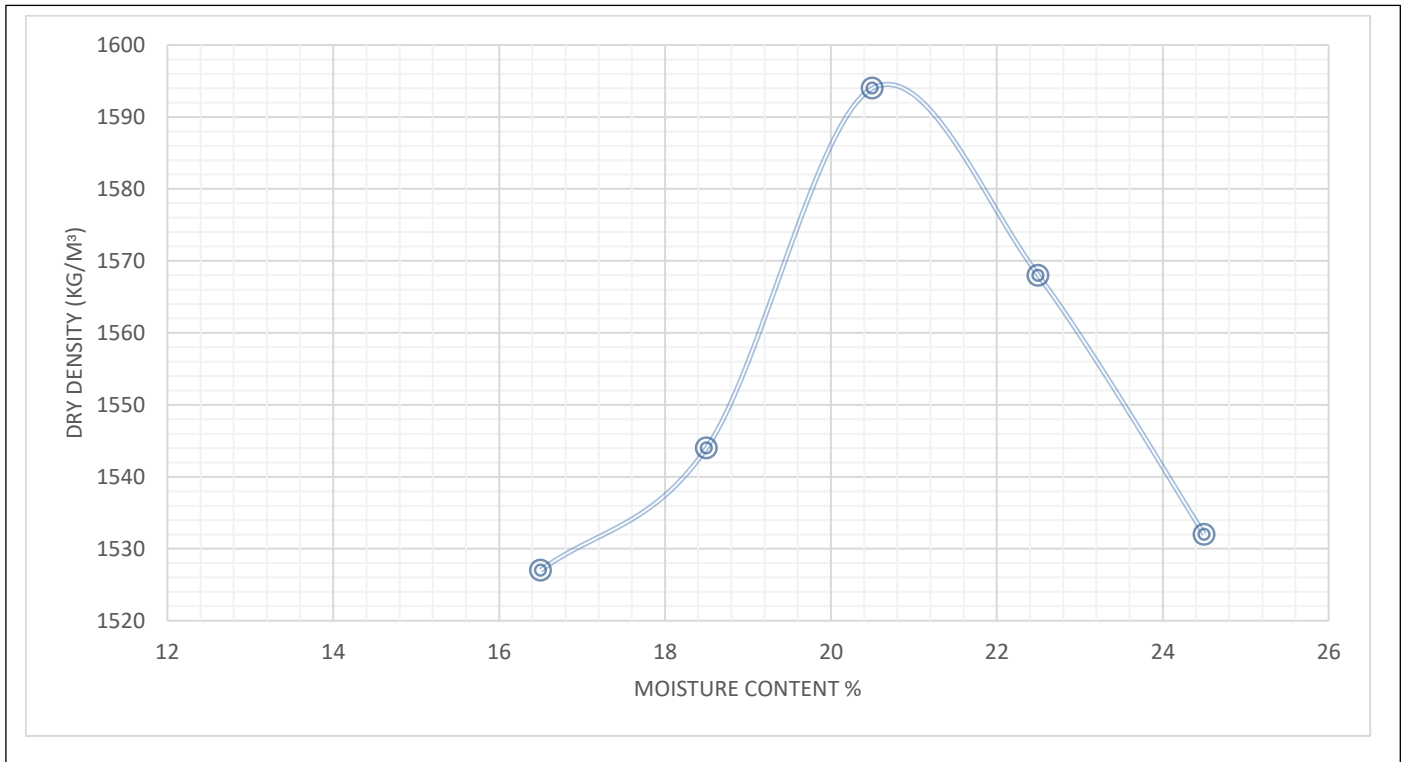
MAXIMUM DRY DENSITY AND OPTIMUM MOISTURE CONTENT – SANS 3001 – GR30

Moisture Content (%)	16.5	18.5	20.5	22.5	24.5		
Dry Density (kg/m³)	1527	1544	1594	1568	1532

Maximum Dry Density (kg/m³)	1594
Optimum Moisture Content (%)	20.3

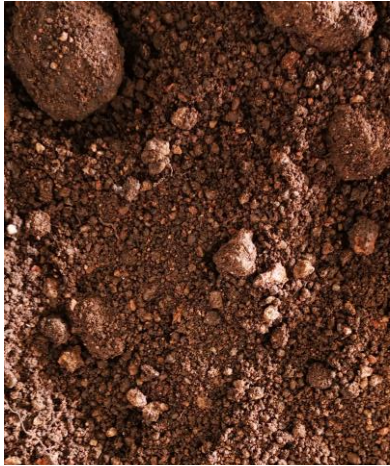
SIEVE ANALYSIS (% PASSING) – SANS 3001 – GR1

-
75.000 mm		-
63.000 mm		-
50.000 mm		-
37.500 mm		-
28.000 mm		-
20.000 mm		-
14.000 mm		100.0
5.0000 mm		98.2
2.0000 mm		77.1
0.4250 mm		51.1
<0.075 mm		30.1
Grading Modulus		SANS 3001 PR 5

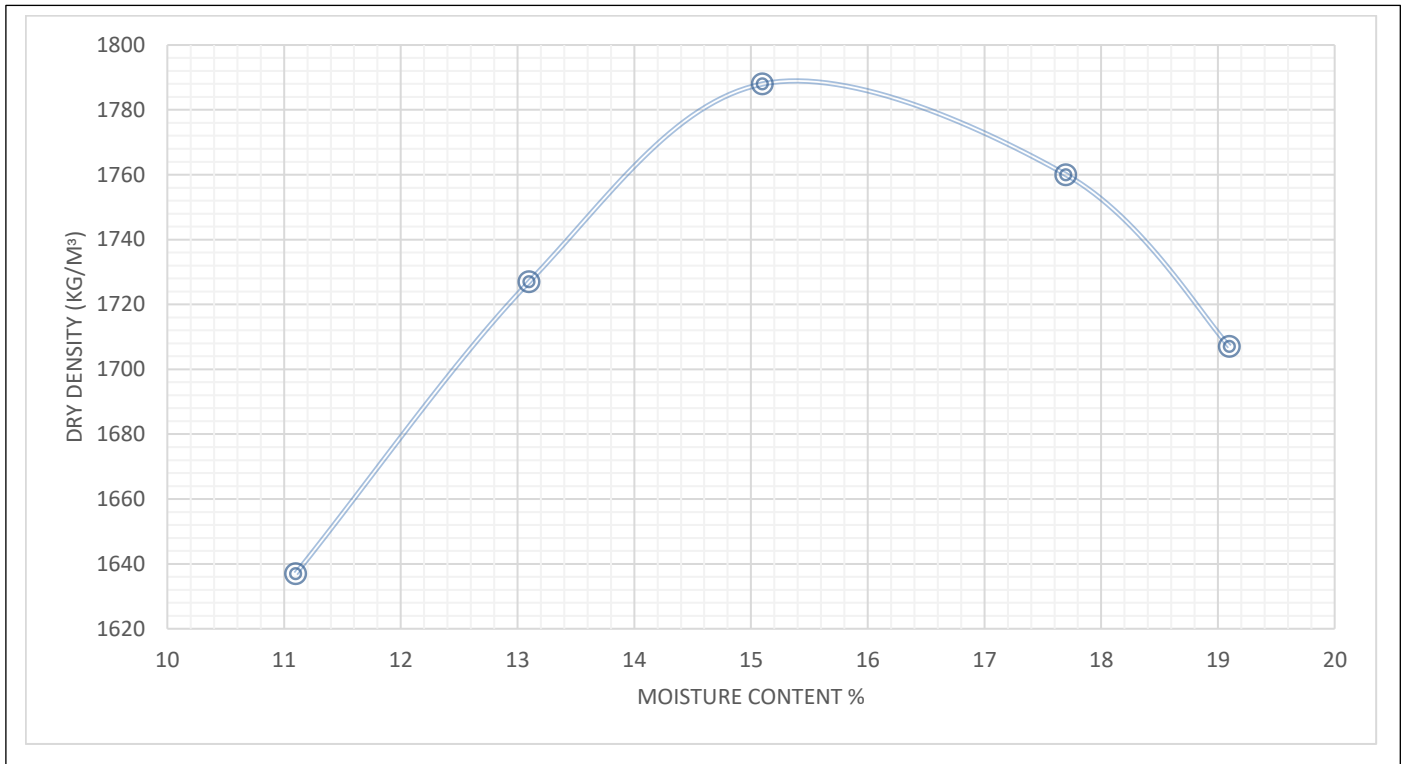
MAXIMUM DRY DENSITY AND OPTIMUM MOISTURE CONTENT – SANS 3001 – GR30

Moisture Content (%)	11.1	13.1	15.1	17.1	19.1		
Dry Density (kg/m³)	1637	1727	1888	1760	1707

Maximum Dry Density (kg/m³)	1788
Optimum Moisture Content (%)	15.1
