Site Sketch showing Locality of Test Pits

**The Square of Thornville**

**Mondli Consulting Services**

REFERENCE No.  
22-035

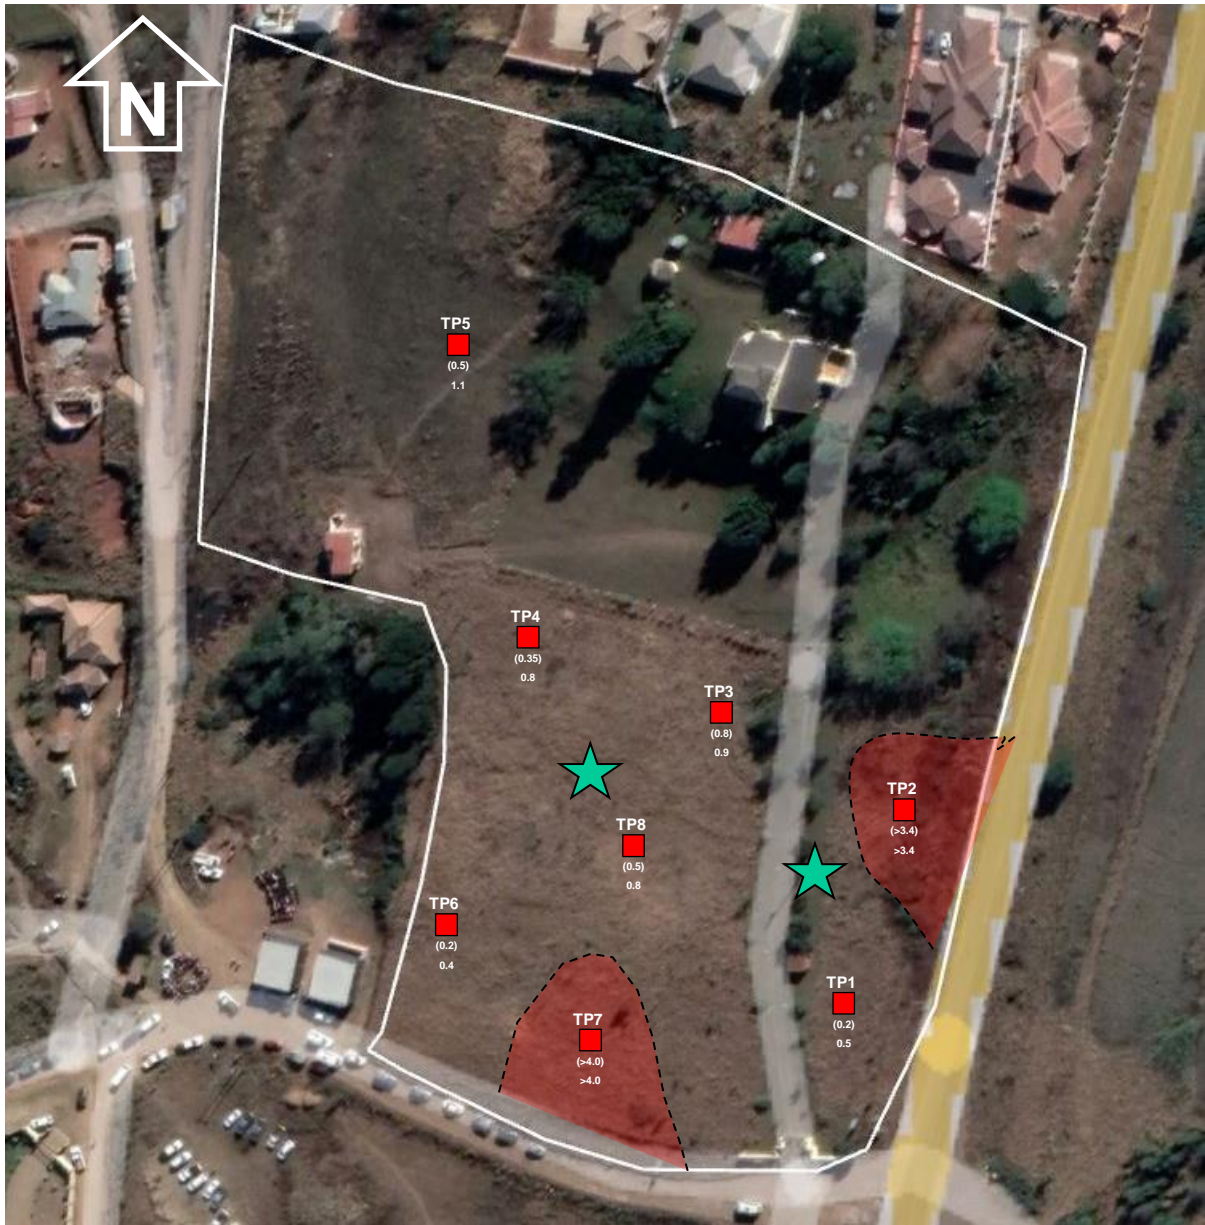
Dwg. No.  
Figure 1

Position of Test Pit showing depth to bedrock ( ) and refusal depth in metres below existing ground level.

Shale outcrop

Inferred limits of dolerite soils
