Phase 1 Archaeological Impact Assessment of a proposed new 132 kV transmission line between the Harvard and Noordstad Substations, Bloemfontein, Free State Province.

Dr. L Rossouw National Museum PO Box 266 Bloemfontein 9300 11 / 05 / 2017

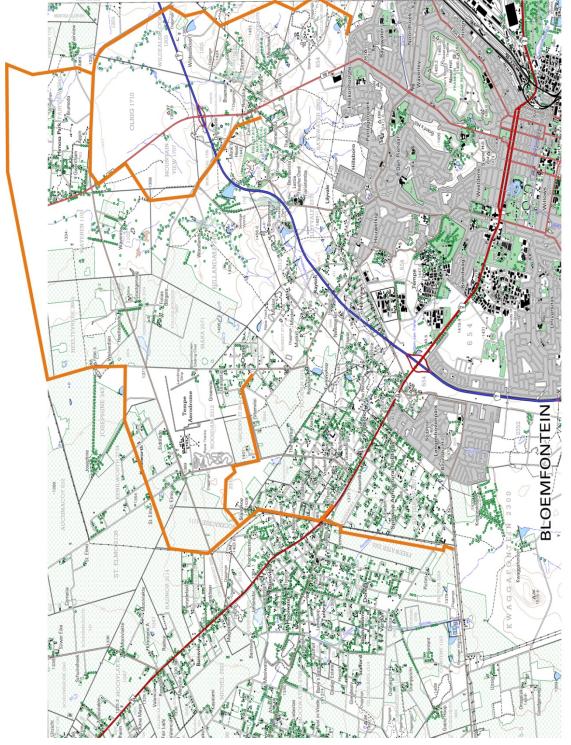
Figure 1. The proposed new 132 kV transmission line between the Harvard and Noordstad Substations, marked on portion of 1:50 000 scale topographic 2926 AA Bloemfontein.

At the request of Enviroworks Environmental Consultants, a Phase 1 Archaeological Impact Assessment was conducted for a proposed new 36km-long, 132 kV overhead transmission line from the Harvard to Noordstad Substations located west and north of Bloemfontein in the Free State Province (**Fig. 1**). Planned development also includes the construction of 6 distribution centers, each covering approximately 1ha (**Fig. 2 & 3**).

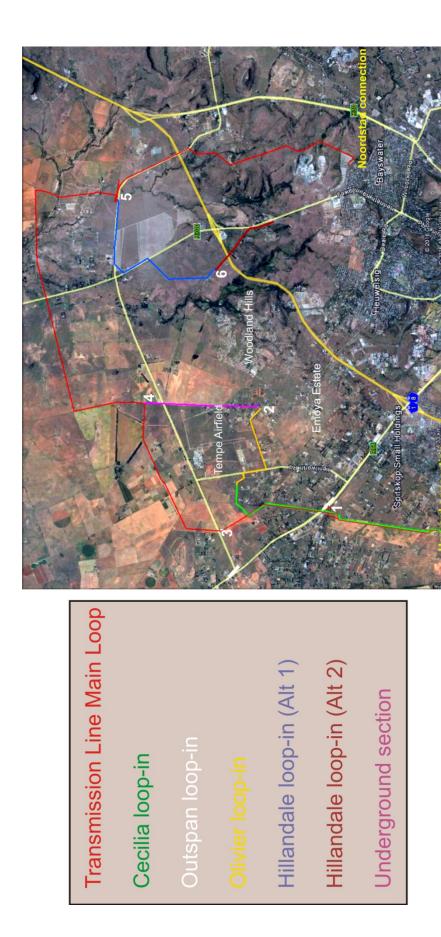
Figure 2. Aerial view of the proposed overhead powerline sections and alternatives. The distribution centre localities are numbered 1 Outspan, 2 Olivier, 3 Rooidam, 4 Tevrede, 5 Mimosa and 6 Hillandale.

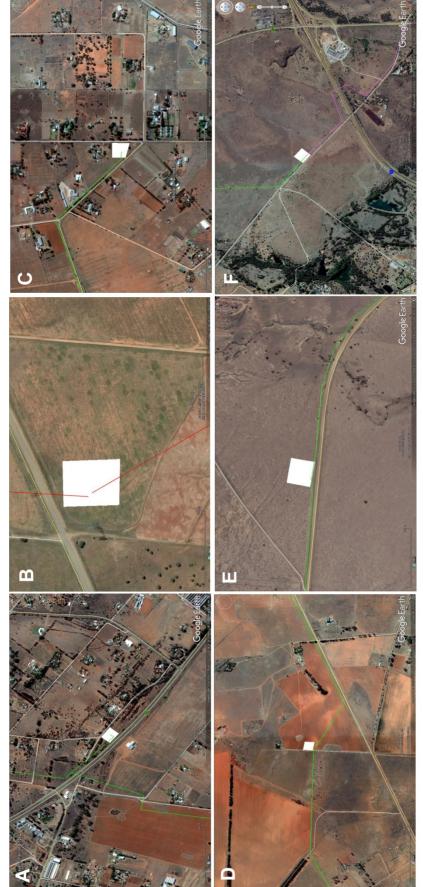
Figure 3. Aerial view of the (A) Outspan, (B) Rooidam, (C) Olivier, (D) Tevrede, (E) Mimosa and (F) Hillandale Distribution Centre footprints.

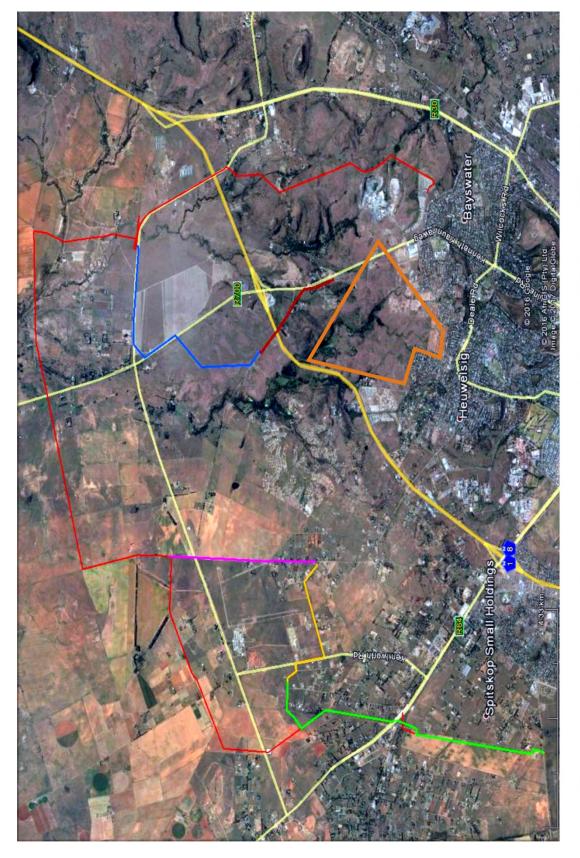
Figure 4. The orange polygon indicates formerly undisturbed veld at Bayswater 286, Lilyvale 2313 and Hillandale 249 where stone tool scatters and individual surface finds, have been recorded in the past.

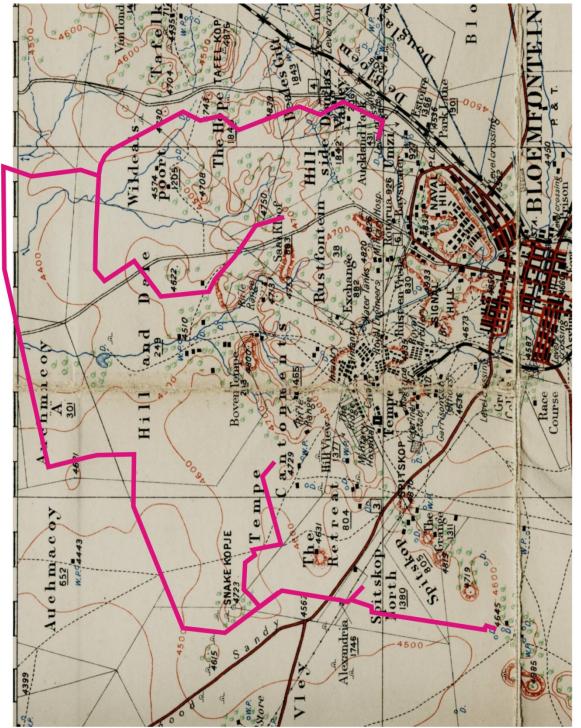
Figure 5. The position of the two power line route alternatives marked on a portion of a British military map circa 1913.

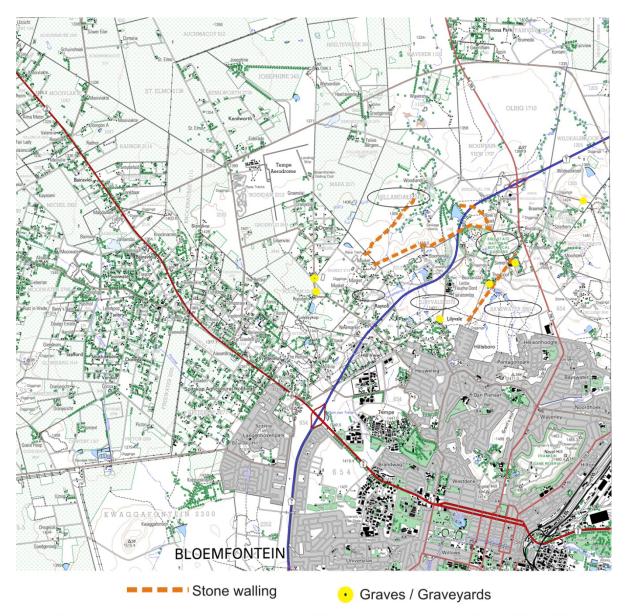
Figure 6. Low stone wall structures are one of the last remaining traces of the British military occupation of the northern part of Bloemfontein. The walls were built by the British Engineers, which had their camp stationed at Tempe. They formed part of a wall that originally ran from the water towers east of Tempe to the edge of Hillandale farm.

Cultural recorded the northern outskirts of remains previously around Bloemfontein can be divided into four categories: Stone Age remains, South African War remnants, graveyards and historical structures, including residential buildings, stone-built kraal and dam walls (Dreyer 2004a, 2004b, 2004c, 2004d, 2005; Henderson 2006; Henderson et al. 2008; Rossouw 2012). The Stone Age archaeological record of the Modder River catchment north of Bloemfontein spans back to the early Middle Stone Age. Localized occurrences of in situ Middle and Later Stone Age material are preserved within overbank sediments of the Modder River and its tributaries between Maselspoort and Glen north of Bloemfontein (Churchill et al. 2000; Rossouw 2006). Widespread traces of prehistoric human habitation, in the form of stone tool scatters and individual surface finds, have previously been recorded at Bayswater 286, Lilyvale 2313 and Hillandale 249 (Goodwin and Van Riet Lowe 1929, Henderson et al. 2008; Rossouw 2012) (Fig. 4). After Bloemfontein was occupied by British forces on 13 March 1900, the city became a major military centre, with several farms north of Bloemfontein requisitioned for military purposes which also included military hospitals, rifle ranges, sangars and a large remount camp at Hillandale (Fig. 5). Hillandale was owned by Abraham Fischer, and was expropriated by the British along with the Tempe farms. In the military correspondence it is referred to as Fischer's Farm (FS Archives). The Tempe Farms were originally expropriated as grazing for the horses of the South African Constabulary in August 1901, and eventually bought by the War Office in 1904. Archaeological remains related to British military activities in the area include stone wall structures and rubbish dumps, kraals and graveyards. A large military rubbish dump was recorded on Lilyvale 2313/25(33), the property adjacent to the survey area. The stone wall structures are one of the last remaining traces of the British military occupation of the northern part of Bloemfontein. The walls were built by the British Engineers, which had their camp stationed at Tempe. They formed part of a wall which originally ran from the water towers east of Tempe to the edge of Hillandale farm. Some sections can still be seen at the Botanical Gardens, as well as in the Lilyvale and Bayswater areas, between Hillsboro and the R700 road south of the N1 (Fig. 6). Graveyards and isolated graves are also known from this area.

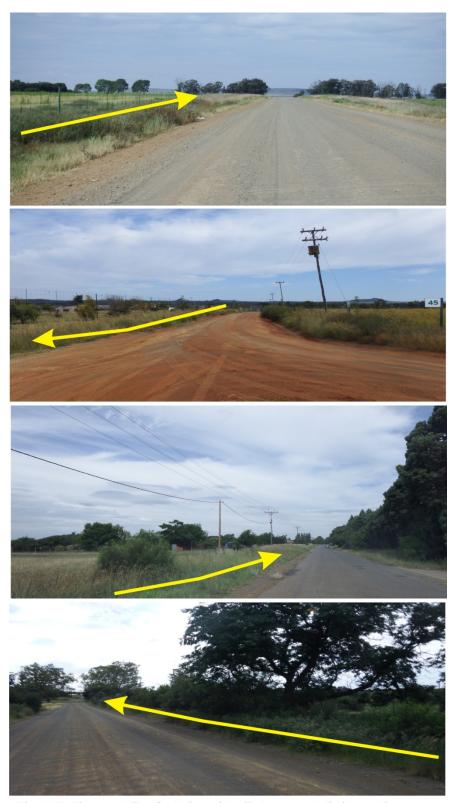
The powerline footprint traverses existing road reserves, degraded farmland and areas formerly disturbed by the residential developments (**Fig. 7**). The associated distribution center footprints are located on degraded farmland, areas formerly disturbed by the residential developments and relatively undisturbed patches of open veld (**Fig. 8**).

Figure 7. The powerline footprint primarily traverses existing road reserves, degraded farmland and areas formerly disturbed by the residential developments.
