Environmental  
Management Group  
June 2021

ECOLOGICAL REPORT OF THE  
PROPOSED NURSING COLLEGE  
AND STUDENT ACCOMODATION  
DEVELOPMENT KIMBERLEY, NORU

# **Phase 1 Heritage Impact Assessment for a proposed new Nursing College facility in Kimberley, NC Province.**

Report prepared by  
Paleo Field Services  
PO Box 38806 Langenhovenpark  
Bloemfontein 9330  
July 2021

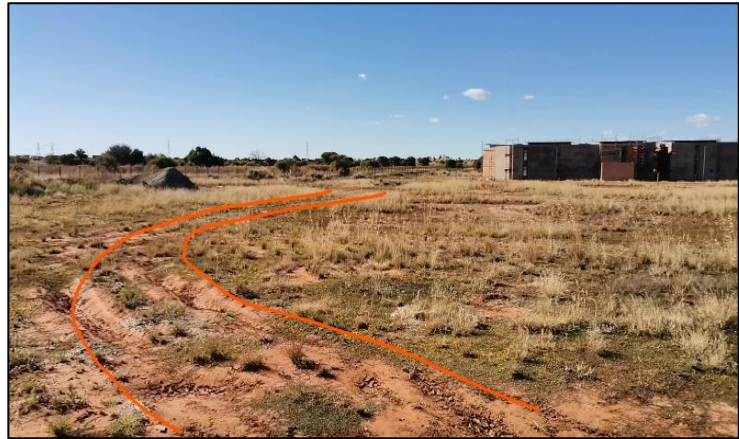
Figure 5 Extreme degradation followed the removal of topsoil. Ground cover represented by pioneering grass species. (Red) tire tracks of construction vehicle adding to the compaction of the soil.

This unit is located between VU-E and the first phase of student accommodation (Figure 3). This VU will later be replaced by the second phase of student accommodation on completion of the project. The majority of topsoil close to the student accommodation was removed, leaving this unit highly degraded (Figure 5).

pioneering grass species such as *Aristida congesta*, *Melinis repens*, *Tragus racemosus* and *Schmidtia kalihariensis*. The grading of topsoil has invited many exotic species such as *Bidens pilosa*, *Tagetes minuta*, *Verbesina encelioides* and *Conyza sumatrensis*. This unit experiences frequent heavy vehicle traffic, as indicated by the many tire tracks (Figure 5 red lines). The frequent movement of construction vehicles have compacted the remaining soil and only worsens the unit's degraded state. Other sources of disturbance include littering and random dumping of construction debris across the VU.

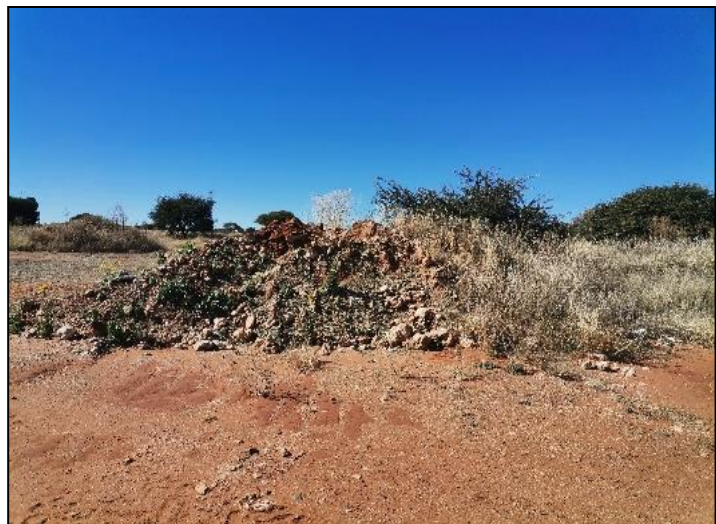
Figure 6 View of the severe degradation caused by dumping of overburden and other construction waste material.

This unit is located within the north-eastern parts of the proposed development, which borders the R31 (Figure 3). This area is being used as a dumping site for many purposes but mainly for dug up soil. Historical imagery indicates that the dumping activities have been ongoing for the past five years. The dumping of unearthed soil and construction debris has left this area entirely degraded (Figure 6). Other sources of

degradation include footpaths, movement of heavy vehicles and the high level of infestation of exotic species. This unit consists of a broken herbaceous layer dominated by the grasses *Eragrostis lehmanniana* and *Schmidtia kalihariensis* with large areas of exposed and compacted soil. *Conyza sumatrensis*, *Verbesina encelioides* and *Bidens pilosa* are only but a few exotic species frequently observed in this unit and increases in density moving towards VU-A. Furthermore, the presence

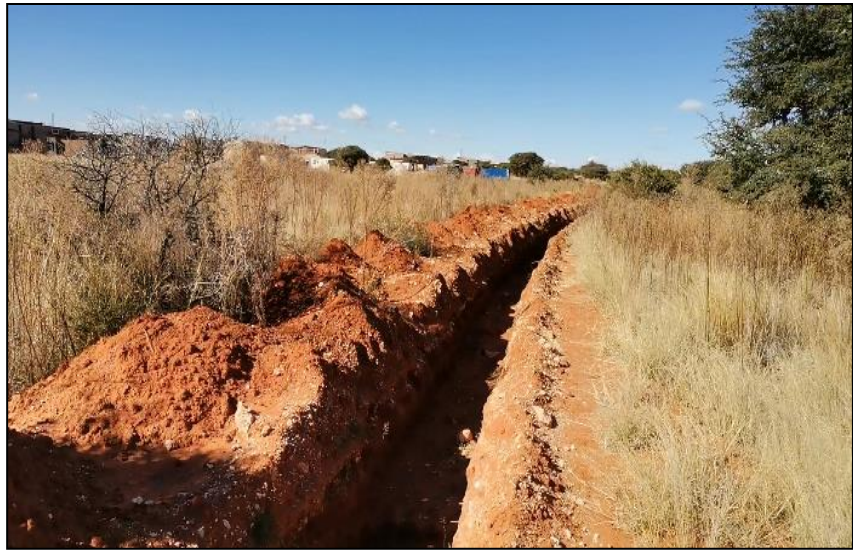
Figure 7 An open trench 50-70cm deep, running across VU-E. The first phase of student accommodation is visible in the background.

VU-E is situated in the most southern parts of the site (Figure 3). This vegetation unit is separated from VU-C by a temporary road constructed from piled-up topsoil, mudstone and calcareous deposits most likely procured during the grading of VU-C. This unit's herbaceous layer is represented by numerous pioneering

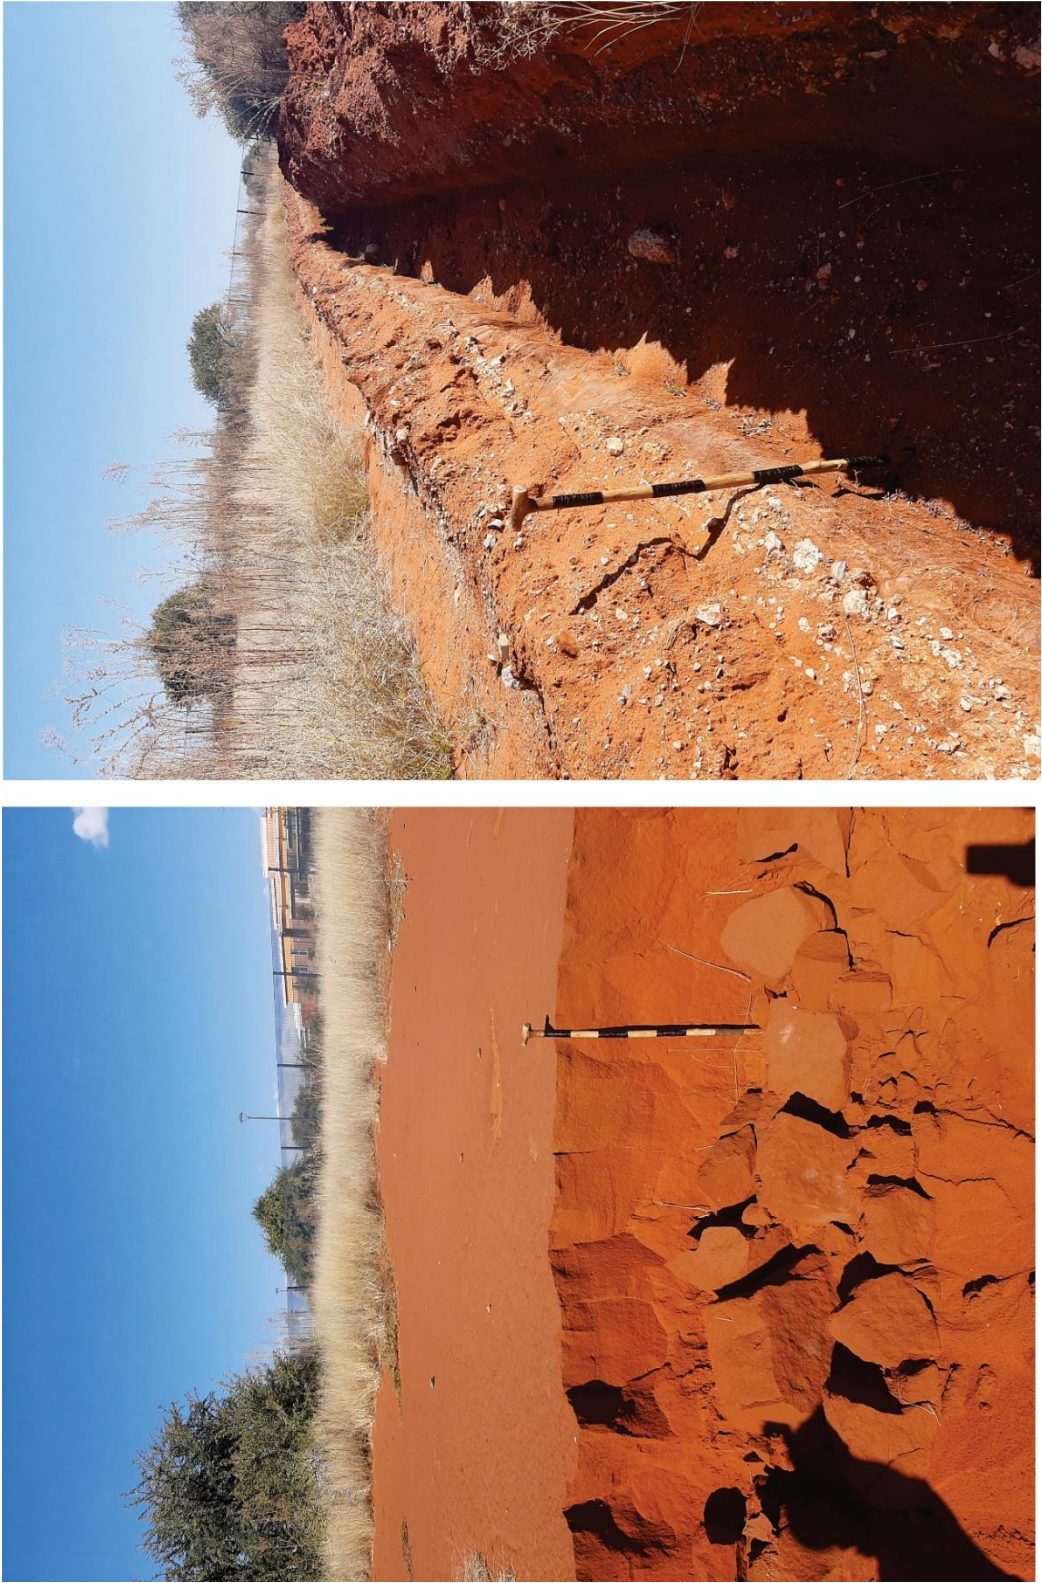
Figure 11. The terrain is capped by thick deposits of late Quaternary, Kalahari Group aeolian sand and calcrete matrix (Scale 1 = 10 cm)
