Technical Report:

**PROPOSED FILLING STATION ON ERF 4413 AT
THE INTERSECTION BETWEEN ROADS R71
AND D978 IN TZANEEN EXTENSION 75,
LIMPOPO PROVINCE:**

Geo-environmental investigation.

January 2022

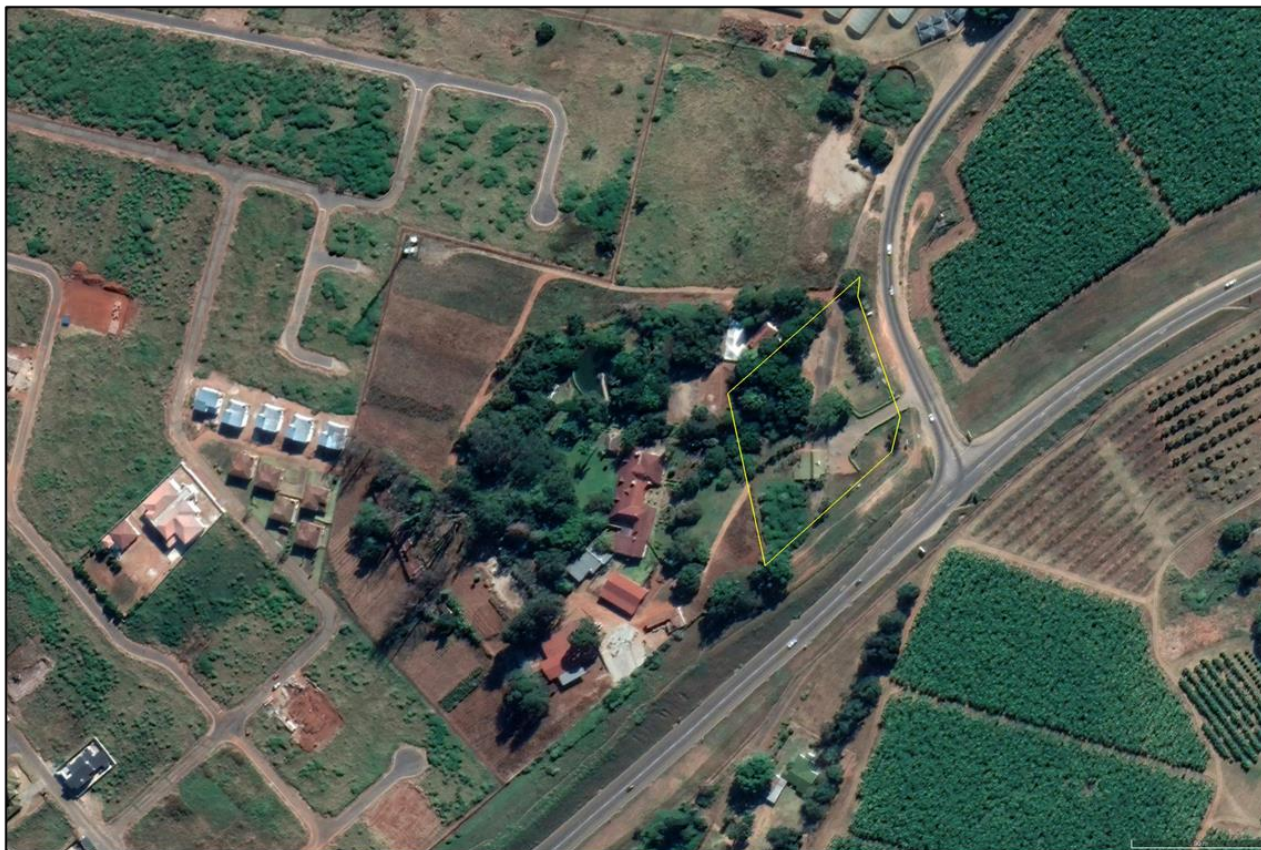
Vertical Google Earth Pro™ image.

- the regional morphological setting classifies as *low mountains*,
- the site itself is draped along the southeastwardly facing upper side slope of a northeast-southwestwardly trending ridge with a rounded crest that acts as a localized watershed,

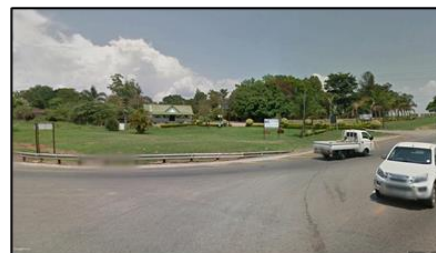
Google Earth Pro Streetview™ image from the southeast (taken in 2014).

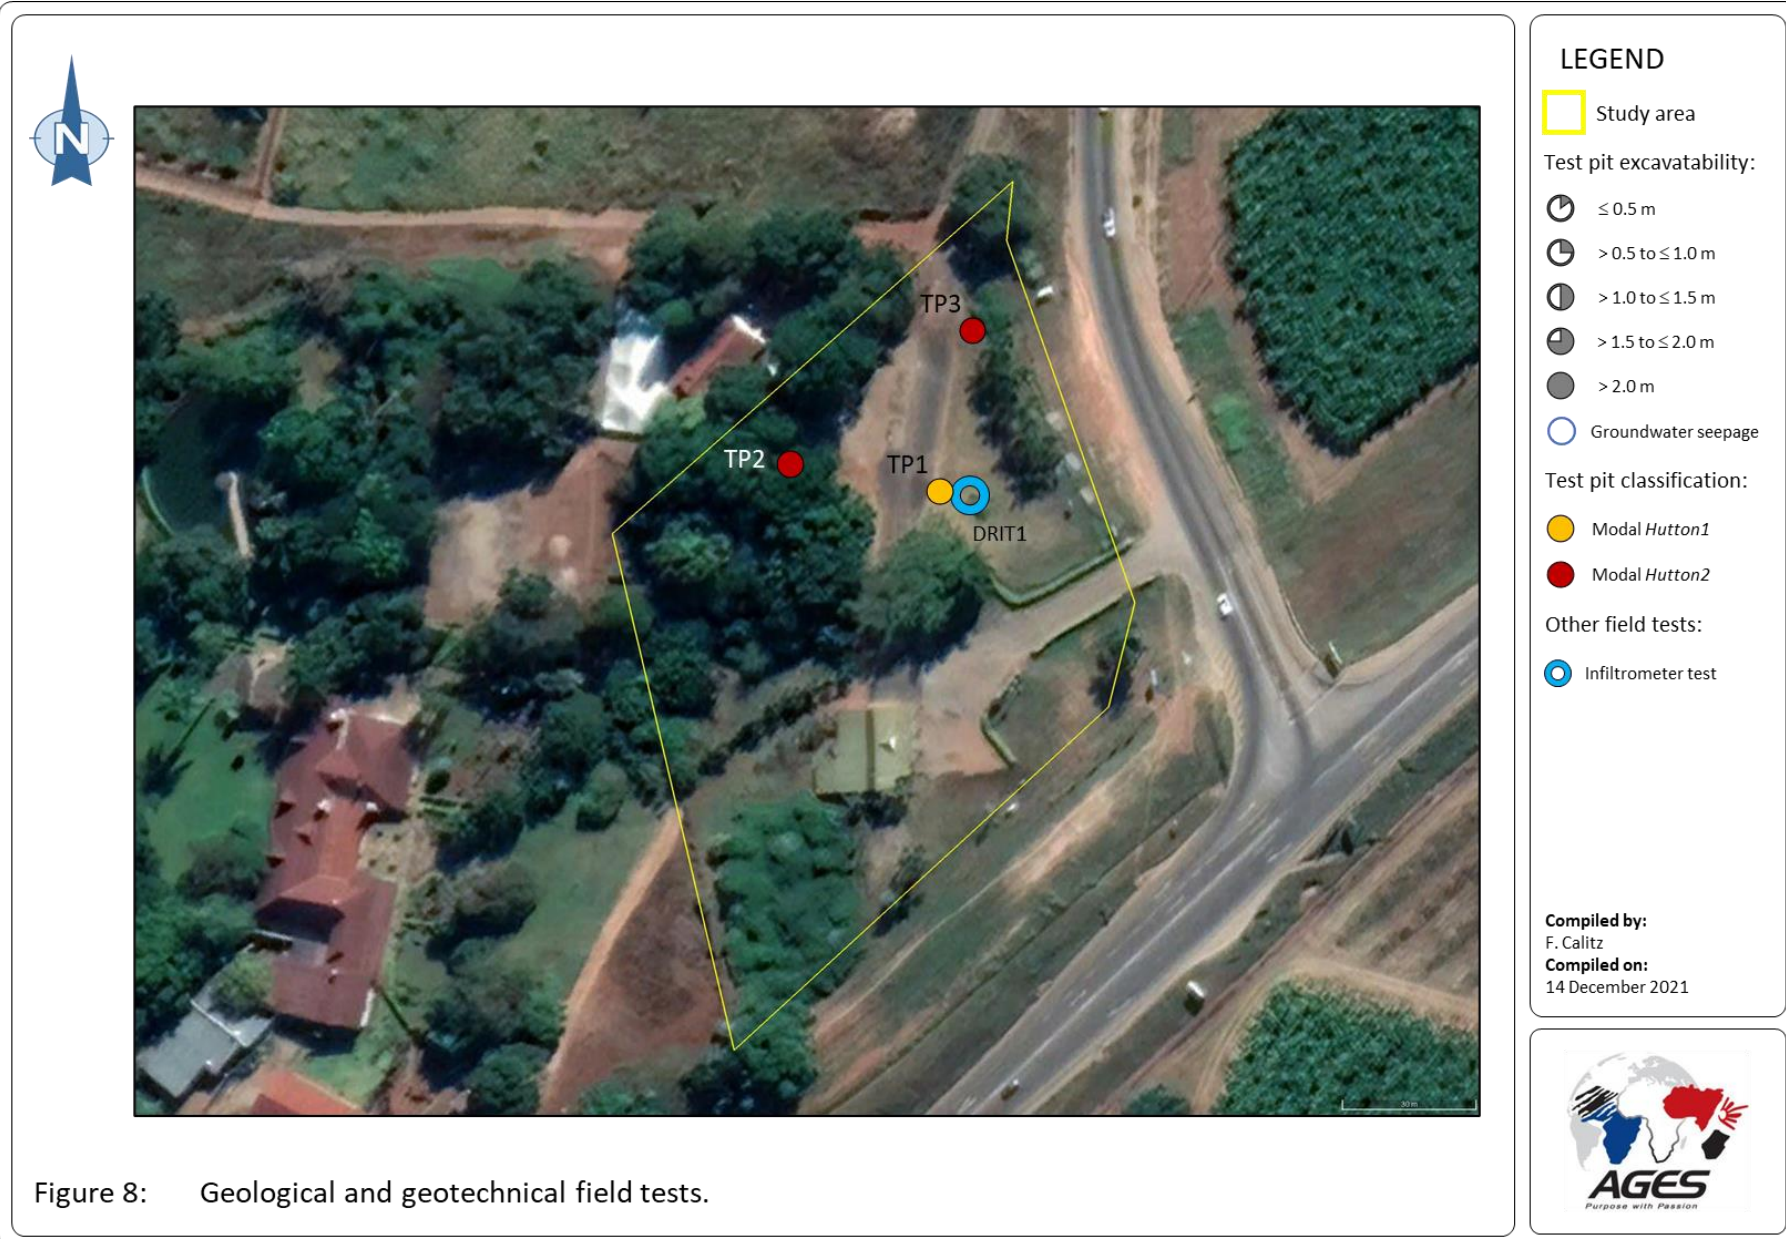
Figure 8: Geological and geotechnical field tests.

- Three test pits, numbered TP/1 to TP/3, were excavated within the northern portion of the study area by means of a Bell TLB-type light mechanical excavator on 16 February 2011, after which the exposed soil and rock layers were profiled according to the relevant industry standards. No test pits were placed in the areas around the existing structure and in the vicinity of the paved access road in the south to prevent damage to above-ground and buried infrastructure.

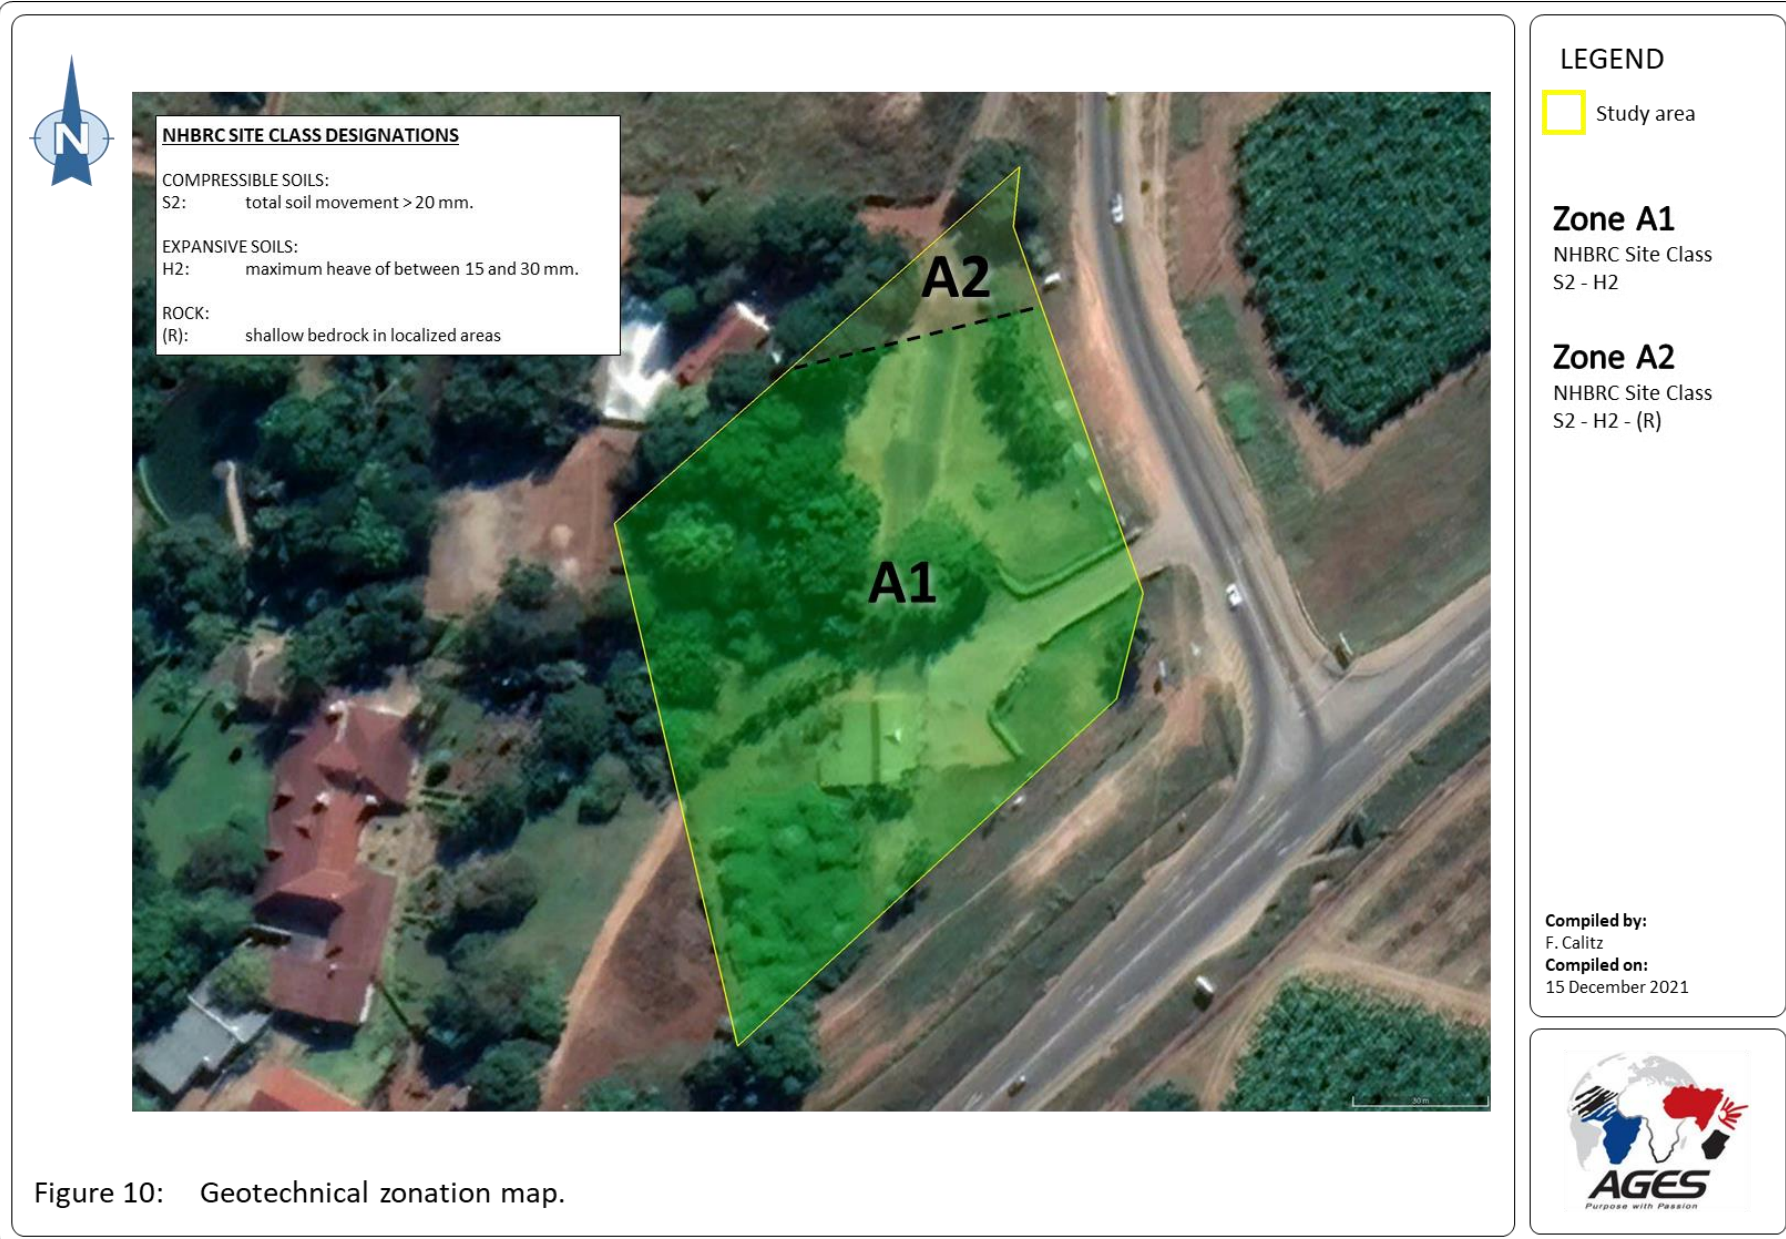
Figure 10: Geotechnical zonation map.

- the presence of potentially slightly compressible material beneath the foundations that could cause localized differential settlement under loading or when saturated, especially in the period after construction until a state of equilibrium has been achieved,
- the presence of potentially slightly expansive material beneath the foundations that could cause structural damage over time especially when saturated, considered to occur for the entire lifespan of the proposed development, and
- the highly localized occurrence of weathered bedrock at relatively shallow depth, associated with dolerite / diabase dyke intrusions.

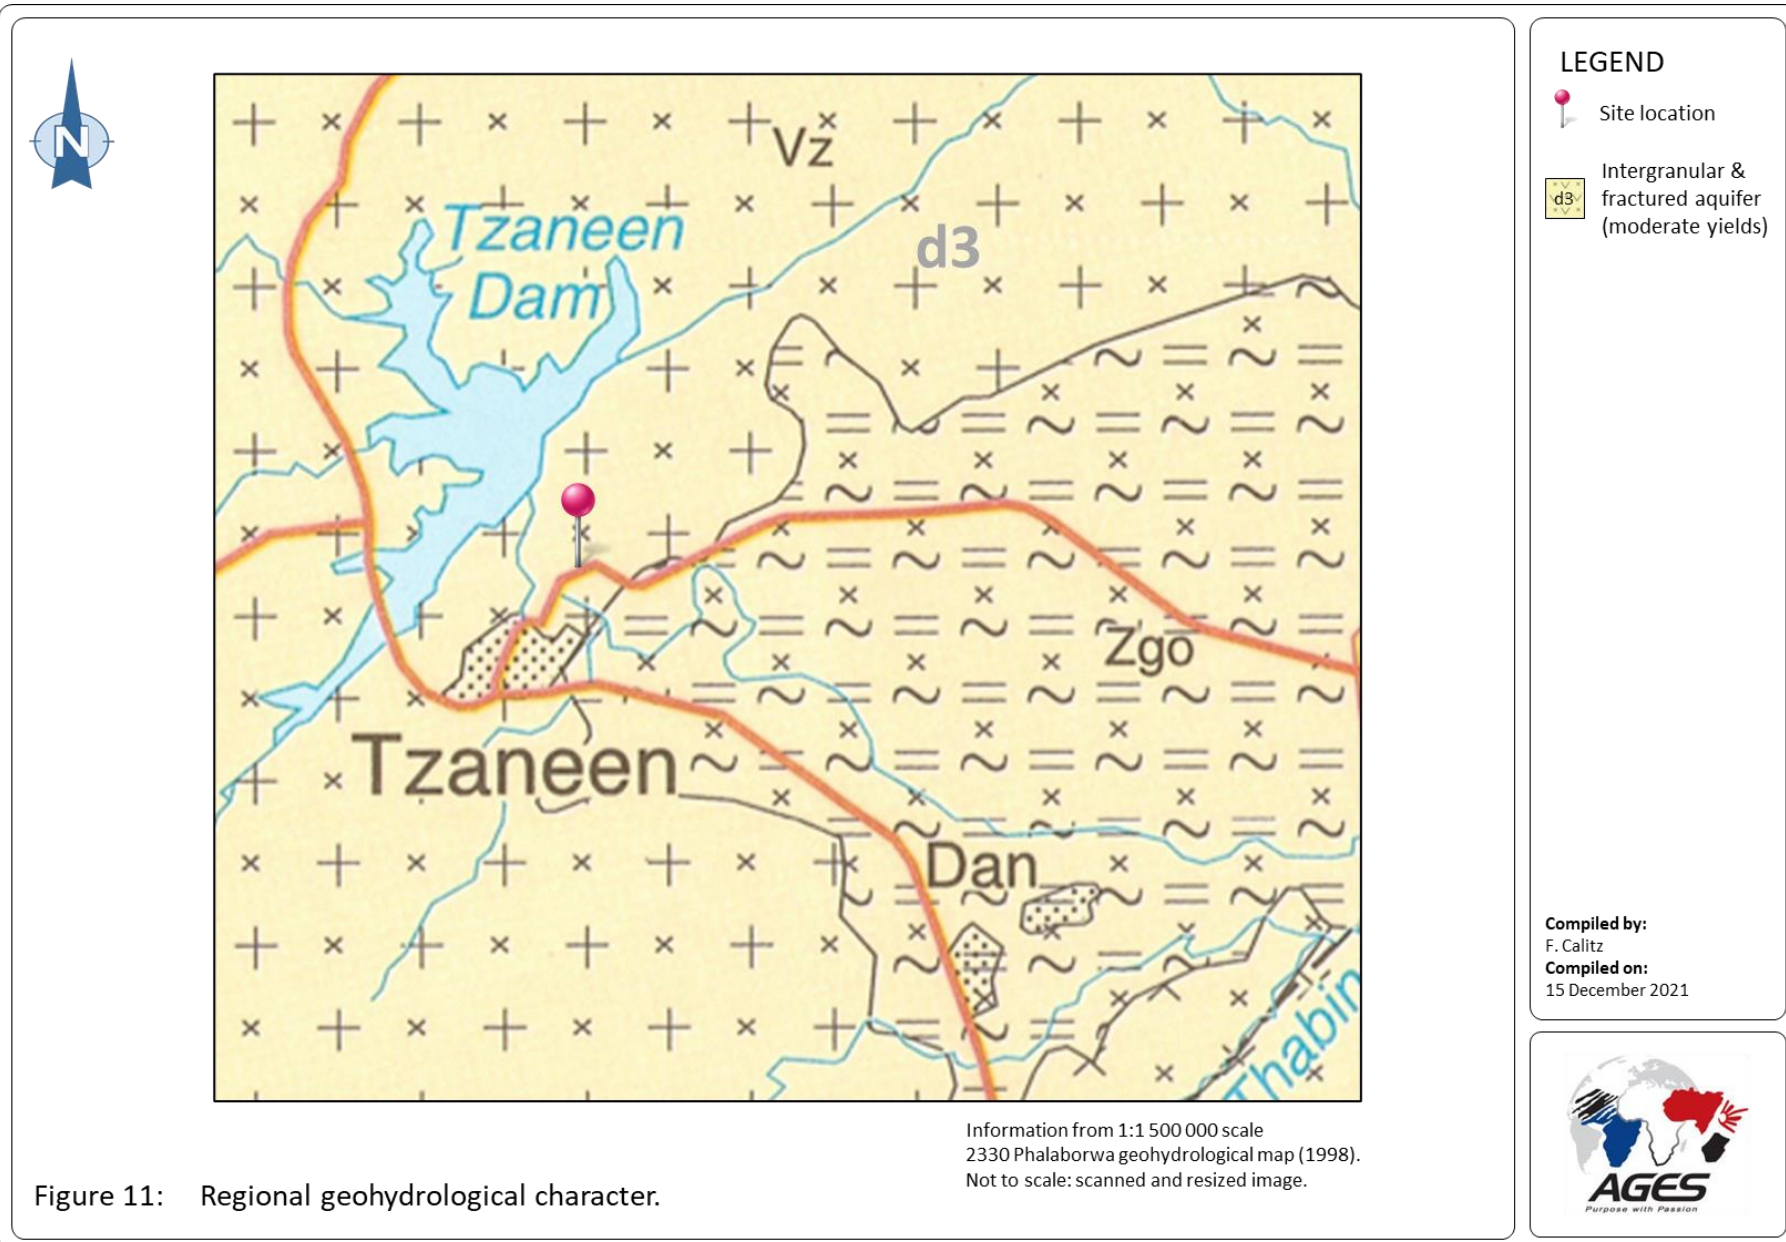
Figure 11: Regional geohydrological character.

The study area is located within Quaternary Catchment Area **B81C** that forms part of the Levubu & Letaba Water Management Area. The available hydrogeological information indicates that the strata underlying the study area define an intergranular and fractured aquifer with borehole yields of between 0.5 to 2.0 l/s. Groundwater occurrences are limited to fault and/or contact zones and dyke structures, with groundwater recharge and lateral movement primarily restricted to these zones. The rate of movement / recharge will likely be very low due to the fine-grained nature of the parent material. According to Vegter (2003), groundwater strikes generally occur at a depth of between 20 and 30 m below surface, with aquifer depth at 24 m below surface. Water bearing fractures are predominantly restricted to a shallow zone beneath the static groundwater level.

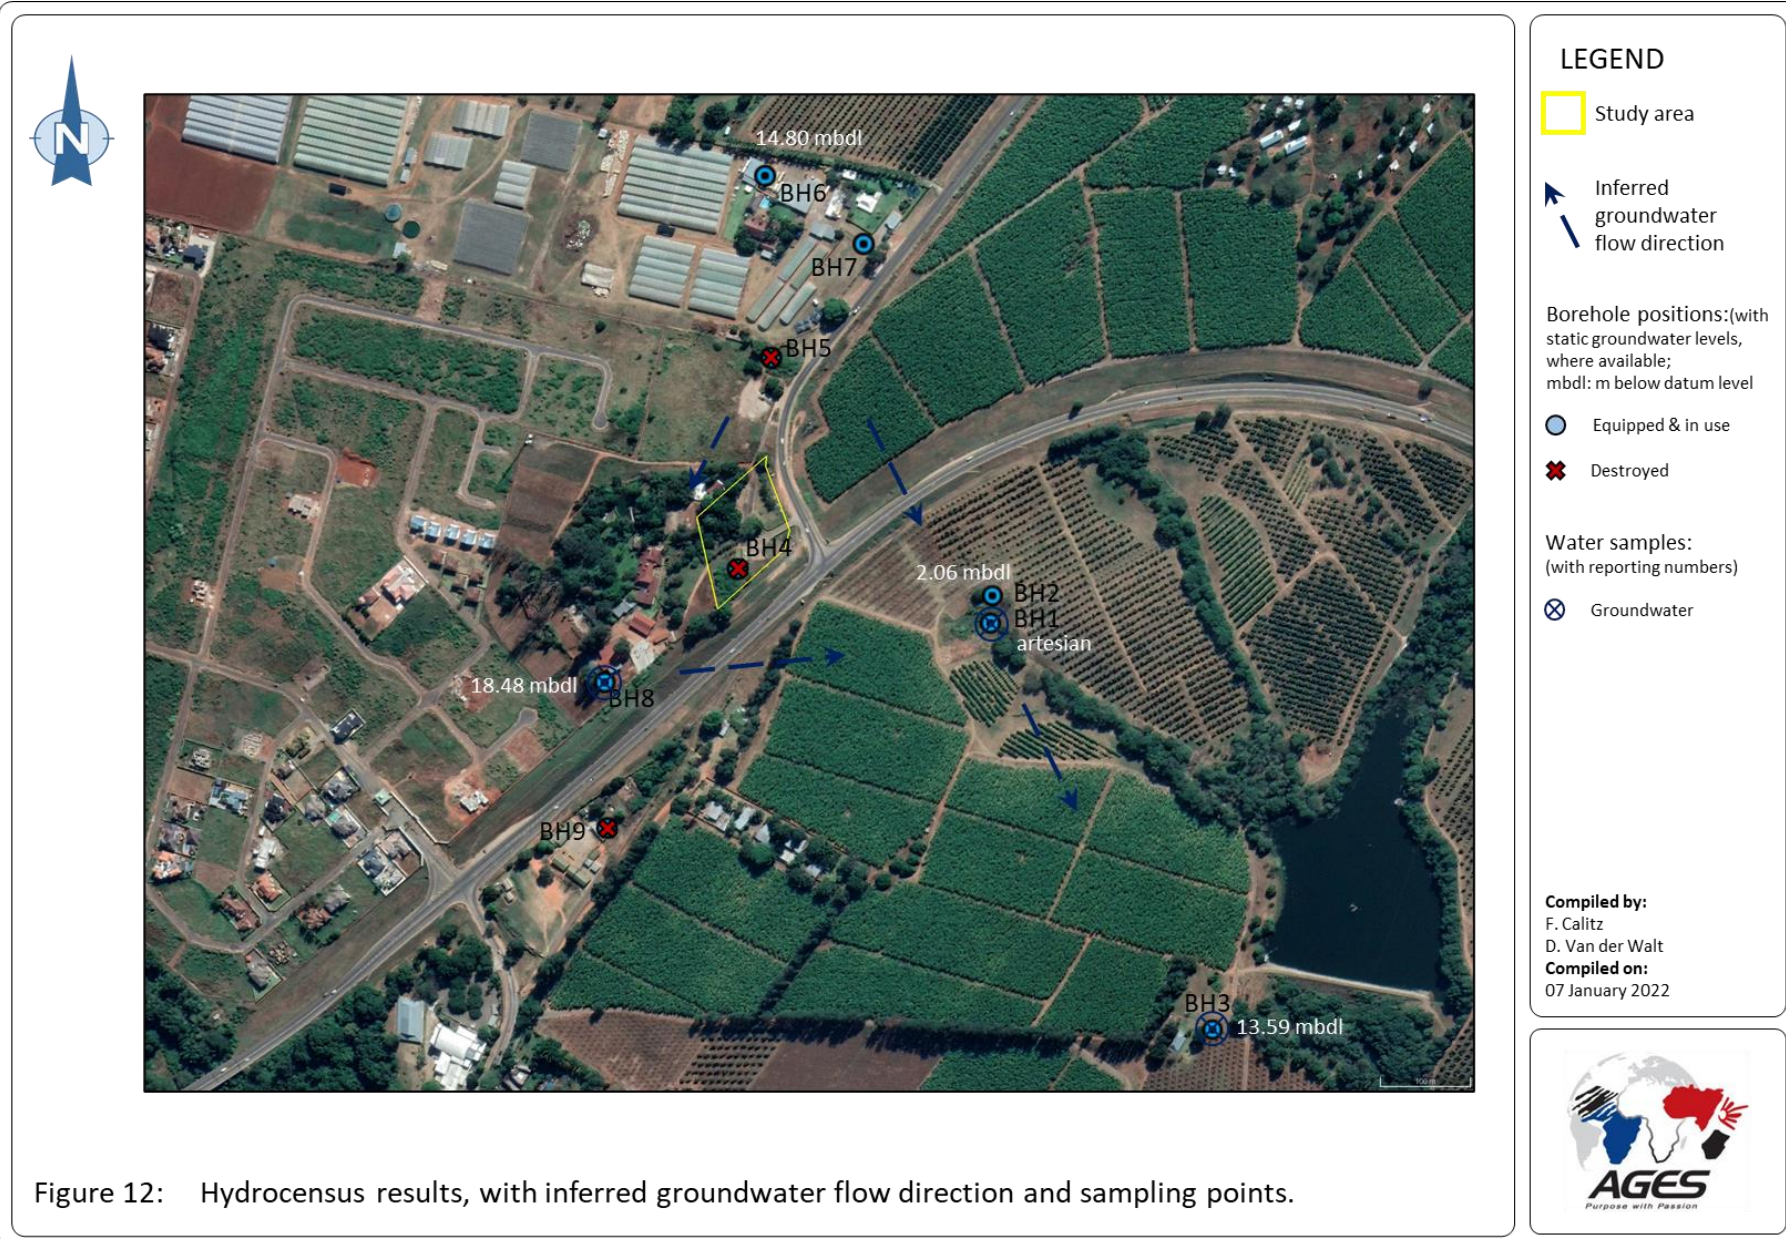
Figure 12: Hydrocensus results, with inferred groundwater flow direction and sampling points.

The results of the newly conducted hydrocensus revealed that nine boreholes are located in the vicinity of the proposed filling station (both upstream and downstream of the site). Of these, three are deemed to have been destroyed, while the remainder are currently equipped with submersible pumps and are in use for the abstraction of groundwater for both domestic and agricultural purposes.

It must be noted that boreholes BH1 and BH2 are located very close to the afore-mentioned spring, occurring approximately 260 m to the southeast (i.e., downstream) of the site.

It is inferred that the spring is associated with groundwater flow along the contact between the granite and a diabase dyke intrusion. However, prolonged drought conditions in the area necessitated the drilling of borehole BH1 to augment the supply of water to the dam, with artesian groundwater conditions (i.e., caused by a static groundwater level occurring at an elevation above that of the top of the borehole casing, thus leading to natural groundwater flow from the borehole) encountered.

It was possible to measure the groundwater level at five of these boreholes, with levels of between 2.06, 14.80, and 18.48 mbgl recorded at BH2 close to the spring to the southeast, BH6 at the greenhouses to the north, and BH8 at a guesthouse to the west of the site, respectively, and excluding the artesian conditions encountered at borehole BH1 at the spring. This translates to a groundwater elevation of approximately 690 mamsl at borehole BH2, 663 mamsl at BH3, 707 mamsl at BH6, and 694 mamsl at BH8.

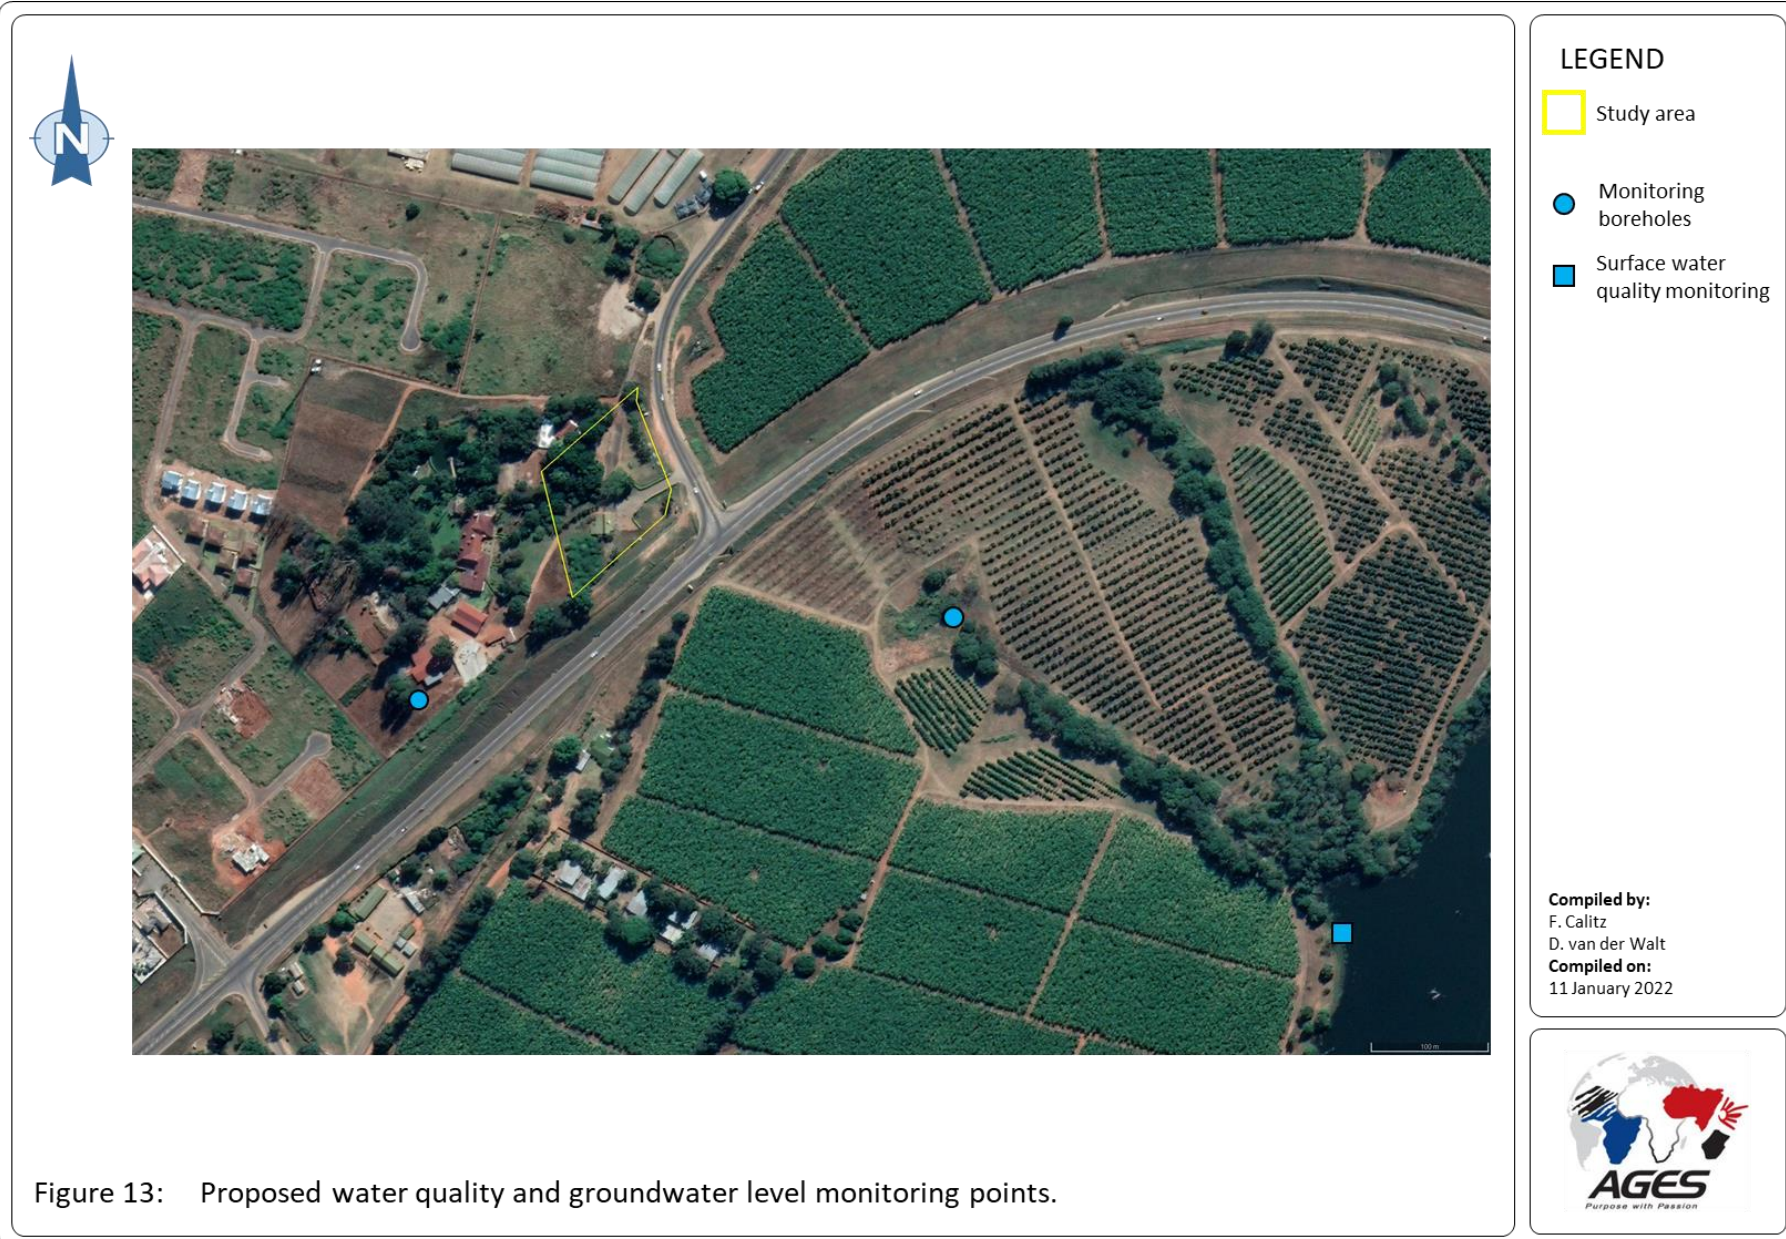
Figure 13: Proposed water quality and groundwater level monitoring points.

In the light of the importance of groundwater to agricultural end-users in the area, it is essential that proper geohydrological monitoring points be established to allow long-term documentation of groundwater levels and quality. This will also allow the timeous detection of contamination resulting from spillages and/or leaks at the facility and will establish a purging point for remediation if required.

It is recommended that the identified monitoring boreholes be maintained and finished to prevent localized contamination from surface. The borehole installations need to allow for access to measure groundwater levels and water quality sampling.

Borehole number	Latitude:	Longitude:
BH2	23.81480°S	30.17518°E
BH8	23.81533°S	30.17118°E

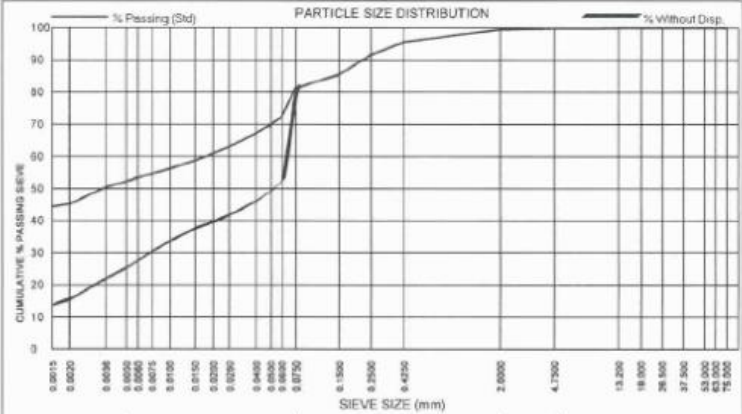
PARTICLE SIZE DISTRIBUTION

Sample No. : G285	Liquid Limit (%) : 49	Pl of Whole Sample : 13	P.R.A. Classification : A-7-5(11)
Hole No. : TP1	Plasticity Index : 14	Grading Modulus : 0.34	Unified Soil Classification : ML
Depth (mm) : 0.3-3.0m	Linear Shrinkage (%) : 8.0	Percentage (+0.002) : 45.0	Activity : 0.29
Description : RD BROWN SANDY SILTY CLAY	Moisture Content (%) :	Heave Classification : LOW

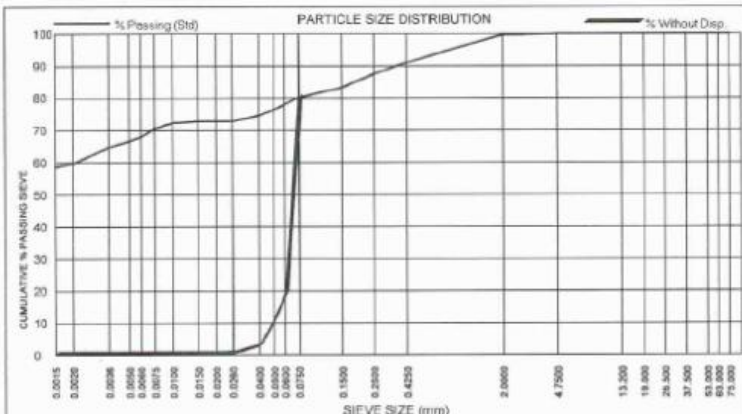
PARTICLE SIZE DISTRIBUTION

Sample No. : G286	Liquid Limit (%) : 53	Pl of Whole Sample : 11	P.R.A. Classification : A-7-5(11)
Hole No. : TP2/1	Plasticity Index : 12	Grading Modulus : 0.29	Unified Soil Classification : MH
Depth (mm) : 0.3-1.0m	Linear Shrinkage (%) : 7.0	Percentage (<0.002) : 60.0	Activity : 0.18
Description : RD BROWN SILTY SANDY CLAY		Moisture Content (%) :	Heave Classification : LOW

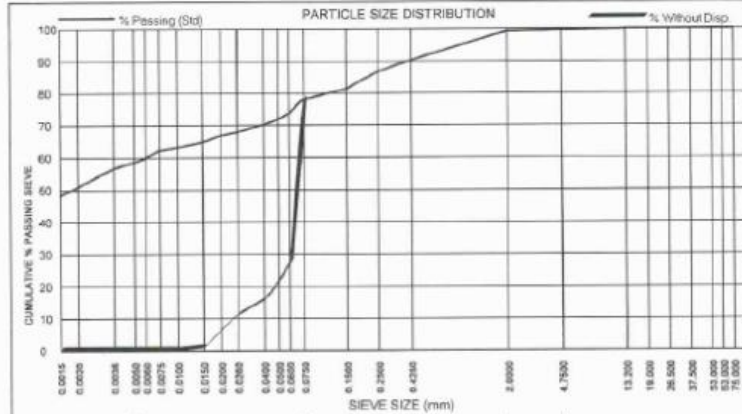
PARTICLE SIZE DISTRIBUTION

Sample No. : G287	Liquid Limit (%) : 54	Pl of Whole Sample : 11	P.R.A. Classification : A-7-5(12)
Hole No. : TP2/2	Plasticity Index : 12	Grading Modulus : 0.52	Unified Soil Classification : MH
Depth (mm) : 1.0-1.45m	Linear Shrinkage (%) : 7.5	Percentage (<0.002) : 51.0	Activity : 0.22
Description : RD BROWN SILTY SANDY CLAY		Moisture Content (%) :	Heave Classification : LOW
