Report **2020/10**

**Report on a Phase 1 Geotechnical Site Investigation for the
proposed KSL Student Lifestyle Precinct on Portion 191 of
the farm Tweefontein 915LS- Limpopo Province**

July 2020

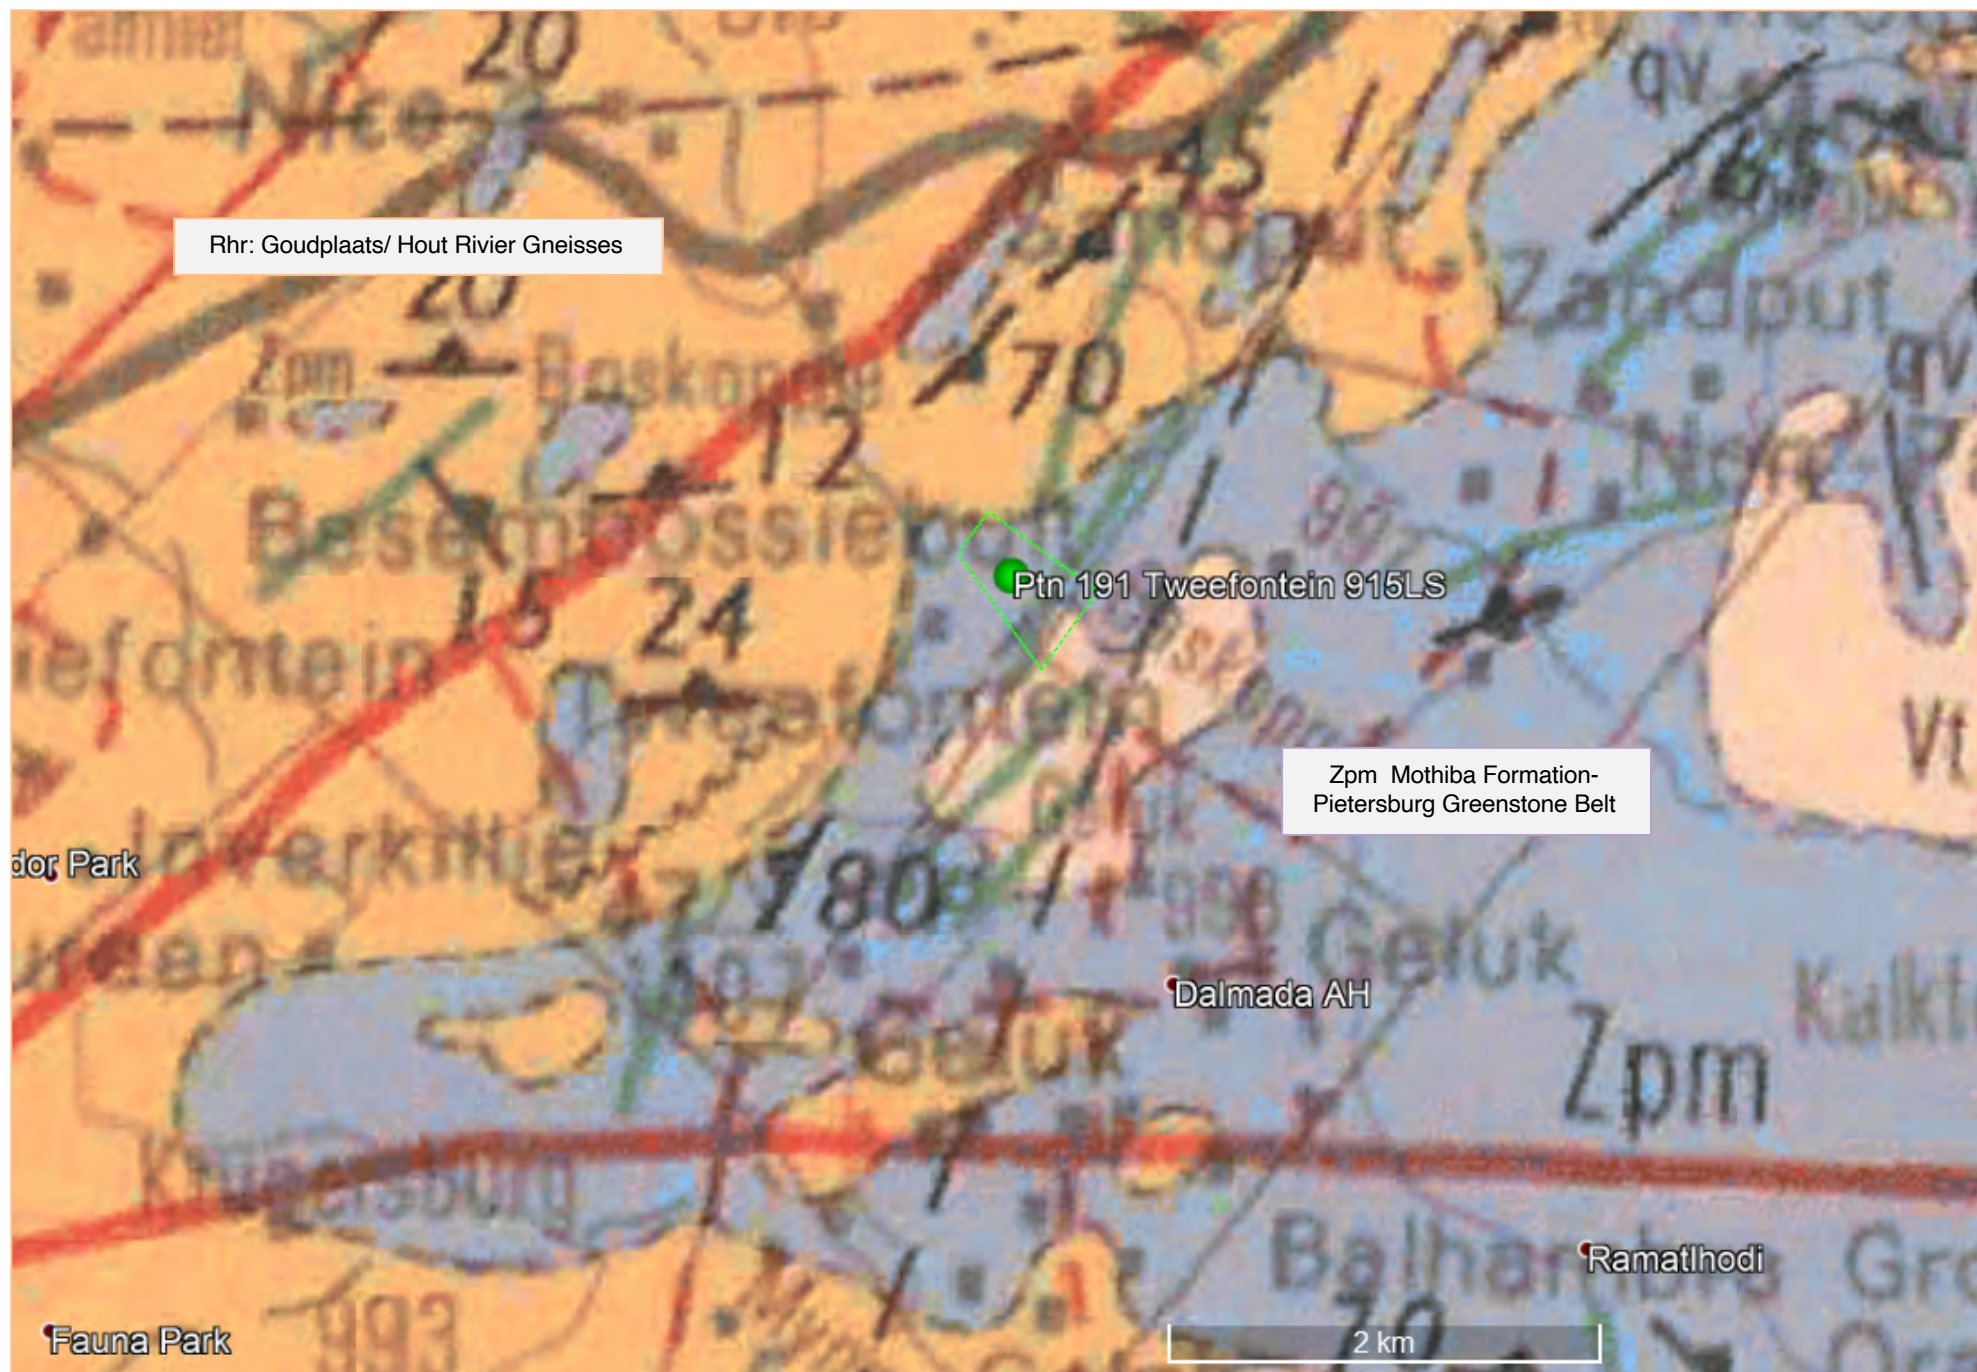
Figure 4. Regional Geological Map 1:250 000 (Geological Sheet 2328 Pietersburg)

Following excavations and geological field mapping; the majority of the site was seen to be underlain by intercalated gneiss and schist bedrock- with the central portions of the site seen to host a small diabase dyke. Where intrusions are present, it is predicted that the gneissic bedrock has undergone various degrees of contact metamorphism. A highly undulating bedrock topography was exposed across the site; ranging from undisturbed competent rock to highly fractured and weathered incompetent rock/residual soil. This may impact the continuity of excavatability across the site as well as amplify differential settlement.
