**FLORA, FAUNA AND AESTHETIC REPORT**

**THE PROPOSED TOWNSHIP**  
**ESTABLISHMENT ON PORTION 385 OF THE**  
**FARM WATERKLOOF 305 JQ, RUSTENBURG,**  
**NORTH WEST PROVINCE**

**OCTOBER 2012**

**GEOTECHNICAL INVESTIGATION REPORT  
OF  
PORTION 385  
OF THE FARM WATERKLOOF 305-JQ,  
RUSTENBURG.**

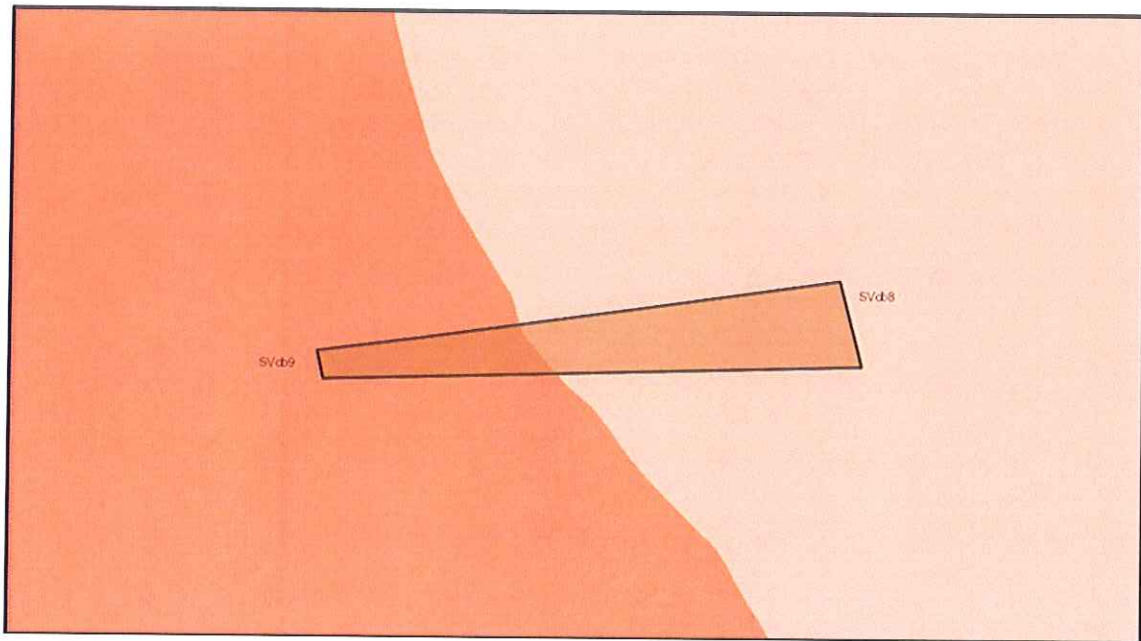
**Figure 2: The vegetation types identified for the project area – Gold Reef Mountain Bushveld (SVcb 9) and Moot Plains Bushveld (SVcb 8) (Mucina and Rutherford, 2006)**

The Moot Plains Bushveld forming the southern plains of the Magaliesberg consists of open to closed woodlands dominated by *Acacia caffra* and *Acacia karroo*. The threatened status of this vegetation type is Vulnerable and the conservation target is 19% (Mucina and Rutherford, 2006).

Gold Reef Mountain Bushveld is characteristic of ridge vegetation, which is a sensitive system although the vegetation type specifically is not of conservation concern as it is already adequately protected. Moot Plains Bushveld, however, is identified to be of conservation value as it is not adequately protected. The site survey indicated that the vegetation on the site was predominantly transformed due to existing development (buildings etc) and other anthropogenic impacts (littering, chopping of trees). When approaching the ridge area and mountain bushveld, the vegetation was found to be less disturbed, however anthropogenic impacts were still identified, only reduced compared to the remainder of the site.

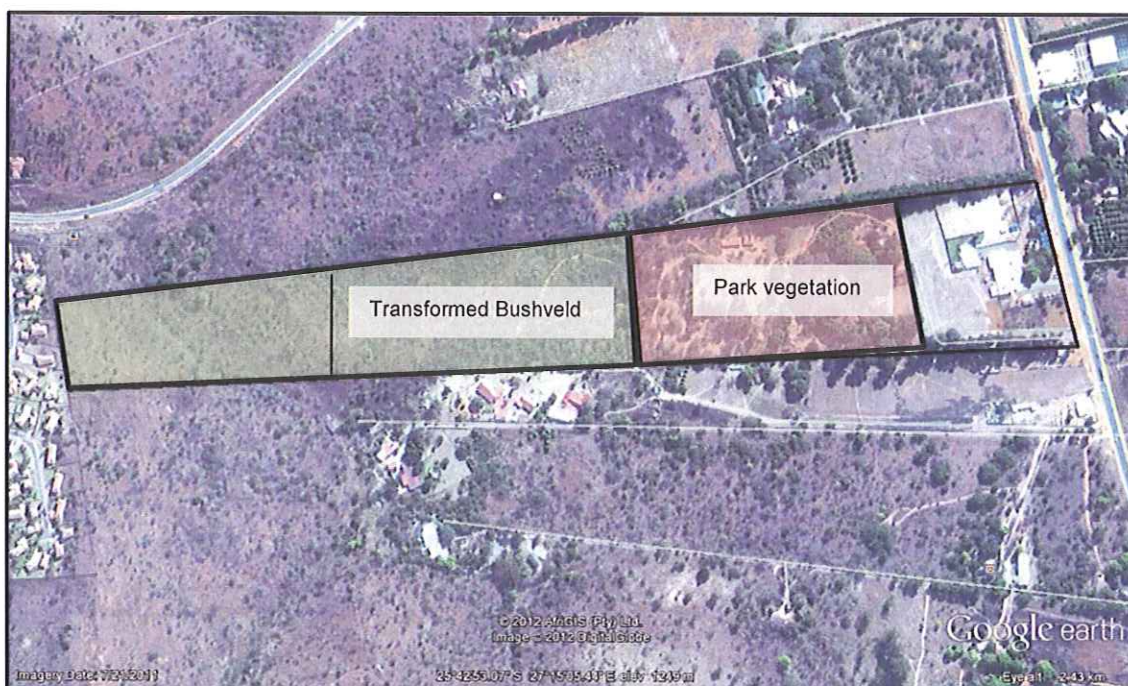
**Figure 3: Vegetation communities identified for the project area**

Vegetation communities are identified based on the change in the dominant species. As described above, the majority of the project area (> 70%) has been severely altered from its natural state due to anthropogenic impacts. Based on this, only two vegetation communities were identified (Figure 3).

**Park vegetation:** As part of the hotel garden area and Caravan Park, the vegetation is maintained/gardened. Furthermore, the permanent residents of the Caravan Park have established their own gardens around their stands also comprising of garden species. Species in this community therefore include mostly garden plant species, a few bushveld trees still remaining from the bushveld vegetation found here and exotic/invasive species. Dominant species include:

**Transformed Bushveld** – The remaining surface area extending from the end of the Caravan Park to the ridge area can be described as Transformed Bushveld. This is bushveld that has been degraded by illegal waste dumping, burning of waste and the encroachment of exotic/invasive species. The further the vegetation extends to the ridge, the less disturbed it becomes. A full species list can be seen in Appendix A.

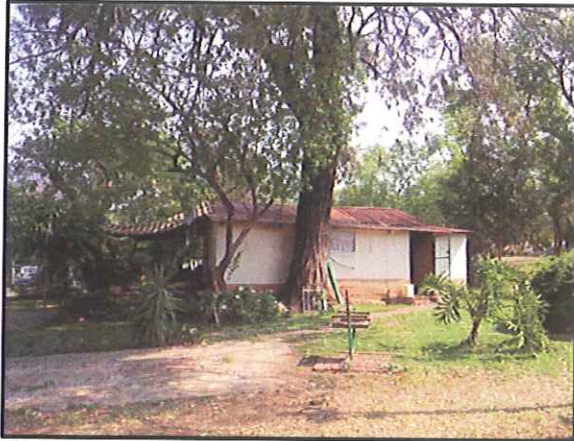
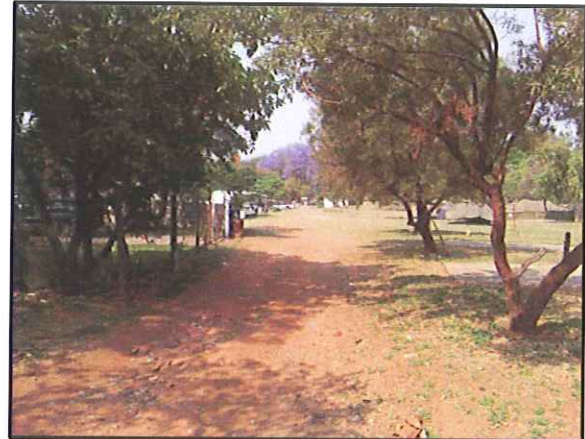
Park vegetation – consisting of caravan stands on *Pennisetum clandestinum*, garden areas and some remaining bushveld trees

### Plate 2: Photographs indicating the different vegetation communities

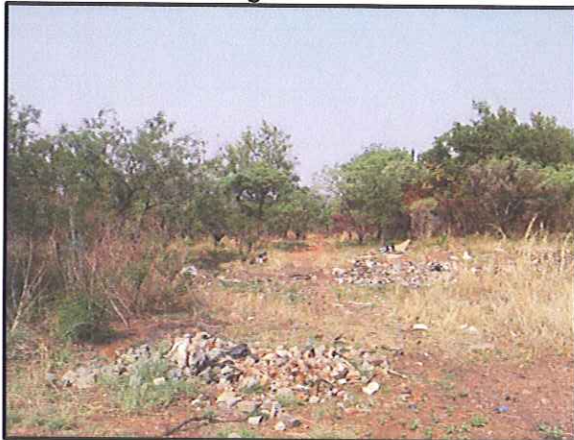
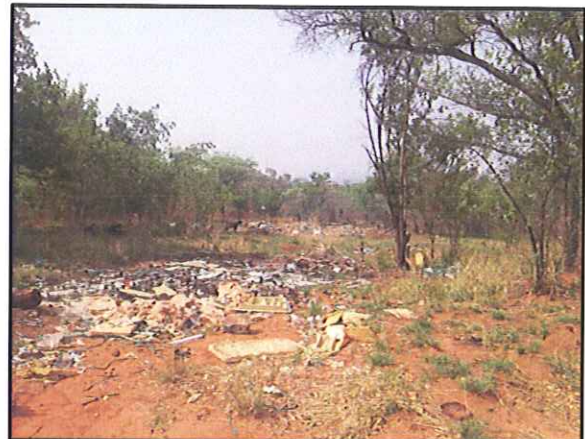
Transformed Bushveld – bushveld trees and grasses

Shrubs and Trees: *Acacia karroo*; *Acacia caffra*, *Ziziphus mucronata*; *Searsia lancea*; *Dombeya rotundifolia*; *Burkea Africana*; *Dichrostachys cinerea* and *Combretum zeyheri*.

Grasses: *Eragrostis cilianensis*; *Eragrostis rigidior* and *Hyparrhenia hirta*

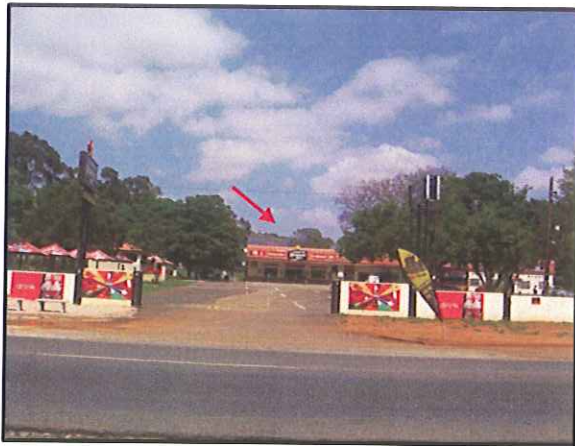
Upper most of ridge area visible from the road (eastern boundary) facing the project area

From the photographs, it can be seen that only the upper most part of the ridge area (which will not be disturbed during construction/development) was visible from the road (R24/P16-1) located east of the site (which the topography slopes down to). The caravan park (which will be removed and developed) was however, not visible from the road. This was also found on the project area. When taking photographs facing the east from the most westerly point of the development, the road was not visible.

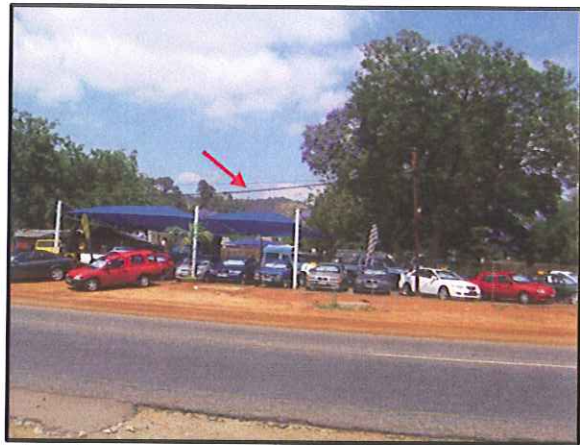
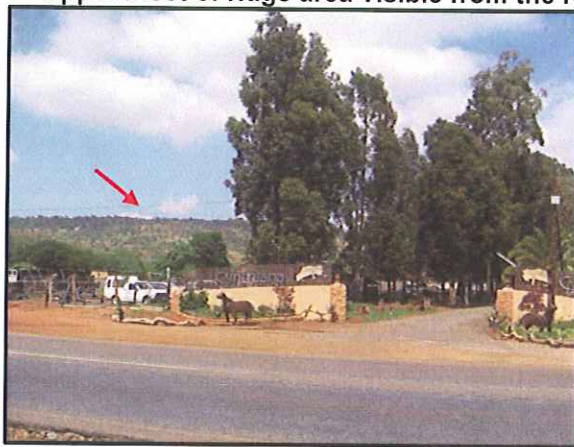
Higher neighboring ridge visible from the road

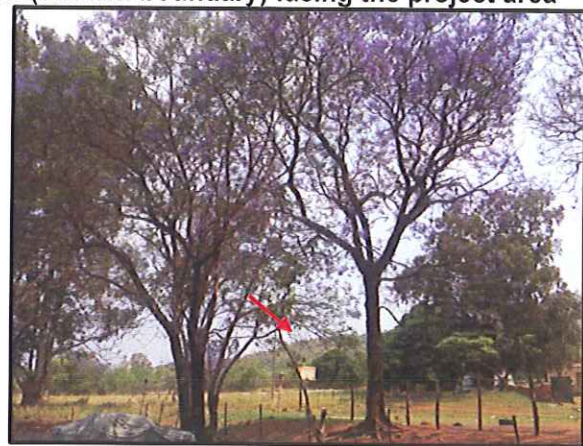
Neighboring ridge visible from on site

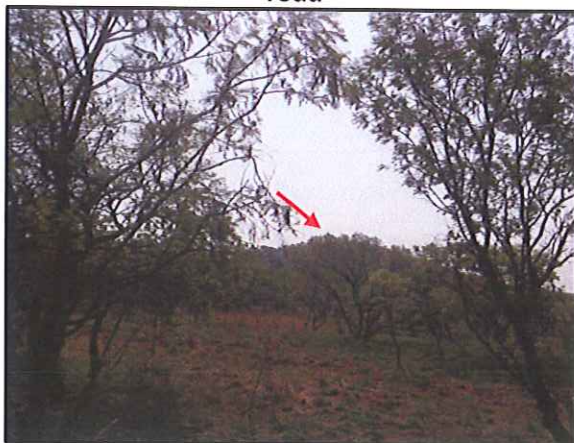
Ridge visible facing west from on the project area

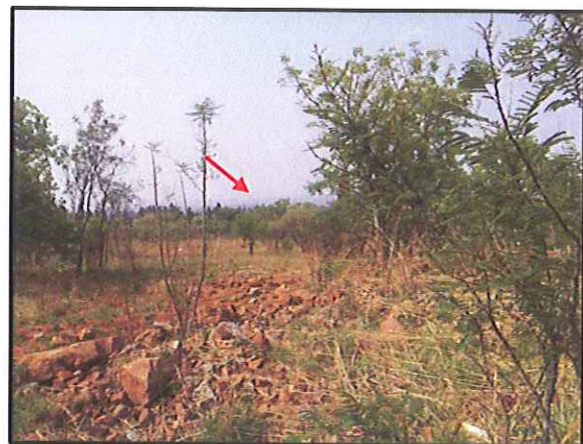
Same spot as left facing east, road is not visible from site only distant landscape features

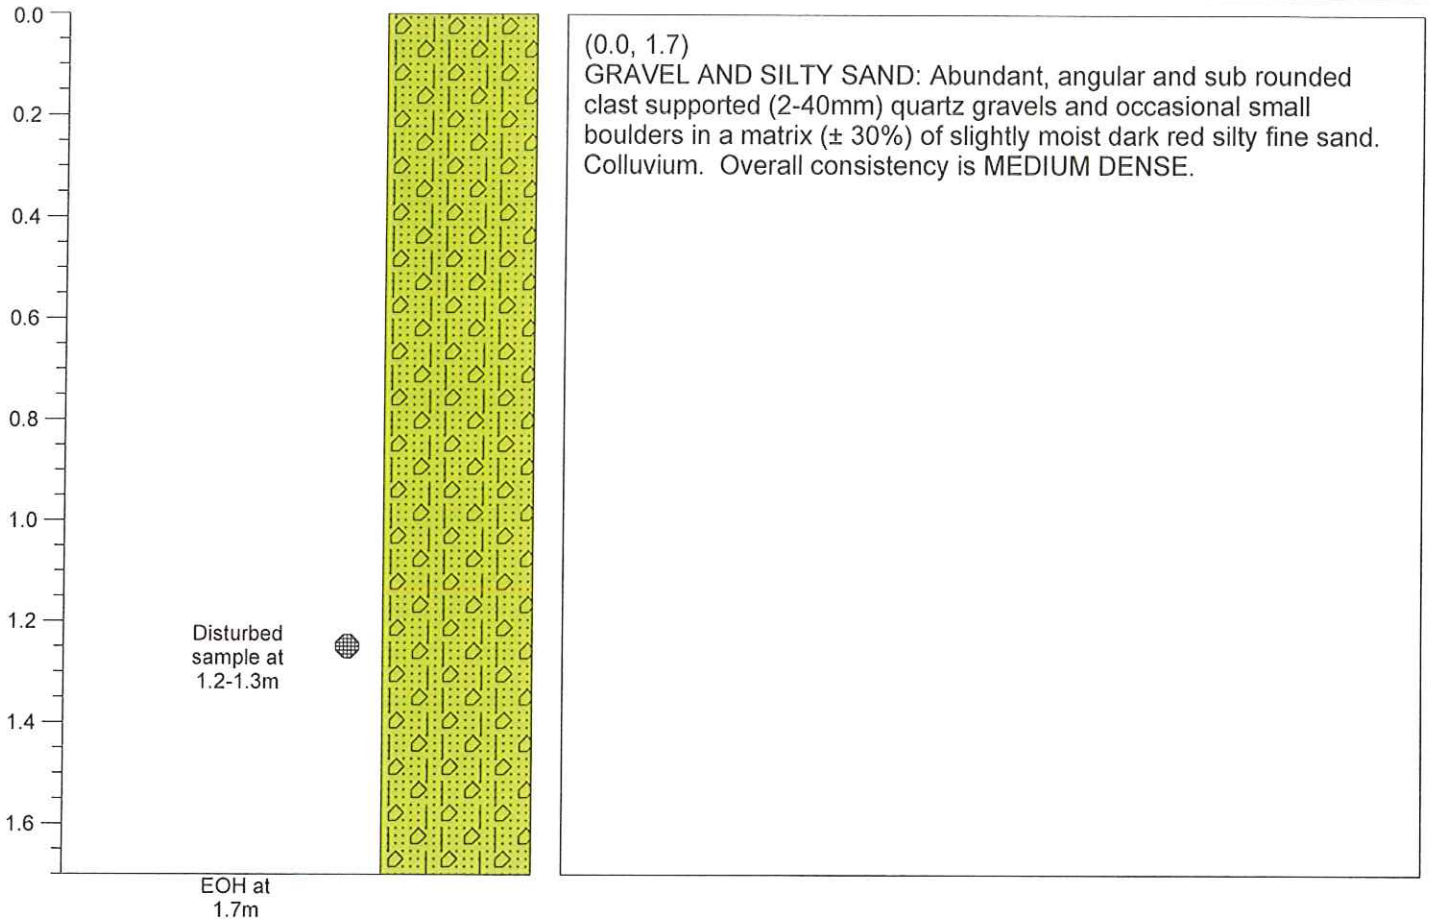
**HOLE No.:** TP 2

1. EOH easy dig
2. No ground water seepage
3. Disturbed sample taken at 1.2 to 1.3m

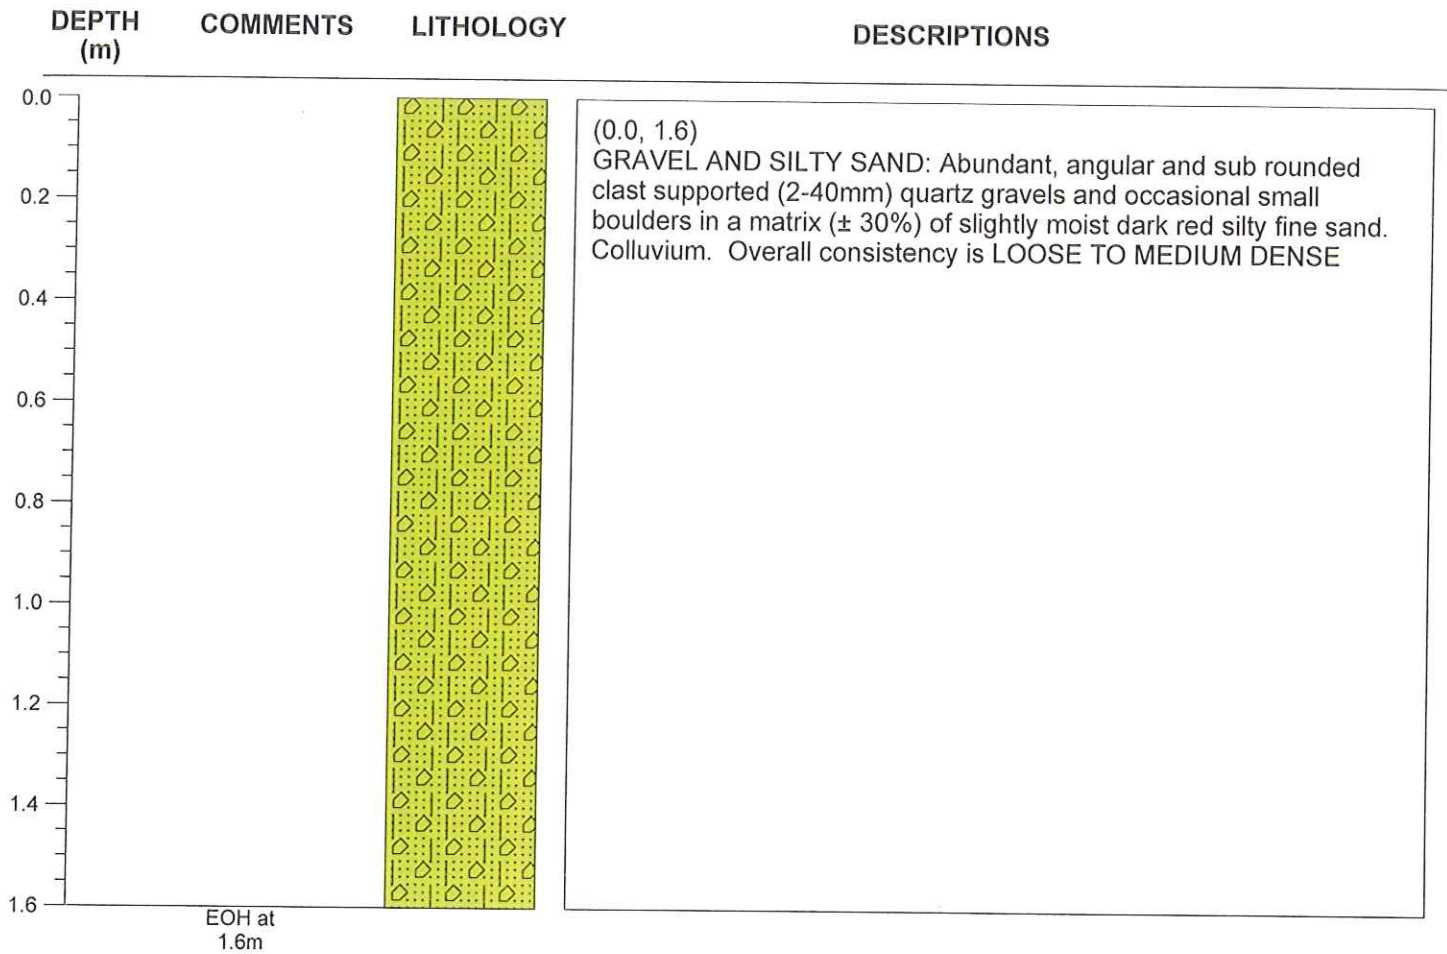
**HOLE No.:** TP 3

1. EOH easy dig
2. No ground water seepage
3. No samples taken

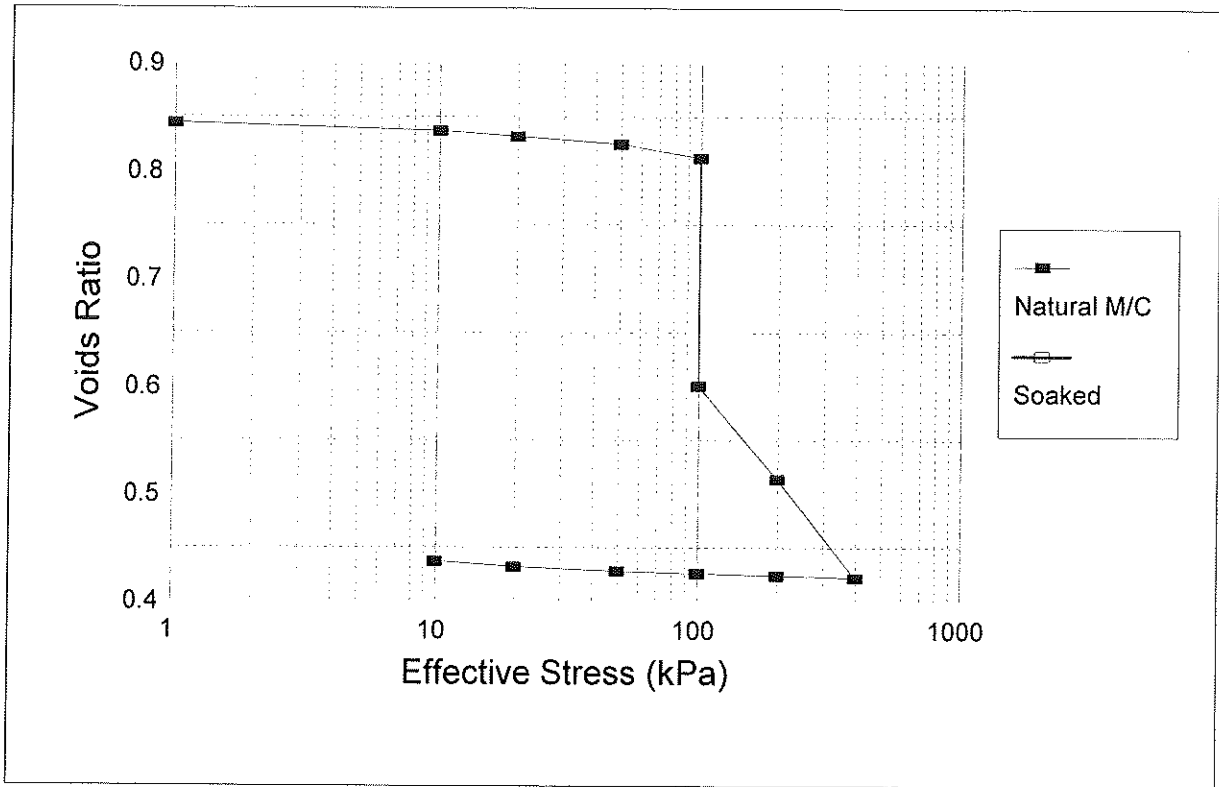
Test No: TP 2 @ 1.2-1.3m

# VOIDS RATIO v EFFECTIVE STRESS

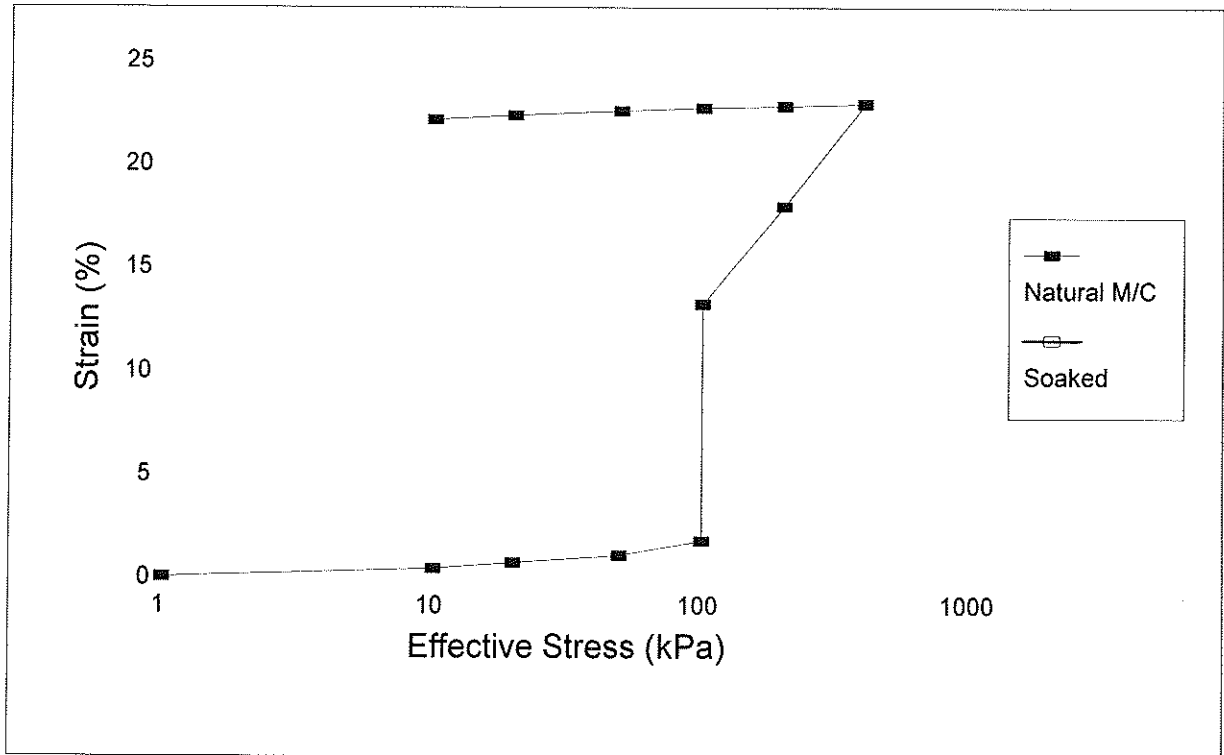
Test No: TP 2 @ 1.2-1.3m

# STRAIN v EFFECTIVE STRESS

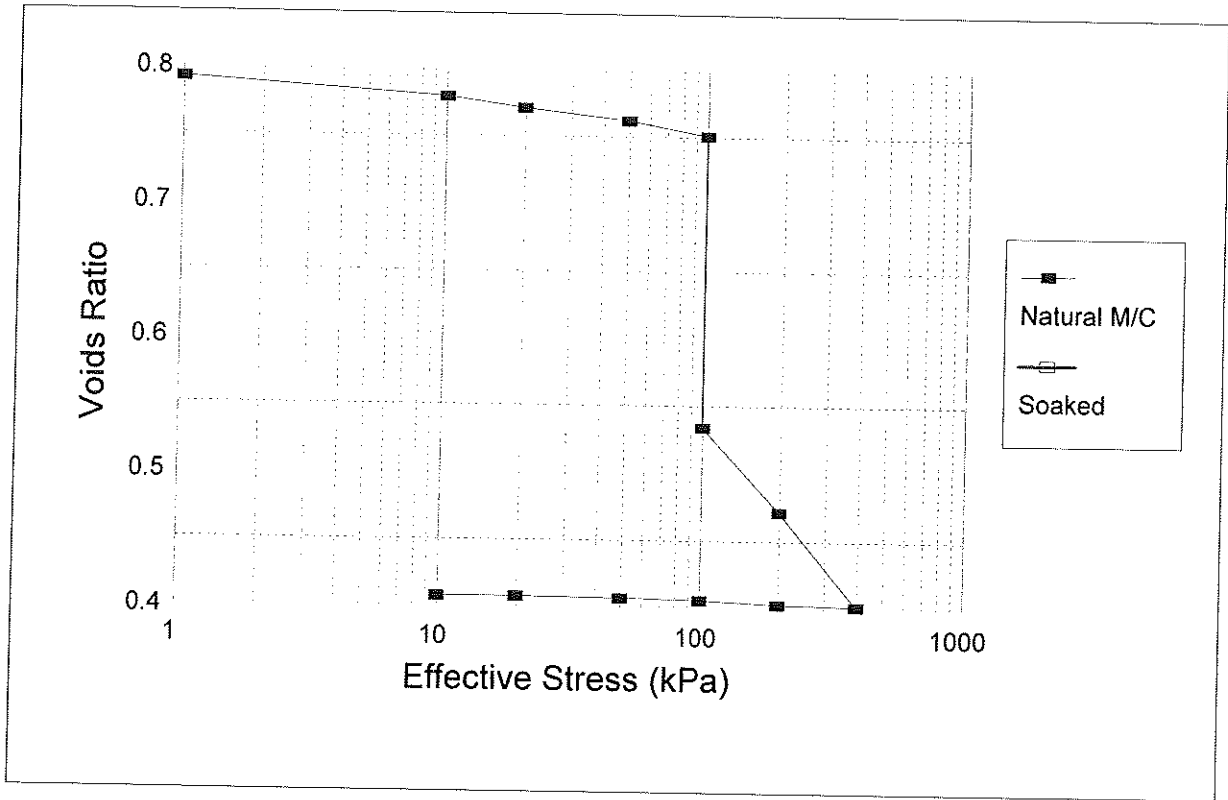
Test No: TP 5 @ 1.0-1.1m

### VOIDS RATIO v EFFECTIVE STRESS

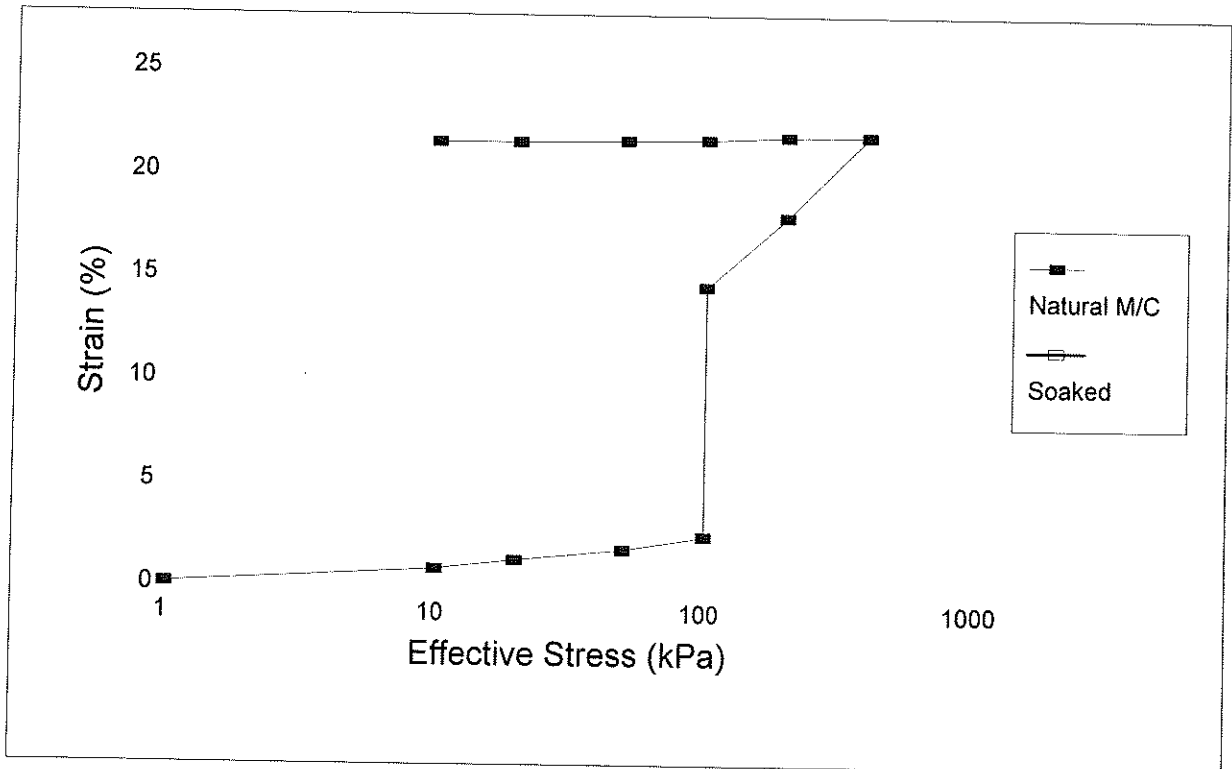
Test No: TP 5 @ 1.0-1.1m

### STRAIN v EFFECTIVE STRESS
