VEGETATION OPINION

Proposed Powerline Alternatives Farm: Boschmanskop 154 IS near Pullens Hope, Mpumalanga

Date: December 2017

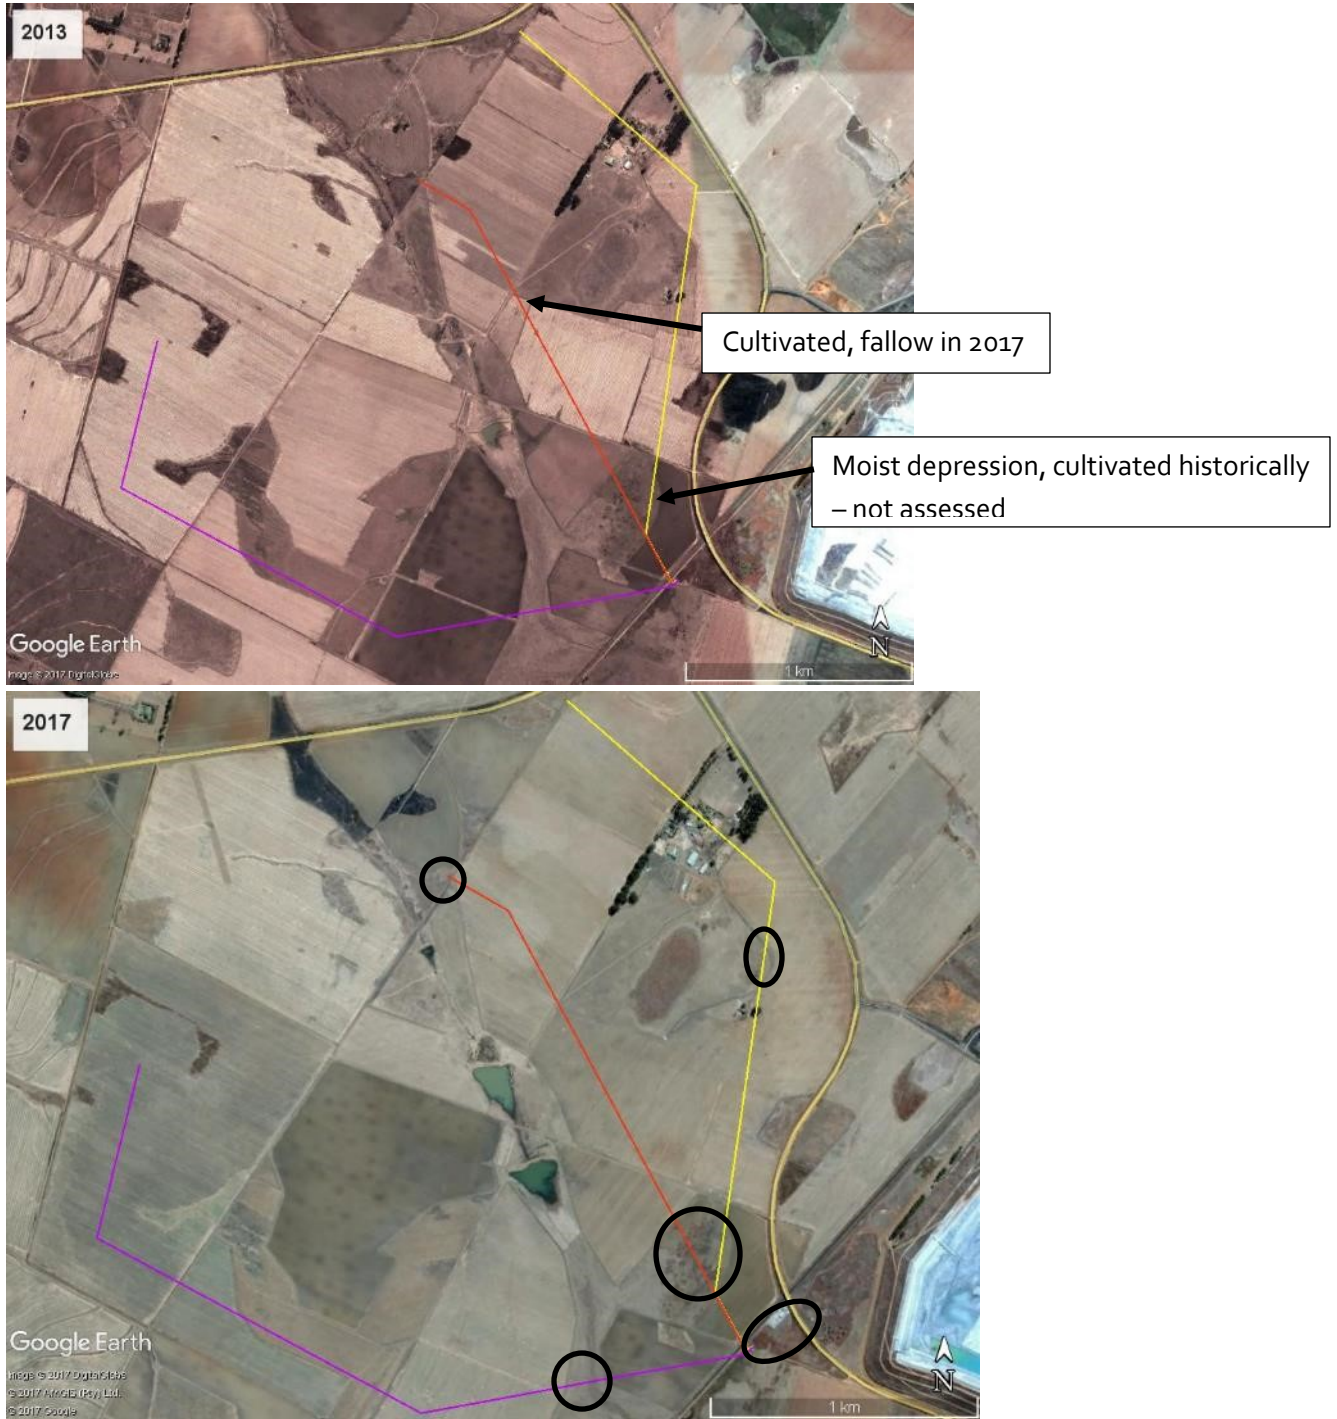
Past disturbances were considered to determine the vegetation response to such disturbances. Google Earth imagery and the topographic map in Figure 1 shows that the majority of the extent of the alternatives are cultivated with small pockets of natural grassland or fallow lands (Figure 4).

Figure 4: The majority of the project site is cultivated, remaining natural or near-natural (fallow areas) are indicated in black circles on the bottom image

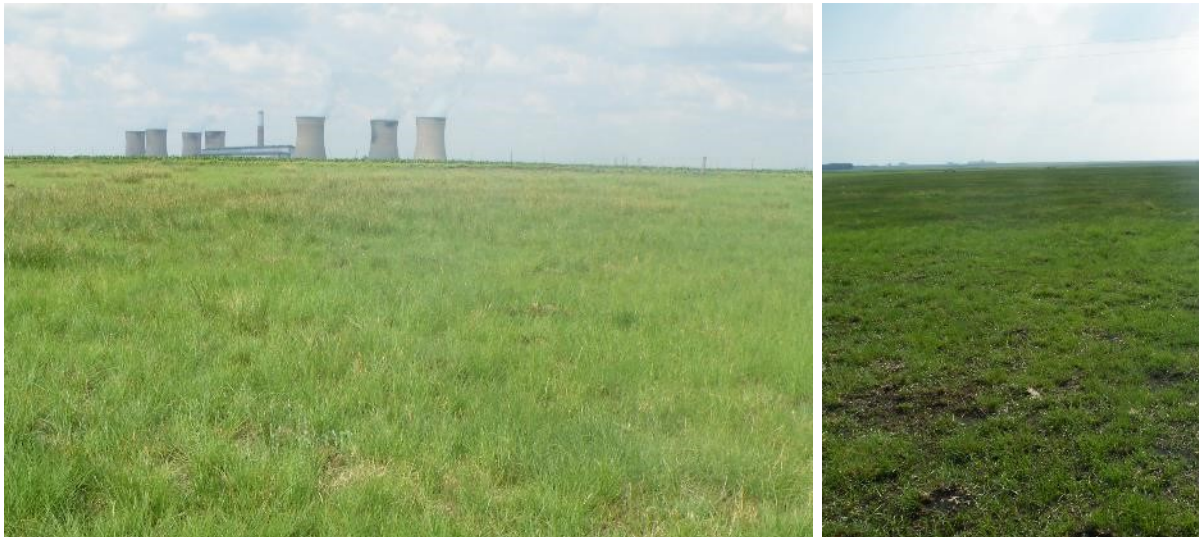
All three proposed routes traverse moist grasslands in various stages of disturbance. Alternative 3 aligns north-east of a pan area, traversing a small portion of moist grassland (Photograph 1), while another pan depression along alternative 1 & 3 was historically ploughed and not assessed at the time of the site visit. The forb diversity at the pans was limited. The moist grassland along Alternative 1 was intact, diverse and has a likelihood of supporting plant species of conservation concern (Photograph 2).

Photograph 1: Pan depressions are embedded in moist grasslands just west of Alternative 3

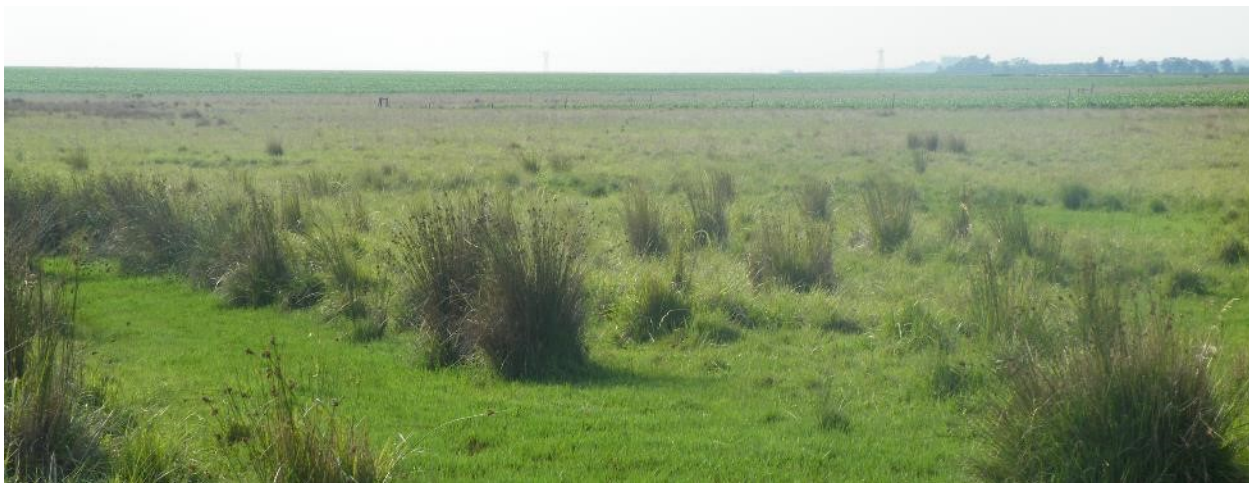
Photograph 2: Intact moist grassland that will be traversed by Alternative 2

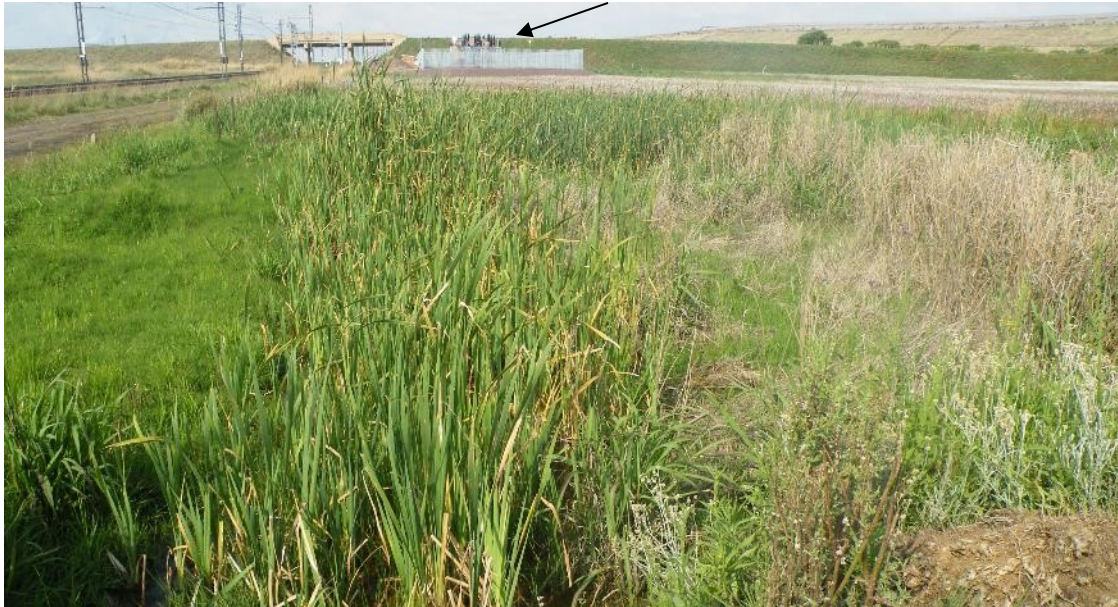
The substation locality is situated within moist grassland dominated by *Imperata cylindrica* (cotton wool grass) and *Typha capensis* (bulrush) (Photograph 3).

Photograph 3: View to the substation in the distance, situated within moist grassland dominated by *Typha capensis* and *Imperata cylindrica*
