Appendix D1: Surface Water Verification Assessment

FRESHWATER RESOURCE VERIFICATION AND DEPARTMENT OF WATER & SANITATION'S RISK ASSESSMENT MATRIX IN FULFILMENT OF REGULATION GN509 OF 2016 AS IT RELATES TO THE NATIONAL WATER ACT. FOR THE PROPOSED NEW KATHU CEMETARY, KATHU, NORTHERN CAPE PROVINCE

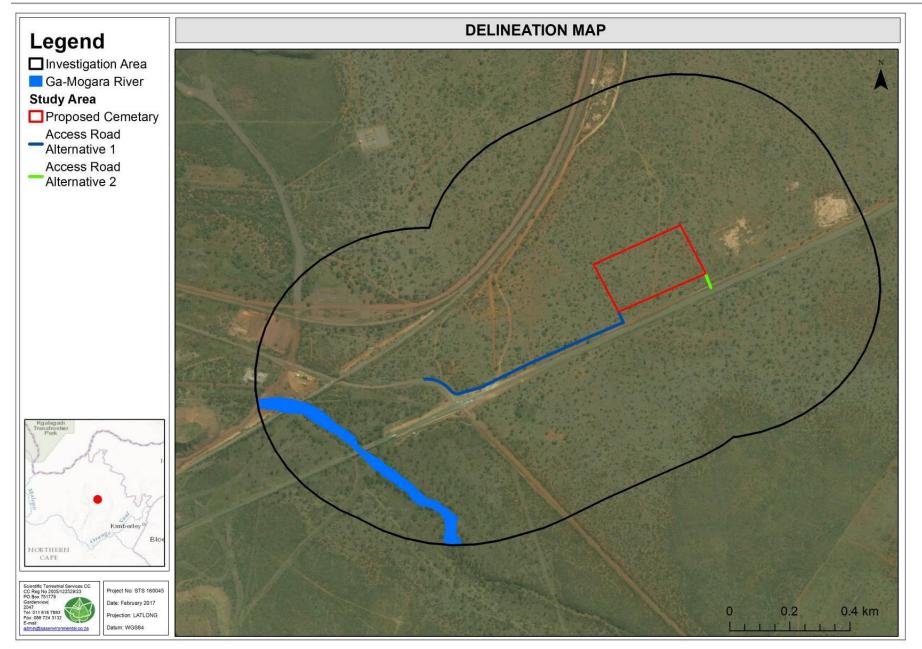
Figure 3: Digital Satellite image depicting the identified fresh water resource

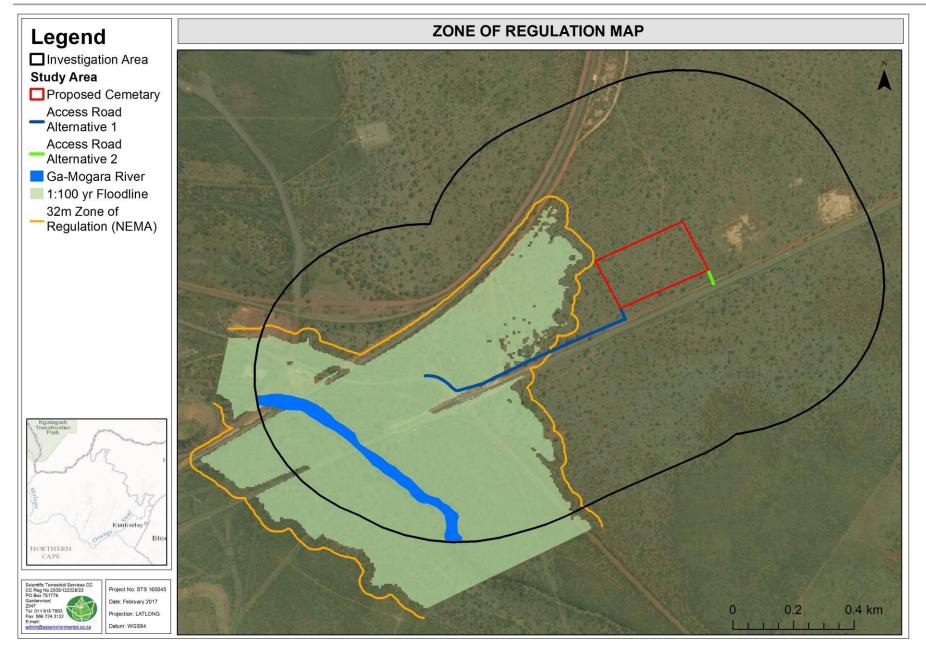
- Scientific Terrestrial Services was supplied by SLR Consulting with the calculated 1/100-year² floodline data, which indicates that Alternative 1 falls within the 1:100year flood line;

Figure 4: Freshwater resource within 500m of the study area, and the associated regulated zones

- Alternative Access 1 falls within the 1/100-year floodline, and as such if any activities are to take place within this regulated zone, authorisation will be required in terms of the NWA. Please refer to Figure 4 for the conceptual depiction of these buffer and regulated zones.

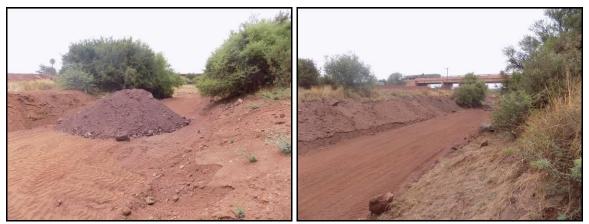
- This riparian zone of the Ga-Mogara river is considered to be more intact further downstream past the N14 bridge, however the riparian zone associated with the N14 bridge and further upstream has been significantly impacted upon and altered as a result of earth moving activities, channel diversions and mining activities;

- High levels of disturbance have altered the faunal habitat within the riparian zones, as well as within the areas outside of the riparian zone;
- Large mining roads (dirt), localised excavations, overburden dumps and the continuous movement of heavy mining equipment through the riparian zone and stream bed itself have resulted in widespread bank and stream bed disturbances; and

- These long term and ongoing impacts have resulted in an observable increased in the sediment load of the river system, where in some areas excavated material has been dumped in the stream bed;

Figure 5: Representative photographs of Ga-Mogara River north of the N14 bridge.

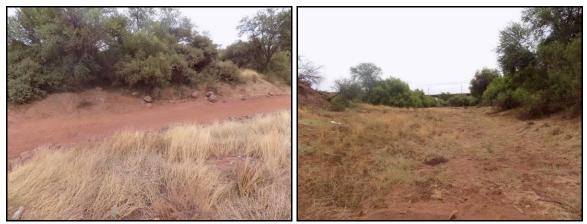
Figure 6: Representative photographs of Ga-Mogara River where the riparian zone is less degraded, south of the N14 bridge.

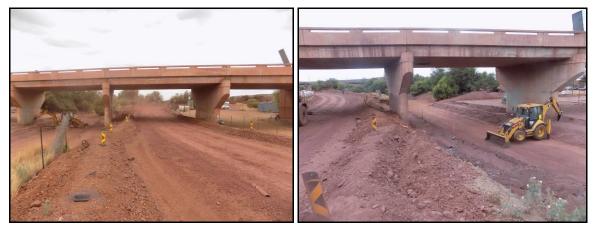
Figure 7: Representative photographs of Ga-Mogara River where the N14 crosses the river.

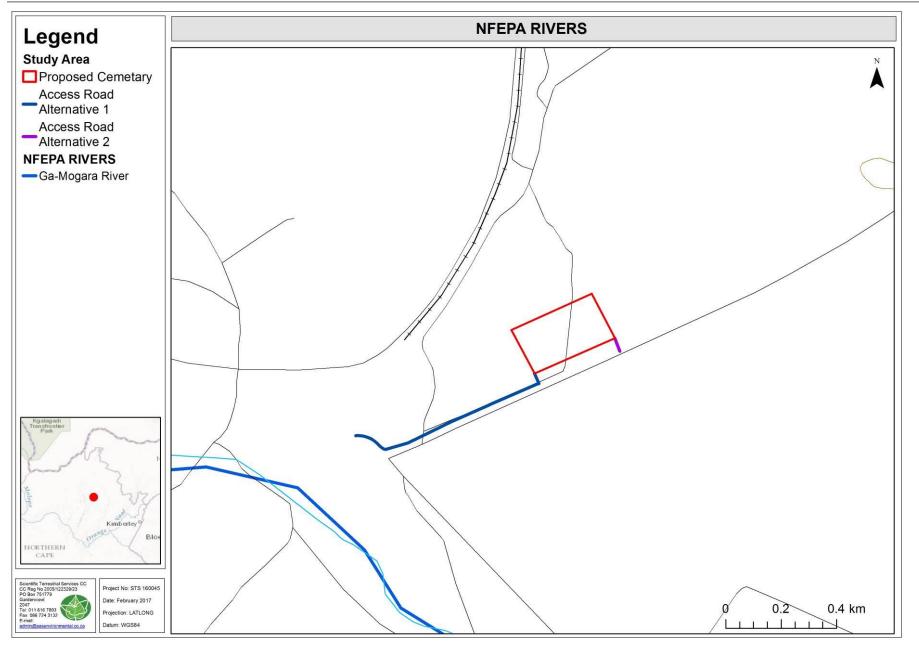
Dominant primary vegetation types	Mountain Bushveld, Kalahari Plateau Bushveld		The Ga-Mogara River is located \pm 300m to the southwest of the study area. According to the NFEPA Database the Ga-Mogara River is considered to be in a moderately modified ecological condition (Class C) (Figure A2)				
Altitude (m a.m.s.l)	700-1500	NFEPA Rivers					
MAP (mm)	0 to 500						
Coefficient of Variation (% of MAP)	30 to 40	Detail of the study area in terms of the Gamagara Local Municipality Biodiversity Summary Project (MBSP, 2010).					
Rainfall concentration index	60 to >65	The database indicated the presence of the Ga-Mogara River 300m southeast of the study area, which corresponds with the					
Rainfall seasonality	Rainfall seasonality Late summer		NFEPA database.				
Mean annual temp. (°C) 16 to 22		Ecological Status of the most proximal sub-qu	aternary reach (DWS, 2014)				
Winter temperature (July)	0 to 22 °C	Sub-quaternary reach	D41J-02464 (Ga-Mogara)

Figure A2: The Ga-Mogara River located southeast of the study area (NFEPA, 2011)
